**Preliminary Roost Assessment and Nocturnal  
Presence and Absence Bat Survey**  
98-100 High Street, Penistone S36 6BS

April 30, 2024

Paul Liptrot MCIEEM

P106

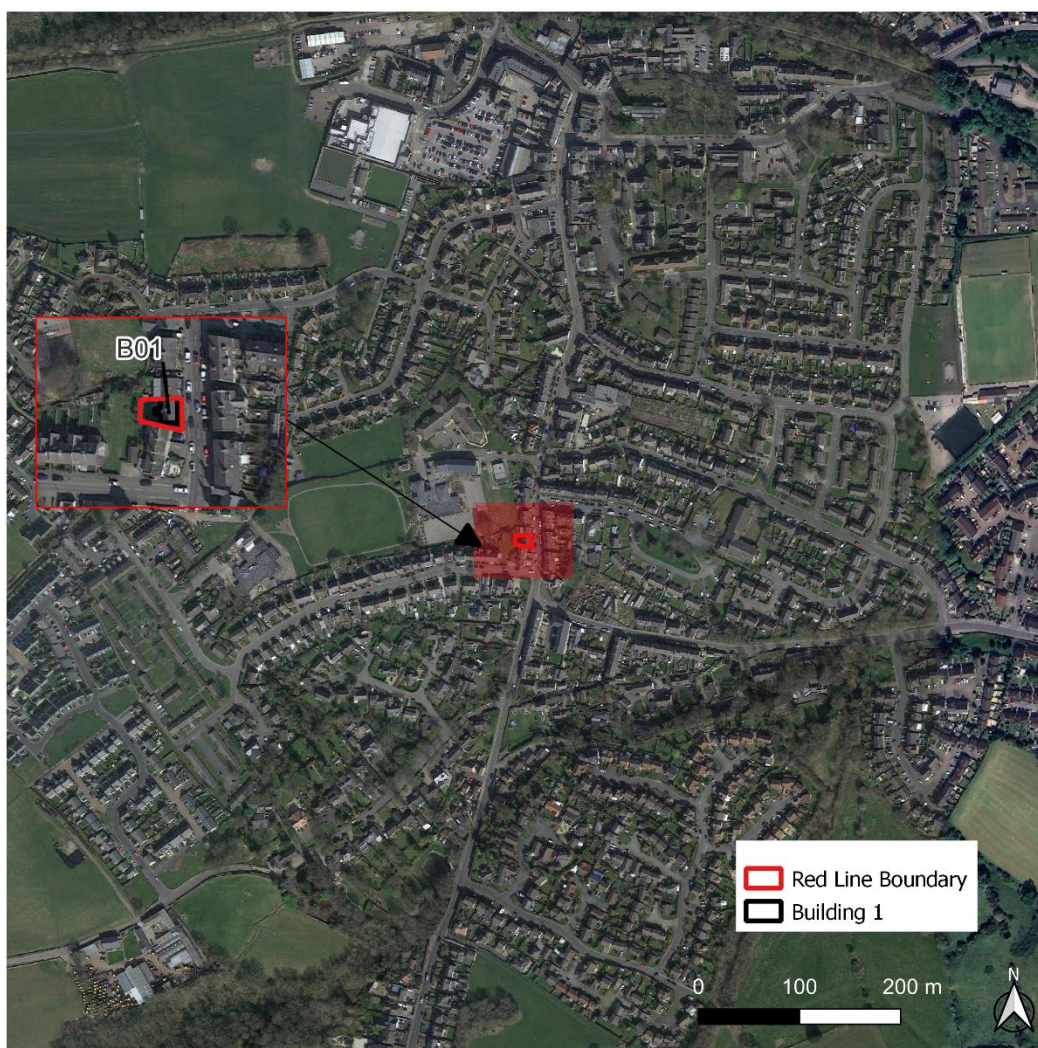
Figure 2-1 Aerial Image of the site location and surrounding habitat (© Bluesky International, © Crown copyright and database rights [2024] AC0000807948 and Google 2024).

20. Please refer to Figure 2-1 for a plan showing the location of the site and Photo Plate 1 for photos of the site's buildings.

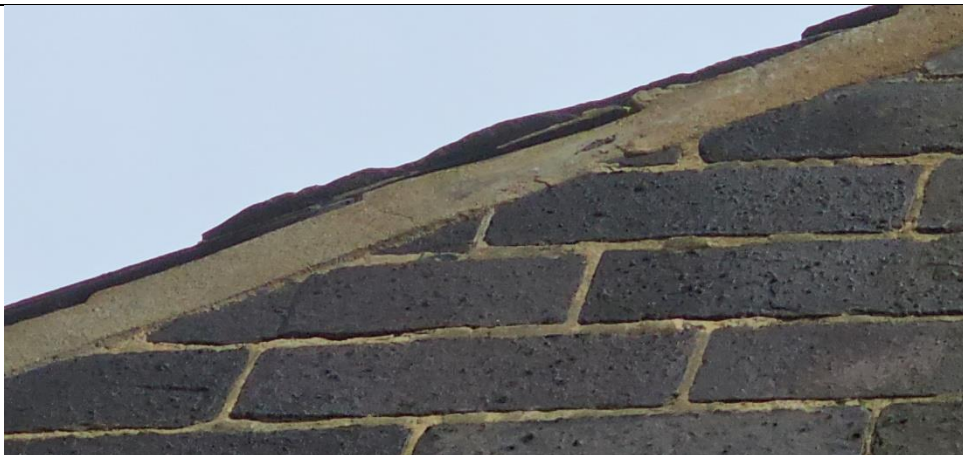
62. Suitable gaps and crevices were noted in association with the ridge tiles, as well as shifted and broken tiles around the chimneys.
63. The building incorporates a limited number of gaps and crevices, which are suitable for single to low numbers of crevice-dwelling bats. The voids offer suitability for void-dwelling species due to their size; however, no evidence of occupation was noted during their inspection.
64. Due to the location of these gaps and crevices (i.e. mainly associated with the tiles along the ridge and around the chimneys), they could not be fully inspected as part of the assessment.

Photo 5 gap along the verge of the gable.

82. The surveys confirmed that a roost is possibly present in an adjacent building and that common pipistrelle bats are active within the local area. Bat roost can form overnight; as such, we would recommend proceeding under reasonable avoidance measures detailed below;

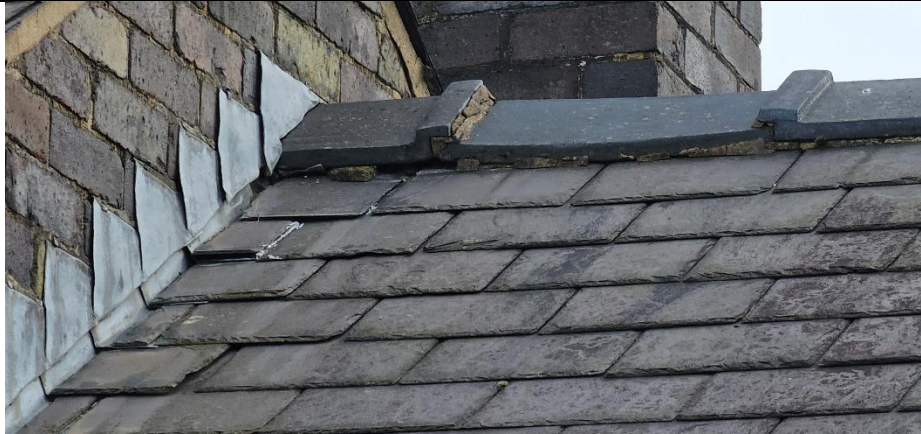
Photo 6: missing mortar and a gap under the ridge tile.

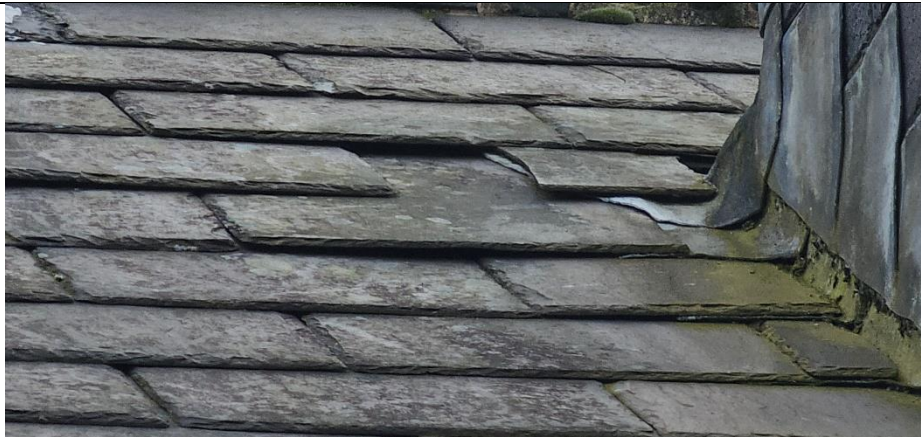
Photo 7 Shifted tiles/broken tiles near the chimney.

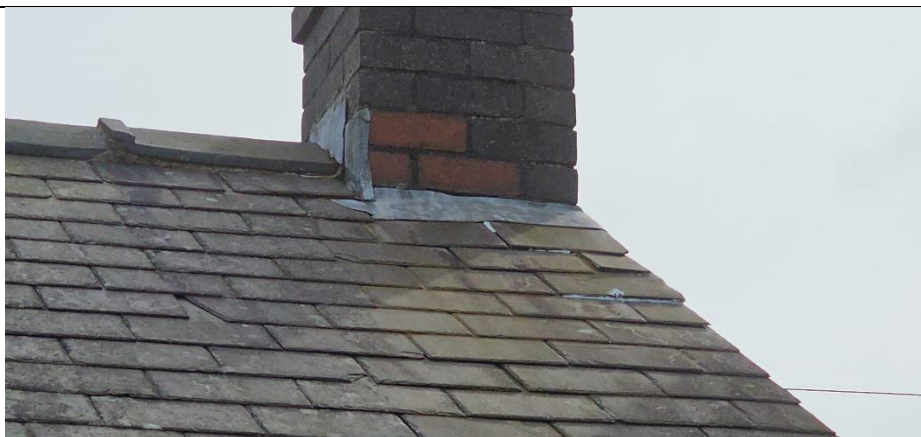
Photo 8 left tiles and gap under ridge tile.

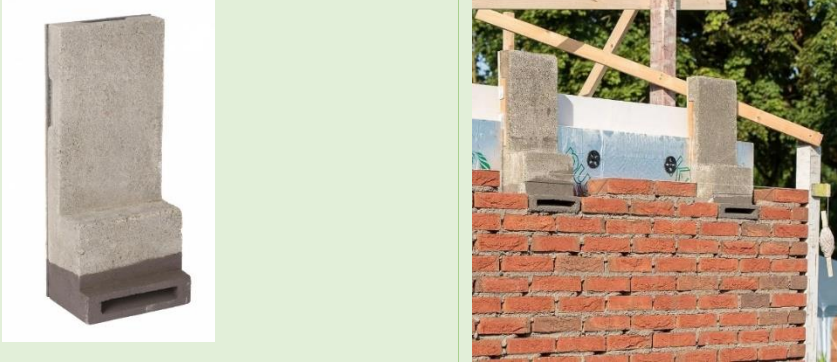
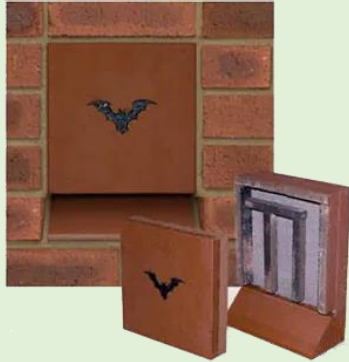
Figure 8-1 Bat roost features.

| Vivara Pro Build-in WoodStone Bat Box | Ibstock Enclosed Bat Box 'C' |
|---|---|
| <p>The Vivara Pro Build-in WoodStone Bat Box has been specifically designed to fit into the cavity of house walls. It features a slim-sized entrance hole which can sit flush with a course of bricks to provide a discreet entryway for bats. It is manufactured from hard-wearing WoodStone and plywood with removable side panels so that several boxes can be placed side by side. Position the box at least 2m above ground level, away from artificial light sources. WoodStone is a mixture of sawdust from FSC wood sources and concrete, and it is designed to last for years. It is breathable, so there will be no problems with condensation. Woodstone maintains a consistent temperature inside, providing excellent insulation for roosting bats.</p> <p><b>Dimensions: (H) 500 x (W) 210 x (D) 150mm, Weight: 5.6kg</b></p> <p>* Height: 500mm/ Depth: 150mm / Width: 210mm<br/> Weight: 5.6kg<br/> * Material: WoodStone</p> | <p>The Enclosed Bat Box 'C' from Ibstock is designed for the pipistrelle bat. It is ideal for new builds as it can be integrated directly into the brickwork to produce a discrete but attractive home for bats.</p> <p>The inside of the box is designed to create several roosting zones, which are ideal for crevice-dwelling bats such as the pipistrelle. The bottom entrance means that no maintenance is required, as droppings will simply fall out the bottom.</p> <p>This Ibstock Bat Box C is available in two sizes and three colours. Choose from smooth red, smooth blue or smooth cream brick. The box has an attractive bat motive on the front and is both durable and fully frost-resistant.</p> <p>Dimensions: Small Box - 215 x 215mm, Large Box - 215 x 290mm.</p> <p>7</p> |

It is recommended that the proposed designs incorporate integrated bat roosting and bird nesting provisions. Wall-integrated swift and house sparrow boxes and wall-integrated bat roosting boxes, as shown in Appendix 8.2, should be included in updated designs.

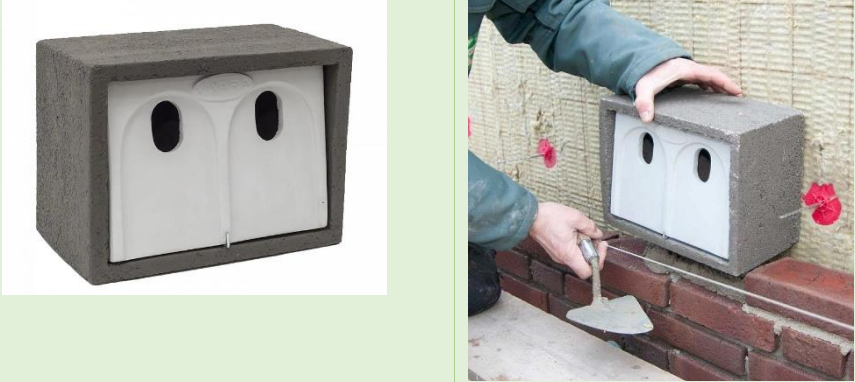
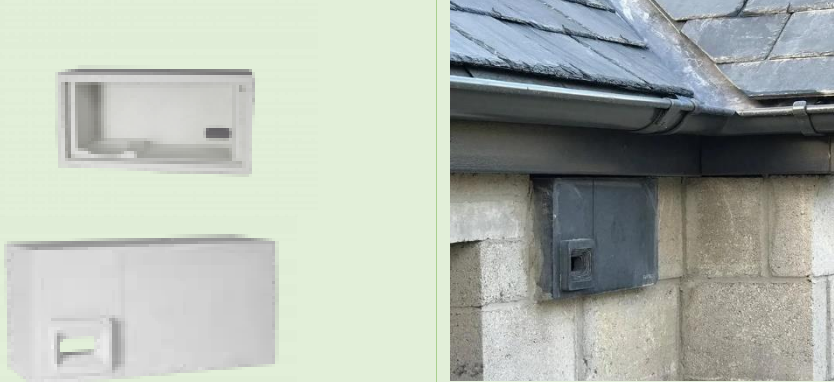
Figure 8-2 Bird nesting features – house sparrows.

| Vivara Pro WoodStone House Sparrow Nest Box | Swift Block (Large) |
|---|---|
| <p><b>House sparrows (<i>Passer domesticus</i>) are sociable opportunists that survive in most UK habitats, from towns and cities to farmland and countryside. Substantial declines in both urban and rural populations (an estimated 71% decrease between 1977 and 2008) have led to concerns for this species.</b></p> <p><b>This House Sparrow Nest Box is manufactured from WoodStone - a mix of concrete and FSC wood fibres. This material is strong and highly insulating, which helps provide a thermally stable environment within the box. It also protects against damage from predators such as cats, woodpeckers and squirrels. It is available with one or two breeding chambers, which can be particularly suitable for house sparrows as they prefer to nest in colonies.</b></p> <p><b>The House Sparrow Nest Box can be integrated into the masonry of a new house or fixed onto an external wall using strong screws and wall plugs (not included). If possible, it should be positioned near vegetation and at a minimum of 2m above ground.</b></p> | <p>The Swift Block is designed to create nesting space for swifts that can be easily integrated into new builds or retrofitted in existing properties. The front of the Swift Block is designed to sit flush with the outside bricks of a building, with the entrance slightly protruding. The Swift Block features an internal nesting bowl, a small entrance hole to deter larger birds and predators, full instructions cast into the surface for easy fitting, and a stylish entrance feature.</p> <p>Made from cast concrete, it is long-lasting and will not rot or deteriorate like a traditional wooden nest box. The cast concrete is made using up to 75% of waste materials from the Cornish China Clay industry and is standard UK breezeblock size.</p> <p>The Swift Block should be positioned at least 5m from ground level, avoiding south-facing walls, on the side of a building that gets shade during the day, or under an overhang or eaves. It should be mounted away from windows and vents and predator access. Swift Blocks should also be placed in a spot with clear adjacent access, allowing high-speed, direct flight entry.</p> <p>N.b The Swift Block does include a plate to close off the back of the box.<sup>8</sup></p> |

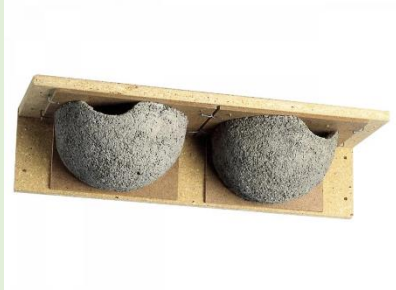
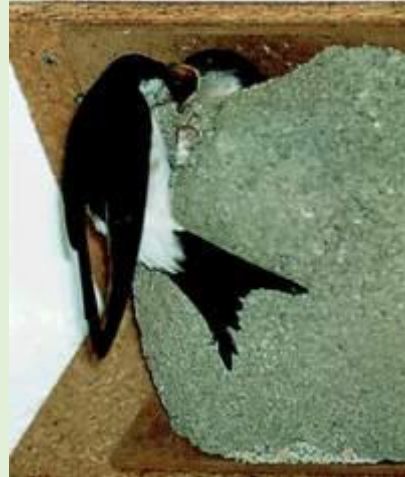
Figure 8-3 Bird Nesting features – house martins.

Easily fixed under the eaves on the outside walls of buildings, these nest boxes are perfect for house martins to return to year after year. The bowl-shaped nest is made of air-permeable wood-concrete and a backing board made of exterior grade, formaldehyde-free chipboard to prevent warping.

**Siting:** Under eaves on the external walls of buildings at a minimum height of 2m above the ground, on the sheltered side of the building. As the chipboard on these nests is moisture resistant but not weatherproof, they should always be positioned in a sheltered site, such as under overhanging eaves.

The design of the bowl means that it can be easily cleaned out in the autumn when the birds have departed. Cleaning is not absolutely necessary but is recommended if possible.

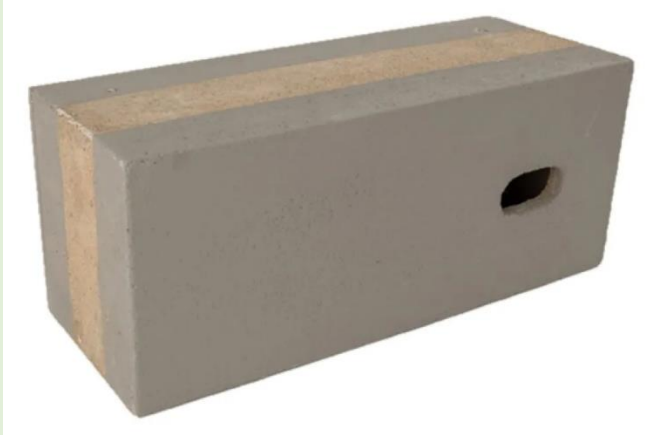
#### WoodStone Build-in Swift Nest Box Deep

Swifts in the UK have been declining rapidly over the past decades. It is thought that the destruction of suitable nesting habitats is a core reason for this decline, and many councils are now advising swift bricks to be used in new builds and renovations. Installing nest boxes such as this one will greatly help support their numbers. This built-in nest box is designed to be integrated into the cavity of a building. It is constructed from long-lasting FSC-certified WoodStone with a plywood backing. This nest box should be sat at least 5m high, with a clear flight path, and south-facing sites should be avoided.

Dimensions: 18cm x 42cm x 15.5cm (H x W x D), Weight: 5.3kg, Material: FSC-certified WoodStone and plywood
