## Preliminary Roost Assessment

Alexandra Working Men's Club, 59 High Street, Royston, Barnsley, S71 4RF

"The demolition of the on-site working men's club building (B1) and two small outbuildings (B2 and B3)."

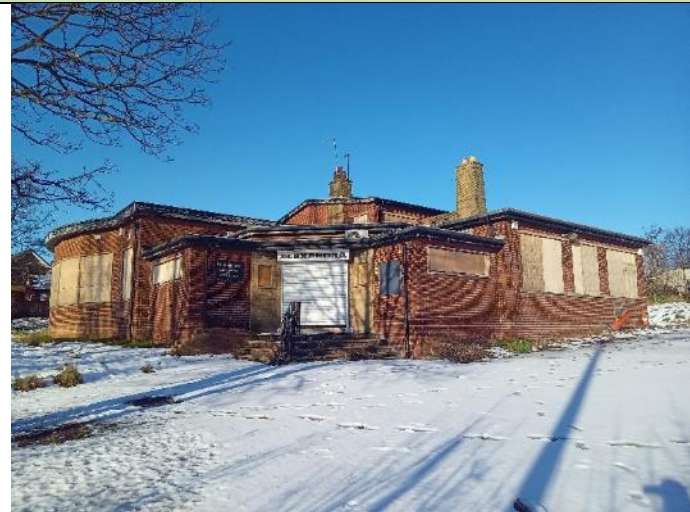
Buildings to be impacted by the proposed development are assessed for their suitability to support roosting bats below. There are a total of four buildings on-site: the vacant working men's club (B1), two small outbuildings (B2 and B3), and a small electricity substation (B4). All of the buildings were subject to survey. No evidence of roosting bats was identified along or within any of the on-site buildings.
B1 - description			Photographs
<p><i>Summary</i></p> <p>B1 is a double-storey vacant building with a pitched and gabled roof clad in bitumen, with areas of flat roof also clad in bitumen. There are wooden soffits around the building, and areas of wooden fascias and barge boards. There are two chimneys along the roof structure. The majority of the windows and doors around B1 are boarded, and the entry doors are covered by metal shutters. A few features were recorded along the building suitable for crevice and void-dwelling bat ingress to potential roosts (i.e., holes in soffits, gaps along bitumen, and missing brickwork). These features are suitable for moderate numbers of crevice or void-dwelling species. The building is unlikely to support a hibernation or maternity roost. The building has <b>moderate roost value</b>.</p>

<p><i>Recommendations</i></p>	<p><b><u>Roosting habitat:</u></b></p> <p><b>B1: Two bat emergence surveys are required during the active bat season (optimal May to August, suboptimal September) to confirm presence or likely absence of a bat roost in the building.</b> Both of the surveys should be completed during the optimal survey period mid-May to August inclusive and surveys should be spread at least three weeks apart. Infra-red cameras should be used as an aid. Six surveyors are required to provide full coverage of the building.</p> <p><b>If bat roosts are confirmed in the building additional surveys may be required to characterise the roost and to inform an EPSL application to Natural England. Surveys should be a minimum of three weeks apart. The EPSL application requires that surveys have been undertaken within the most recent active bat season and planning permission must have been granted and all relevant wildlife-related conditions have been discharged prior to submission.</b></p> <p><b>B2:B4:</b> In the unlikely event that a bat or evidence of bats is discovered during the development all work must stop, and a bat licensed ecologist contacted for further advice.</p> <p><b><u>Foraging and commuting habitat:</u></b></p> <p>No further surveys are required.</p> <p><b>A low impact lighting strategy will be adopted for the site during and post-development which outlines the areas of the site that will be retained as dark corridors.</b> Parameters can be found on the Bat Conservation Trust website: <a href="https://www.bats.org.uk/our-work/buildings-planning-and-development/lighting-2">https://www.bats.org.uk/our-work/buildings-planning-and-development/lighting-2</a></p> <p><b><u>Suggested biodiversity enhancements:</u></b></p>

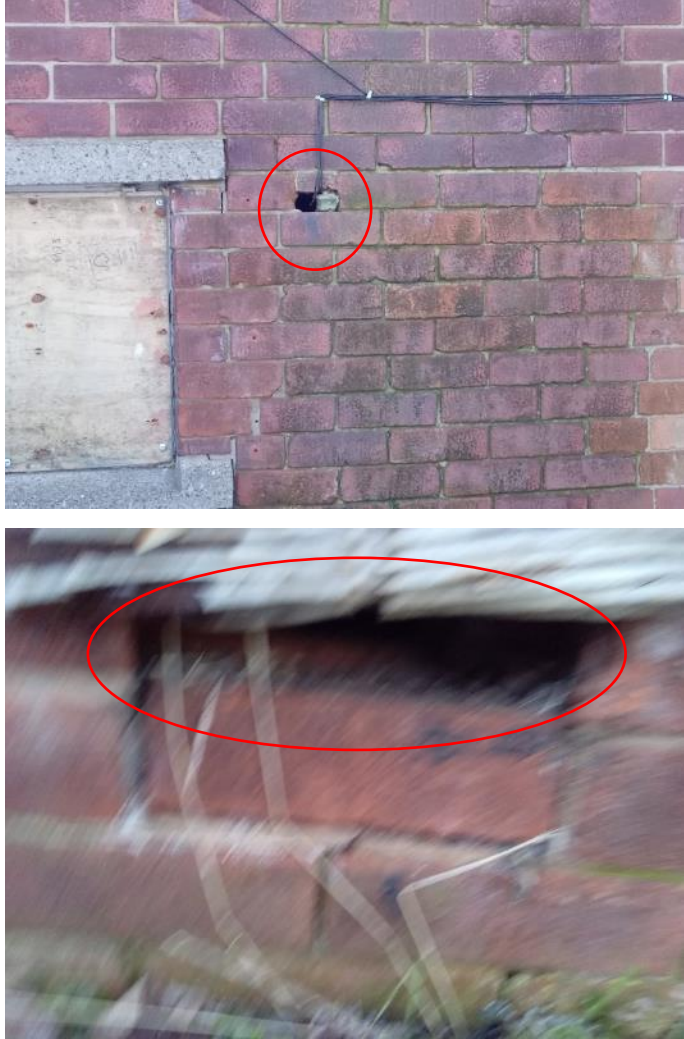
Walls	Brick and mortar	<p><b>Condition/description:</b></p> <p>An area of missing brickwork was recorded along the west elevation, which may support bat roosting ingress opportunities within the cavity walls. Also, along the north elevation of B1, is a low-lying opening where a vent is damaged, which provides possible access to bats into the cavity walls and within the ground-level cold room of the building.</p> <p><b>Suitability/access/evidence of bats:</b></p> <p>Missing brickwork and vent provide bat access into cavity walls and the vent also provides ingress opportunities into the cellar room. Suitable for moderate numbers of crevice or void-dwelling species.</p>

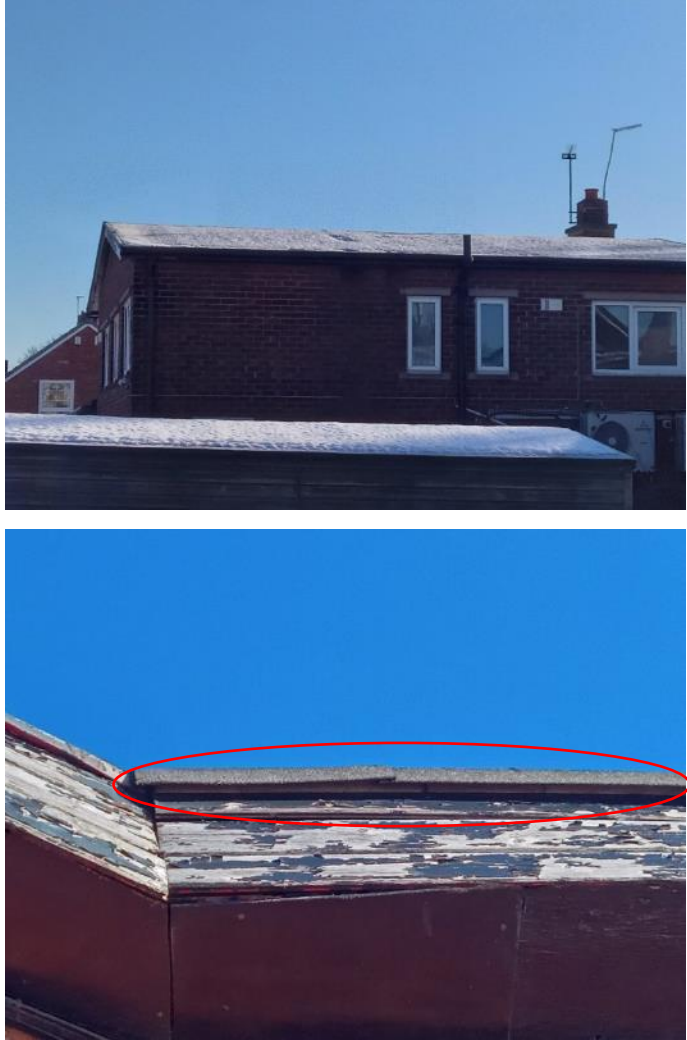
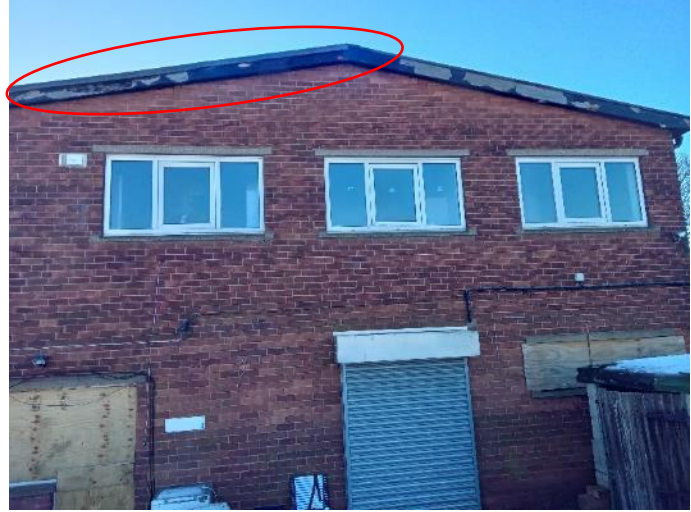
Roof	Bitumen	<p><b>Condition/description:</b></p> <p>There are areas of pitched and flat roof clad in bitumen. The area of pitched roof bitumen appears to lie flush; however, light snow covered the roof in sections, thus tears may be present suitable for bat ingress. Furthermore, lifts along the bitumen along the south and north elevations of the building are present, which may be bat ingress locations with roosting potential for crevice-dwelling species beneath the bitumen.</p> <p><b>Suitability/access/evidence of bats:</b></p> <p>Bitumen roof could support moderate numbers of crevice-dwelling species for roosting. Lifts were recorded along the north and south elevation for ingress, and further ingress locations along the bitumen may be present, not visible from ground level.</p>

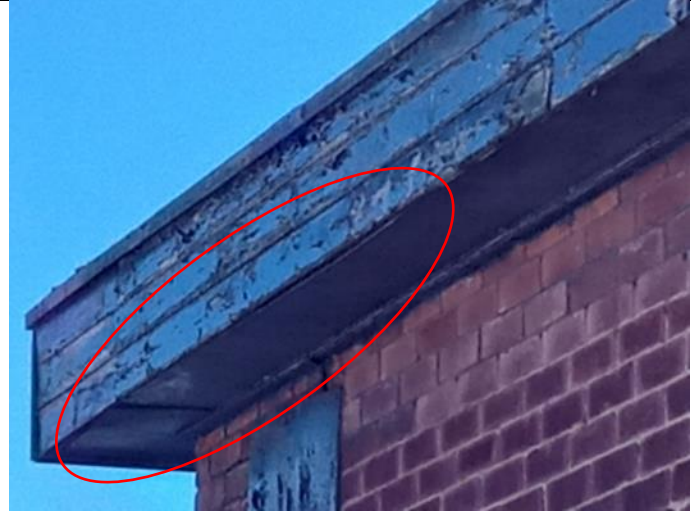
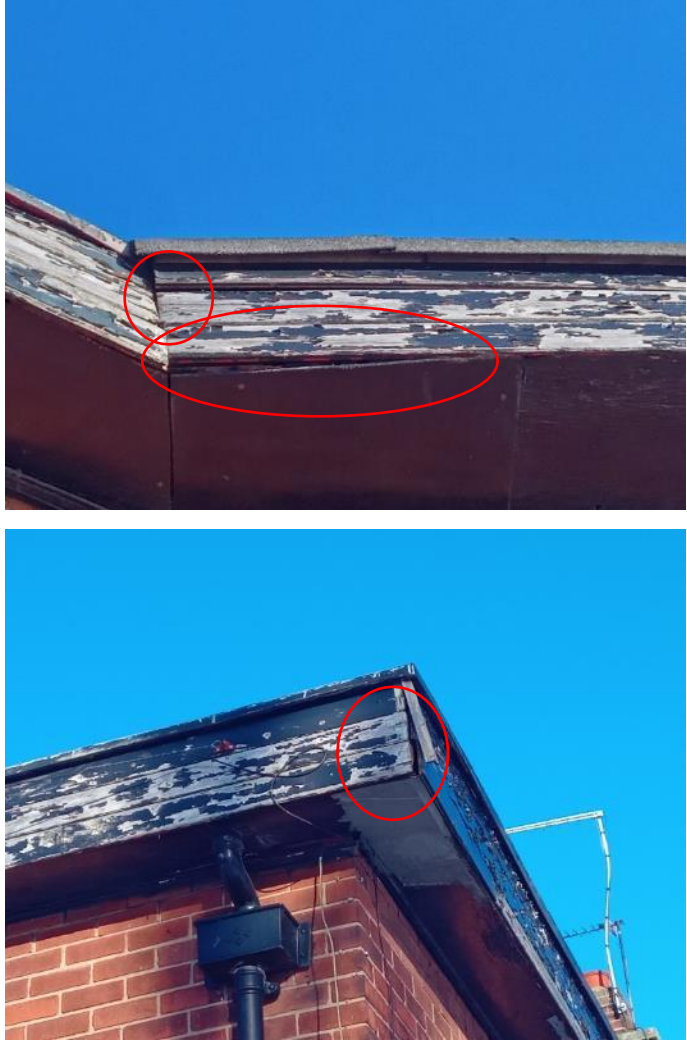
Eaves	Overhanging with wooden soffits	<p><b>Condition/description:</b></p> <p>Multiple gaps into the soffits were recorded along the west and south elevations, with opportunities for ingress by crevice or void-dwelling species, into the soffits.</p> <p><b>Suitability/access/evidence of bats:</b></p> <p>Provides bat ingress opportunities into the soffits, suitable for moderate numbers of crevice or void-dwelling species.</p>

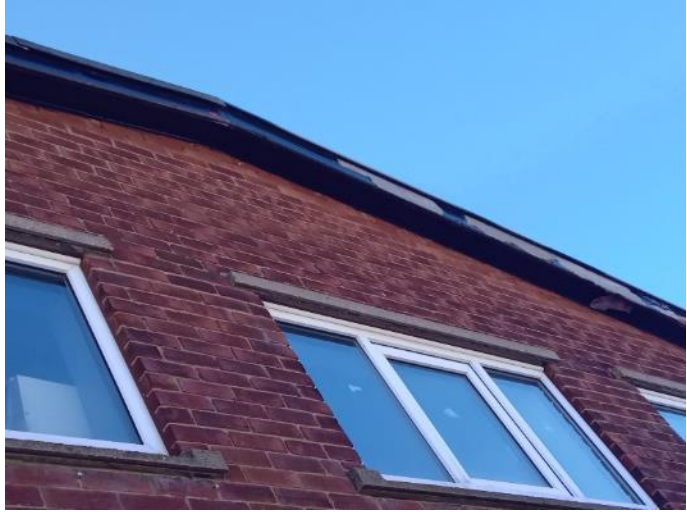
Barge boards/fascia boards	Wooden	<p><b>Condition/description:</b></p> <p>The barge boards and fascia boards appear intact with some cosmetic damage, but with no points of ingress recorded.</p> <p><b>Suitability/access/evidence of bats:</b></p> <p>No features were recorded.</p>

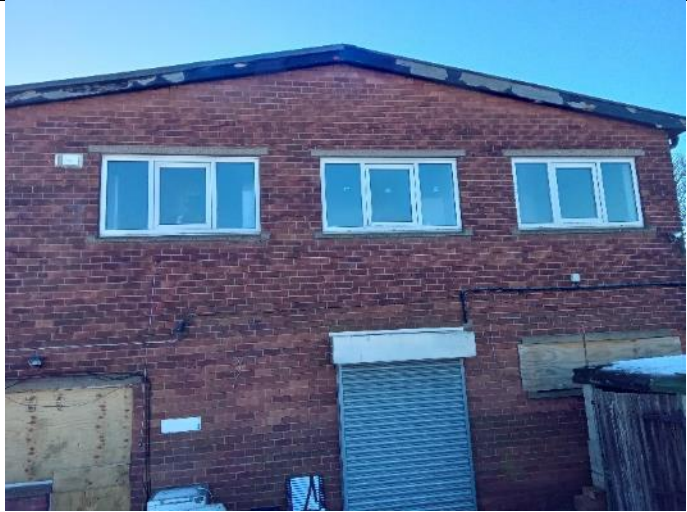
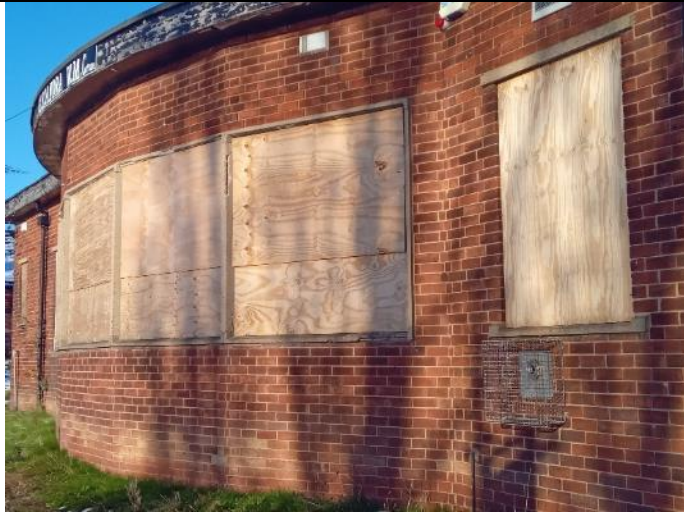
Windows/doors	uPVC framed, boarded, or covered by metal shutters	<p><b>Condition/description:</b></p> <p>The ground level windows are all tightly boarded, with no suitable features recorded. The doors have metal shutters which are tight fitting. The second-storey windows also appear tight fitting without suitable bat roost features.</p> <p><b>Suitability/access/evidence of bats:</b></p> <p>No features or evidence were recorded.</p>

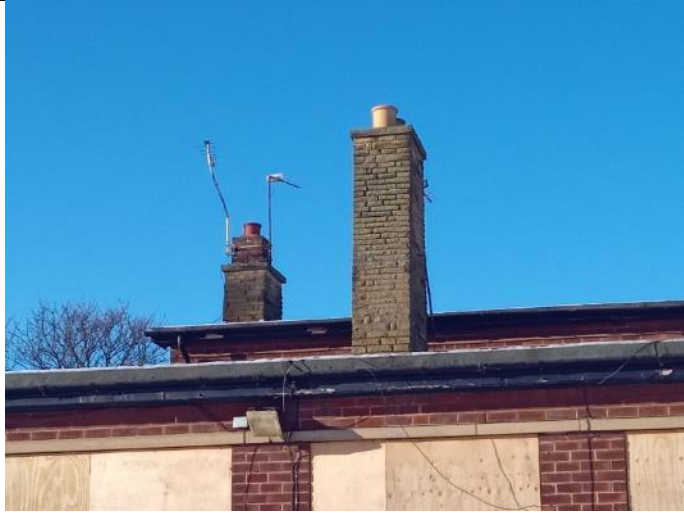
Chimneys	Stone	<p><b>Condition/description:</b> Appear intact.</p> <p><b>Suitability/access/evidence of bats:</b> No features were recorded.</p>

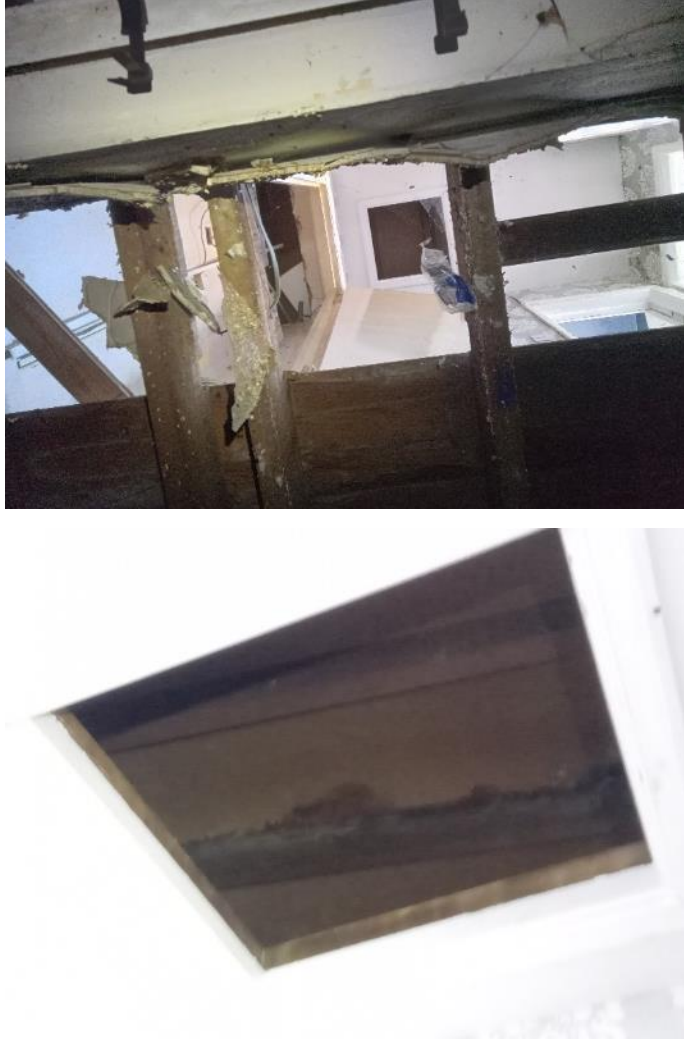
Internal voids	Plyboard	<p><b>Condition/description:</b></p> <p>The loft void of B1 was inaccessible as the building had been broken into and areas of floorboard removed, including underneath the loft hatch. However, visible from the second storey level was plyboard roof lining within the void. The building does not have any cellar space (i.e., subterranean levels), however, there is a cold room where alcohol was previously stored prior to the building being vacant. The missing vent visible externally was recorded to provide a possible ingress point into the cavity walls along the north elevation, for roosting bat ingress. The interior of the cold room and other ground level spaces were found to be unsuitable for hibernating bats, given a lack of subterranean deep crevices with a stable cold temperature and consistent humidity. The cold room temperature and humidity measurements are as follows:</p> <ul style="list-style-type: none"> <li>❖ Temperature reading: 12.0°C</li> <li>❖ Humidity reading: 50.3%</li> </ul> <p><b>Suitability/access/evidence of bats:</b></p>

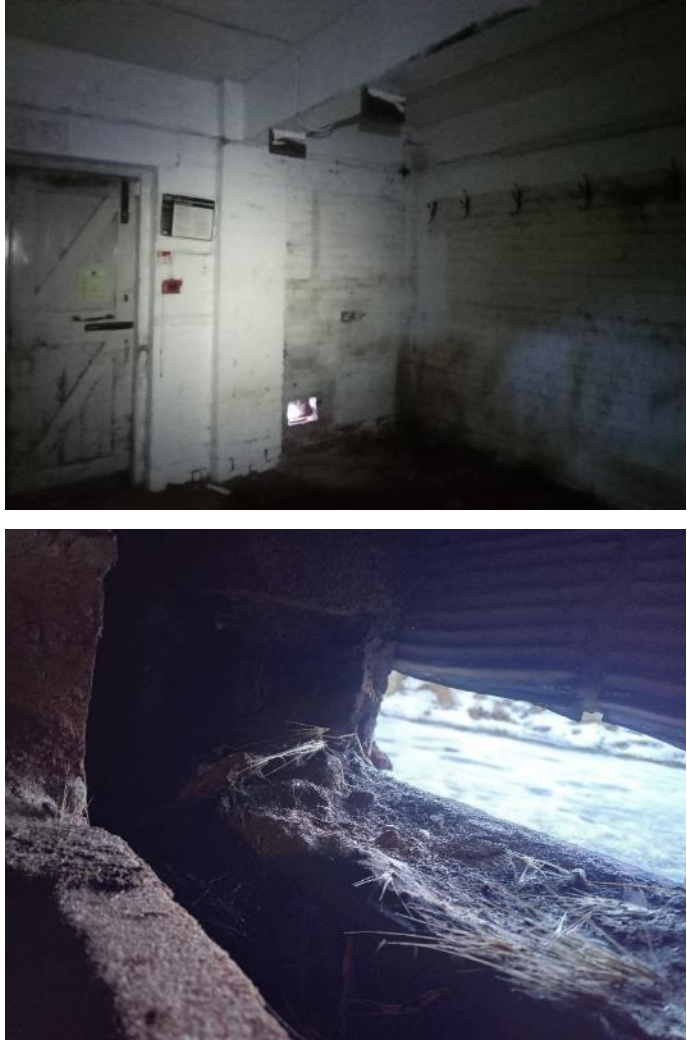
<p>Ingress via external vent into cavity walls, suitable for moderate numbers of crevice or void-dwelling species.</p>

<p>The top photograph shows the exterior of a building with white-painted walls and a white door. A small, dark vent is visible in the wall to the right of the door. The bottom photograph shows a dark, narrow cavity, likely inside a wall, with a nest made of straw and debris. A bright light source is visible at the end of the cavity on the right.</p>
--	--	--	---

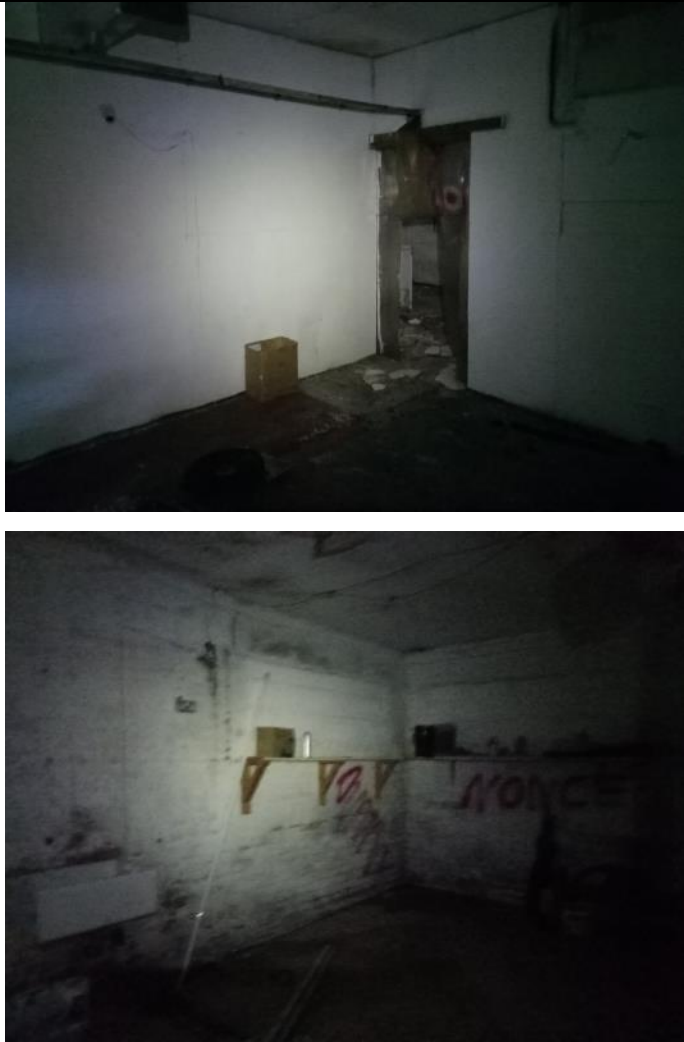
<i>B2:B4 - description</i>	<i>Photographs</i>
<p><i>Summary</i></p> <p>B2:B4 are small outbuildings which were recorded to lack any suitable roost features for crevice or void-dwelling species, and as such, have <b>negligible roost value</b>.</p>
