P17-00360-Met-RP-GE-001

Darley Grove

Phase I Desk Study

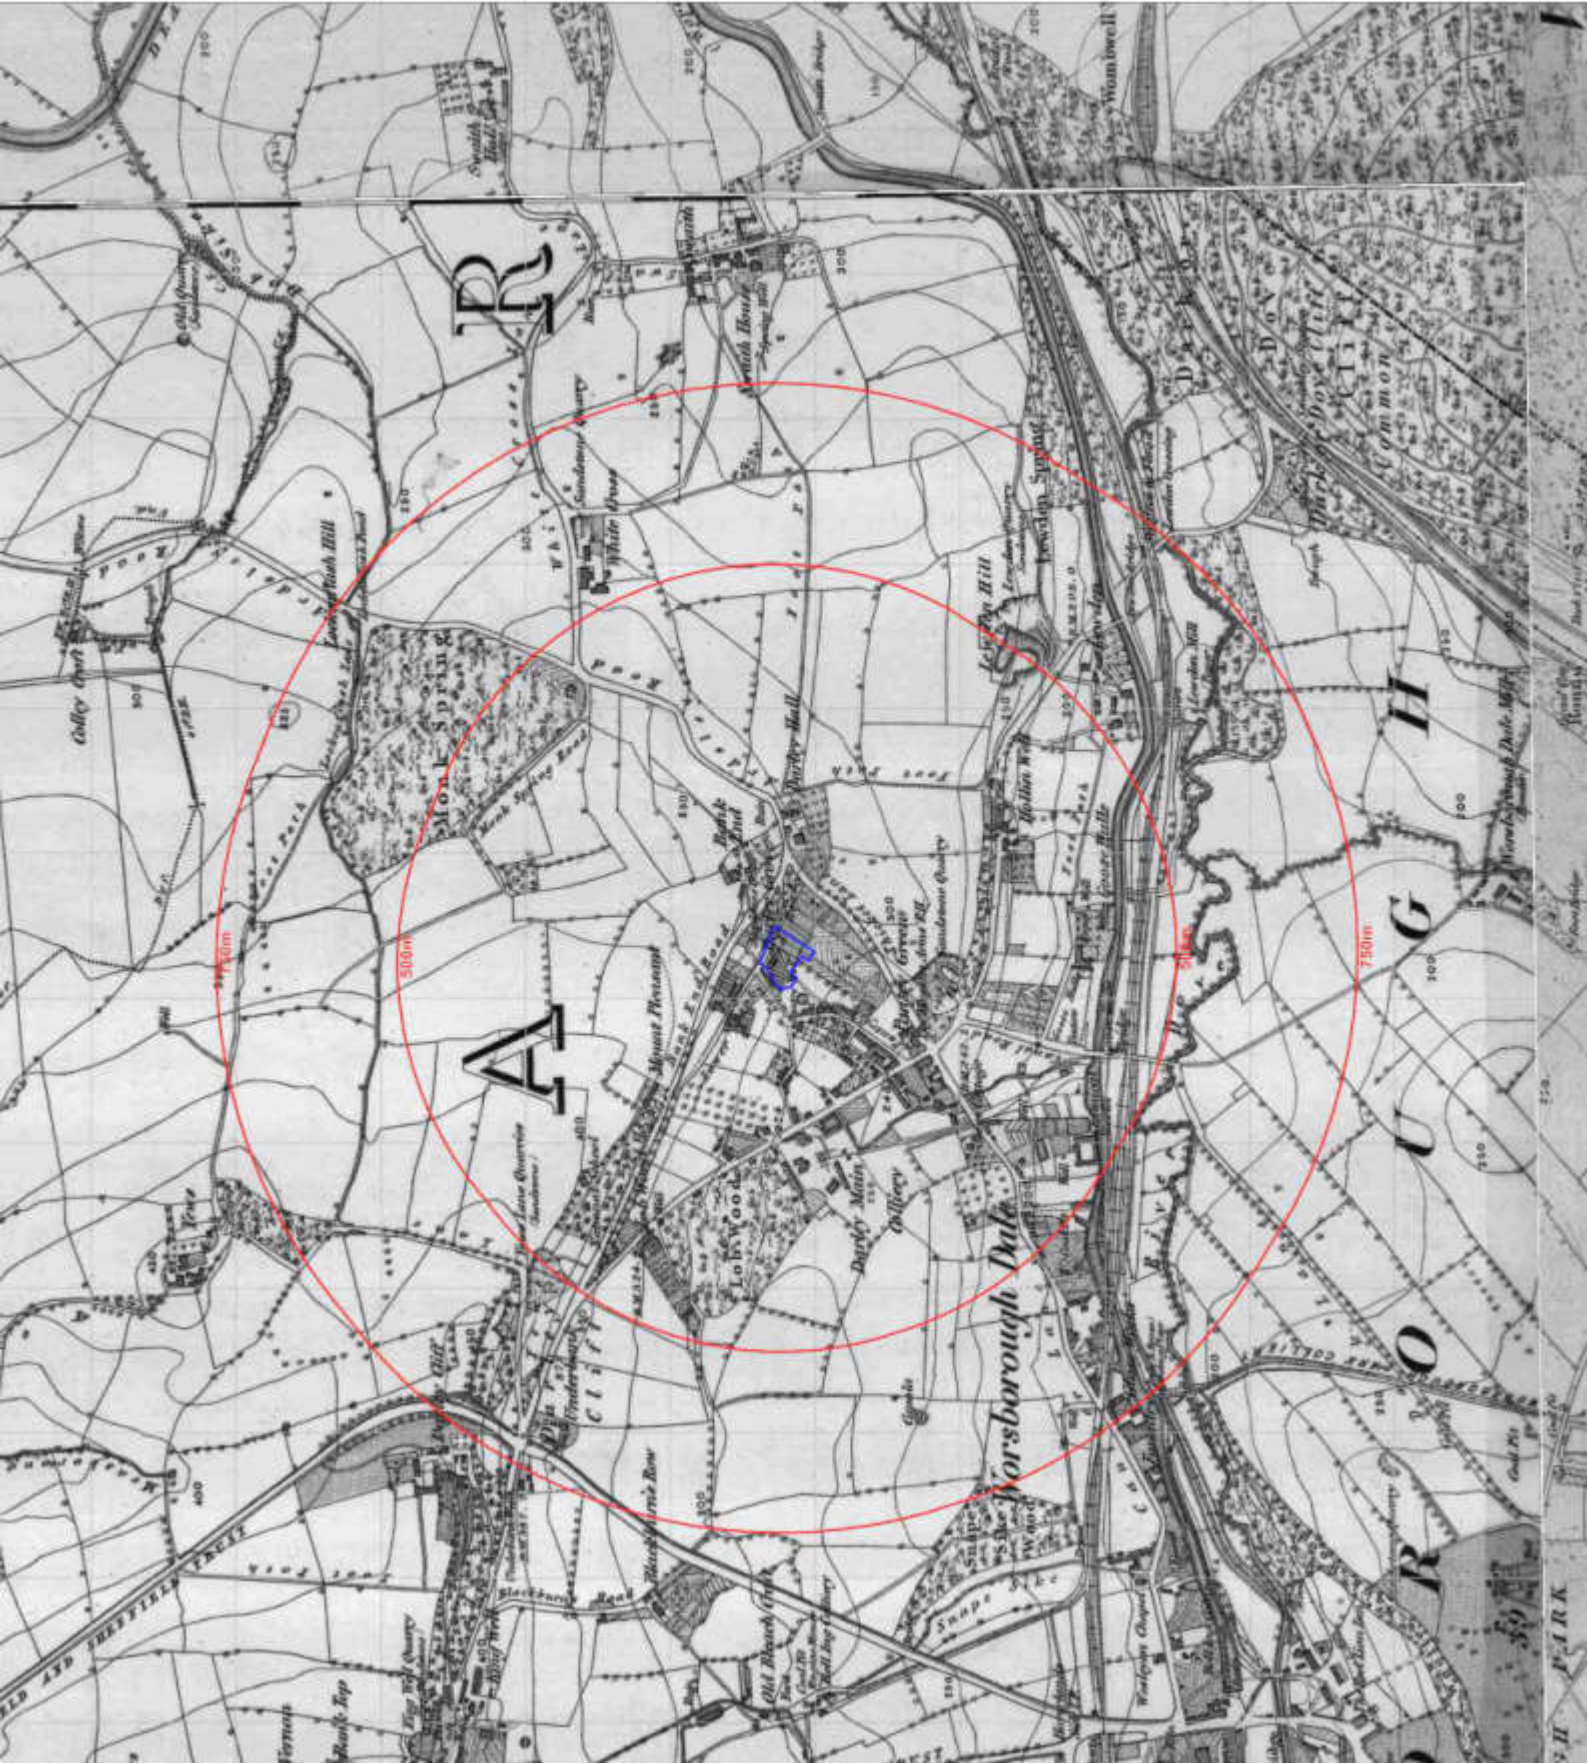
Map Name: County Ser
Map date: 1850-1855
Scale: 1:10,560
Printed at: 1:10,560

Year (map scale)	Comment
1850-1855 (1:10,560)	<p>The site was originally noted as agricultural land labelled 'Darley Grove'.</p> <p>The surrounding area was mainly agricultural land with sandstone quarries 20m north and 200m south of the site. Darley Main Colliery was located approximately 250m south west of the site. A railway line and the Dearne Dove Canal Worsborough are also situated less than 500m south of the site.</p>
1892 (1:2,500)	<p>The site has now been developed with unlabelled residential housing in the north, including the existing Darley House and Stables, and a small woodland in the centre. A small excavation appears in the western corner of the site.</p> <p>Buildings are shown along the north western boundary of the site. A pump is located 50m south west of the site and a cricket ground has been developed approximately 60m north. The sandstone quarries to the north and south still appear to be active. Shafts are shown approximately 200m and 225m west of the site.</p>

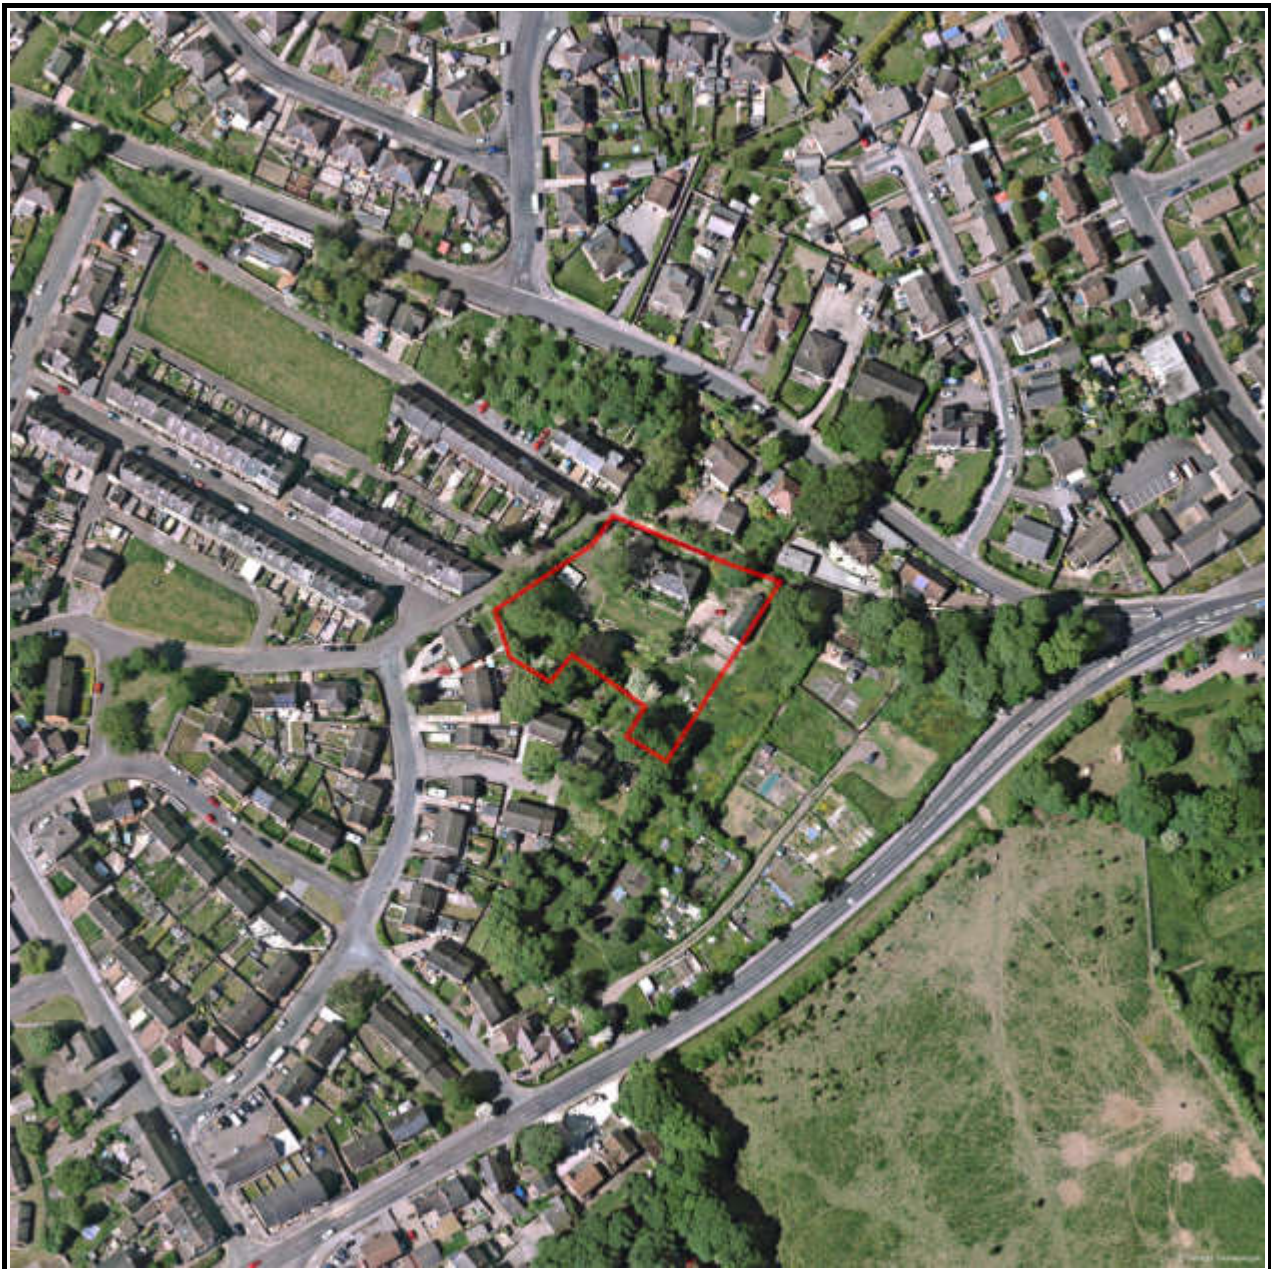
Aerial Photograph Capture date: 07-Jun-2013
Grid Reference: 436256,404044
Site Size: 0.33ha

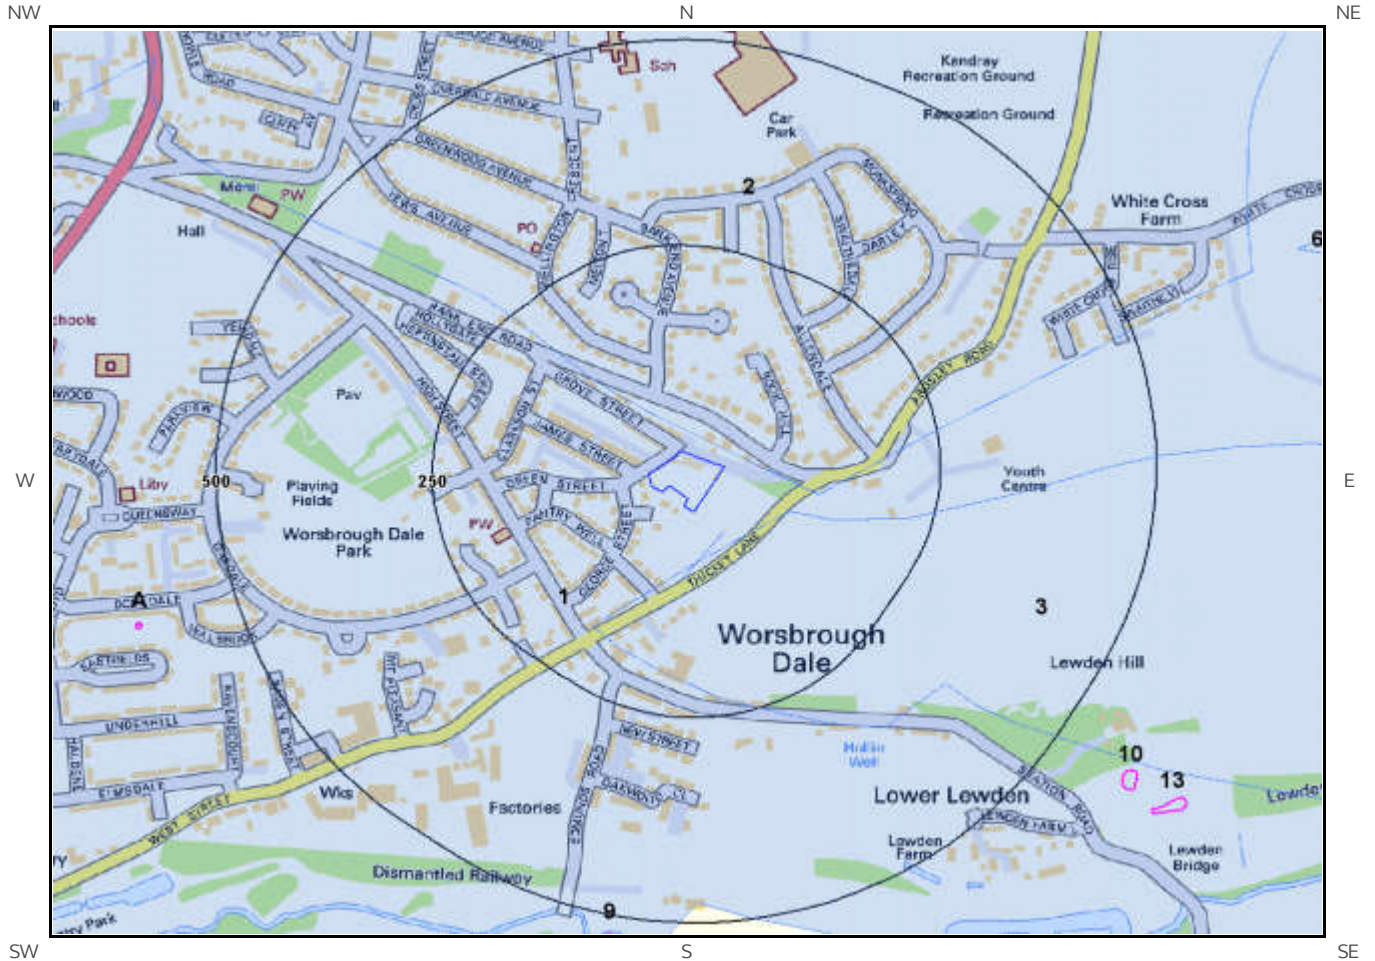
5 Mining, Extraction & Natural Cavities Map

ID	Distance (m)	Direction	Name	Commodity	Assessment of likelihood
1	0.0	On Site	Not available	Iron Ore (Bedded)	Localised small scale underground mining may have occurred. Potential for difficult ground conditions are unlikely or localised and are at a level where they need not be considered
2	20.0	NE	Sheffield Area	Vein Mineral/Iron ore	Localised small scale underground mining may have occurred. Potential for difficult ground conditions are unlikely or localised and are at a level where they need not be considered
3	54.0	SE	Sheffield Area	Vein Mineral/Iron ore	Localised small scale underground mining may have occurred. Potential for difficult ground conditions are unlikely or localised and are at a level where they need not be considered
Not shown	558.0	S	Sheffield Area	Vein Mineral/Iron ore	Localised small scale underground mining may have occurred. Potential for difficult ground conditions are unlikely or localised and are at a level where they need not be considered

Mining	<p>The site is within a Coal Mine Reporting Area therefore a Coal Report has been obtained from The Coal Authority, which can be found within Appendix III of this report.</p> <p>The Coal Authority confirm that the site is in the zone of influence of workings in 11 No seams of coal at 150m to 530m depth, last worked in 1970. Any movement from these workings should have stopped by now.</p> <p>In addition, the property is in an area where the coal authority believes there is coal at or close to the surface which may have been worked at some time in the past.</p> <p>The site is not affected by any present or planned underground mining however reserves of coal do exist in the area which may be worked at some time in the future.</p> <p>There are no mine entries within 20m of the site. There may however be mine entries in the local area which the coal authority has no knowledge of.</p> <p>The site is not affected by any past, present or future opencast mining.</p> <p>The Coal Authority have received a claim for coal mine related subsidence for a property within 50m of the site. This is located to the north west of the site boundary.</p> <p>The site is within a Development High Risk Area with regards to shallow coal mining, therefore a Coal Mining Risk Assessment has been carried out as part of this report and is presented in Section 4.</p>

Coal Mining Issue	Yes	No	Discussion	Risk
Underground coal mining (recorded at shallow depths)		X	There is no evidence of shallow coal mining beneath the site.	Low
Underground coal mining (probable at shallow depths)	X		It is likely that coal seams are beneath the site at depths of less than 30m	High
Mine entries (shafts and adits)	X		There are no known mine entries or adits. However mine entries may exist that the coal authority have no record of.	Moderate
Coal mining geology (fissures)		X	There are coal seams outcropping in close proximity to the site. However the coal authority has no record of faults or other lines of weakness that have been affected by coal mining.	Low
Record of past mine gas emissions or potential		X	No record made by the Coal Authority	Low
Recorded coal mining surface hazard	X		1 claim for coal mining related subsidence within 50m of the site boundary.	High
Surface mining (opencast workings)		X	There are no known surface workings within close proximity to the site	Low

From the above discussion it is likely that underground coal seams are present beneath the site at depths less than 30m. The Coal Authority believe that there is a risk that these have been worked at some time in the past by underground methods. Therefore the risk to the site from migration of crown holes towards the surface as a result of the collapse of unrecorded shallow coal workings is considered to be **HIGH** and further intrusive site investigation is recommended.

The site is located within a development high risk area with regards to shallow depth coal mining, and as such a formal coal mining risk assessment has been carried out. Based on the information presented within this report, it is considered that the risk from shallow depth mining works is High and a shallow coal mining site investigation comprising rotary open hole boreholes to 30m is recommended.
