**Bat Emergence Survey  
Barnsley Road Cottage, Penistone**

Report reference: R-2371-04  
October 2015

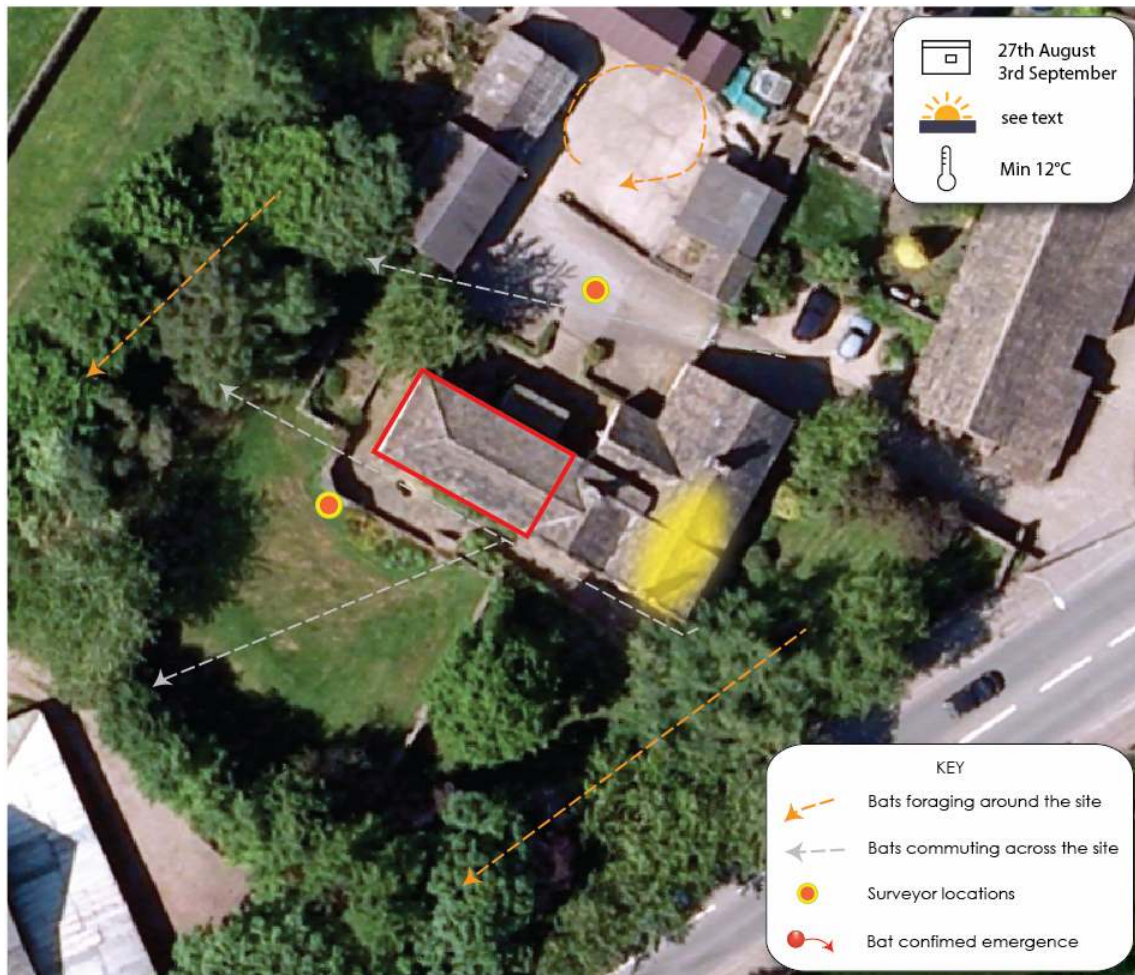
**Figure 1** Bat activity drawing. Shaded Yellow area indicates the possible location of a small common pipistrelle roost in the adjacent building.

17. Emergence survey work has confirmed the likely absence of roosting in the section of building where demolition is proposed.
18. However, due to the nature of the roof having multiple small crevices between the tiles, and the potential presence of a single common pipistrelle roosting in the roof of the adjacent cottage. It is recommended that if works are to commence during the peak season when bats are active (April - August) that another emergence survey is undertaken in order to confirm absence of roosting immediately prior to works, or that works to remove tiles from the roof are supervised by a suitably qualified ecologist. During the remainder of the year (when emergence survey is not suitable) it is advised that the roof strip is supervised by a suitably qualified ecologist.
