Arboricultural Constraints / Impact Report

Land off Castle Lane, Penistone Sheffield S36 6AH

Report Reference: 051225/ RP/CL
Tree Constraints Plan Reference: AA01TCP/RP/CL
Survey Conducted: December 5th, 2025

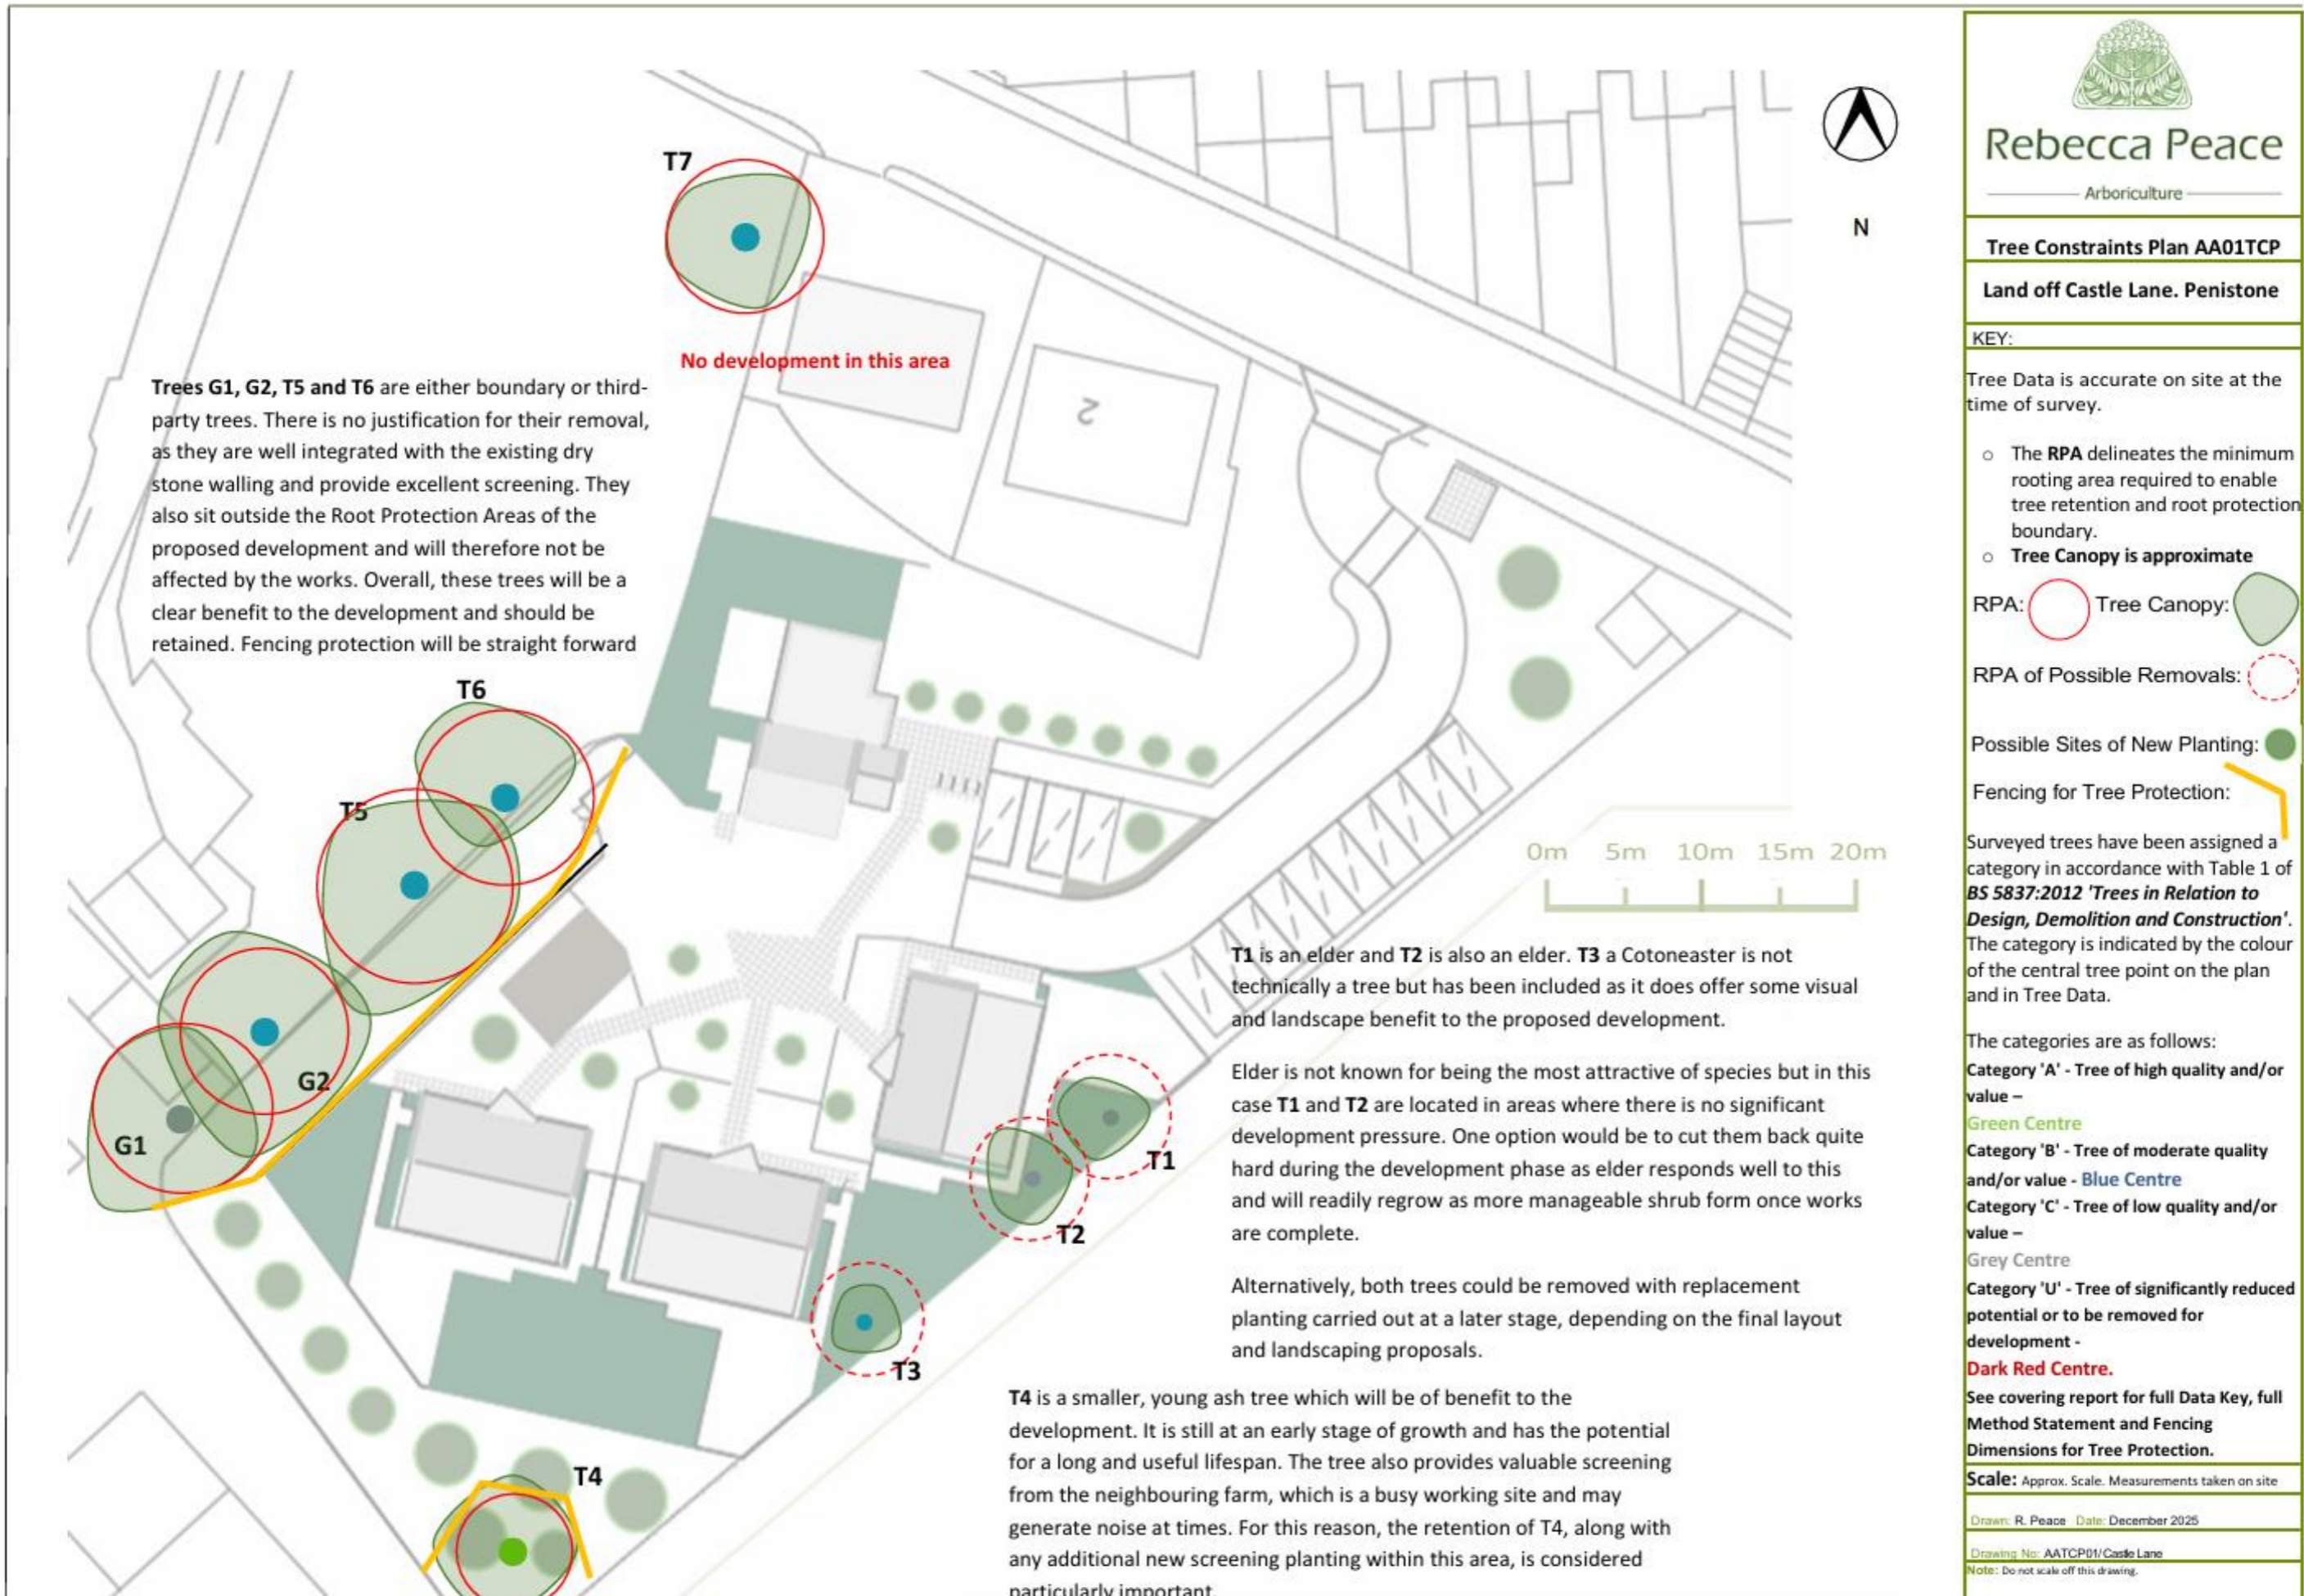
- 6.2** The development proposals are still at a preliminary stage and, as such, this assessment focuses on identifying key arboricultural constraints, opportunities for retention and areas where flexibility in design will support successful tree integration. The assessment is informed by the tree survey data in Appendix 1 and the Tree Constraints Plan AA01TCP/RP/CL, which is attached to this report.

- 6.7** The Tree Constraints Plan clearly identifies Root Protection Areas and canopy spreads and should be used to inform the final layout, access routes and construction sequencing. Where works are proposed close to retained trees, appropriate tree protection fencing and ground protection will be required in line with BS5837:2012.

Protective fencing shall be erected at the positions shown on the approved Tree Constraints and Protection Plan AA01TCP/RP/CL.
