# New House Farm (Outbuilding), Penistone

## Bat Survey Report

15<sup>th</sup> February 2018

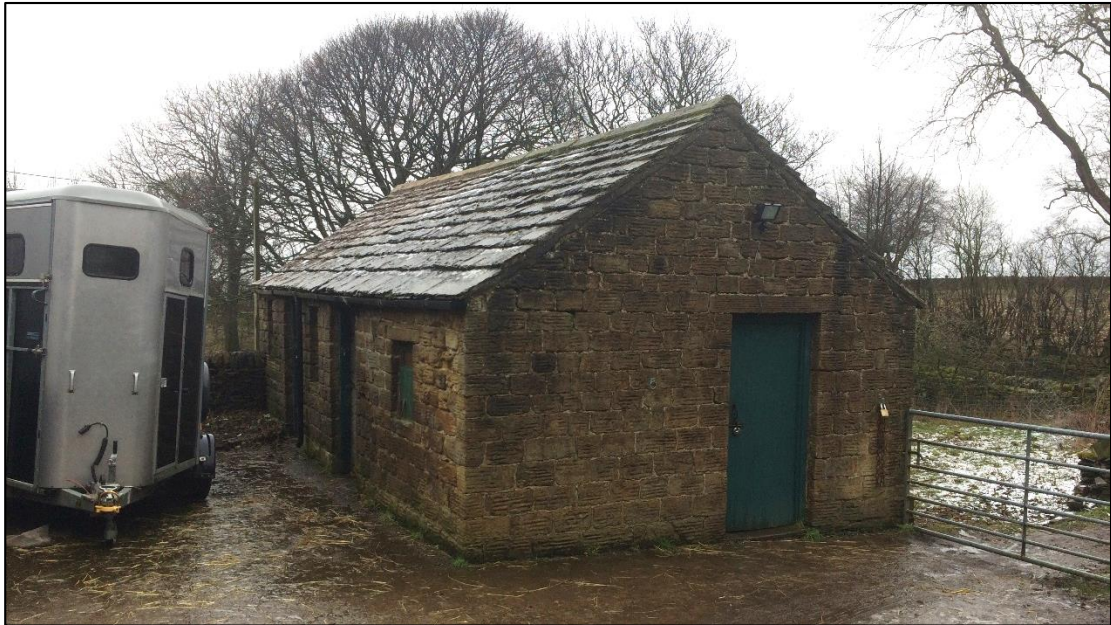
**Plate 1. South-southwest gable**

5.2.2 The surveyed building comprises an old rectangular single storey detached stone built out-building on a south-southwest to north-northeast axis. The building is small with three doorways which lead to three small separate compartments beneath a pitched York stone/grey slate roof (see Plates 1, 2 & 3). The out-building is part of a complex of buildings including a dwelling, large barn and derelict (former) farm house, all of which offer bat roost potential.

- 5.2.4 The buildings masonry offers potential access to the rubble filled core of the walls in at least 15 locations (mainly on the east-southeast elevation). There is also potential access to the wall top on both side together with a York stone slate roof which offers a plethora of potential access locations to the void between slates and membrane.

6.3.1 It compliance with bat survey good practice guidelines (Collins 2016) and in order to confidently determine the presence/absence of roosting bats, it is recommended that the building is subject to two nocturnal surveys. The initial dusk nocturnal survey should be undertaken by a team of two surveyors, with the second survey (dawn) undertaken by a single surveyor. The two surveys should be separated by an interval of at least two weeks during the bat activity period (peak period: May-August).

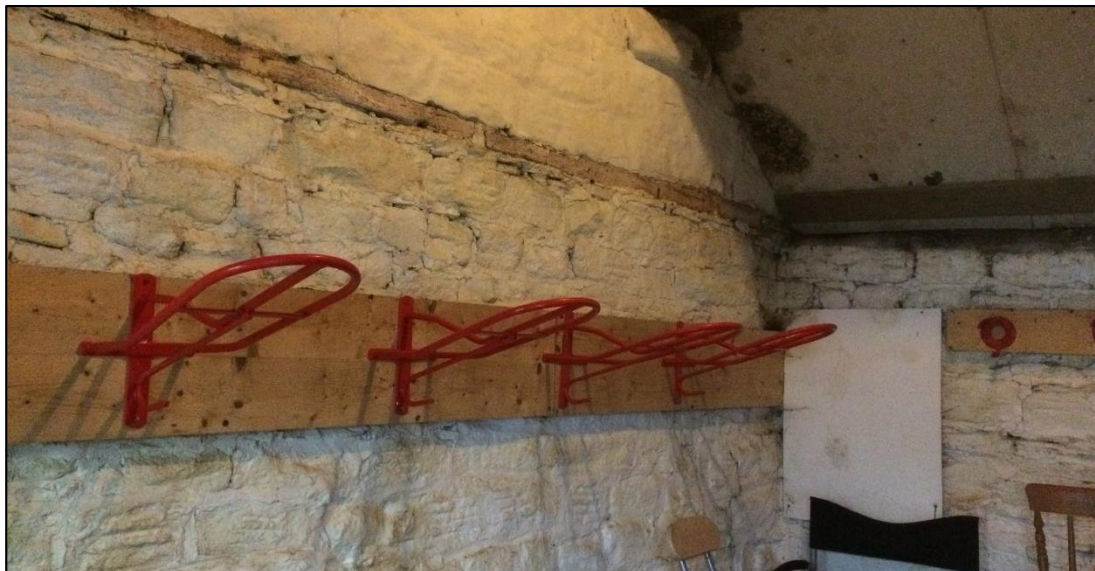
**Plate 3. Inside of one of the end compartments**

- 5.2.5 The inside is open to the underside of the roof which has been constructed in the traditional way with purlins. There is a plastic membrane (not breathable) beneath the

slates and the compartments at either end comprise plywood sarking. Wood boards supporting cycle hangers display a feature (gap behind) with potential to accommodate bats (see Plate 3).
