**HILL END ROAD FORMER PUMPING  
STATION.**

**BAT SURVEY.**

**Ref No: 220177.**

**Date: 24<sup>th</sup> January 2022.**

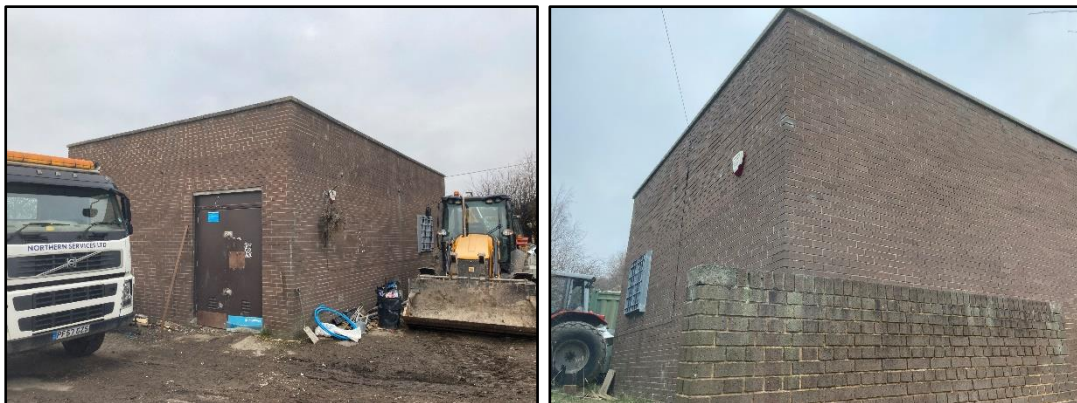
3.3.2. Photographs to show the general nature of the external of the former pumping station.

3.3.3. The building is very well sealed on the external. The brickwork is in good condition, there is the occasional gap at the very top of the parapet but these do not

lead into the wall cavities as there is a damp course between the parapets and the walls of the building. There are two redundant wall fittings from some old external lights on the north elevation wall. These have some small gaps next to them but these are not ideal features for bats and there is no evidence of these being utilised by bats.

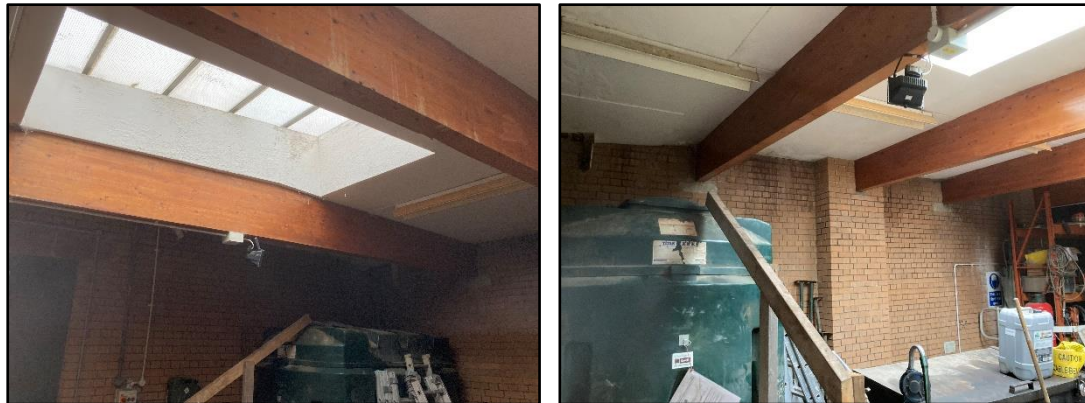
3.3.4. Internally the building is open throughout with a plasterboard ceiling and large beams supporting the roof. The walls are exposed brickwork. The large skylights light up the most part of the internal of the building. The walls and ceilings are well sealed with no access for bats inside the building.

3.3.5. The photographs below show the general nature of the internal of the building.

3.3.6. As the building is in very good condition with no suitable potential roosting opportunities and no access for bats inside the building and no evidence of roosting bats found, the building is assessed to provide **negligible** potential for roosting bats.
