UK COAL MINING LTD.

PROPOSED NORTH GAWBER MINING SCHEME

GEO-ENVIRONMENTAL ASSESSMENT

April 2005

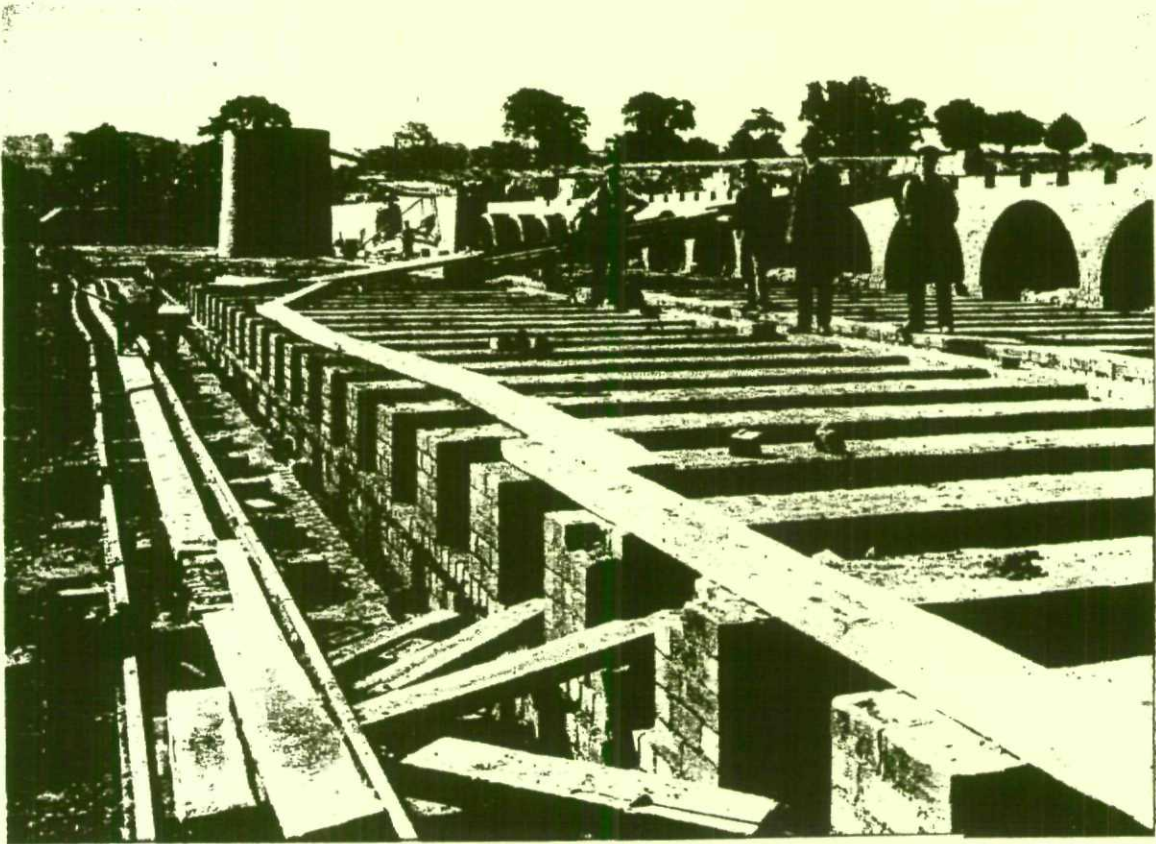
No 1 Battery - red brickwork foundation
ready for firebrick 20 06 1911

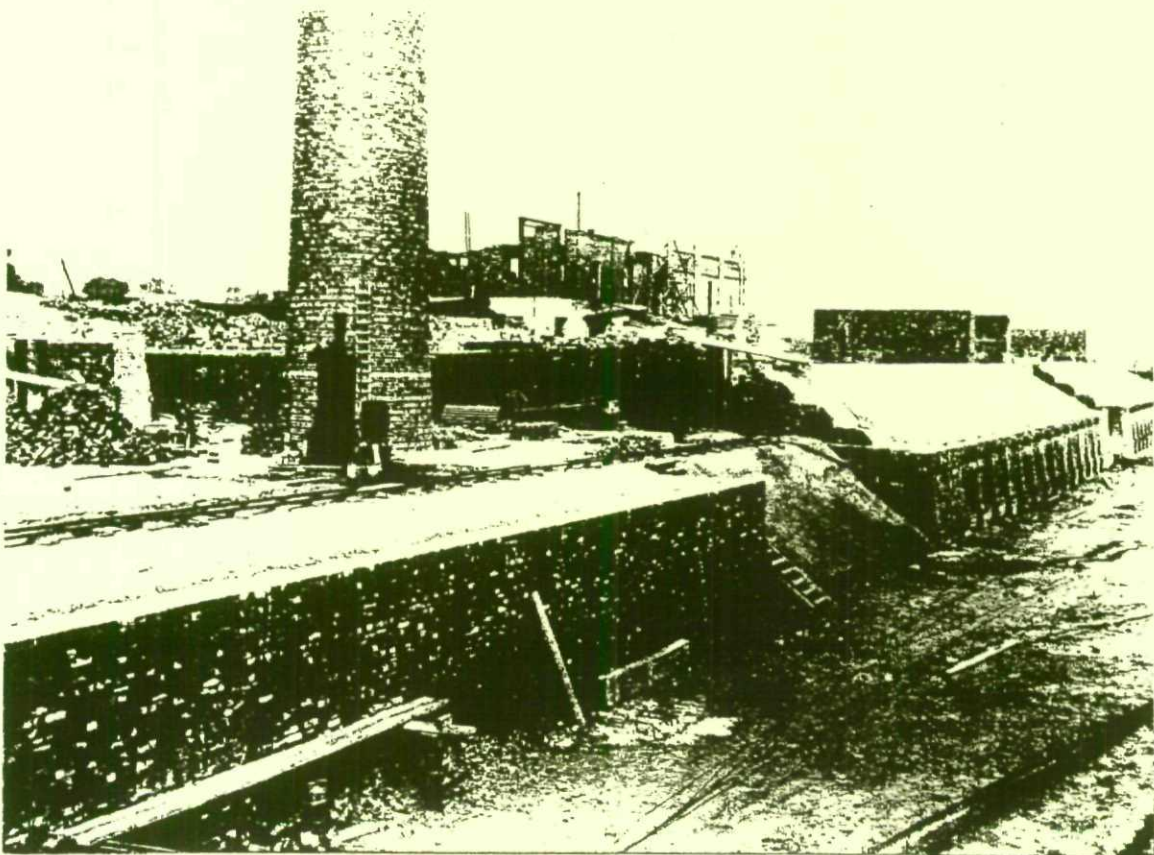
General view of works from SE corner

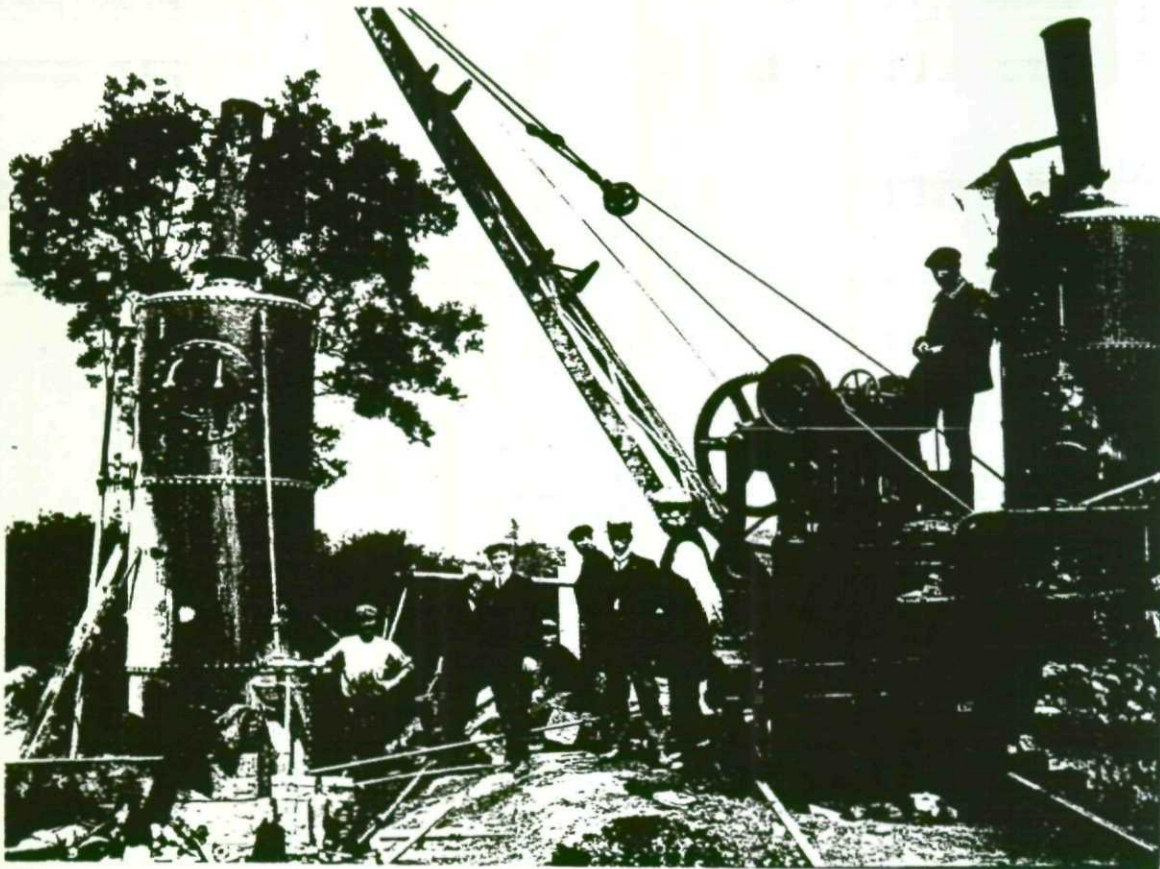
Sinking operations at well & reservoir
Crane and pump boiler 05 08 1911

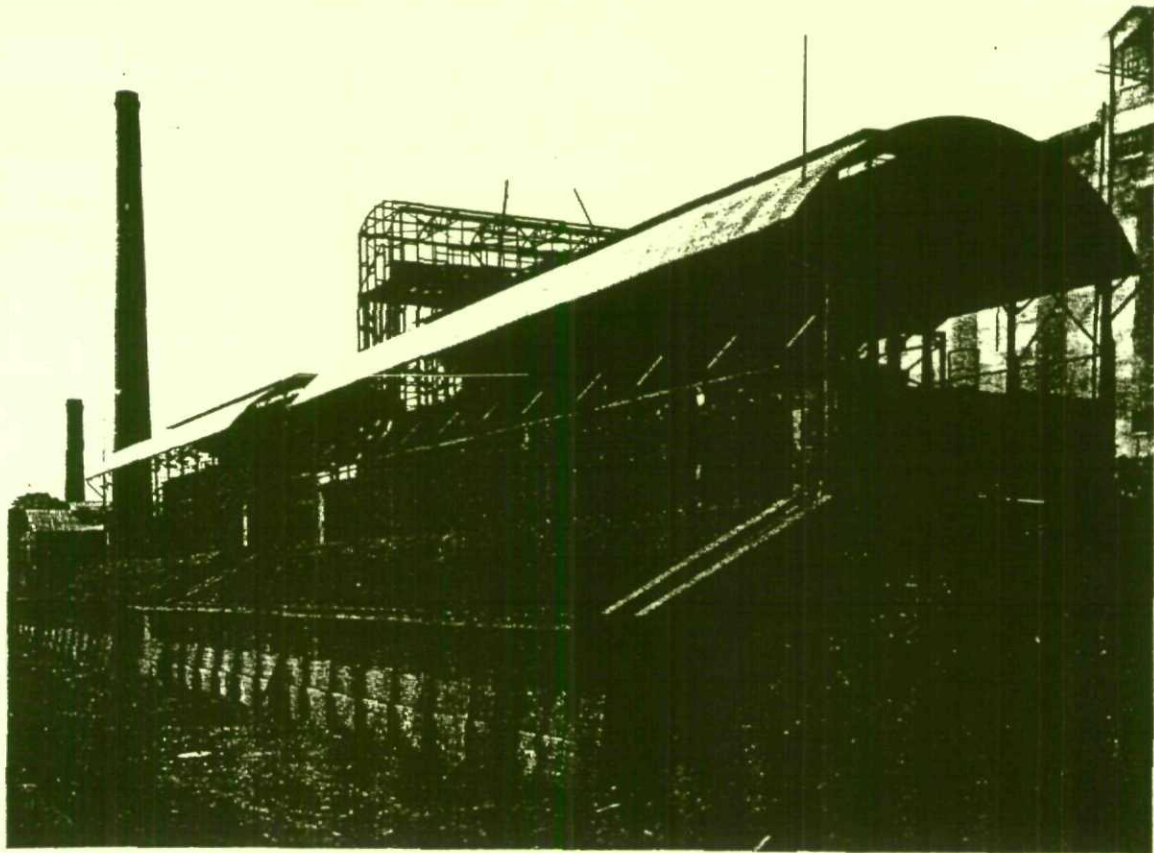
General view of works from South
End 26 04 1912

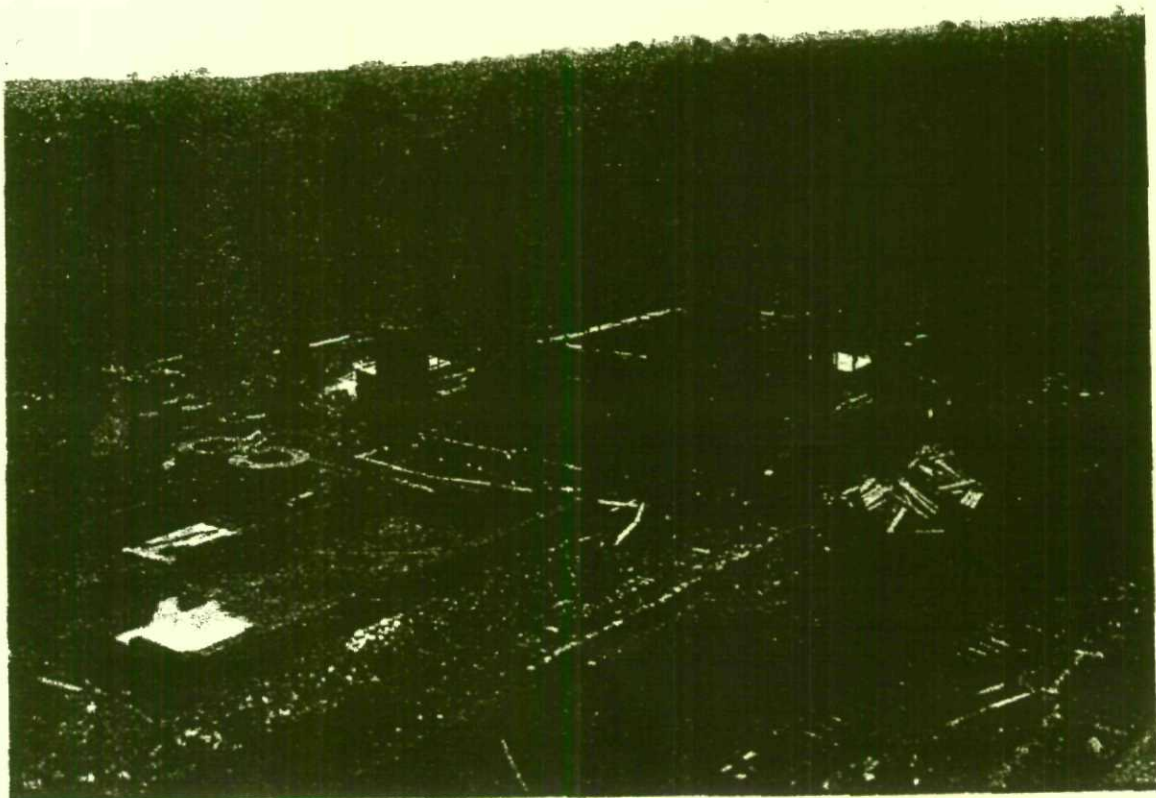
General view of Tar Plant pot May 1912

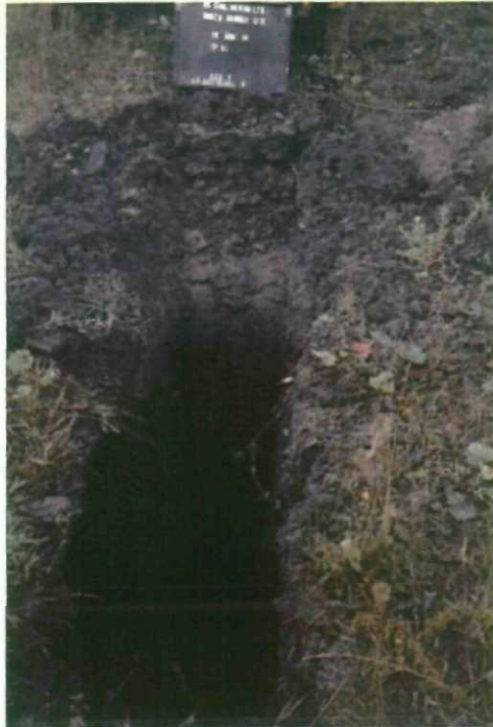
Photograph:

0.40	[Cross-hatch pattern]	MADE GROUND (Black very clayey sand and gravel of coal, brick, siltstone and mudstone. Gravel is fine to coarse, angular to subrounded).	(0.30)	70.29	0.40	D

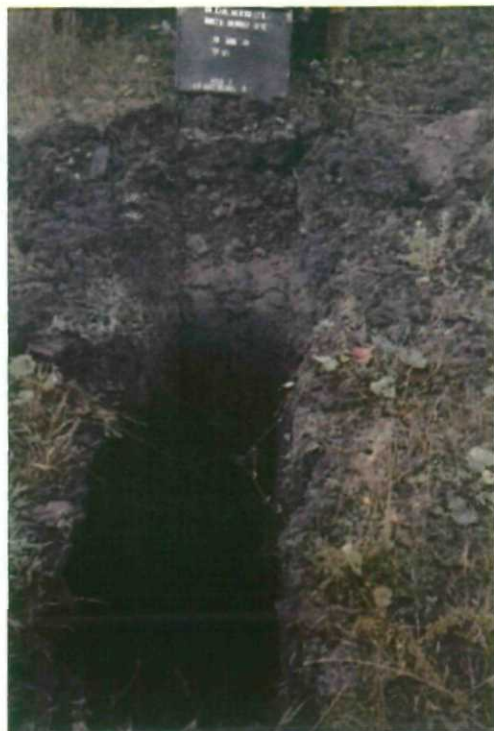
Photograph:

Strata				Samples		Tests			
Depth (m)	Legend	Description	Strata Depth (Thickness) (m)	Reduced Level (mAOD)	Depth (m)	Type	Depth (m)	MEXE	Shear Vane (Peak/Res)
6.00		cobbles of sandstone. Gravel is fine to coarse, subangular to subrounded and consists of sandstone, siltstone and mudstone. End of Trial Pit at 3.10 m							
7.00									
8.00									
9.00									
10.00									
Date of Excavation: 18/08/2004 Equipment: JCB 3CX Logged By: Ground Level: 70.6 Coordinates: 433116E - 409465N				Groundwater: Slight seepage at 1.8m.					
Legend: D Small Disturbed Sample B Large Disturbed Sample W Water Sample U Undisturbed U100 Sample				Remarks: Trial pit sides very unstable.					
Trial Pit: TP01			TRIAL PIT RECORD North Gawber Site			Revision: Final Project No. 04014

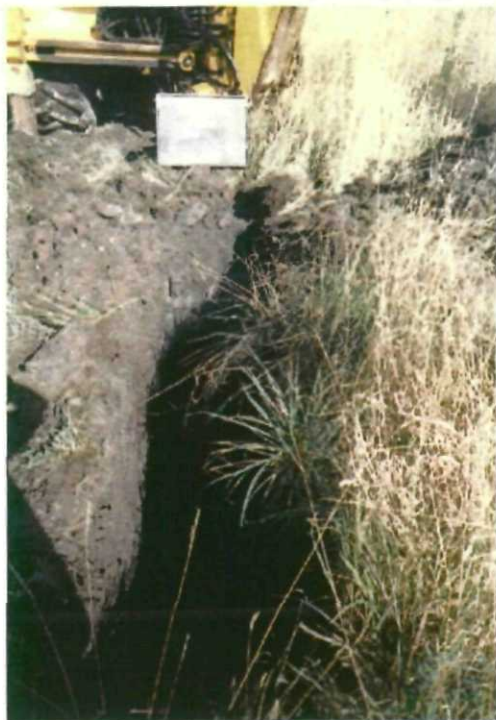
Photograph:

1.00	[Cross-hatched pattern]	MADE GROUND (Grass over firm and stiff brown black and red very gravelly sandy clay. Gravel is fine to coarse, subangular to subrounded and consists of burnt shale and coal with occasional sandstone, mudstone and brick. Contains cobbles of sandstone, timber fragments, many whole bricks, plastic and metal fragments)	(2.20)		0.60	D

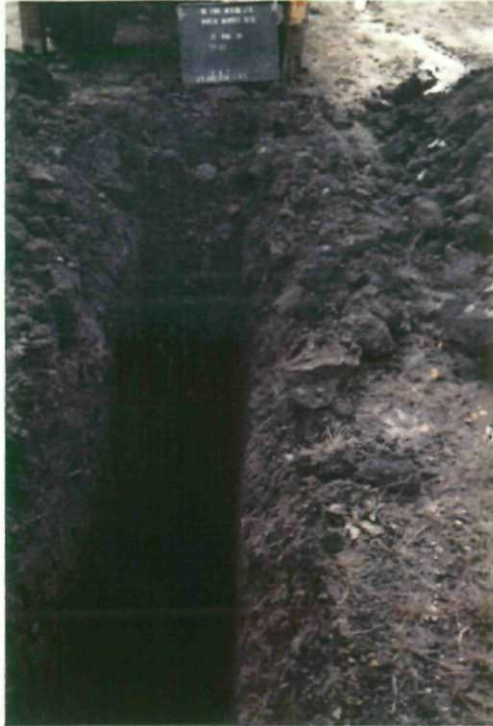
Photograph:

1.00	[Cross-hatched pattern]	MADE GROUND (Rough grass over firm and stiff dark brown and black sandy gravelly clay. Gravel is fine to coarse, angular to subangular and consists of mudstone, coal and sandstone).	(1.00)		0.70	D

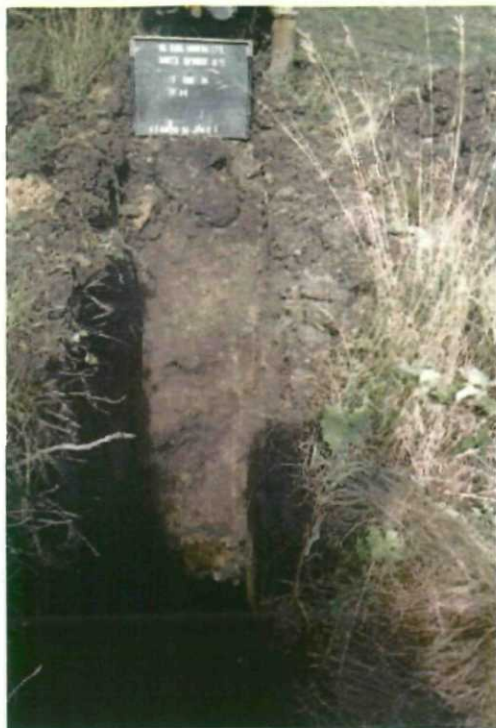
Photograph:

Strata					Samples		Tests		
Depth (m)	Legend	Description	Strata Depth (Thickness) (m)	Reduced Level (mAOD)	Depth (m)	Type	Depth (m)	MEXE	Shear Vane (Peak/Res)
		MADE GROUND (Grass over firm brown and light brown sandy gravelly clay. Gravel is fine to coarse angular to subangular and consists of sandstone and mudstone).	(0.40)	74.97

1.00		MADE GROUND (Firm and stiff light brown and grey sandy gravelly clay. Gravel is fine to coarse angular to subangular and consists of coal, siltstone, sandstone and mudstone. Many timber fragments).	(1.00)		0.90	D			
		MADE GROUND (Firm light brown and grey friable sandy gravelly clay. Gravel is fine to coarse, subangular to subrounded and consists of sandstone, mudstone and coal. Possibly reworked clay).	1.40	73.97

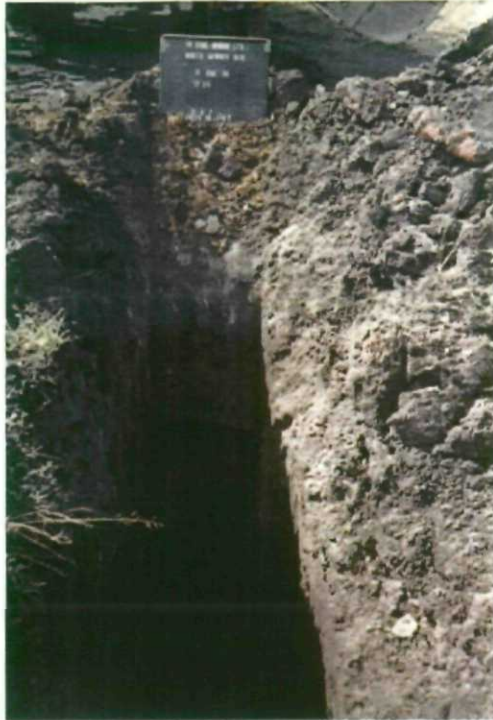
Photograph:

1.00		MADE GROUND (Grass over black and brown firm sandy very gravelly clay. Gravel is fine to coarse angular to subrounded and consists of mudstone and burnt shale. Large sandstone boulder, metal wires and pockets of orange brown sandy clay).	(1.10)		0.80	D				
		Soft and firm black and grey CLAY/SILT becoming more clayey with depth. Moderately strong hydrogen sulphide odour.	(0.40)		1.70	D				
		Firm light brown and yellow CLAY/SILT.	1.50	74.23

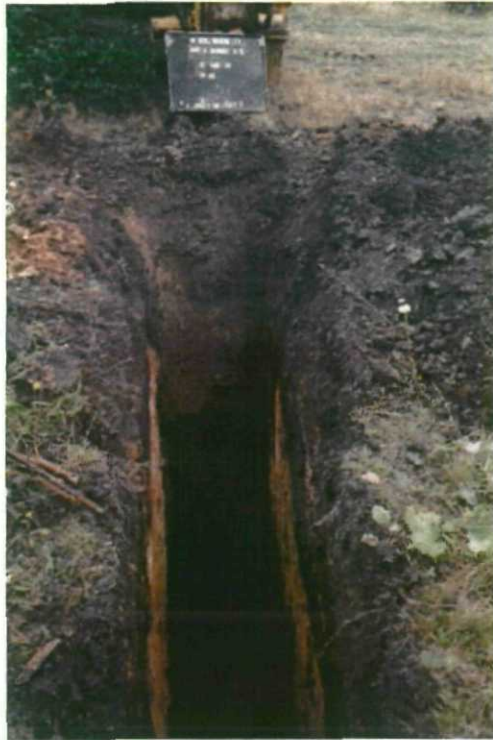
Strata				Samples		Tests			
Depth (m)	Legend	Description	Strata Depth (Thickness) (m)	Reduced Level (mAOD)	Depth (m)	Type	Depth (m)	MEXE	Shear Vane (Peak/Res)
	[Cross-hatch pattern]	MADE GROUND (Sparse grass over brown and black clayey sand and gravel of coal and mudstone).	(0.70)		0.50	D			
		MADE GROUND (Black and red angular - elongate fine to coarse gravel of burnt shale, coal and mudstone).	0.70 (0.30) 1.00	80.35 80.05	0.80	D

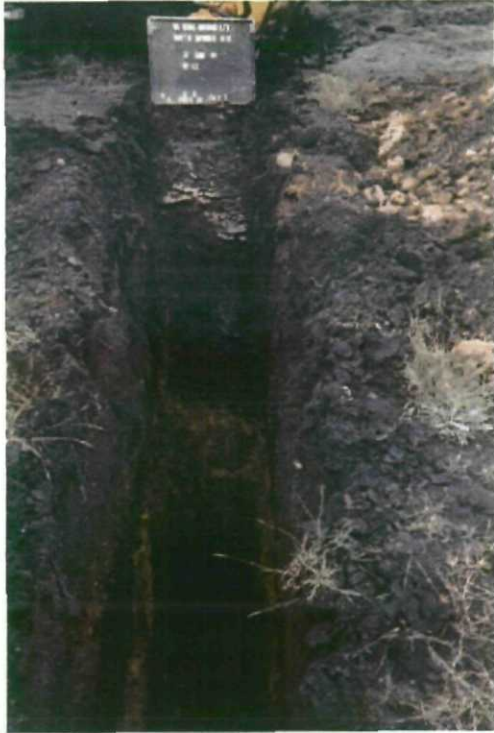
Strata				Samples		Tests			
Depth (m)	Legend	Description	Strata Depth (Thickness) (m)	Reduced Level (mAOD)	Depth (m)	Type	Depth (m)	MEXE	Shear Vane (Peak/Res)
		MADE GROUND (Moist fine sludge of black and red fine sand of coal and burnt shale).	0.20	83.88					
		MADE GROUND (Black slightly clayey sandy gravel. Gravel is fine to coarse, angular to subangular and consists of coal and mudstone).	(0.50)		0.60	D

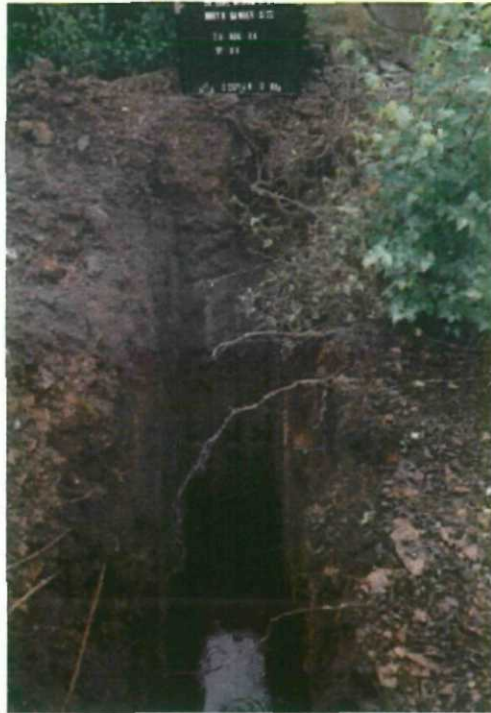
Photograph:

1.00	[Cross-hatched pattern]	MADE GROUND (Small trees and wood chip overlying red orange and black fine to coarse, angular to elongate gravel of burnt shale and coal). To 1.5m in south of pit and 2m in north end.	(1.50)		1.00	D

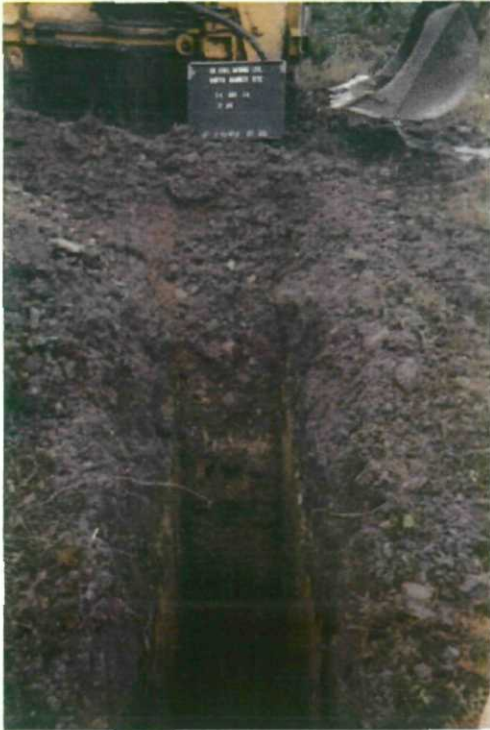
Photograph:

0.00	[Cross-hatch pattern]	MADE GROUND (Stiff dark grey sandy gravelly clay. Gravel is fine to coarse, angular to subangular and consists of mudstone, coal and sandstone. Contains subangular cobbles of mudstone and sandstone).	(0.90)		0.80	D

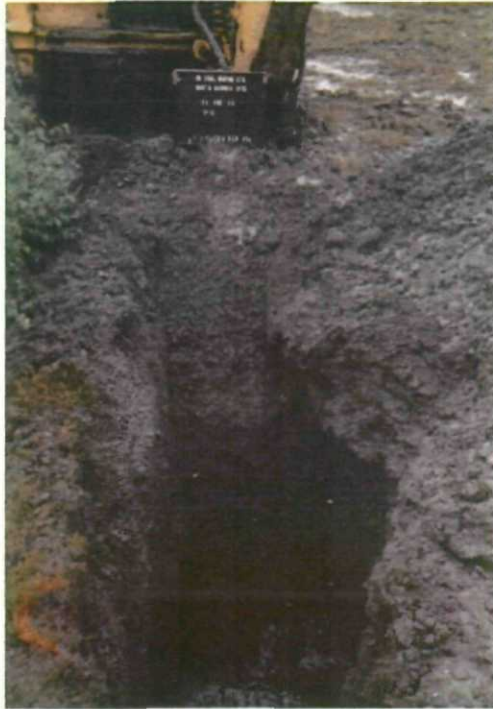
Photograph:

0.00	[Cross-hatched pattern]	MADE GROUND (Firm grey sandy gravelly clay with cobbles of sandstone and mudstone. Gravel is fine to coarse angular to subrounded and consists of mudstone, sandstone and coal). (Moderate seepage into pit from 2m with a slight oily sheen and dark spots on top of the standing water).	(3.00)		0.60	D

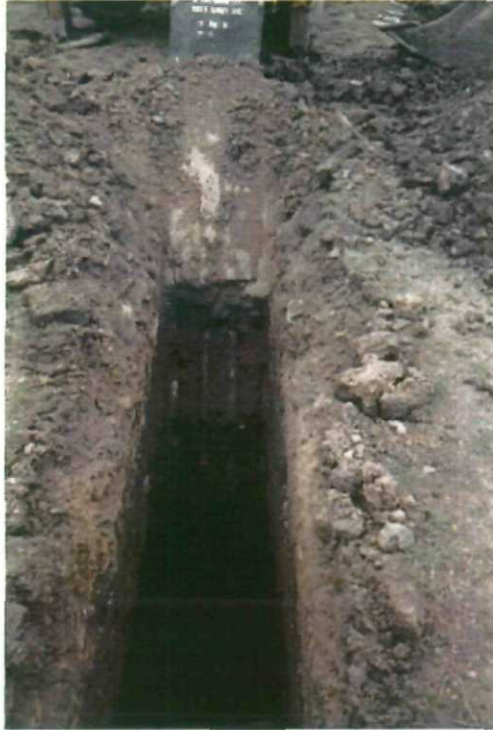
Strata				Samples		Tests			
Depth (m)	Legend	Description	Strata Depth (Thickness) (m)	Reduced Level (mAOD)	Depth (m)	Type	Depth (m)	MEXE	Shear Vane (Peak/Res)
	[Cross-hatched pattern]	MADE GROUND (Firm light brown and grey sandy gravelly clay with subangular cobbles of sandstone and many whole bricks).	(0.80)

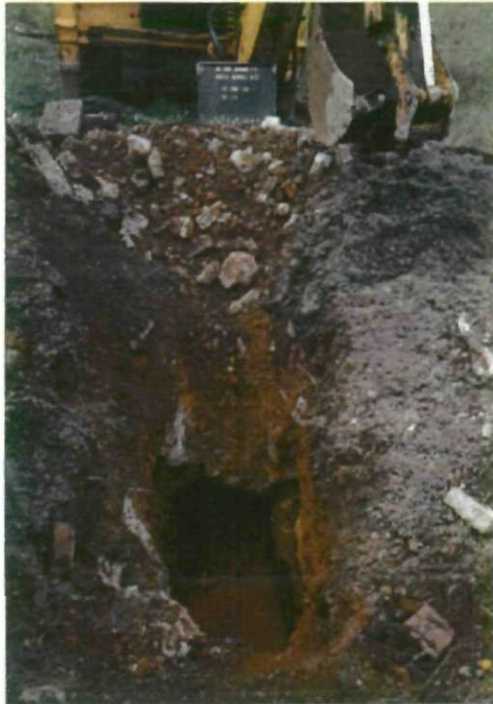
Photograph:

0.00		MADE GROUND (Rough grass over firm black sandy gravelly clay. Gravel is fine to coarse angular to subrounded and consists of coal, mudstone and siltstone. Occasional timber fragments, railway sleepers, metal pipes and wires).	(0.40)	86.85	0.50	D

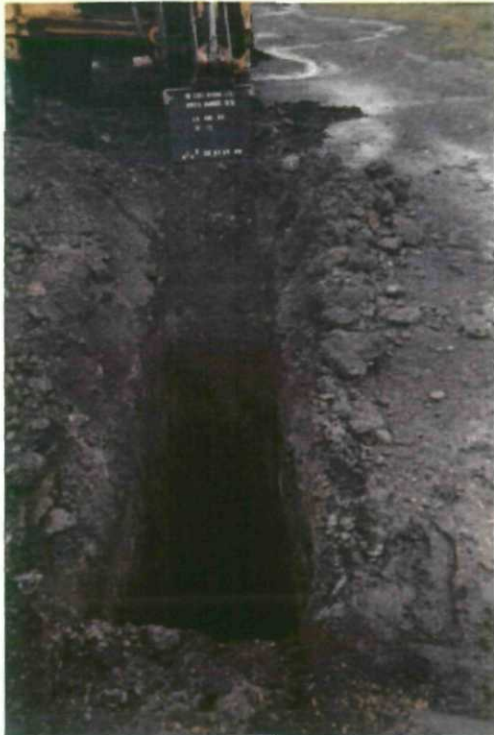
Photograph:

0.00	[Cross-hatched pattern]	MADE GROUND (Firm and stiff brown grey black and yellow sandy gravelly clay with many subangular cobbles of coal, mudstone and sandstone. Gravel is fine to coarse, angular to subangular and consists of coal, mudstone and sandstone).	(3.40)		0.90	D

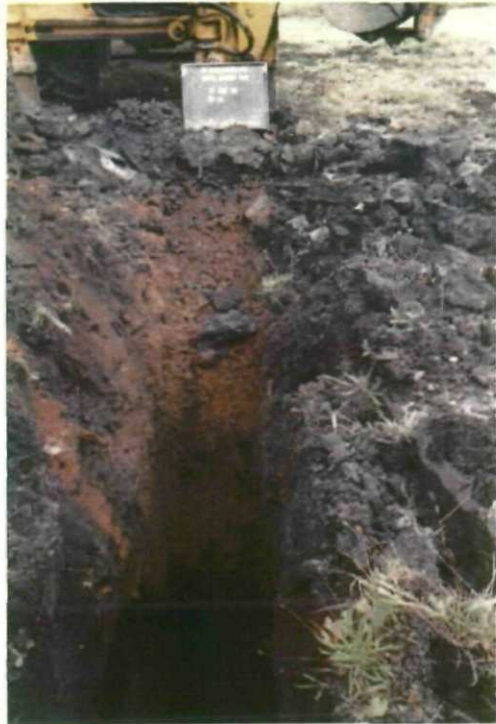
Photograph:

1.00	[Cross-hatched pattern]	MADE GROUND (Black fine silty sand of coal and mudstone fines. Moderately strong hydrocarbon odour. Dislodged old metal pipe containing stagnant slightly oily water).	(1.20)		0.50	D			
		MADE GROUND (Soft and firm light brown and grey sandy gravelly clay with coal traces. Not sampled as it was contaminated by the water from the old pipe).	1.20	86.34					
		MADE GROUND (Red and black fine to coarse, angular to subangular sand and gravel of burnt shale, coal and mudstone. Contains metal fragments and some timber). Pocket of white ground chalk or calcium carbonate material at 1.6m.	1.40	86.14	1.60	D

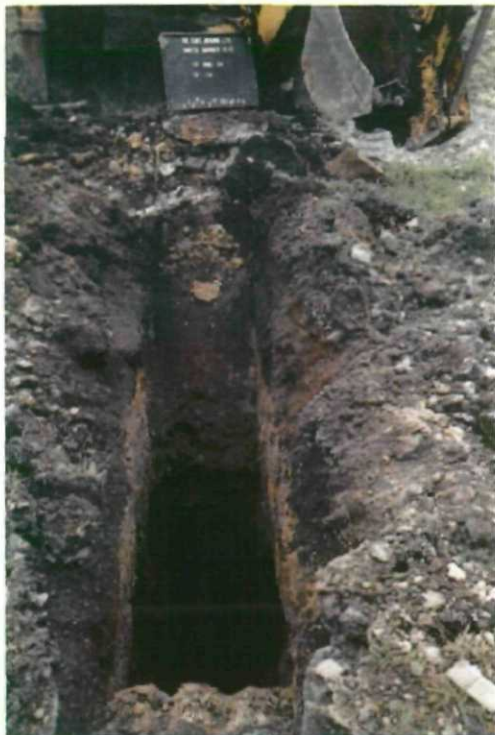
Strata					Samples		Tests		
Depth (m)	Legend	Description	Strata Depth (Thickness) (m)	Reduced Level (mAOD)	Depth (m)	Type	Depth (m)	MEXE	Shear Vane (Peak/Res)
		MADE GROUND (Red black and brown fine to coarse sand and gravel of coal, burnt shale, sandstone and siltstone).	(0.40) 0.40	88.16	0.20	D

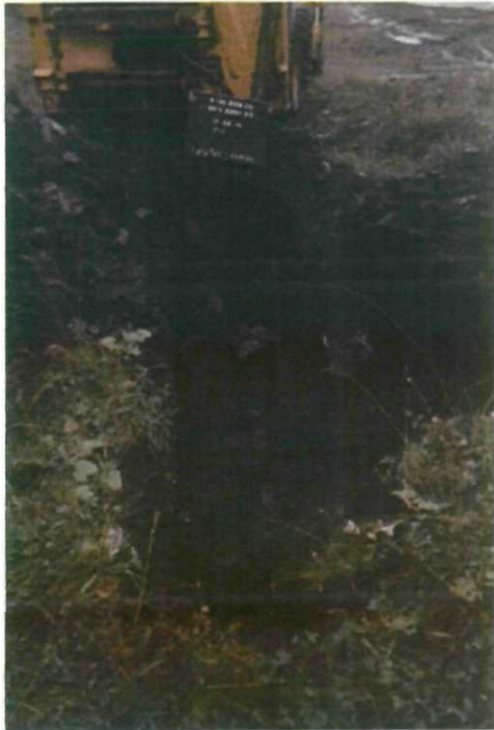
Photograph:

1.00	[Cross-hatched pattern]	MADE GROUND (Grass over firm black sandy clay with much fine to coarse gravel of coal, sandstone and mudstone. Contains many whole bricks, plastic, wires, large sandstone cobbles, timber fragments and sleepers, concrete kerb stones and black granite sets. Very thick twisted steel cable. Many concrete blocks).	(2.10)	85.46	1.00	D

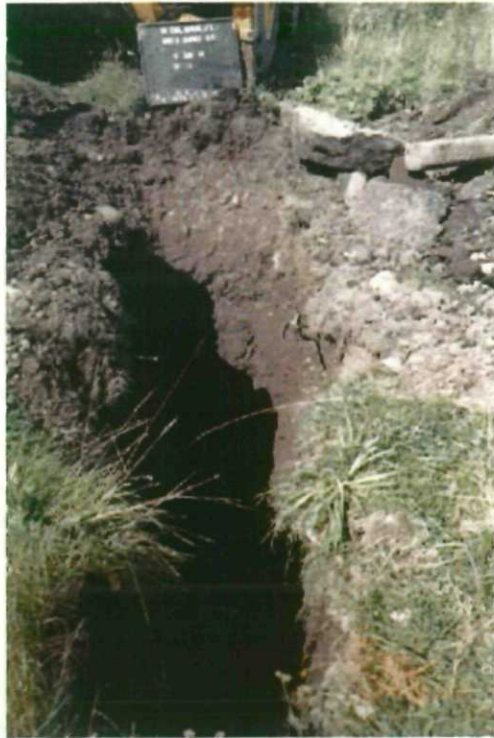
Photograph:

1.00	[Cross-hatched pattern]	MADE GROUND (Grass over black and brown clayey sandy gravelly cobbles and boulders of old tarmac and brick. Gravel is fine to coarse and consists of sandstone, brick and mudstone. Slight odour of bitumen from the tarmac. Many large pieces of tarmac with white quartz and limestone gravel)	(1.90)		0.80	D

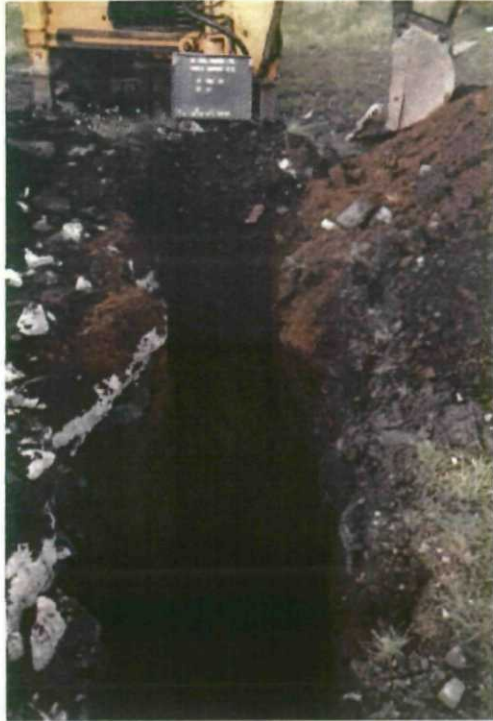
Strata					Samples		Tests			
Depth (m)	Legend	Description	Strata Depth (Thickness) (m)	Reduced Level (mAOD)	Depth (m)	Type	Depth (m)	MEXE	Shear Vane (Peak/Res)	
		MADE GROUND (Reinforced concrete).	0.20	90.61	0.60	D				
		MADE GROUND (Very hard dark grey cemented slab beneath reinforced concrete).	0.40	90.41

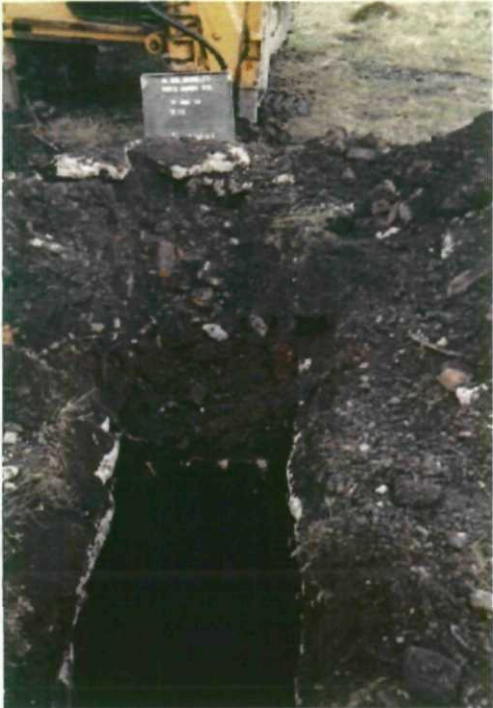
Photograph:

Strata				Samples		Tests			
Depth (m)	Legend	Description	Strata Depth (Thickness) (m)	Reduced Level (mAOD)	Depth (m)	Type	Depth (m)	MEXE	Shear Vane (Peak/Res)
	[Cross-hatched pattern]	MADE GROUND (Grass over black fine to coarse slightly clayey sandy gravel. Gravel is fine to coarse, angular to subangular and consists of coal and mudstone).	0.20	90.70					
		MADE GROUND (Reinforced concrete).	(0.40)

1.00		MADE GROUND (Black slightly clayey sand and gravel of coal, sandstone and mudstone).	0.60	90.30					
		MADE GROUND (Black slightly gravelly sand of coal, mudstone, glass, clinker, ash, brick and sandstone. Gravel is fine to medium, angular to subangular. Many large blocks of bricks and mortar and metal wires).	(0.40)

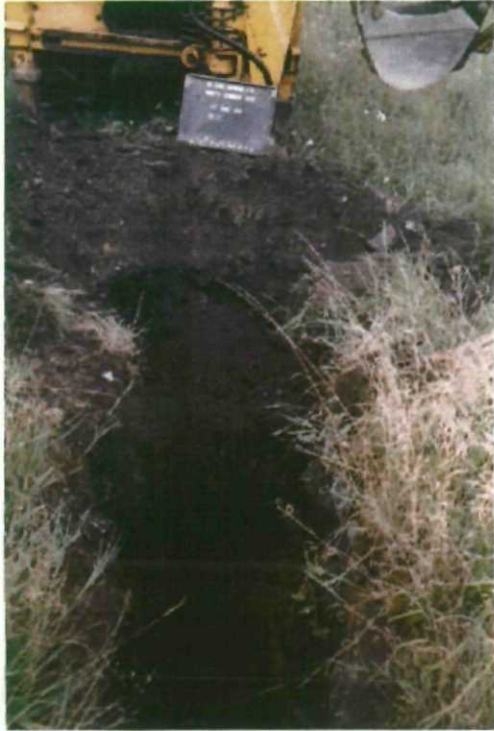
Photograph:

1.00	[Cross-hatched pattern]	MADE GROUND (Rough grass over light brown and dark brown clayey sand and gravel with cobbles of brick. Many pieces of old tarmac, cut sandstone and granite blocks and old kerb stones).	(1.90)		1.00	D

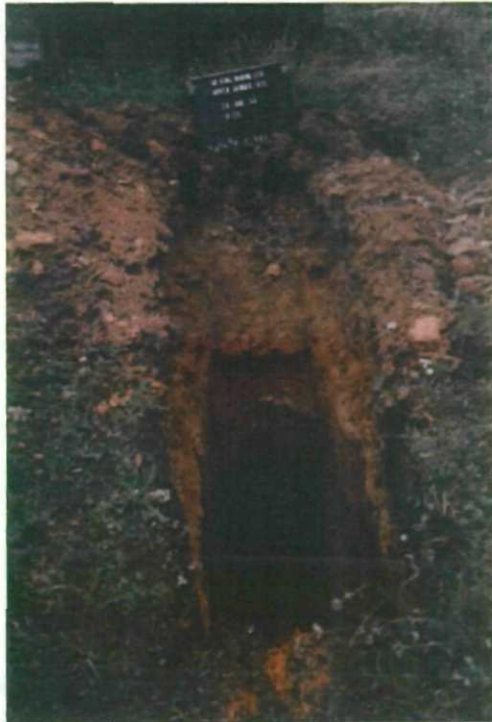
Strata				Samples		Tests			
Depth (m)	Legend	Description	Strata Depth (Thickness) (m)	Reduced Level (mAOD)	Depth (m)	Type	Depth (m)	MEXE	Shear Vane (Peak/Res)
	[Cross-hatched pattern]	MADE GROUND (Grass over firm dark brown sandy gravelly clay. Gravel is fine to coarse angular to subrounded and consists of coal, mudstone and sandstone).	0.20	87.32

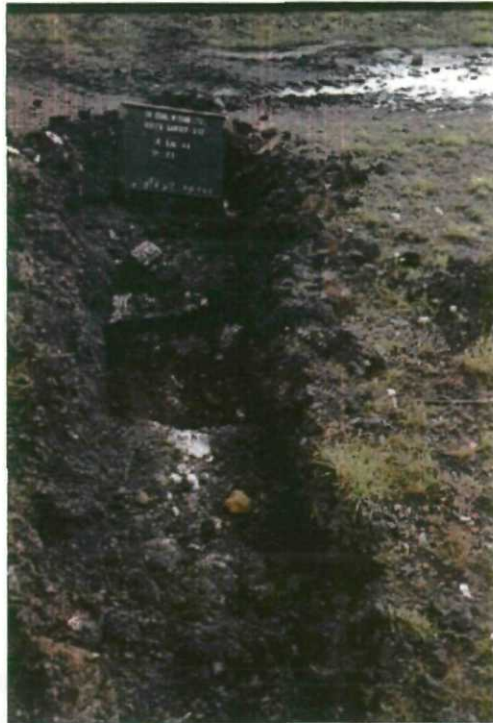
Photograph:

1.00		MADE GROUND (Fine to coarse red brown and black angular to subangular gravel of burnt shale with pockets of fine coal and mudstone gravel).	(1.10)		0.80	D			
	[Dotted pattern]	Possibly reworked light orange brown slightly clayey gravelly SAND with subangular cobbles of sandstone.	1.30	86.22	1.45	D

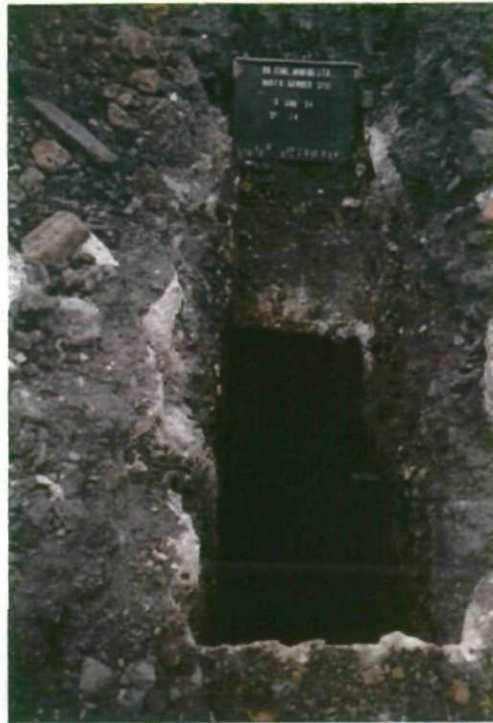
Strata				Samples		Tests				
Depth (m)	Legend	Description	Strata Depth (Thickness) (m)	Reduced Level (mAOD)	Depth (m)	Type	Depth (m)	MEXE	Shear Vane (Peak/Res)	
		MADE GROUND (Black and grey slightly clayey sand and fine to medium gravel of coal and mudstone).	0.20	86.41	0.90	D

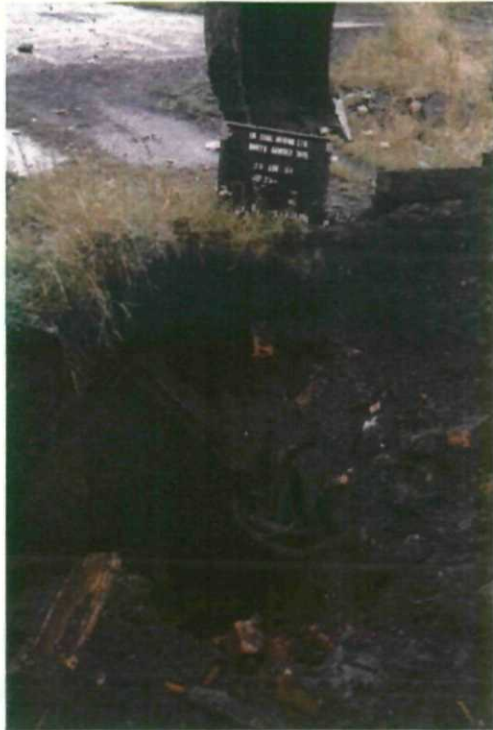
Photograph:

(0.25)	86.16						
			MADE GROUND (Reinforced concrete).	0.46						86.01
			MADE GROUND (Solid brick foundations).	0.60						
1.00			MADE GROUND (Eastern end of trial pit - solid reinforced concrete approximately 0.6m thick, not broken out. Western end of trial pit - firm black, grey brown and yellow sandy gravelly clay with many mudstone and coal cobbles. Gravel is fine to coarse, angular to subangular and consists of coal, mudstone and sandstone. Occasional timber fragments).	(2.40)

2.00					2.70	D				
3.00		End of Trial Pit at 3.00 m	3.00	83.61						
4.00										
5.00										
Date of Excavation: 19/08/2004 Equipment: JCB 3CX Logged By: SD Ground Level: 86.6 Coordinates: 433111E - 409711N			Groundwater: Groundwater not encountered.							
Legend: D Small Disturbed Sample B Large Disturbed Sample W Water Sample U Undisturbed U100 Sample			Remarks: Trial pit sides slightly unstable from 2.1m. Terminated at maximum reach due to reinforced concrete encountered at 0.6m.							
Trial Pit:		TRIAL PIT RECORD				Revision: Final				
TP24						North Gawber Site			Project No. 04014

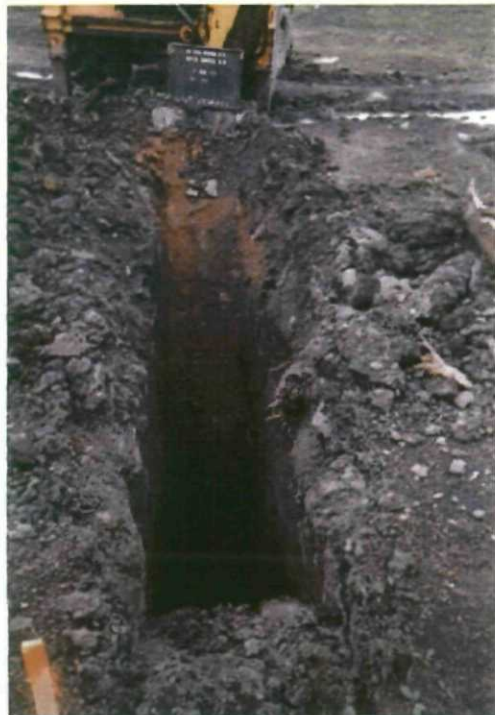
Strata				Samples		Tests			
Depth (m)	Legend	Description	Strata Depth (Thickness) (m)	Reduced Level (mAOD)	Depth (m)	Type	Depth (m)	MEXE	Shear Vane (Peak/Res)
		MADE GROUND (Black fine moist gravelly sand of coal and mudstone).	0.20	85.72	0.45	D

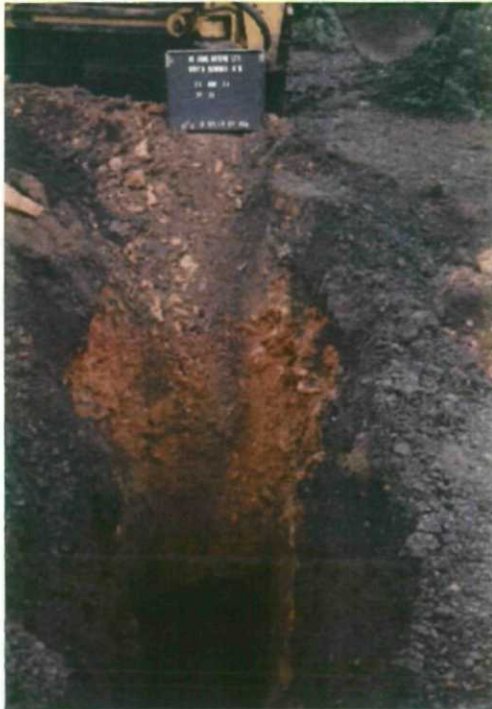
Photograph:

0.00	[Cross-hatched pattern]	MADE GROUND (Brown and grey very clayey sand and gravel. Gravel is fine to coarse, angular to subrounded and consists of mudstone and coal with pockets of burnt shale gravel. Occasional cobbles of clinker).	(1.00)	89.63	0.50	D

1.00			1.00		1.00	D			
1.50	[Dotted pattern]	MADE GROUND (Orange brown sandy gravel. Gravel is fine to coarse angular elongate and consists of clinker, brick, burnt shale and mudstone. Many whole bricks and cobbles of clinker).	(1.90)		1.60	D

4.00									
5.00									
Date of Excavation: 18/08/2004 Equipment: JCB 3CX Logged By: SD Ground Level: 90.6 Coordinates: 433070E - 409774N				Groundwater: Groundwater not encountered.					
Legend: D Small Disturbed Sample B Large Disturbed Sample W Water Sample U Undisturbed U100 Sample				Remarks: Trial pit sides very unstable. Metal pipe encountered but not damaged in northern end of trial pit.					
Trial Pit:		TRIAL PIT RECORD				Revision: Final			
TP27						North Gawber Site

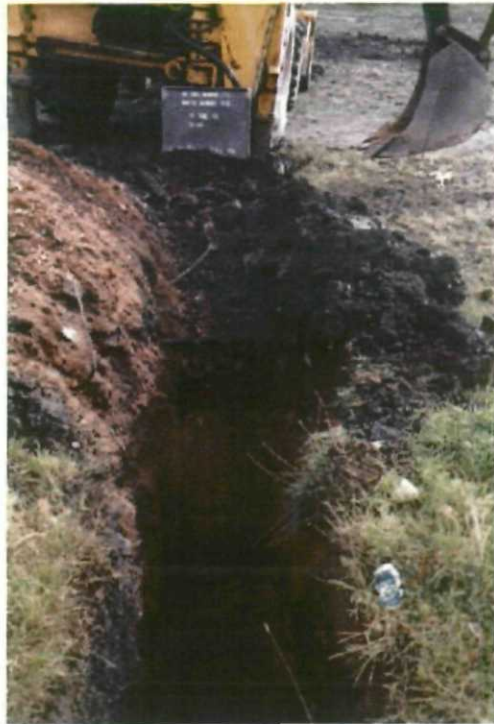
Photograph:

1.00	[Cross-hatched pattern]	MADE GROUND (Firm black, brown, grey and yellow sandy gravelly clay. Gravel is fine to coarse, angular to subangular and consists of coal, sandstone and mudstone).	(1.40)		1.00	D

2.00		MADE GROUND (Red, brown and yellow sandy gravel of burnt shale. Gravel is fine to coarse, angular to elongate).	1.40	83.59	1.80	D			
3.00		MADE GROUND (Black, fine to coarse, angular to subrounded sand and gravel of coal, mudstone, sandstone and clinker with pockets of silver coloured coke works slag).	(0.90)	82.69	2.50 2.60	D D

4.00		End of Trial Pit at 3.40 m	(1.10)						
5.00			3.40	81.59					
Date of Excavation: 20/08/2004 Equipment: JCB 3CX Logged By: SD Ground Level: 85.0 Coordinates: 433152E - 409689N					Groundwater: Groundwater not encountered.				
Legend: D Small Disturbed Sample B Large Disturbed Sample W Water Sample U Undisturbed U100 Sample					Remarks: Trial pit sides unstable.				
Trial Pit: TP28			TRIAL PIT RECORD North Gawber Site			Revision: Final Project No. 04014			 SCOTT DOHERTY ASSOCIATES
