## Desk Study Report

**Project:** S10565 Roughbircworth Lane,  
Oxspring

**Reference:** S10565 R001

**Date:** May 2018

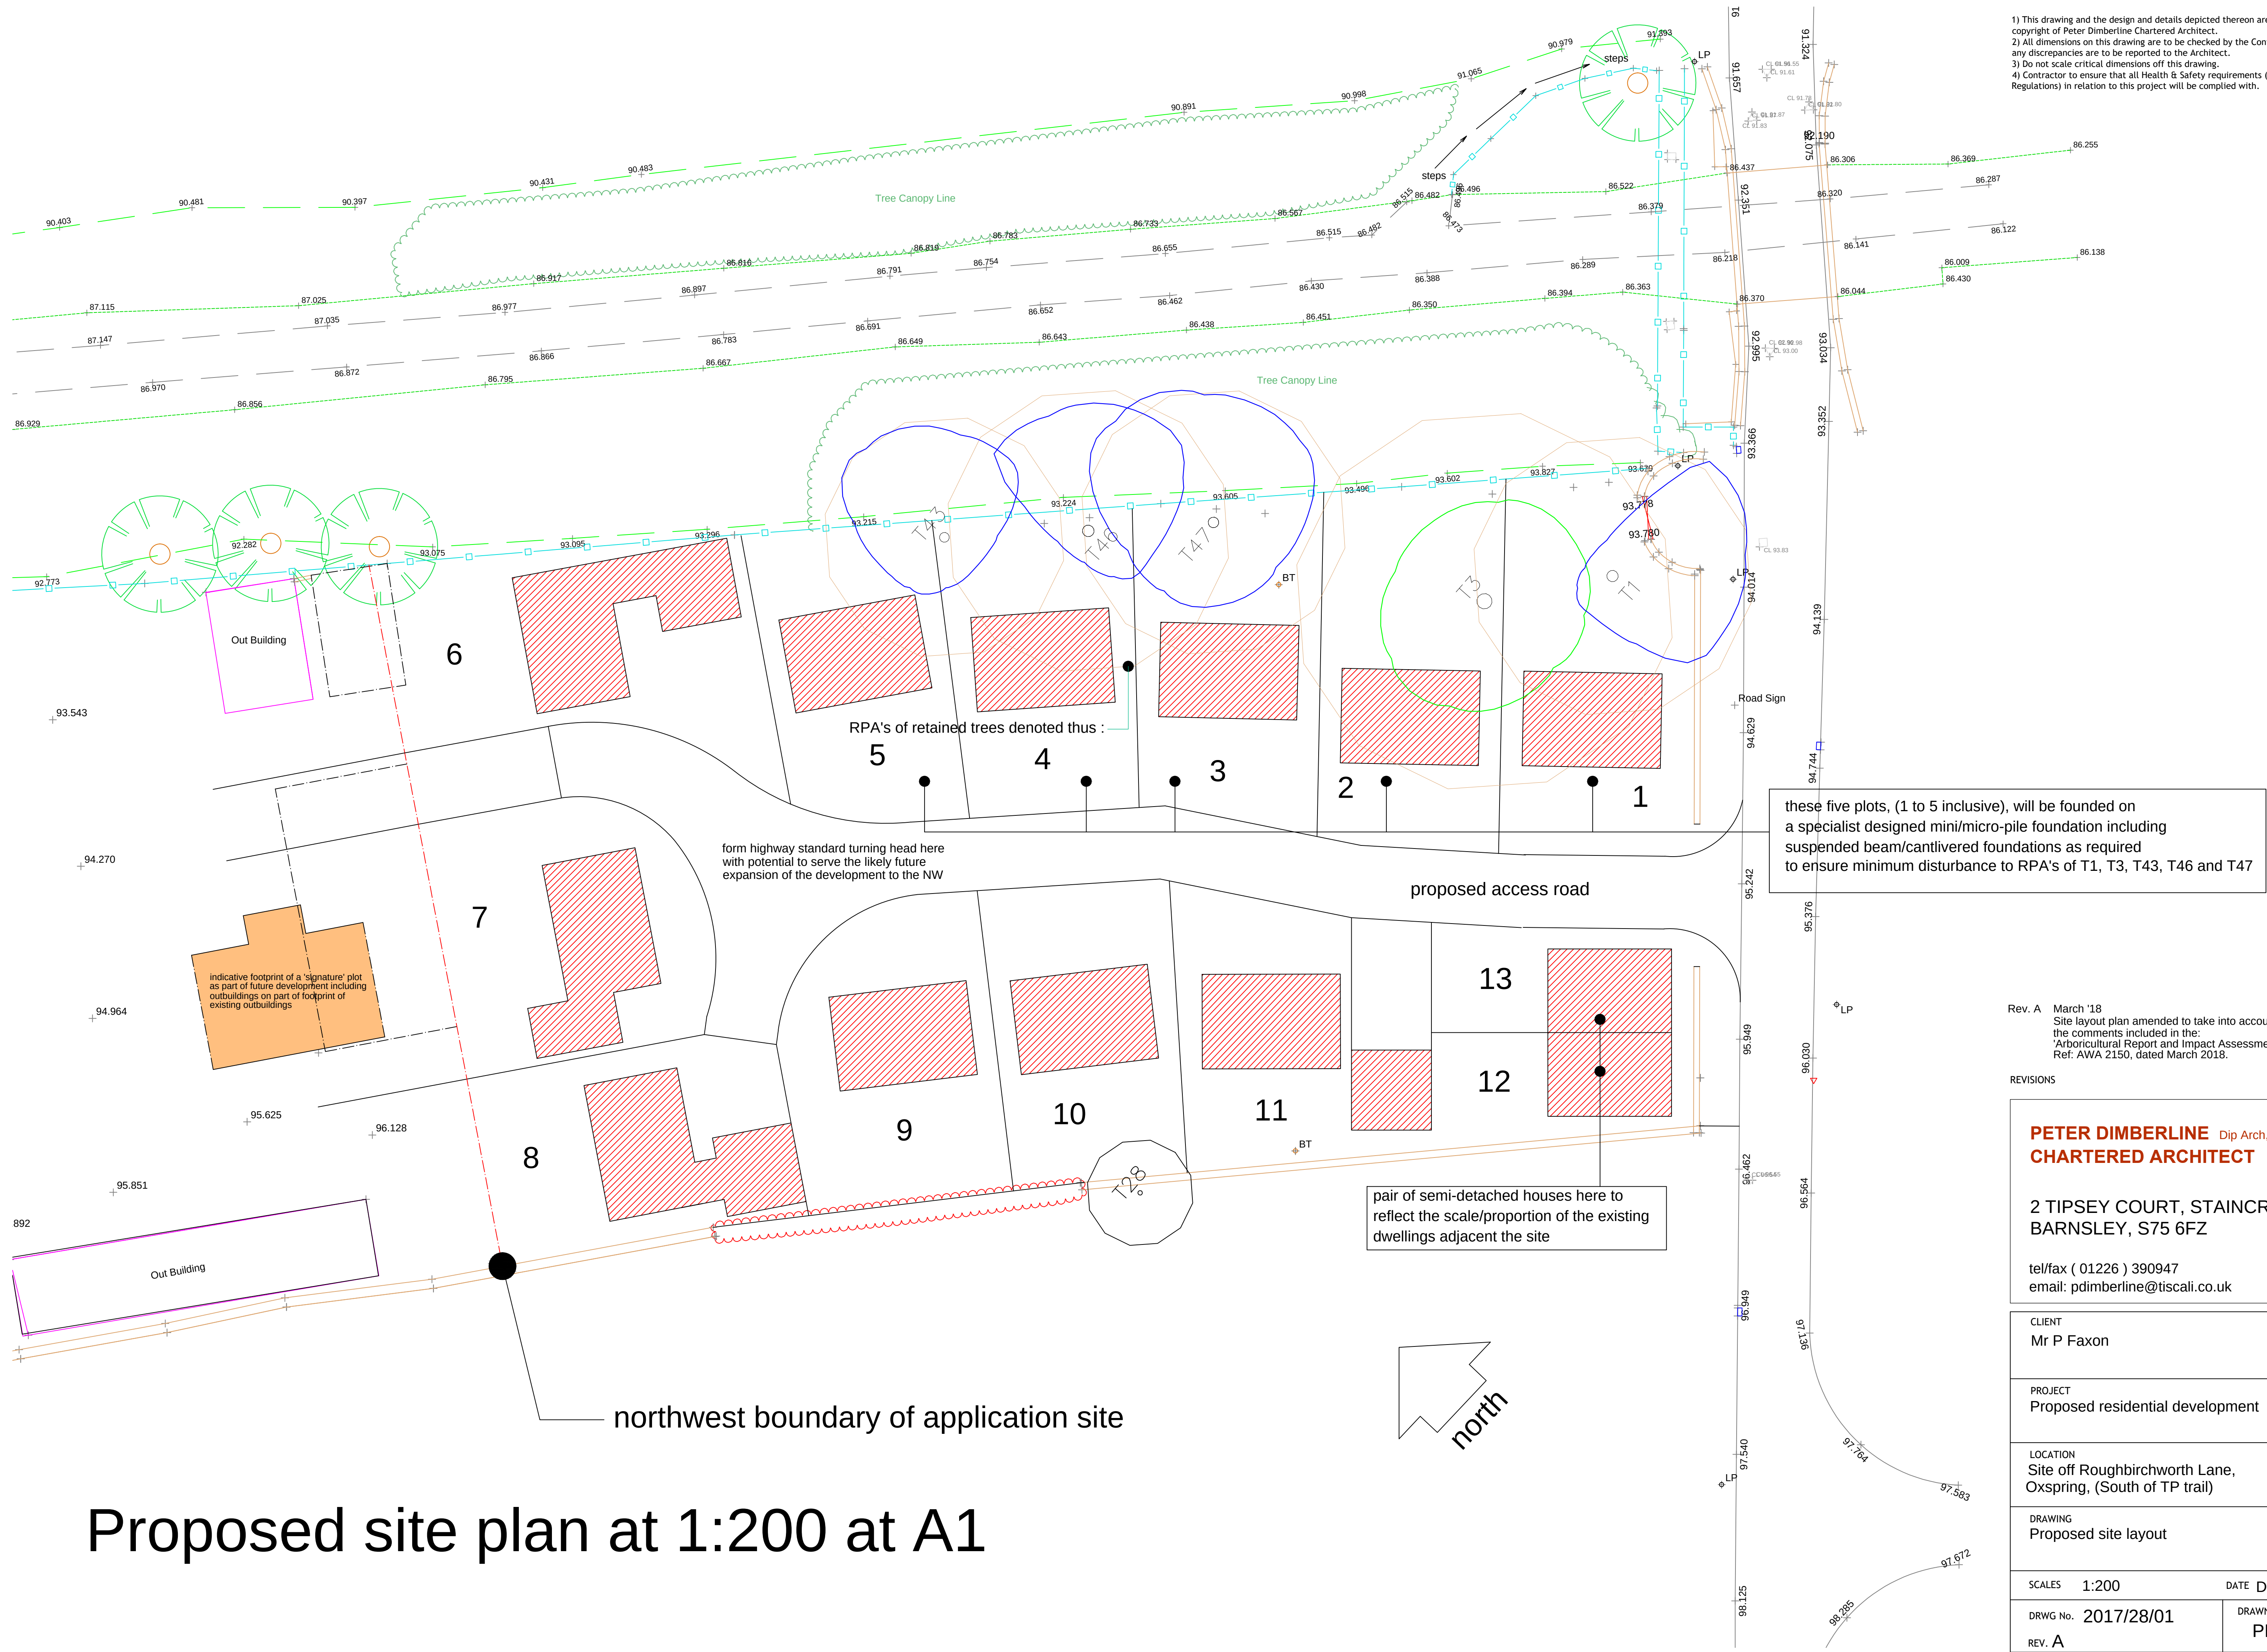
Proposed site plan at 1:200 at A1

Rev. A March '18  
Site layout plan amended to take into account the comments included in the:  
'Arboricultural Report and Impact Assessment'  
Ref: AWA 2150, dated March 2018.

8.2.1 Based on the conclusions from the desk study and the intended redevelopment of the site (as indicated on Drawing No. 2017/28/01, Peter Dimberline) **jnp group** recommends that the following intrusive works are undertaken:

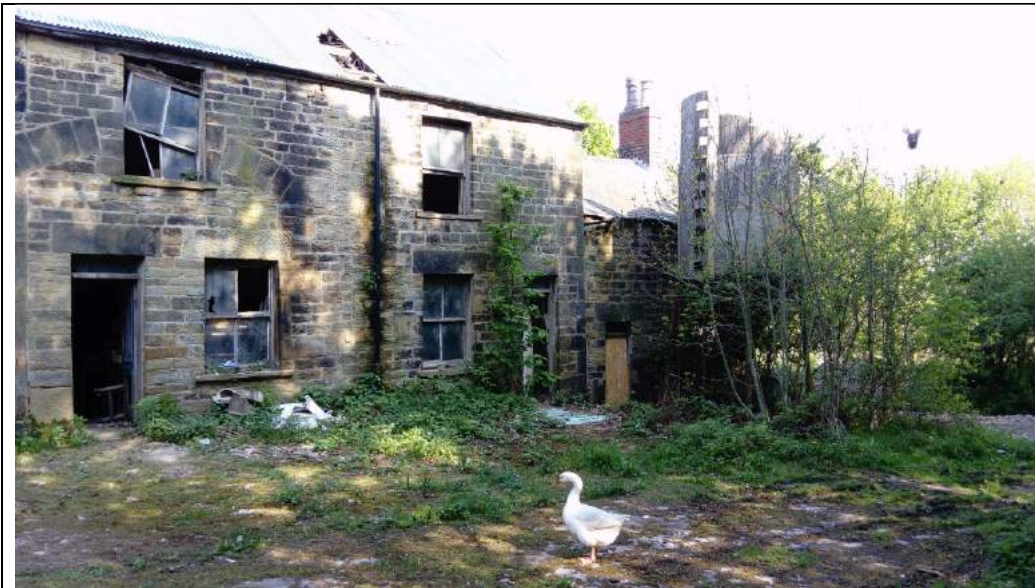
There were buildings noted to be in a poor state of repair in the north of the site, these were brick built and of one and two-storey height. The buildings were not accessed as they were not deemed structurally sound by the engineer;

Derelict cottages in northern portion of the site

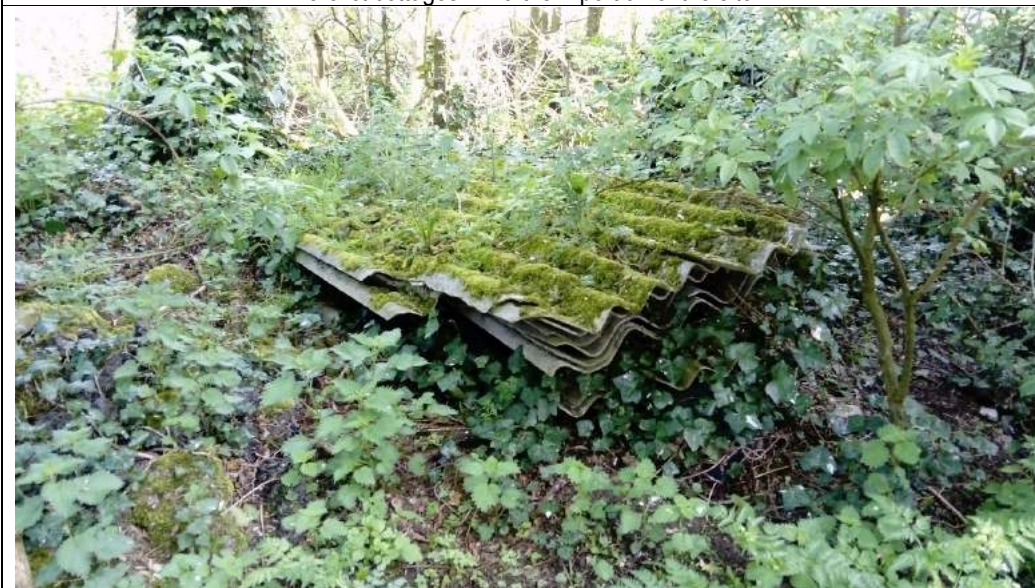
- Notably the potential asbestos containing material (ACMs), as cement roof sheeting, noted on the rooves of the cottages and agricultural building in the north of the site, and also stockpiled along the eastern boundary.
- The fuel tank on-site was raised above the ground and noted to be in good condition; however there was no dedicated bund or spill prevention associated with the tank.
- The LPG tank noted on-site was in poor condition and was also not banded, historical leaks cannot be ruled out.
- The fire pit in the centre of the northern half of the site is considered to be a source of ash and polycyclic aromatic hydrocarbons (PAHs)
- Housekeeping at the site was generally poor, with improperly stored liquid (paint) containers present on unsurfaced ground.

In accordance with C733 guidance, any structure built, refurbished or modified during the Twentieth Century has the potential to contain asbestos containing materials (ACM). In addition, any demolition material either stockpiled or used as backfill on site also has the potential to contain asbestos containing materials (intact or broken up).

Potential asbestos containing material discarded on-site

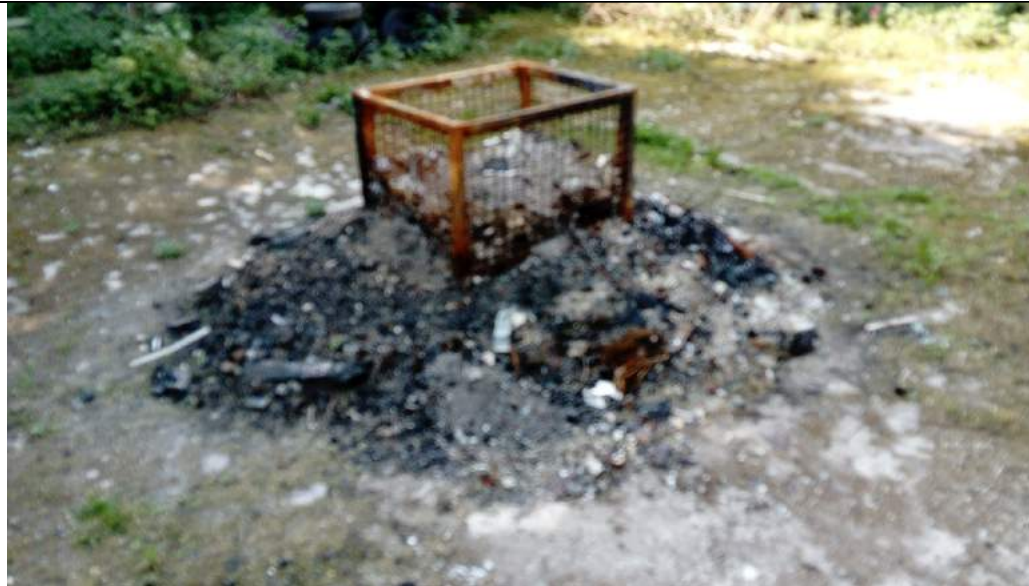
Fire Pit in centre of courtyard in northern portion of the site.

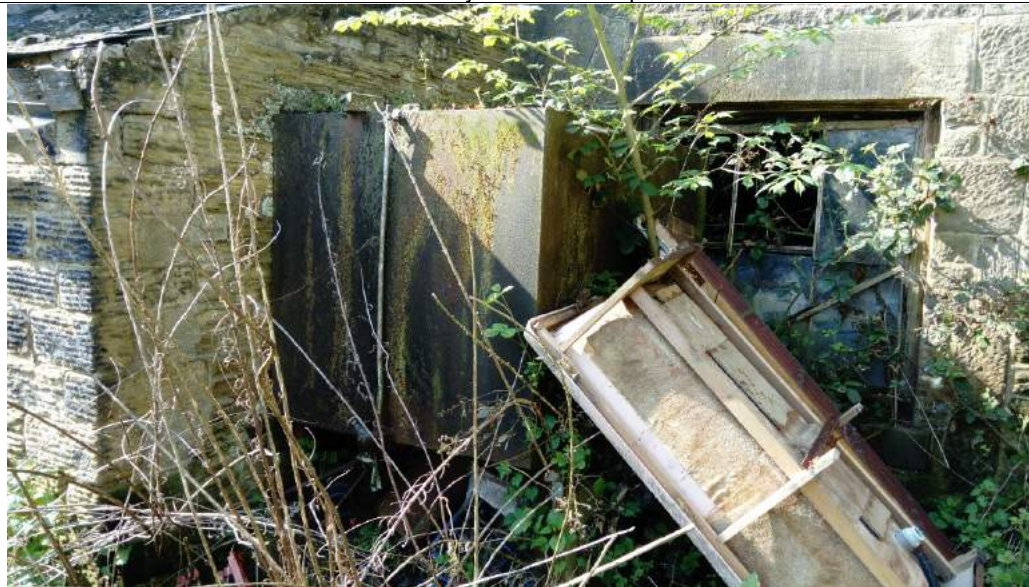
In the north of the courtyard was a rectangular LPG tank, noted to be in poor condition;
-

LPG tank

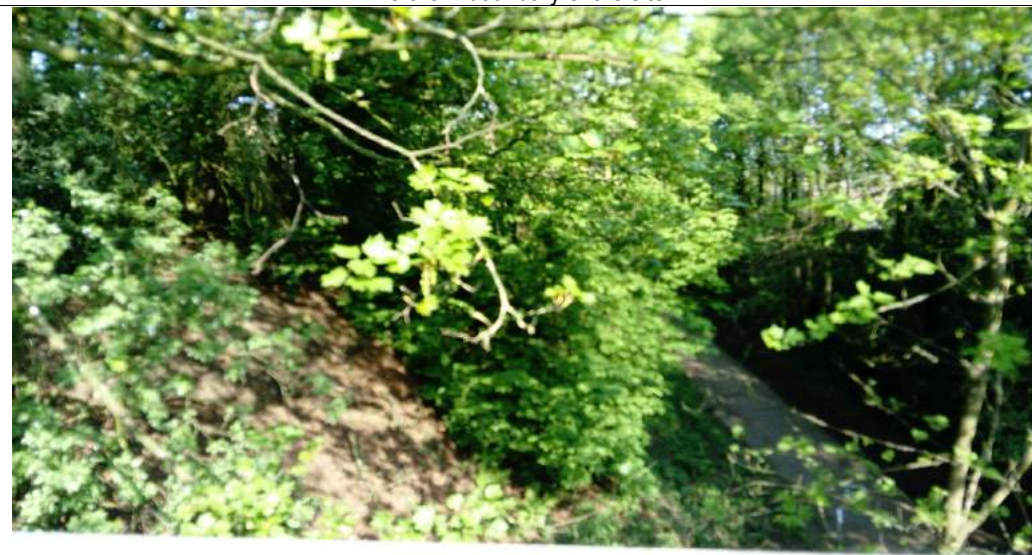
| Date | On-site Historical Land Use | Off-site Historical Land Use |
|---|---|---|
| 1984-1988 | No significant changes noted. | The railway cutting adjacent to the north-east is depicted as being dismantled. |

Historical railway cutting adjacent to the north-east
