**Report for**  
**6 Cliffe Hill, Cawthorne, Barnsley**  
**Protected Species Survey**

**Protected Species Survey at 6 Cliffe Hill, Cawthorne**

**Address of survey site:** 6 Cliffe Hill, Cawthorne, Barnsley, South Yorkshire, S75 4HJ

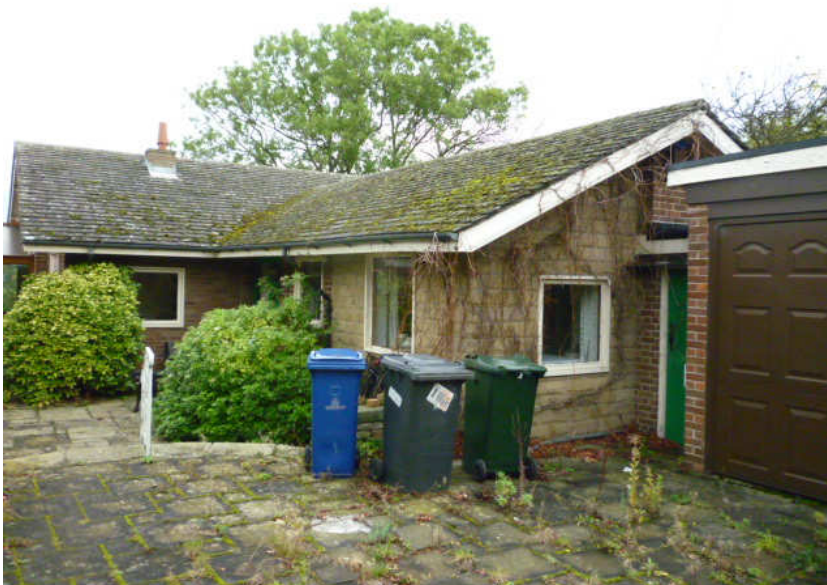
**Photo 1: 6 Cliffe Hill, viewed from front**

The bungalow had brick walls (some of the walls had stone cladding) and a tile roof (flat interlocking composite tiles). It had wooden soffits and fascias, and there were no gaps between the soffits and the walls, as any gap had been covered with a wooden quadrant, plus all the ventilation grills were in place, also the eaves were covered in webs. The roof was in sections, at more than one height, and had gables. Each section had equal pitches. The roof was supported by purlins and rafters. The tiles were lined, with felt. The loft was fully accessible for survey. It was insulated, the insulation being pushed into the eaves.

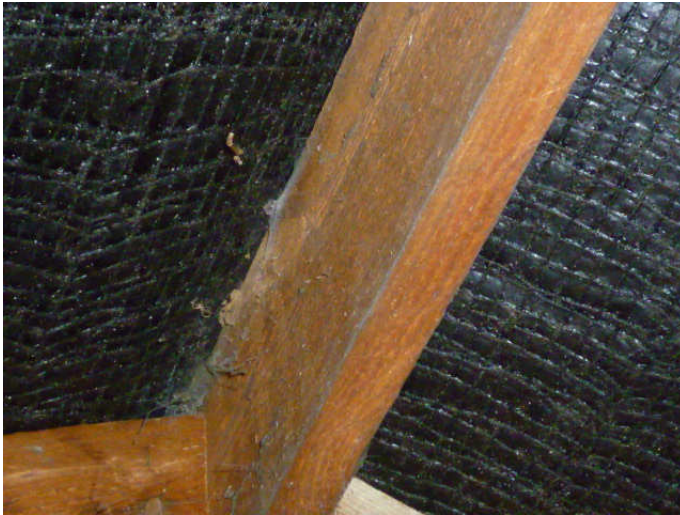
**Photo 2: Webs on roof timbers**

The roof timbers were covered in spiders' webs, and these webs ran from the rafters to the ceiling joists, showing nothing had disturbed the roof void for some time. There were no gaps under the tiles, and no missing tiles. The ridge tiles were all in place, with no gaps between them. The roof was covered in moss, which blocked any potential gaps between the tiles. There were no gaps in the pointing under the ridge tiles. The gables had wooden soffits and bargeboards, also any potential gap was covered in quadrant, and the pointing was all in place under the tiles on the gables. Also these eaves were covered in spiders' webs. The building had wooden and plastic framed windows and doors, all gaps being sealed with silicon.
