**Bat Emergence Survey  
Land Off Saville Lane  
Thurlstone**

Report reference: BE-R-1255-02  
July 2012

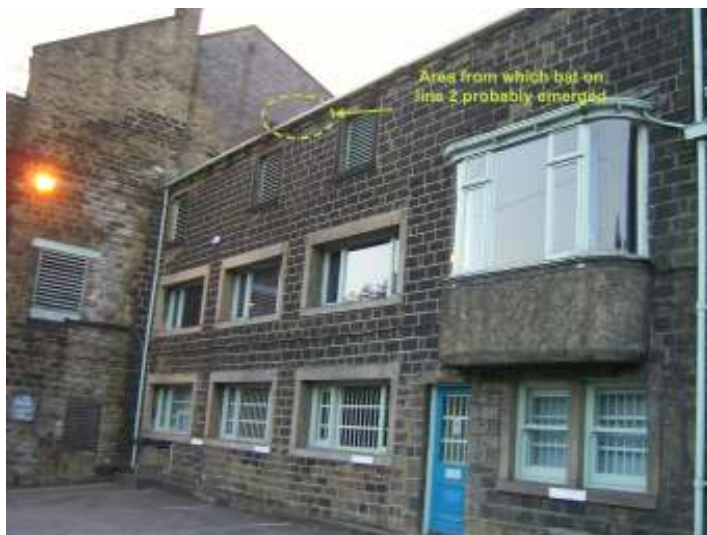
**Figure 1**

The first bat seen was at 21:32 when a common pipistrelle flew from the direction of buildings at the northern edge of the site: surveyors suspected that it may have emerged from beneath eaves at the southern elevation. At 21:43 another bat flew across the site from the west commuting towards trees beyond the south east corner. At 21:46, 2 bats were then seen foraging within the small garden at the eastern corner of the site, where they remained for approximately 10 minutes.

View of building where single bat emerged.

The first bat seen was at 21:20, which emerged from beneath the eaves of the stone building on the north of the site which was identified as a possible roost during the first survey and is shown in Figure1 above. This was followed at 21:26 and 21:46 by two other bats from the same location. At 21:28, a bat re-entered this roost and was seen to emerge again at 22:07. This was repeated at 21:56 with another bat re-entering the roost to emerge again at 22:07. At 22: 47 two more bats emerged from the same location, making the likely total of bats observed using the eaves during this survey to be four.

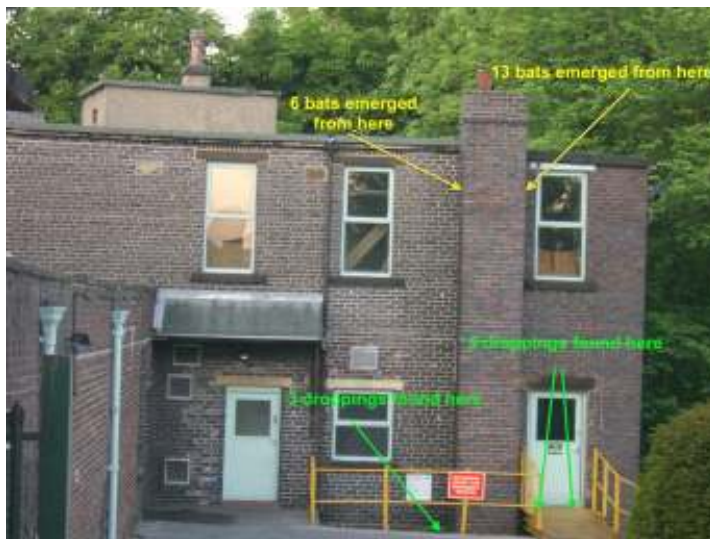
**Figure 2**

At 21:23, a single bat emerged from the gap behind the chimney on the three storey building at the eastern end of the site. This was followed a few minutes later by an additional bats from the same feature with a total of 19 bats

emerging: the last bat to emerge was at 22:25. All of these flew away from the site southwards towards the river. No bats were seen to emerge from beneath the eaves of the building to the north of the site.

View of 3 storey building with chimney showing where bats were seen to emerge.

Plans for the site involve the demolition of the three storey building with the loss of one of these roost sites, therefore a license from Natural England will be required prior to works commencing. New buildings will be erected on the site with works commencing in autumn 2012.

- The ecologist will carry out proving survey of gaps behind the chimney prior to demolition to ensure the absence of bats.
- In the unlikely event of discovery of small numbers of hibernating bats, provision will be made for a small number of bats to be removed to a hibernation box erected on site. The discovery of larger numbers of hibernating bats will result in a halt to works.
- The ecologist will specify and approve the erection of bat boxes in suitable locations in the wider site prior to demolition.
- The ecologist will specify and approve the incorporation of integrated roosts in suitable locations in the new buildings.

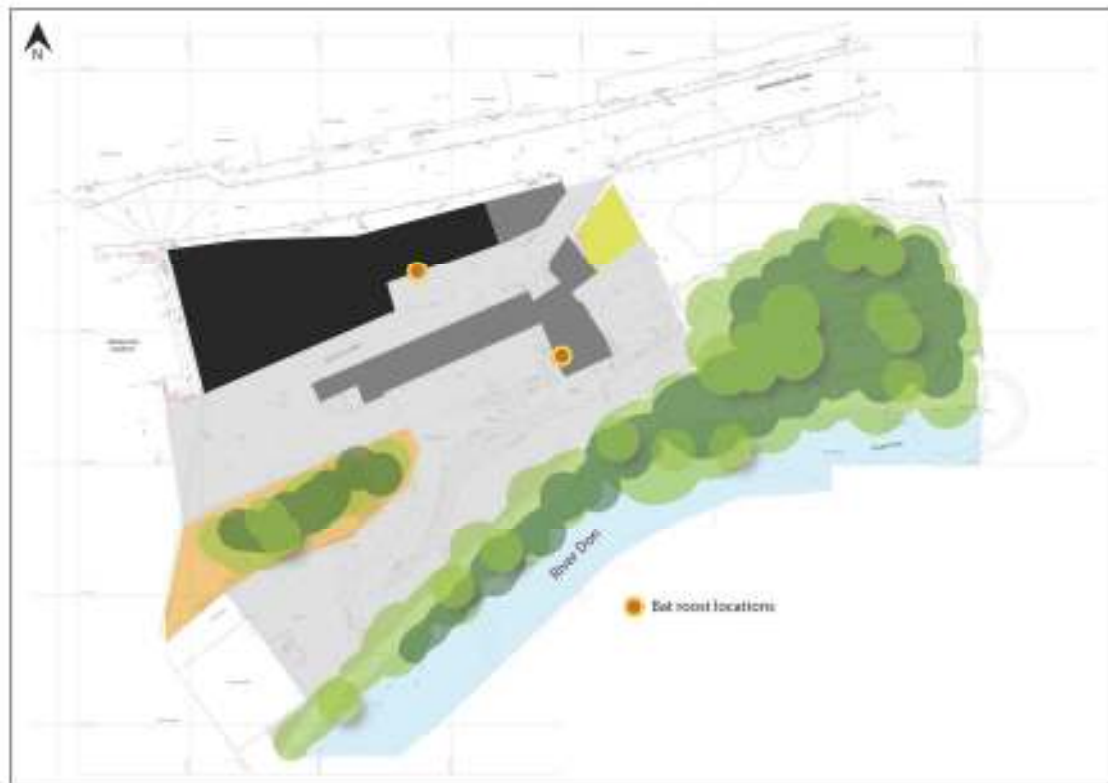
**Figure 3** indicative locations of roosts.

The site is assessed as supporting a small breeding colony of common pipistrelle bats. Up to 19 bats were observed roosting behind the chimney of the three storey building while smaller numbers were found roosting within eaves of buildings at the north of the site (see figure 3). It would appear that this colony of bats move between these roosts sites. It is important to note that all evidence suggests that the two roosts identified are alternative sites used by the same breeding colony and are unlikely be fully occupied at the same time.
