**Swallow Hill Road, Mapplewell**

**Percolation Test Report**

**February 2025**

AMA Project Number: 22972

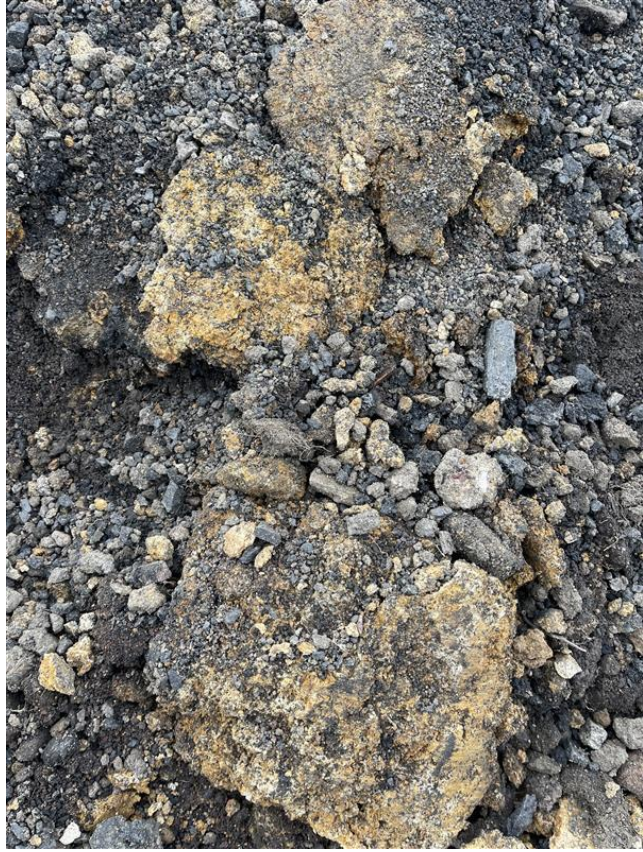
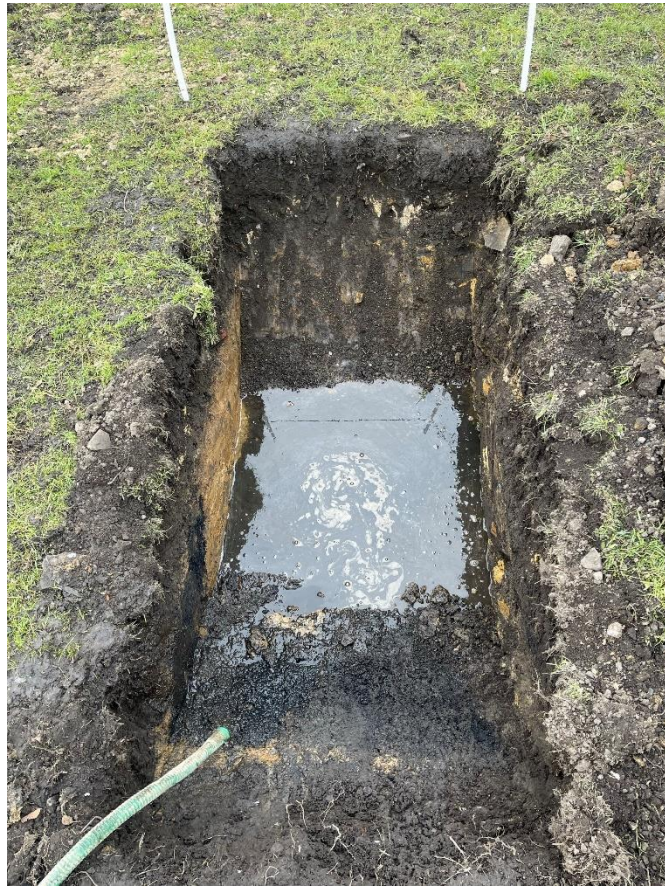
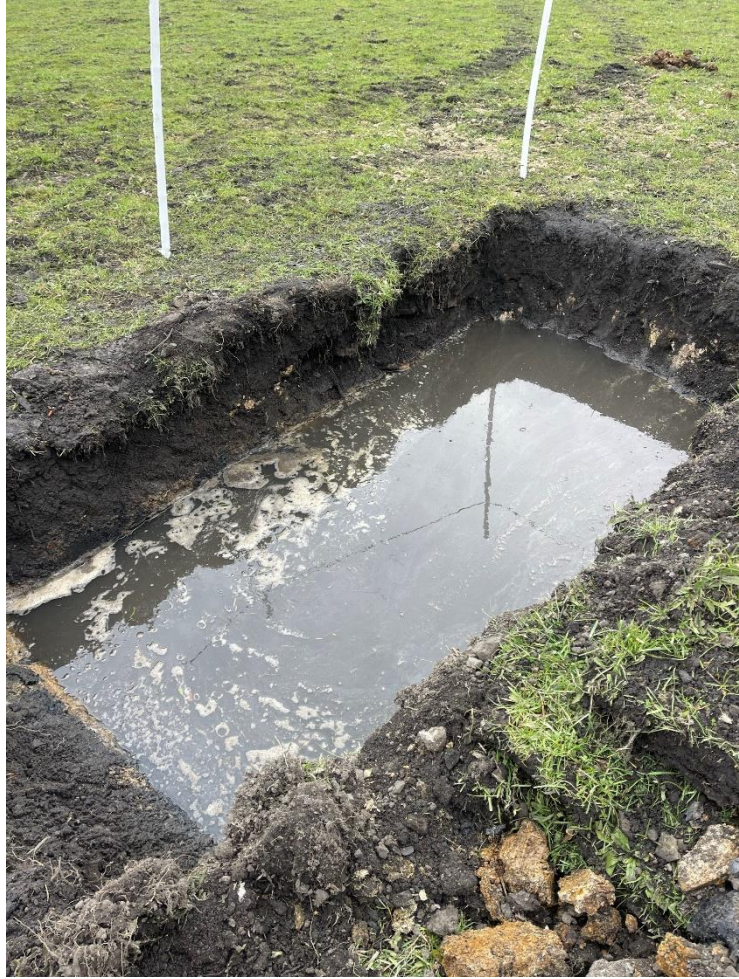
***Appendix A***  
***Photographs from Infiltration Test***

- ▶ Trial Hole 1: 1.5m x 1.00m x 0.90m

2.6.3 The water level drop was monitored and recorded. The trial pit was located in the center of the site.

2.7.1 For the test completed on Test Pit 1, water was filled to a depth of 0.70m, and the water level dropped to 0.65m over a 60-minute period.

2.8.1 Based on the results shown above it can be confirmed that soakaways would not be viable at the site.
