Proposed conversion of Craft  
to residential use - Carr House  
Royd Lane, Thurgolane 2016/1193/INVALID

**CARR HOUSE, ROYD LANE,  
THURLSTONE.**

**BAT SURVEY.**

**Ref No:- 161111.**

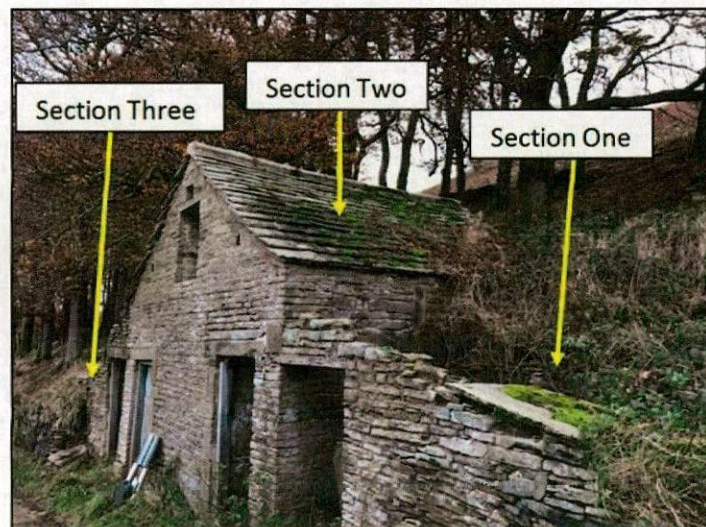
3.2.1. The surveyed building includes three sections all of which are directly adjacent to each other. A description of each section is provided below;

3.2.1.1. The plan below shows different sections of the surveyed building.

3.2.2. Section One is located on the eastern side of the surveyed area. Section One includes solid stone walls approximately 1m in height. This section of the building has no roof and the existing walls are in poor condition and covered in dense bramble and grasses.

3.2.3. Section Two is attached to Section One and Three by solid stone walls. Section Two is constructed from solid stone walls and a pitched stone slate roof.

3.2.8. Section Three is located on the western side of the surveyed area. Section Three includes solid stone walls approximately 1.5m in height. This section of the building has no roof and the existing walls are in poor condition and very exposed due to the location of the building within the surrounding landscape.

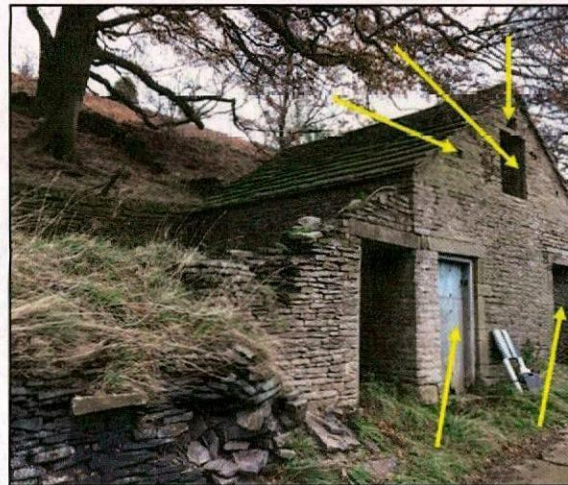
3.2.4. A number of gaps which allow access into the interior of the building are located within the northern and southern walls of Section Two. Two doors allowing access into the building are located on the southern side of the building. One of the doors includes a wooden door and the other door does not include a door structure or a door frame.

3.2.4.1. The yellow arrows on the plan below show the gaps allowing access into the interior of Section Two of the building.

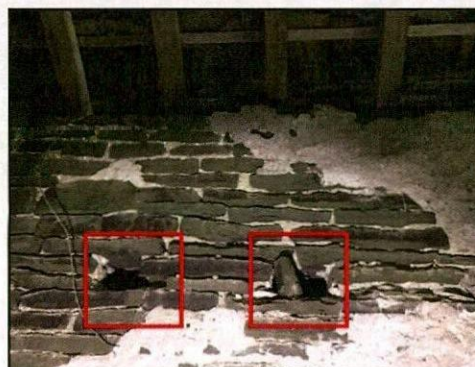
3.2.5. A number of large cracks and voids are located within both the exterior and interior side of the stone walls of Section Two of the building.

3.2.5.1. The photograph below shows some of the identified gaps and voids.

3.3.2. Section Two of the surveyed building contains a number of voids and cracks within the exterior and interior sides of the stone walls. The voids and cracks provide suitable habitat for individual or low numbers of crevice dwelling bats although no bats or bat field signs were identified during this survey; therefore, the building has been assessed as providing low potential for roosting bats in line the Bat Conservation Trust guidelines.

5.1. As one of the sections of the building has been assessed as providing low suitability for roosting bats it is recommended no works are undertaken on the building until one bat dusk emergence survey is undertaken.

5.2. In order for the dusk emergence survey to be in line with the Bat Conservation Trust Guidelines it must be undertaken by an experienced and licenced ecologist during May and September when bats are most active.

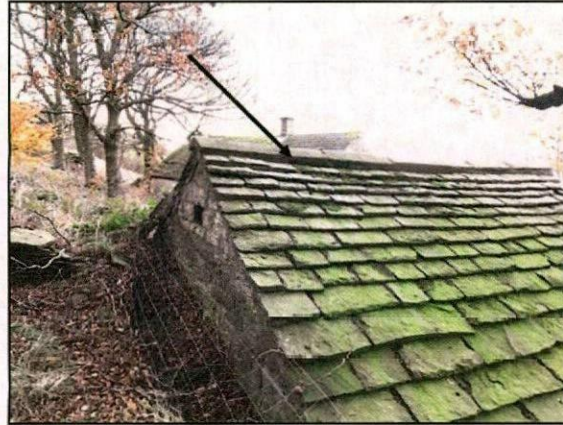
3.2.6. The exterior side of Section Two's roof includes stone slates and stone ridge tiles. The gable ends include bare stone slates and there are no fascias or guttering. The roof is in good condition with the only visible gap allowing access inside the building located underneath the ridge tile on the western side of the roof.

3.2.6.1. The photograph below shows the gap within western side of the ridge tiles.

3.3.3. The gaps between the stone slates also provide suitable habitat for individual roosting bats. No bat field signs were identified along the outside or underside of the roof during this survey and the roof is unlined; therefore the roof is only potentially suitable for low or individual numbers of bats.

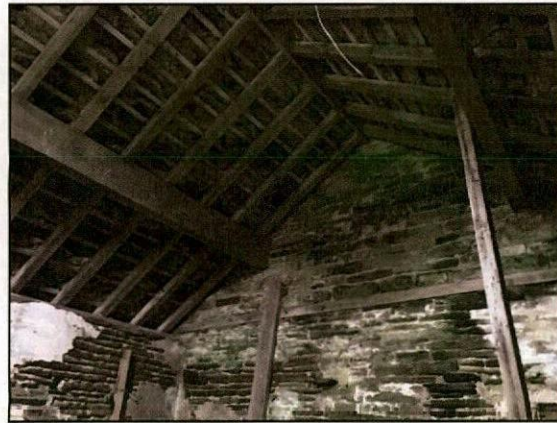
3.2.7. The roof of Section Two is supported by timber rafters, timber tie beam and two large timber joists. The roof also includes bare stone slates which are unlined.

3.2.7.1. The photograph below shows the underside of the roof.

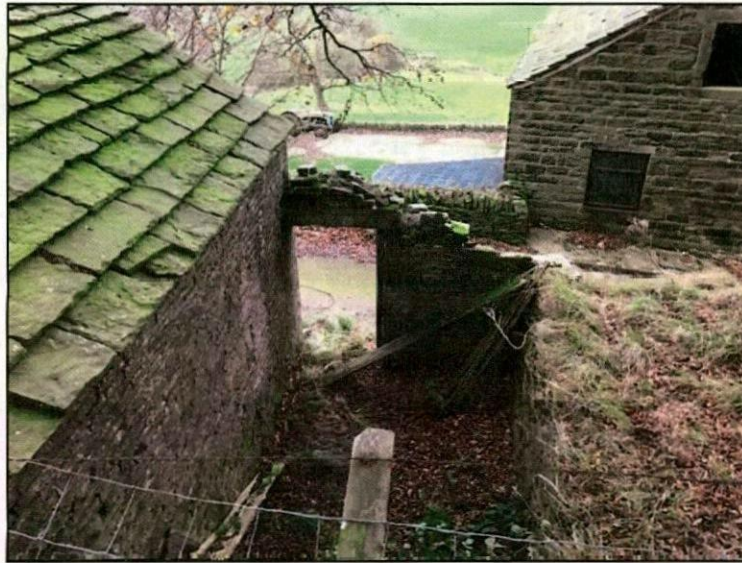
3.2.8.1. The photograph below shows Section 3 of the Building.

3.3.1. Sections One and Three of the surveyed building have partly collapsed walls and no roof; therefore these sections of the building have been assessed as unsuitable for roosting bats.

5.3. If works are to be undertaken on Section One and Three of the building prior to a bat dusk emergence survey the works must have no impact on Section Two and undertaken in a method which will cause no or low levels of noise, air and light pollution.

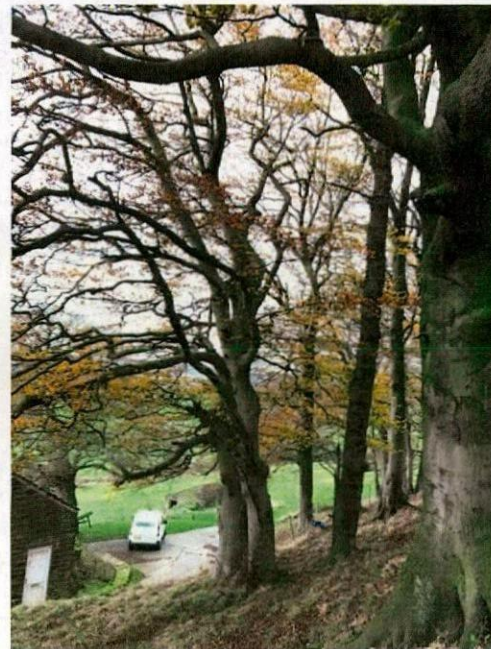
3.2.9. Mature beech trees are located approximately 6m north of building causing a number of large branches to overhang the surveyed building.

3.2.9.1. The adjacent photograph shows the mature beech trees.

3.3.4. A number of large mature beech trees are located approximately 6m north of the surveyed building. A thorough inspection of the beech trees could not be achieved from ground level although they are likely to contain cracks and voids suitable for roosting bats due the trees size and age. No cracks or voids suitable for roosting bats were identified within branches overhanging the surveyed building.

4.5. The mature trees adjacent to the surveyed building provide potentially suitable habitat for roosting bats although a thorough inspection could not be achieved from ground level. No suitable bat roosting habitat was identified within the branches overhanging the surveyed building.

4.5. If any mature beech trees are to be felled during the works there be will potential impact on roosting bats. If the works do not involve felling but include removing the branches overhanging the surveyed building, there will be no potential impact on roosting bats.

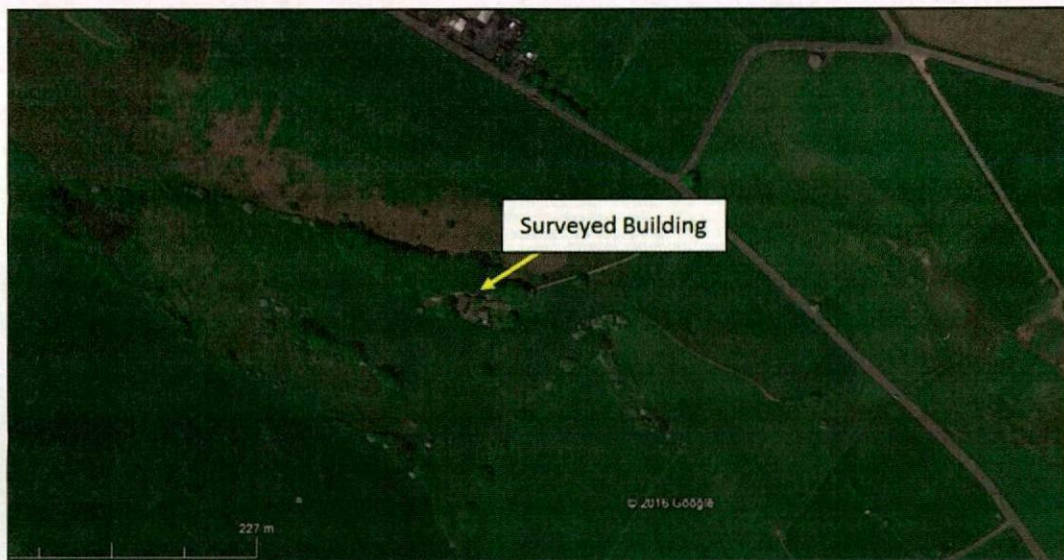
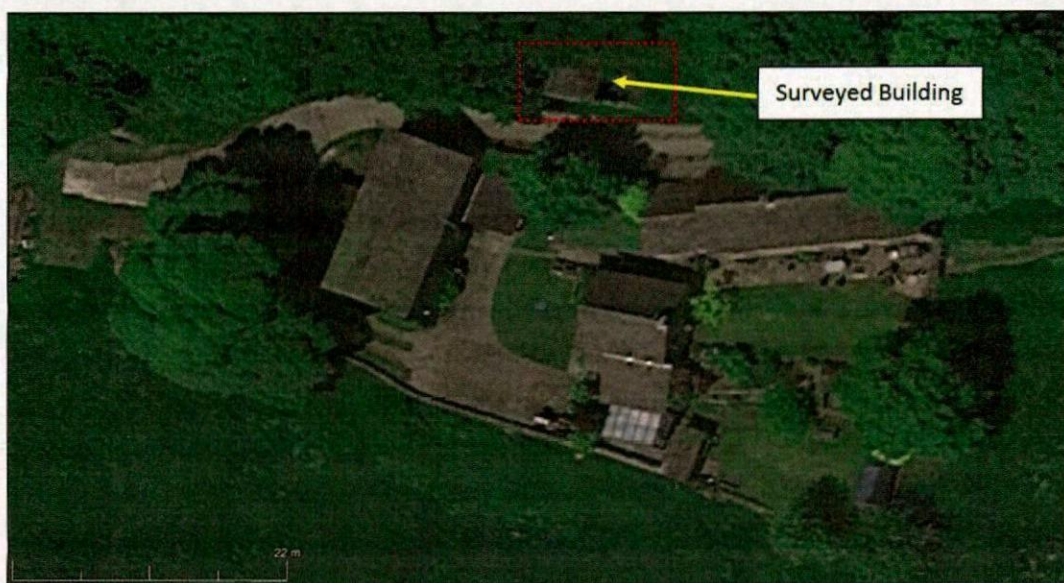
3.2.10. The surveyed building is located within an exposed area of farmland on top of a south facing hillside. The surrounding landscape includes a small area of beech woodland, open pasture farmland and scattered stone farm buildings.

3.2.10.1. The aerial plans below show the surveyed area.

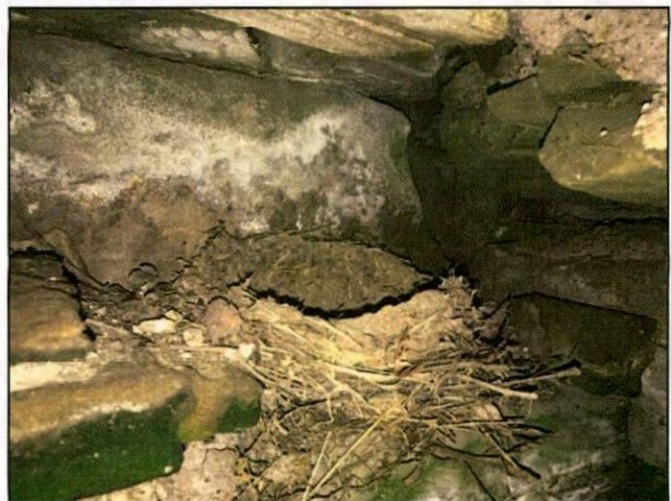
3.3.5. The surveyed building provides suitable habitat for nesting birds during the nesting bird season which extends between March and September each year. A number of old swallow nests and other bird nests likely to be pigeon are located within the interior of the building along the timber rafters and ledges on top of the stone walls.

3.3.5.1. The adjacent photograph shows one of the identified bird nests located within the building.

4.6. A number of old bird nests including swallow and pigeon nests were identified within the interior of the building. The vegetation and stone walls also provide suitable habitat for nesting birds; therefore any works undertaken on the building and vegetation during the nesting bird season which extends between March and September each year will have a potential impact on nesting birds.

5.4. It is recommended any works undertaken on the building and vegetation are carried outside the nesting bird season which extends between March and September each year.

5.5. If works are to be undertaken during the nesting bird season it is recommended a nesting bird survey is undertaken prior to works by an experienced ecologist. Any active bird nests must remain undisturbed until the young have fully fledged the nest.

5.6. It is further recommended the proposed building incorporates nesting bird habitat to compensate for the loss of nesting bird habitat within the existing building. Suitable nesting bird opportunities could include sheltered areas by incorporating overhanging eaves into the building or attaching swallow nest cups along the top of the walls.
