**Barn at Elmhirst Farm, Cawthorne**  
**Bat and Nesting Bird Survey Report**  
**7<sup>th</sup> January 2021**

| Document ref: MBE/BAT/2021/02 | | | | |

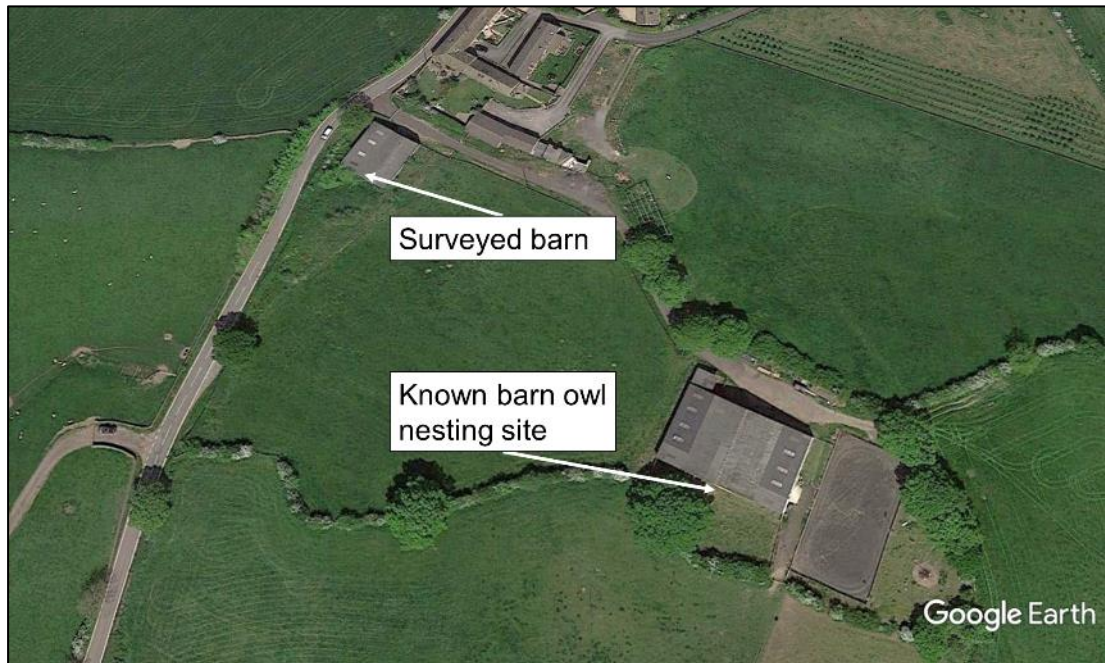
**Figure 2. Proximity of known barn owl nest site from surveyed building**

5.1.2 A barn owl *Tyto alba* record was received from the site owners who confirmed barn owl nesting from a box fitted in a second barn (also in their ownership), located 220m southeast of the surveyed structure (Figure 2). A picture of juvenile birds perched on a beam within this barn was shared with the surveyor. This second barn will not be impacted by the proposed scheme.

6.3.3 There is scope to enhance the site’s potential to support roosting bats, either through integration of bat roosting provision within the re-developed barn and/or the fitting of externally mounted bat box/es to the retained barn, located 220m to the southeast (Figure 2). It is noted that the retained barn is closer to the tree-lined stream and therefore bat roost provision in this area may stand a higher chance of uptake. It is recommended that a minimum of one bat box is fitted in either of these locations.

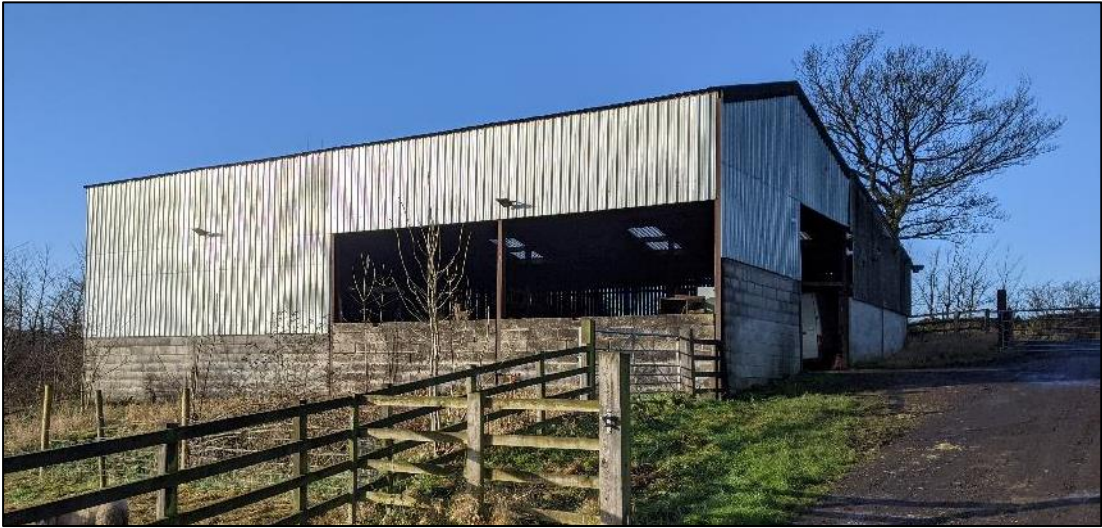
**Plate 1. Eastern corner of barn**

- 5.2.3 The surveyed barn comprises a steel-framed single-storey structure with a pitched corrugated asbestos-cement sheet covered roof. The northwest pitch of the roof is longer than the opposite pitch, and the gables have asbestos-cement verge cappings. The barn walls comprise hollow concrete blocks to a height between 1.2-2m with a mixture of single-skin corrugated metal, corrugated asbestos-cement and hit-and-miss timber wall cladding above. The barn is partially open-sided at the northern end of the southeast elevation, with an additional large double-door sized opening in the northeast elevation.

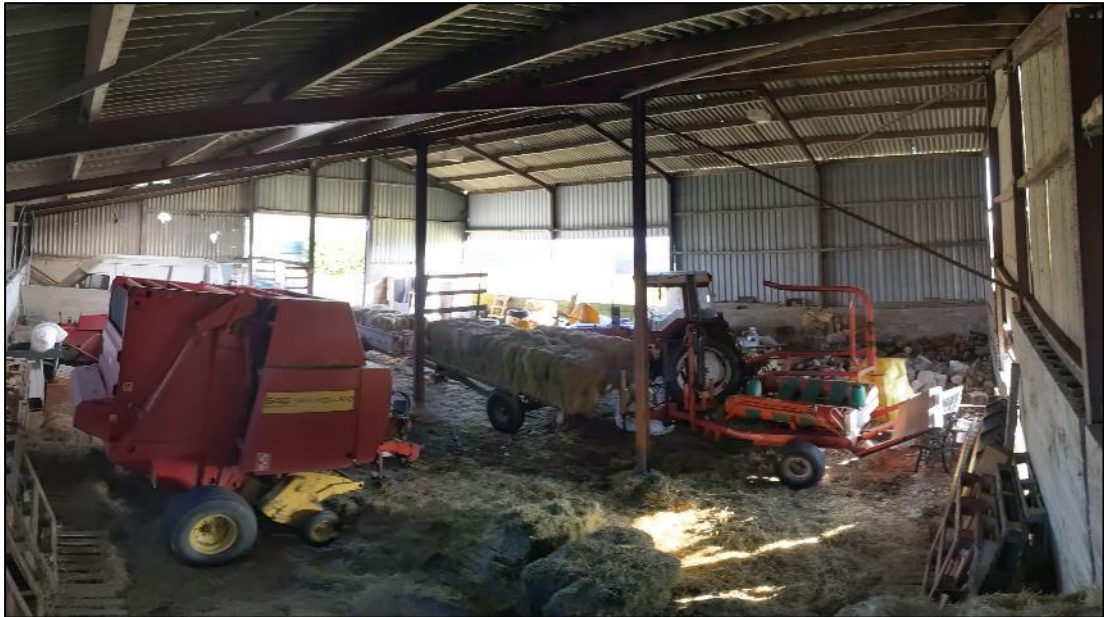
Plate 5. Interior of barn viewed from west corner

- 5.2.5 The interior of the barn is open to the inside of the single skin walls and the underside of the roof sheeting, with the roof suspended on the steel frame and wooden purlins. The interior of the barn is used for storage (Plate 5).
- 5.2.6 The interior of the building lacks any potential bat roosting features or signs of bat presence. No signs of barn owl presence were recorded from the surveyed barn, however, a former house sparrow nest was noted from a location between two parallel wood purlins, spaced c.100mm apart (Plate 6).
