**FORMER NORTH GAWBER COLLIERY, MAPPLEWELL
Shaft reference 433409-001 and adit reference 433409-011**

In October 2015, RSK produced a report (reference 322014-R01) summarising investigatory works carried out at each mine entry within the boundaries of the former North Gawber Colliery site. This letter has been prepared in order to provide further details on the concrete caps that have been encountered at shaft reference 433409-001 and adit reference 433409-011, as requested in your email dated Monday 8 February 2016.

CLIENT	HARWORTH ESTATES				
PROJECT	NORTH GAWBER				
TITLE	SUMMARY OF MINE ENTRIES (HARRON HOMES)				
JOB No.:	322014		DRAWING FILE:	322014-L08 00 D001A	
BY:	DATE:	CONTRACT NO.	REV:		
HD	16.02.16		FIGURE 1		A

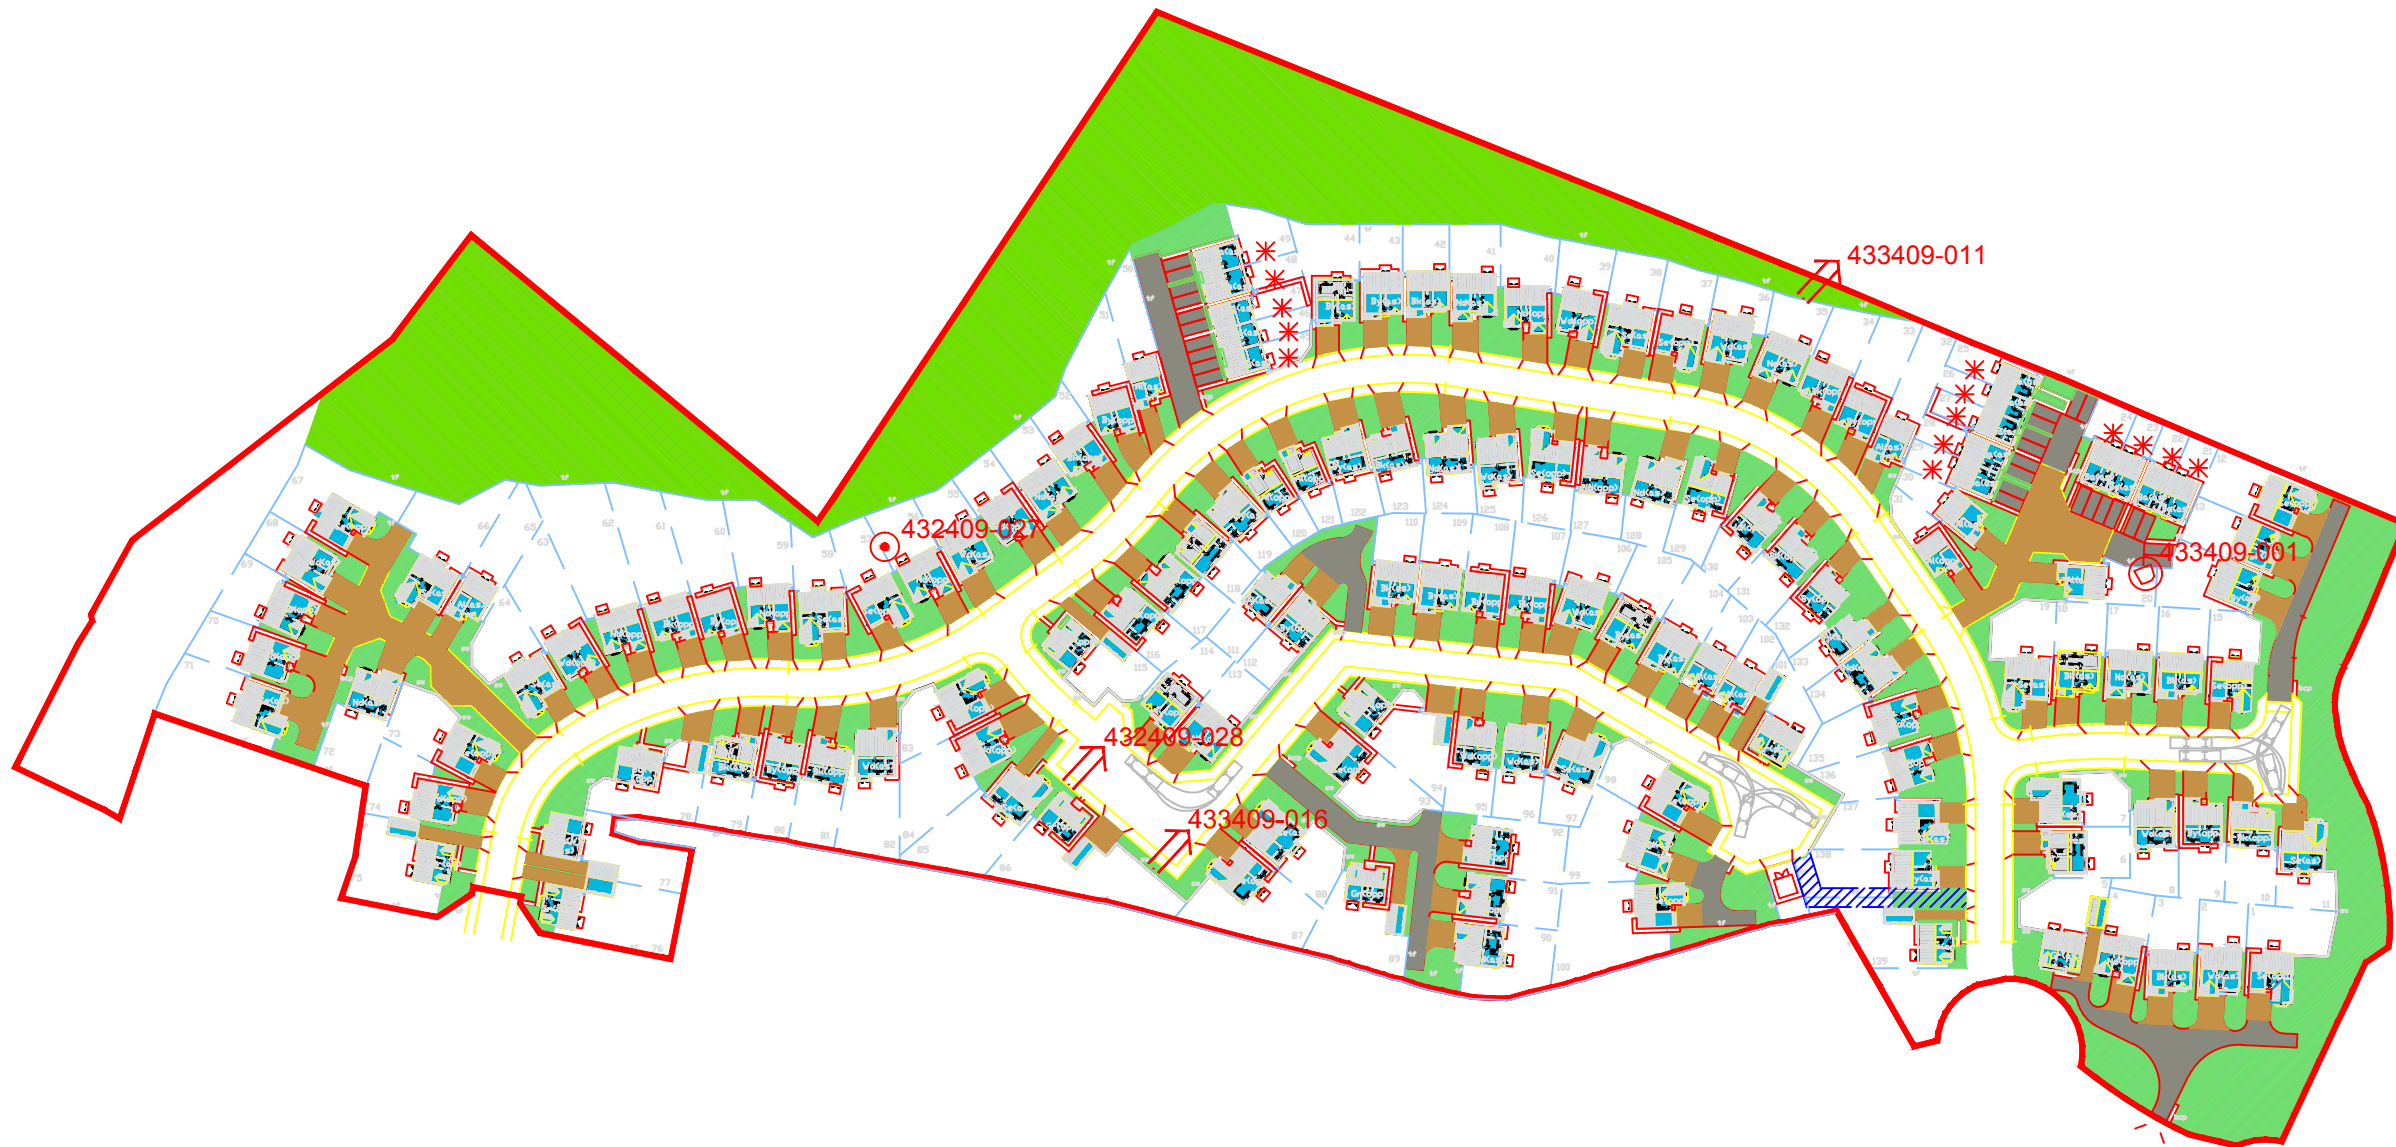
Mine Shaft 433409-001
Reinforced concrete cap identified during enabling works 2015 at 433225.6893 409749.2317 centre provided by contractor - Proposed 'no build one' shown 8m diameter see RSK letter 322014 L08

Adit 433409-011
Adit entrance identified during enabling works 2015 co-ordinates 433153 409808

Mine Shaft 432409-027
Mine feature identified during investigation works 2015 at co-ordinates 432957-95. 409755.27. See RSK reports 322014 R1 322014 R05 and letter 322014 L07. Proposed 'no build one' shown.

The adit plug is located on the northern boundary of the site, falling in a northerly direction away from the site. The plug is beyond the development platform, and is indicated in Figure 1. The ground level to the south of the plug was raised, so the plug is no longer visible. To the south of the plug, the concrete was broken out to weathered rock level, and this area will be part of a back garden in the proposed housing layout. RSK does not consider that the adit will impact the proposed development.

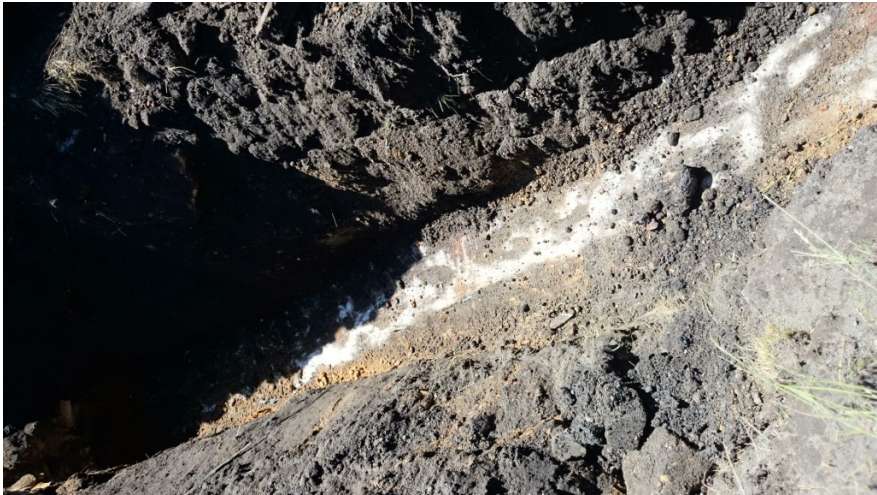
PHOTOGRAPHIC LOG		
Photo no. 1	Date: 10/07/2014

Direction photo taken: Towards the south		
Description: Edge of the concrete cap over 433409-001

Trial trenches were excavated in July 2014 to prove the location of the mine shaft. A concrete cap was encountered within the trenches at the coordinates provided by the Coal Authority, at a depth of approximately 3.8m bgl at the time of the investigation. Photograph 1 provided in Appendix B shows one edge of the concrete slab exposed by the excavator. Three corners of the square slab were exposed during the 2014 investigation and the sides were measured to be 6m long.

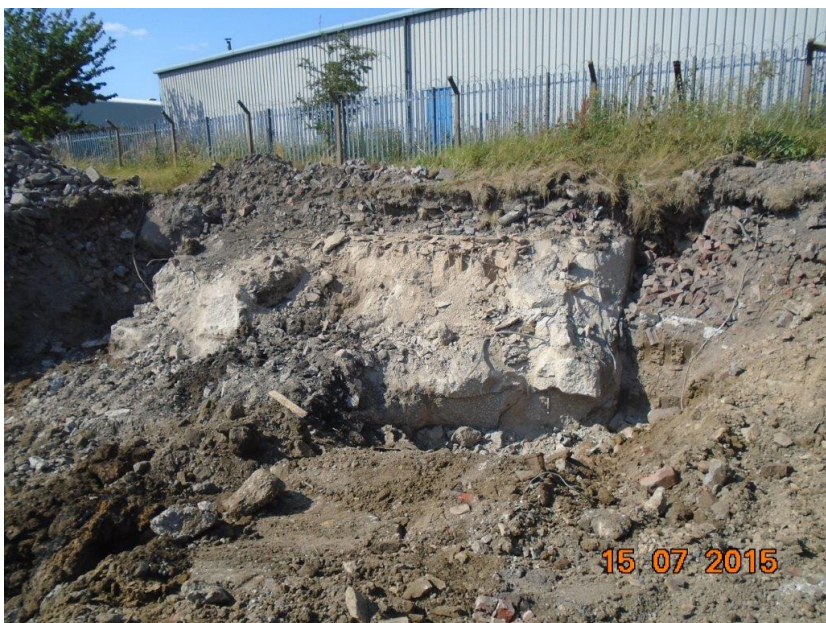
Photo No. 4	Date: 15.07.16

Direction Photo Taken: Northwest		
Description: Extent of excavation around adit 433409-011. Fence in background is northern site boundary. The plug was backfilled.

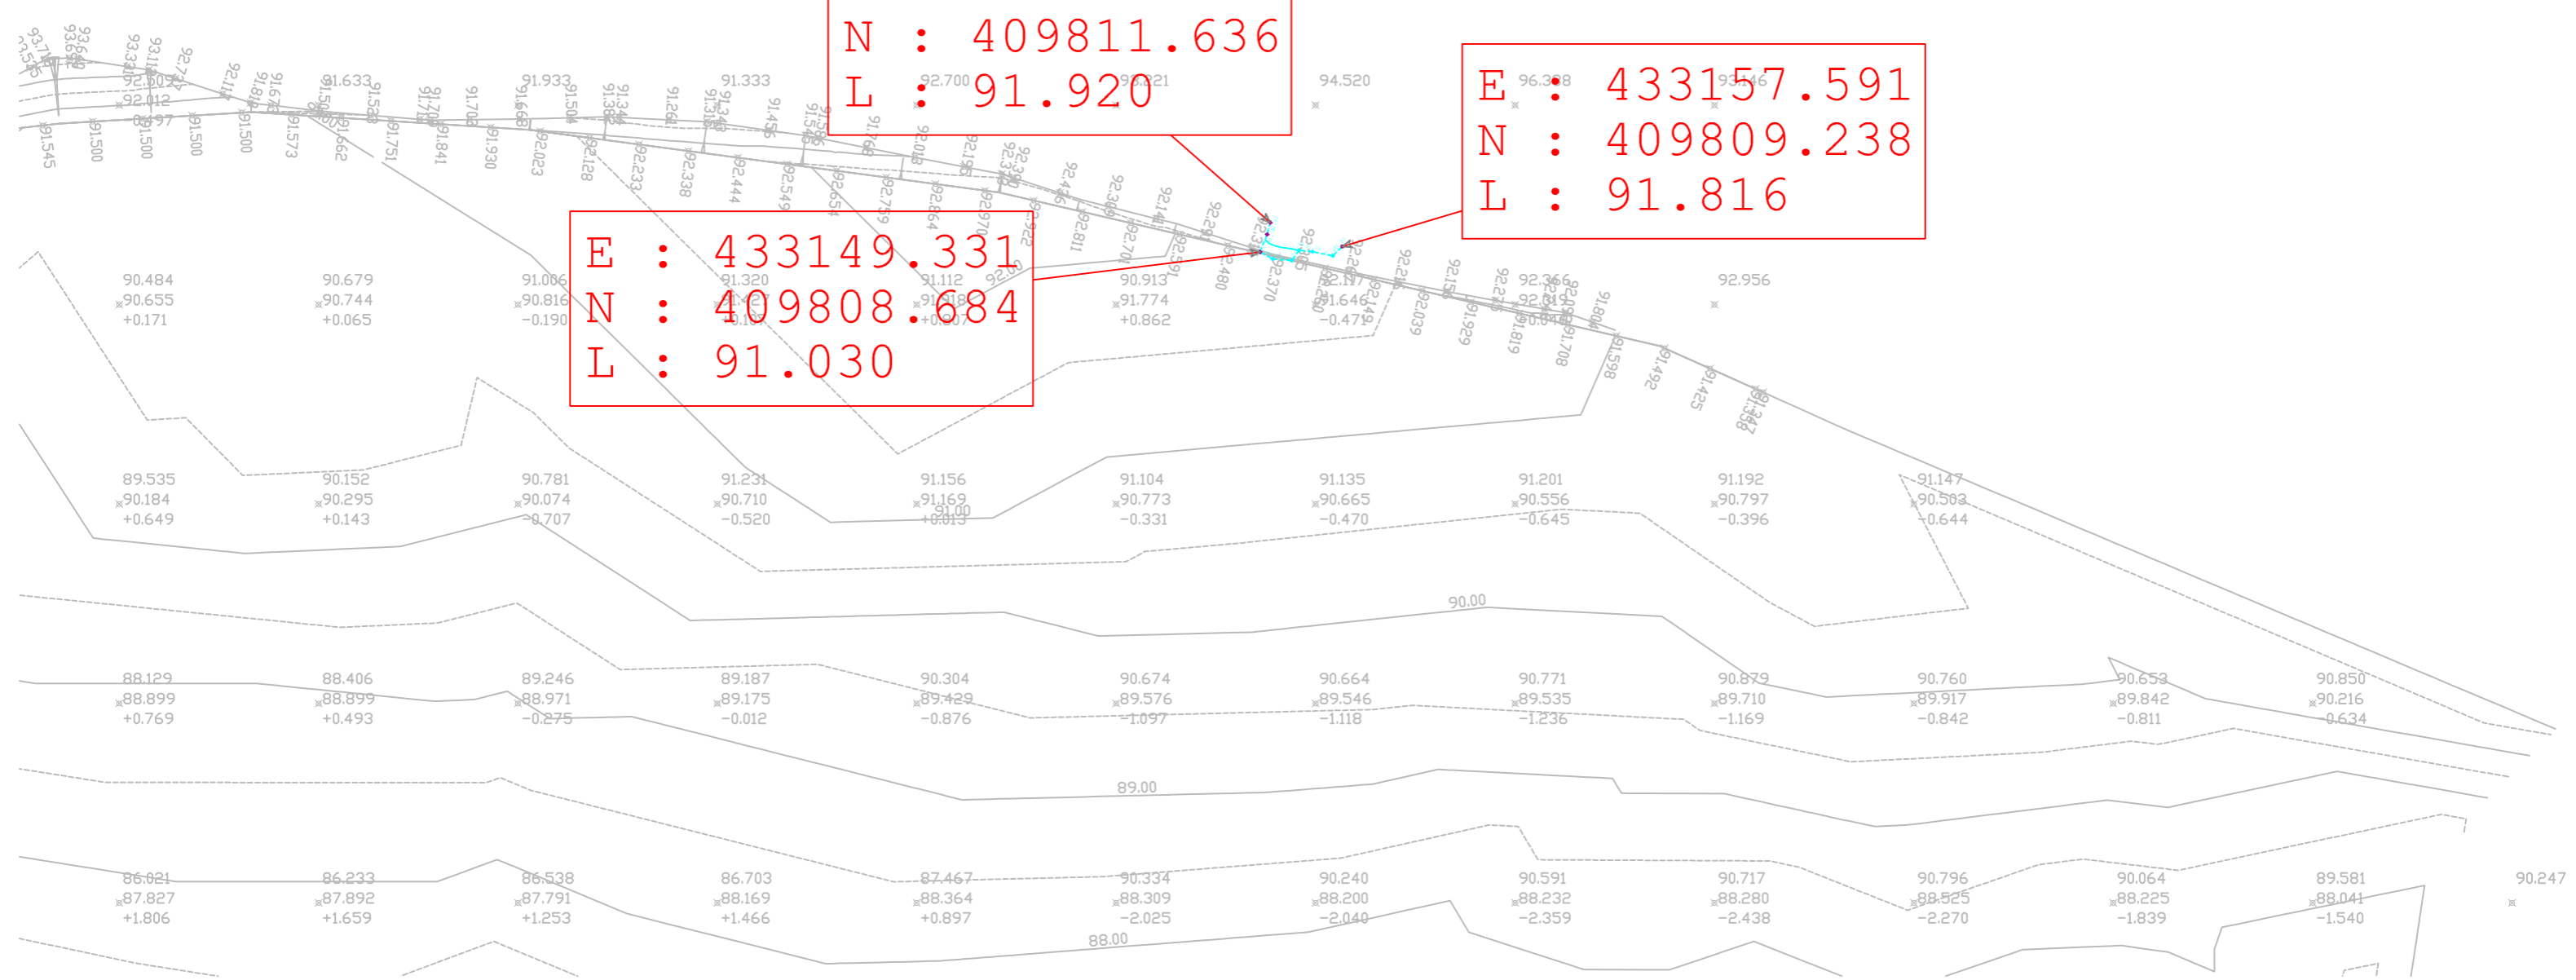
COORDINATES OF PLUG OVER ADIT 433409-011

REMAINING CONCRETE - ADIT CAP

E : 433150.360
N : 409811.636
L : 91.920

E : 433157.591
N : 409809.238
L : 91.816

E : 433149.331
N : 409808.684
L : 91.030

Information provided within The Coal Authority report indicates that adit 433409-011 is located beyond the site's northern boundary. However during site preparatory earthworks, a buried reinforced concrete plug was uncovered within the site, close to the northern boundary, at coordinates 433153, 409808 (approximately 35m southeast of the Coal Authority recorded coordinates). The structure exposed included a linear concrete slab with rails leading towards the plug. These features can be seen in photographs in Appendix B. Appendix D shows the coordinates of the concrete plug, as recorded by the contractor during the restoration works. The concrete slab and rails leading up to the concrete plug were broken out, but the concrete plug at the mouth of the adit was not disturbed, and was re-covered with soil arisings. A small corner of the plug was broken exposing steel reinforcements measuring approximately 30mm in diameter. The concrete appeared to be in good condition and extends beyond the site boundary.
