**Report on a
Phase 1 and Phase 2 Investigation
For A Proposed
Metal Recycling Facility
At
Shaw Lane
Barnsley**

**On Behalf of
Stairfoot Metals Ltd**

Report by: Paul Palgrave BSc (Hons) ARSM MSc C.Geol FGS
Date: September 2017
Report No. 759-R-01

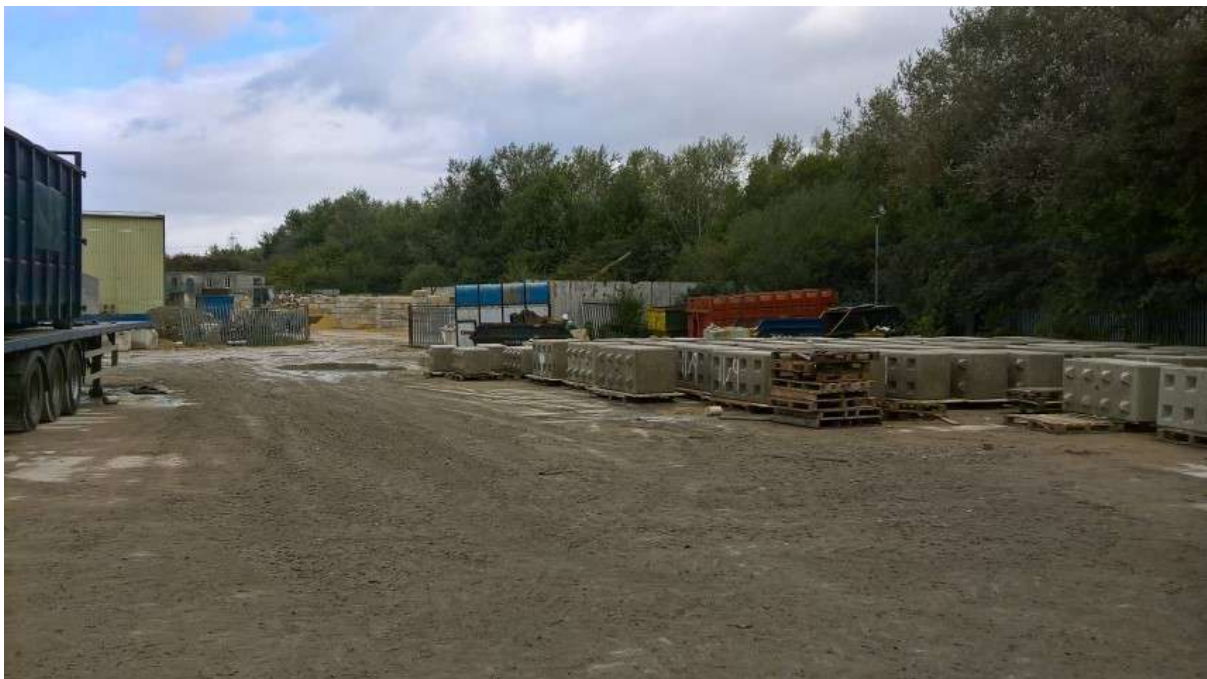
1. View south to north across site, showing concrete block product storage.

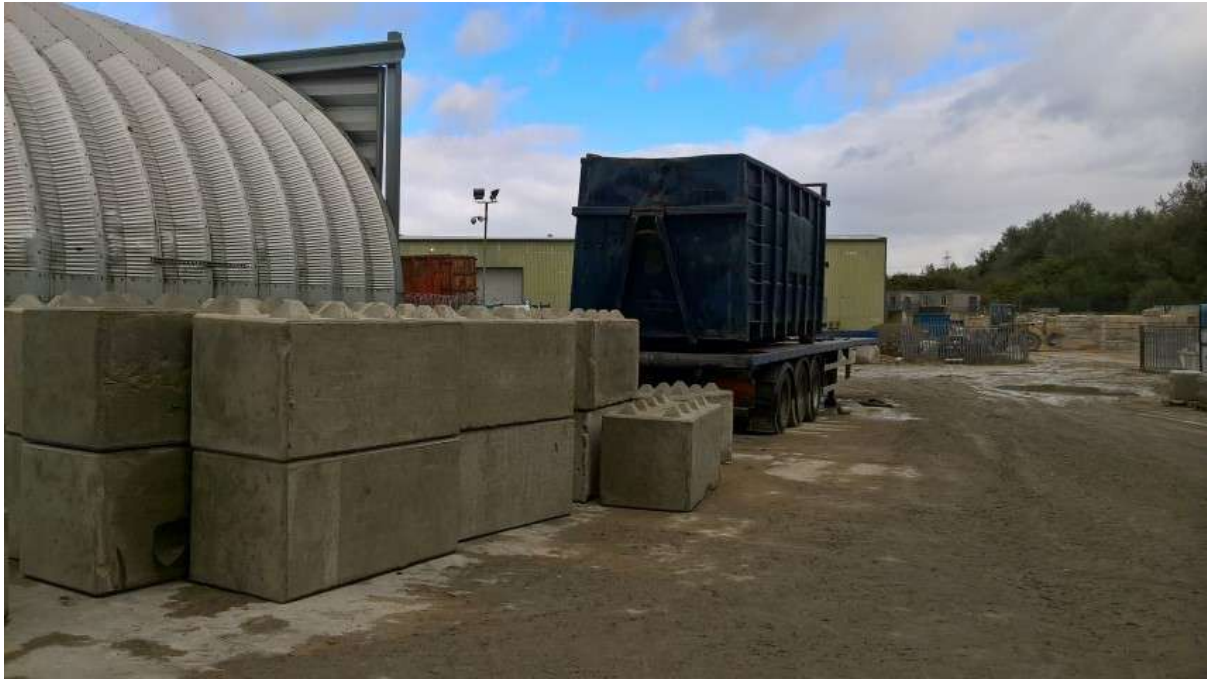
2. View from south to north-west across site. A corner of the corrugated steel sheet-clad building is visible on the left-hand side, and the lorry trailer is also shown.

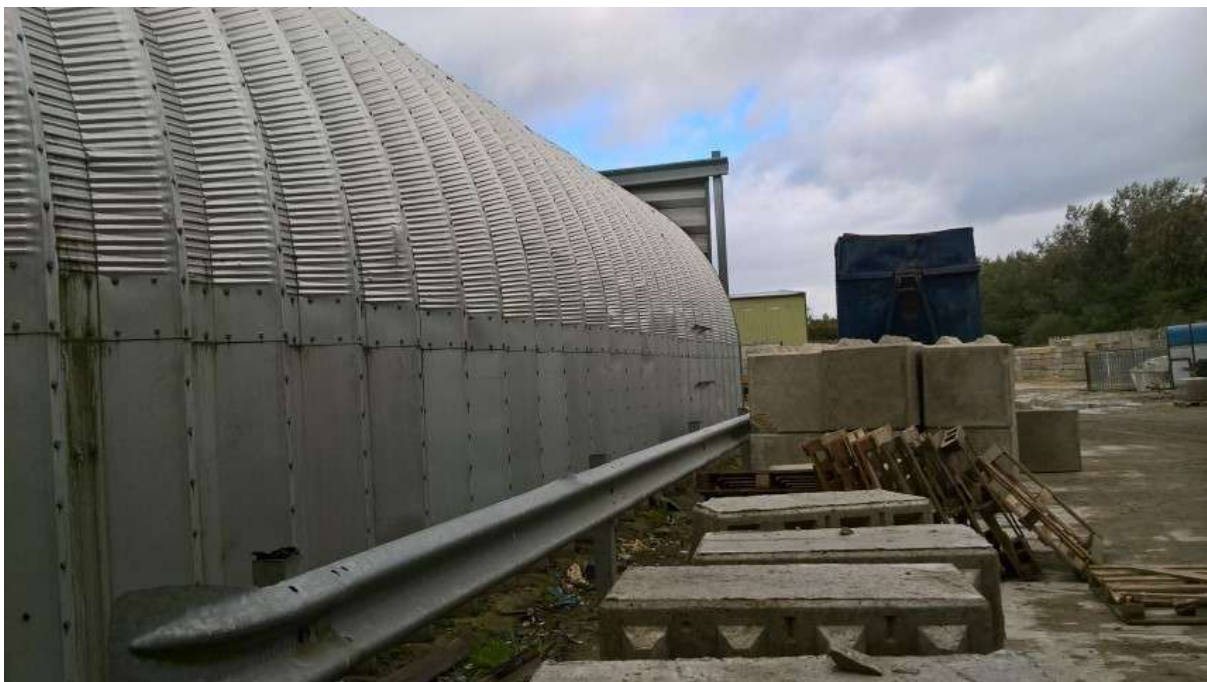
3. Eastern elevation of the on-site structure.

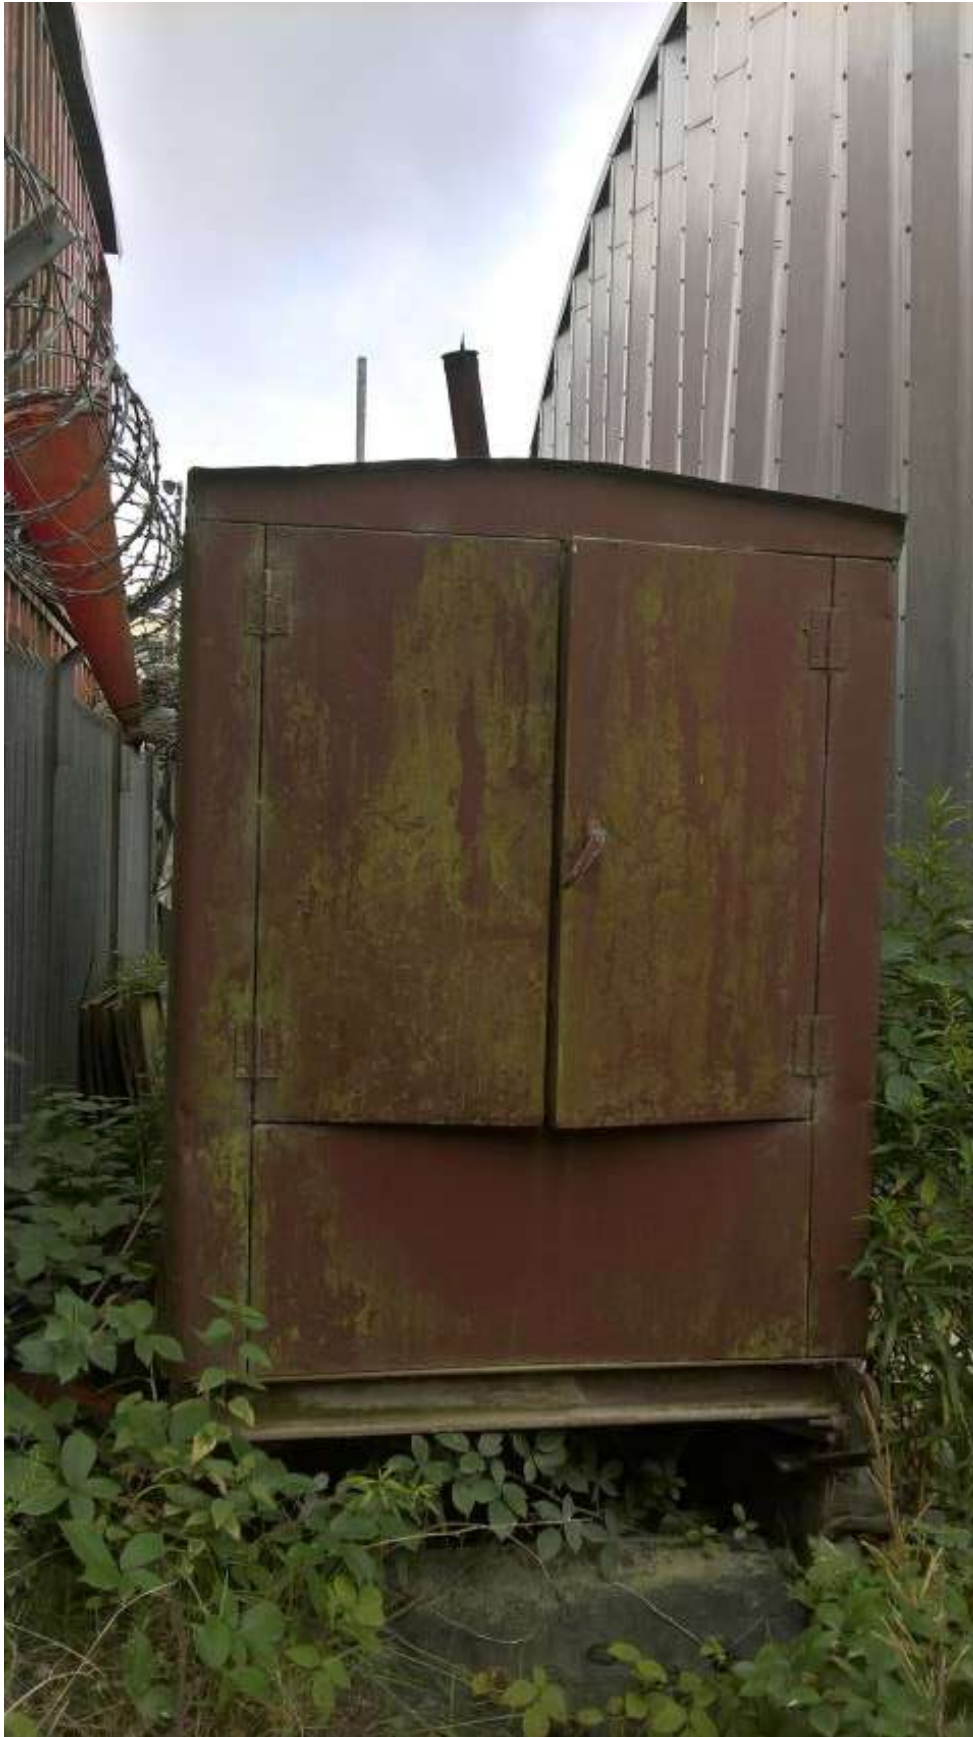
A disused diesel electricity generator is present to the south of the steel sheet-clad building on the site, adjacent to the southern site boundary.

4. Diesel electricity generator located to the south of the on-site structure.

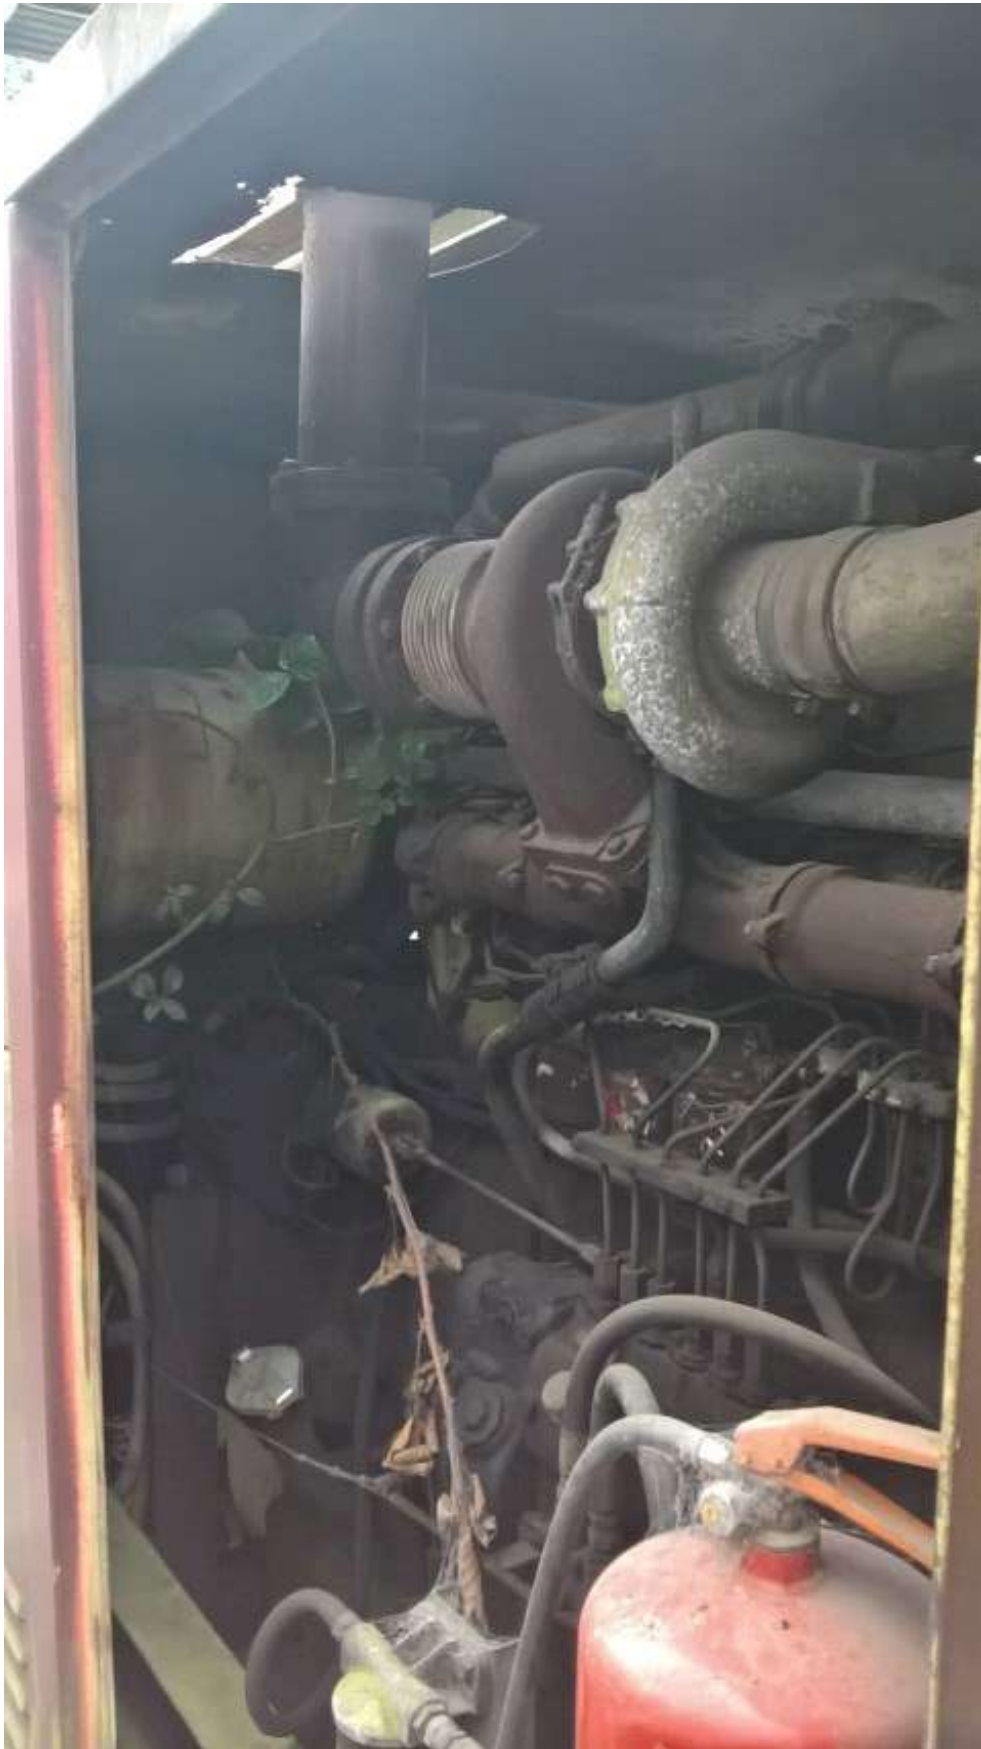
5. View inside disused diesel generator.

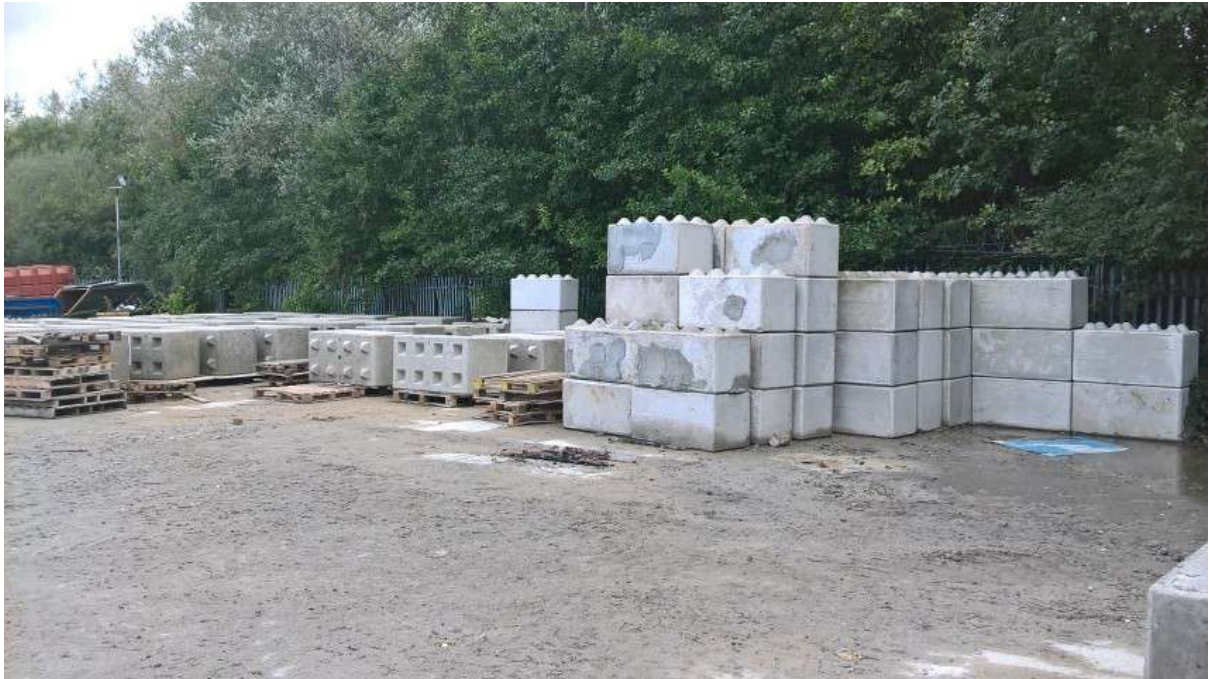
6. Eastern/south-eastern part of site showing interlocking concrete products on the concrete pavement.

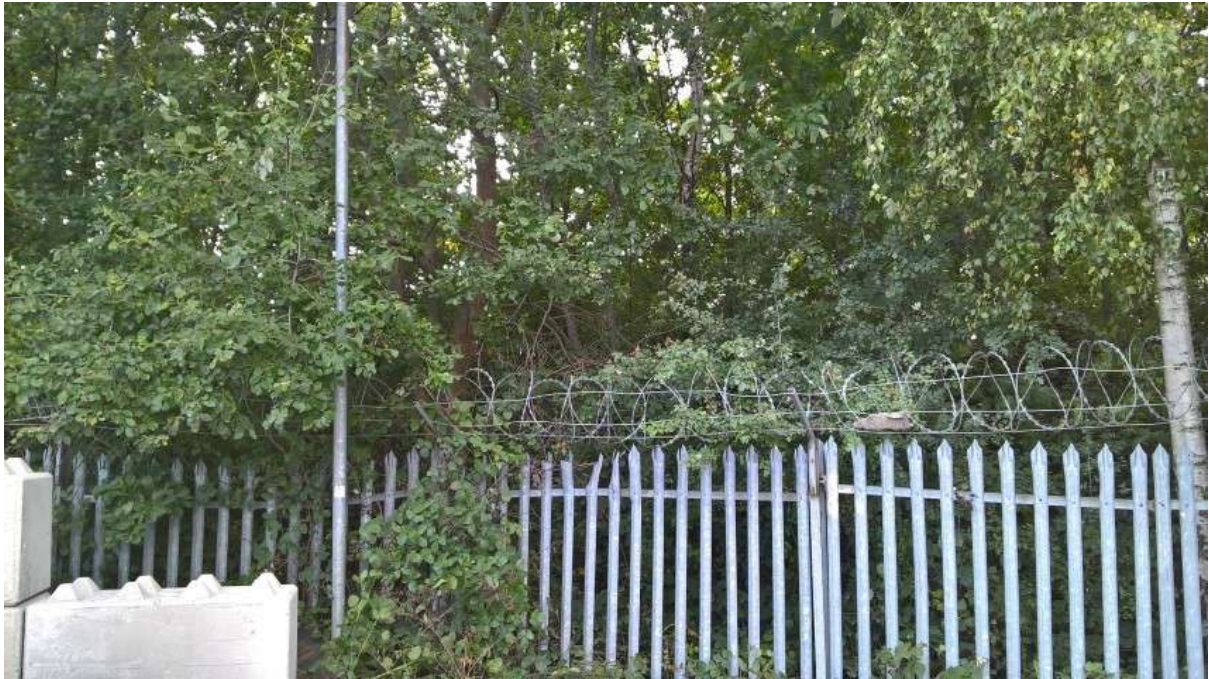
8. Palisade fencing along eastern site boundary. The trees are located on a railway embankment rising to the east from the site boundary. The line is disused and the track removed.

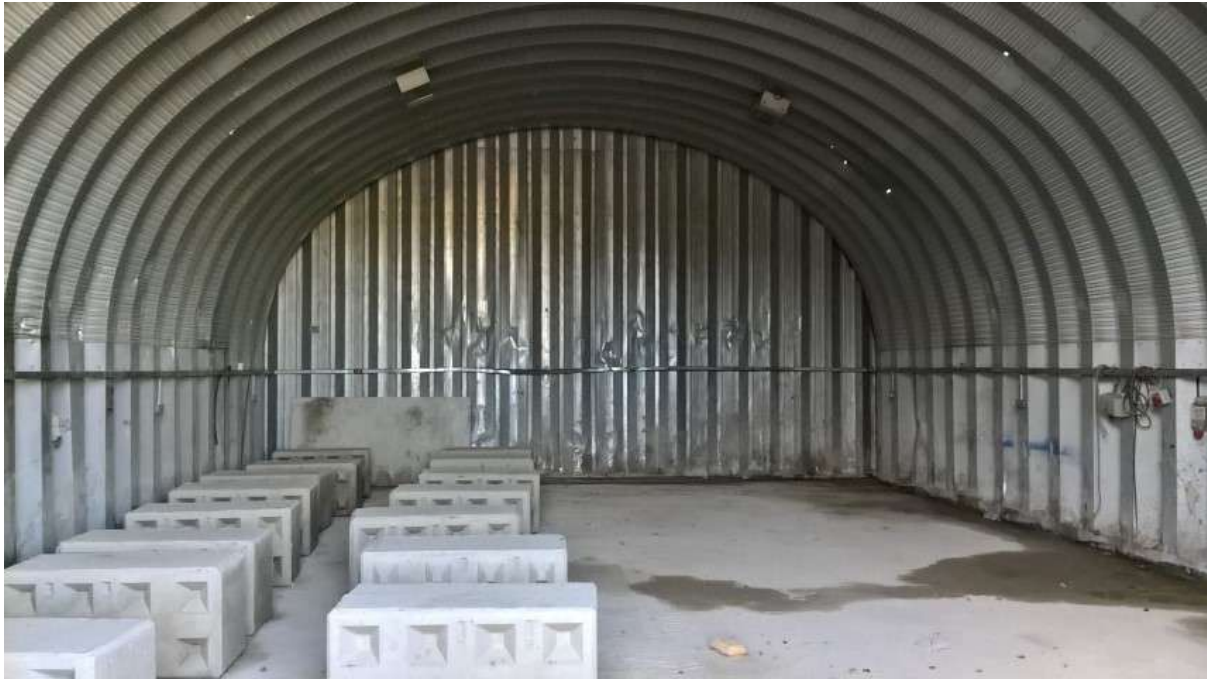
There is corrugated steel sheet-clad building in the south-west corner of the site that was mainly empty at the time of the site visit, with a small number of concrete block products stored within it.

12. View inside the corrugated steel sheet clad building on the site.

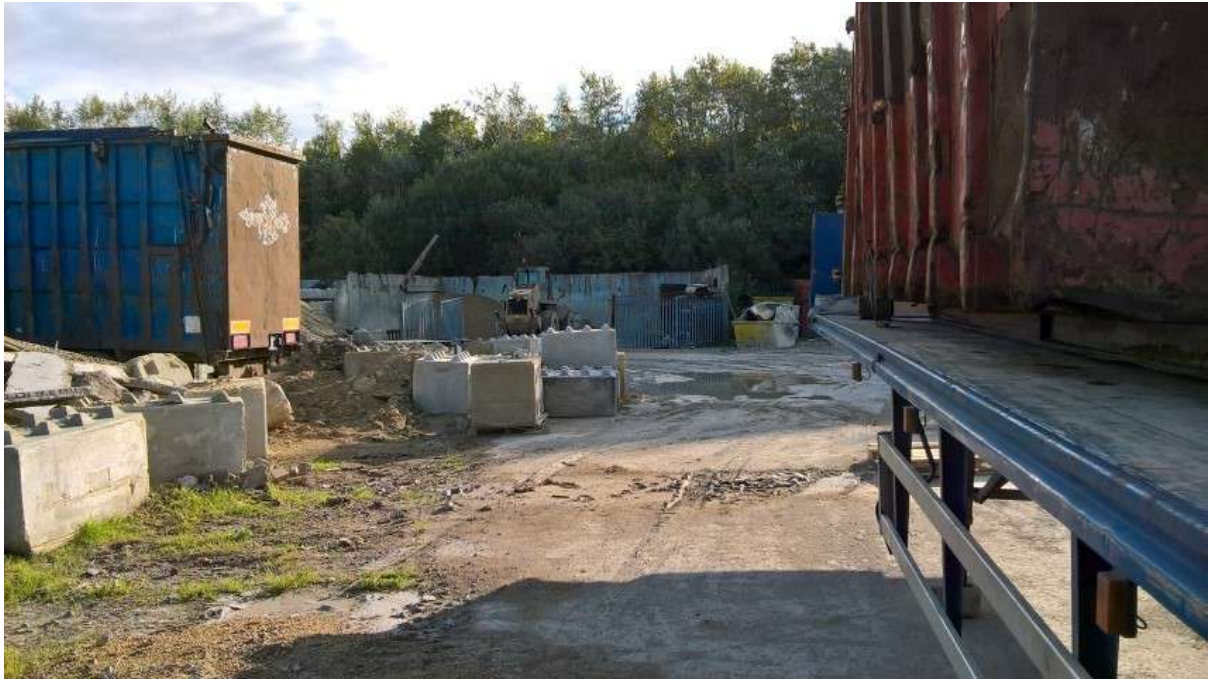
The southern, western and eastern site boundaries are defined by steel palisade fencing, but the northern site boundary is not fenced or demarcated.

14. View east along poorly defined northern-site boundary, from north-western end of the site, at the end of the access road that forms part of the site.

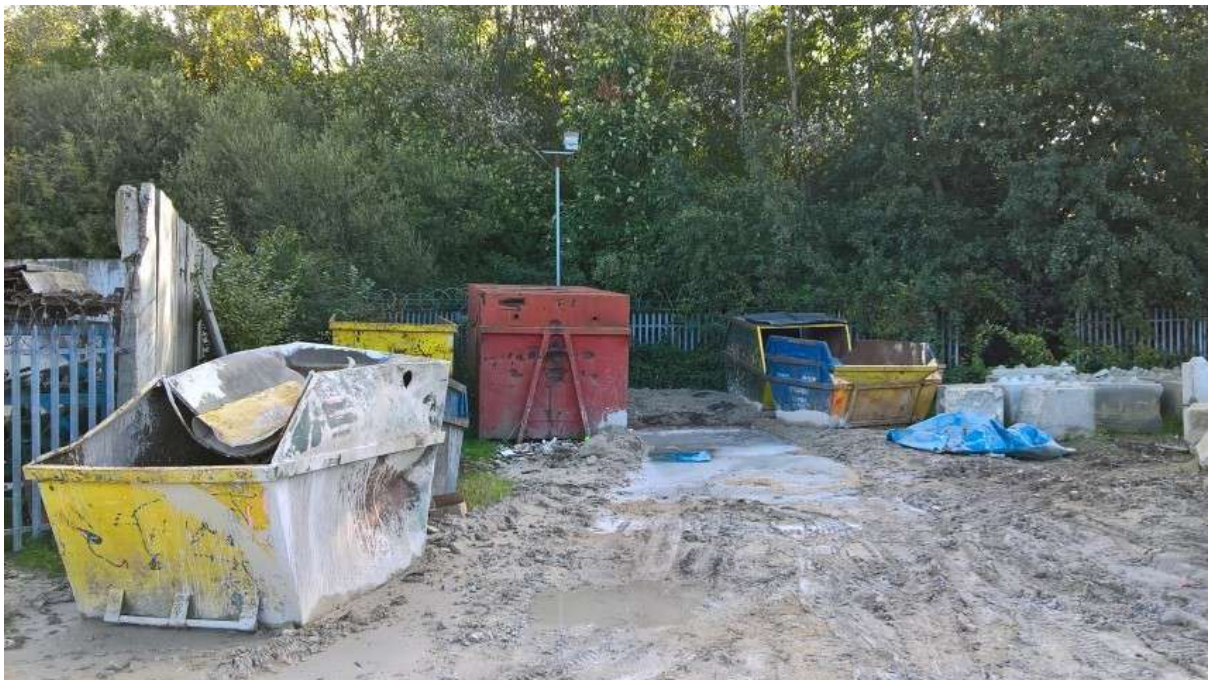
15. Skips within the north-east corner of the site, located within the unpaved area.

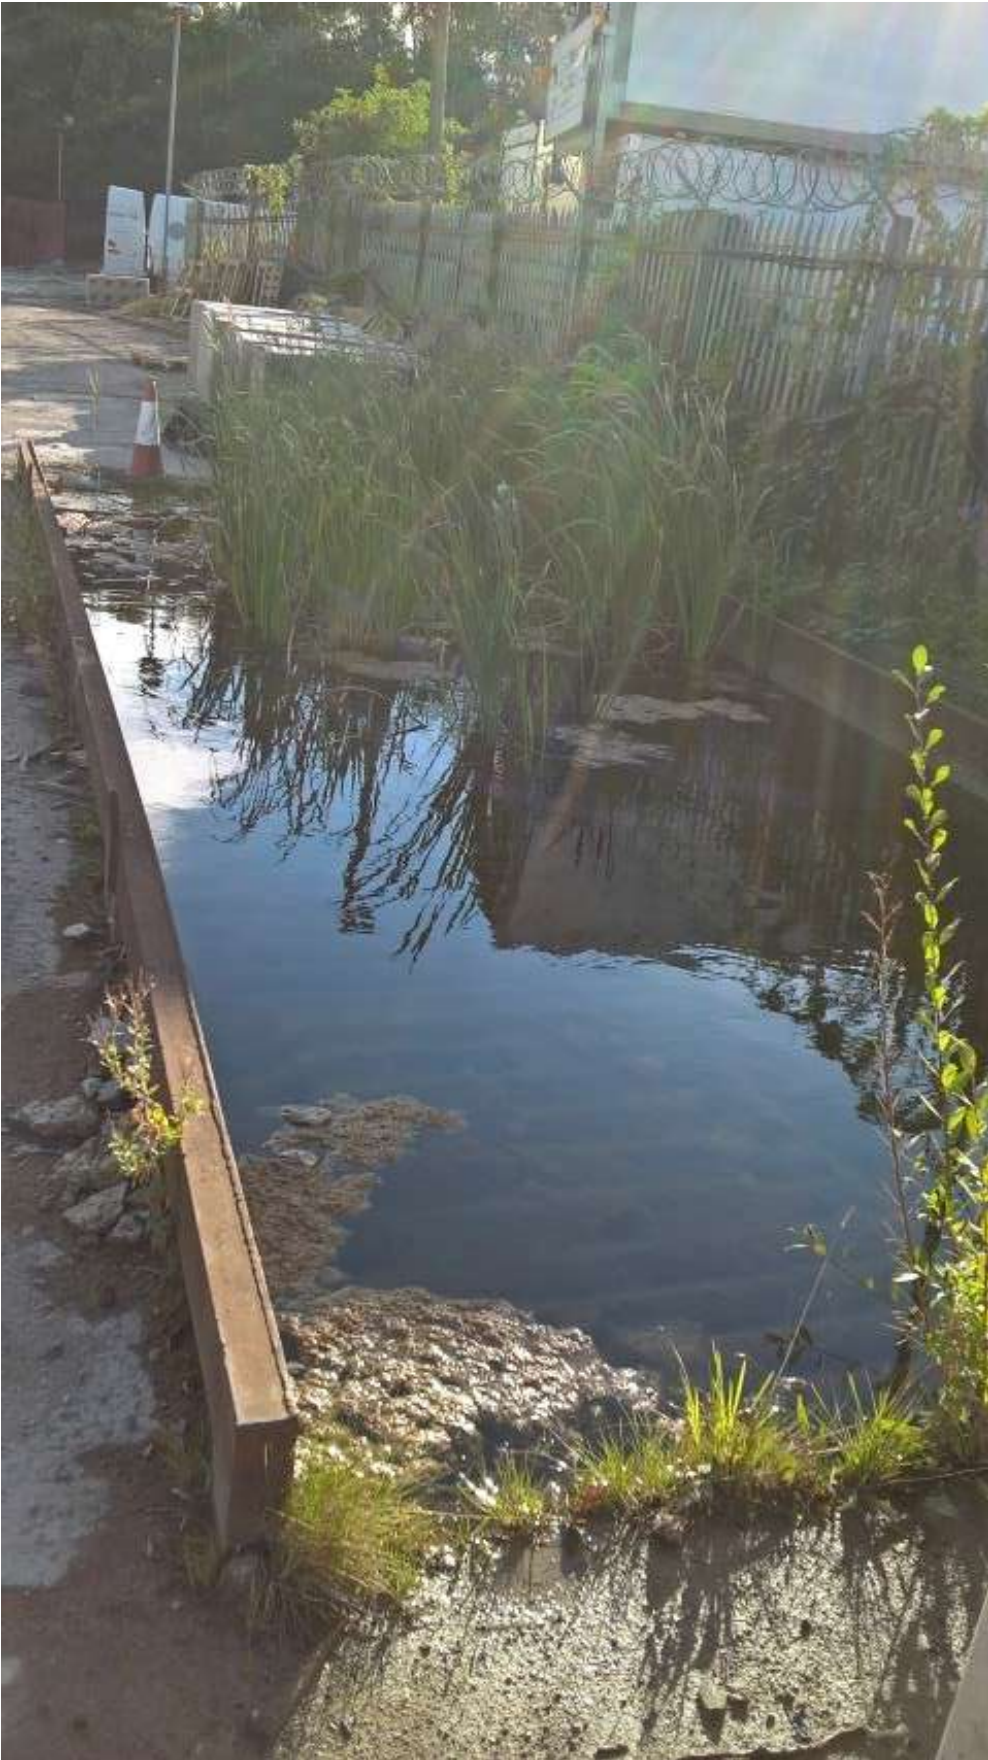
26. Weighbridge pit filled with essentially clear rainwater. Located west of north-west corner of the site of interest, along the access road into the site of interest.

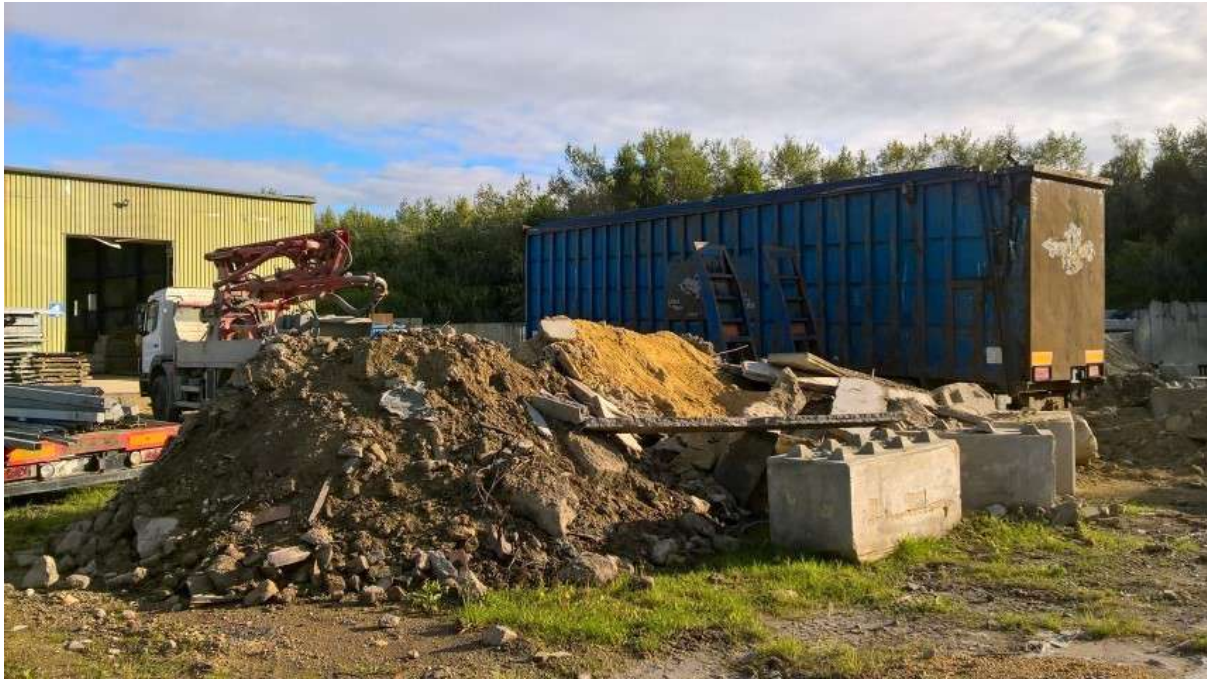
27. Soil/rubble mound on DTS yard to the north of the site of interest.

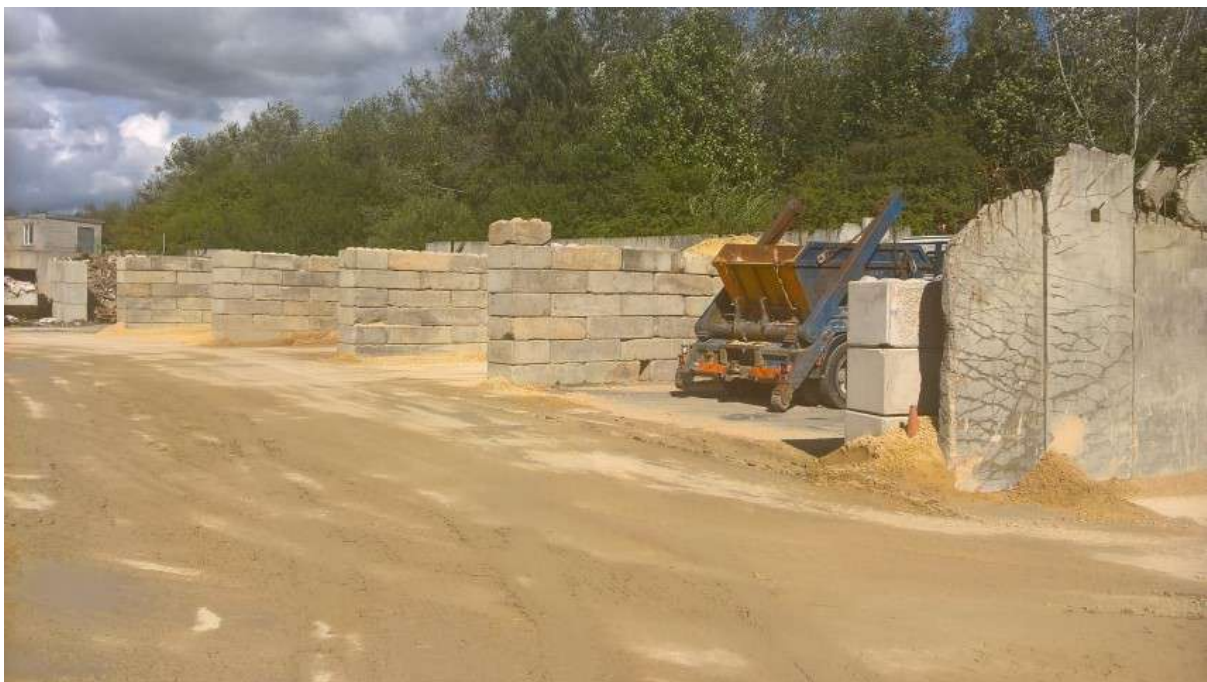
28. Aggregate storage bins along the eastern boundary of the DTS Waste Management site.

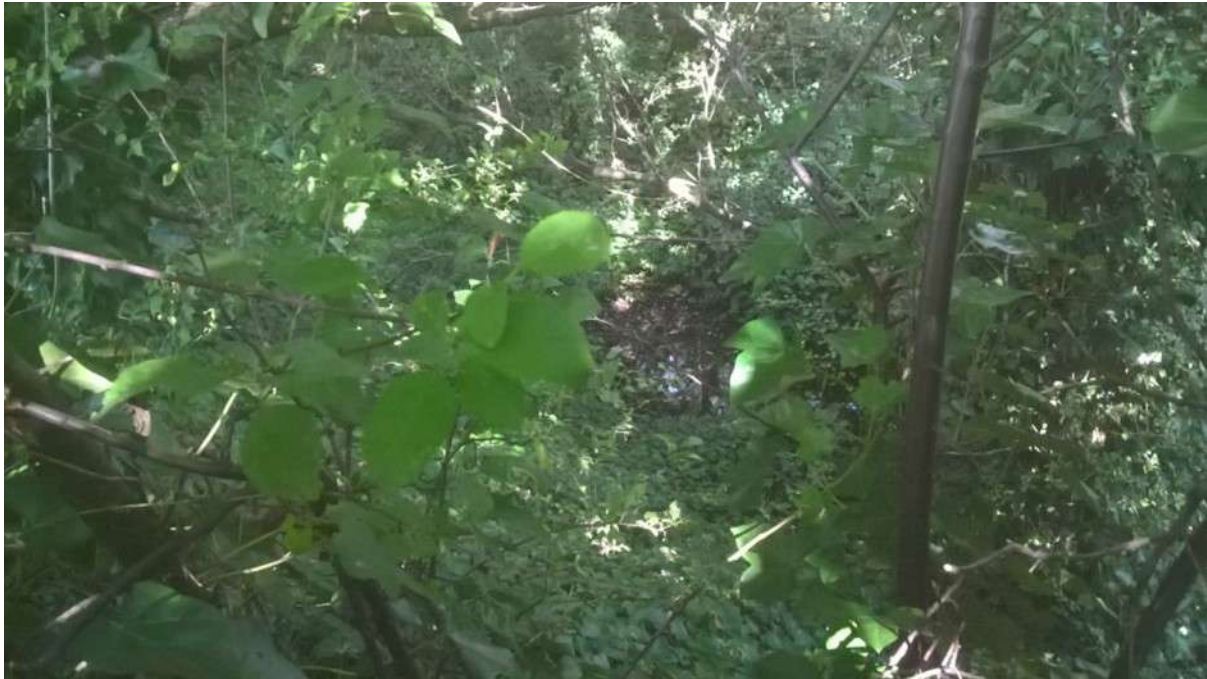
View east down the railway embankment to the nearest water body to the site (80m east of the site) at the base of the railway embankment. The open lake associated with Carlton Marsh is located beyond the base of the embankment.

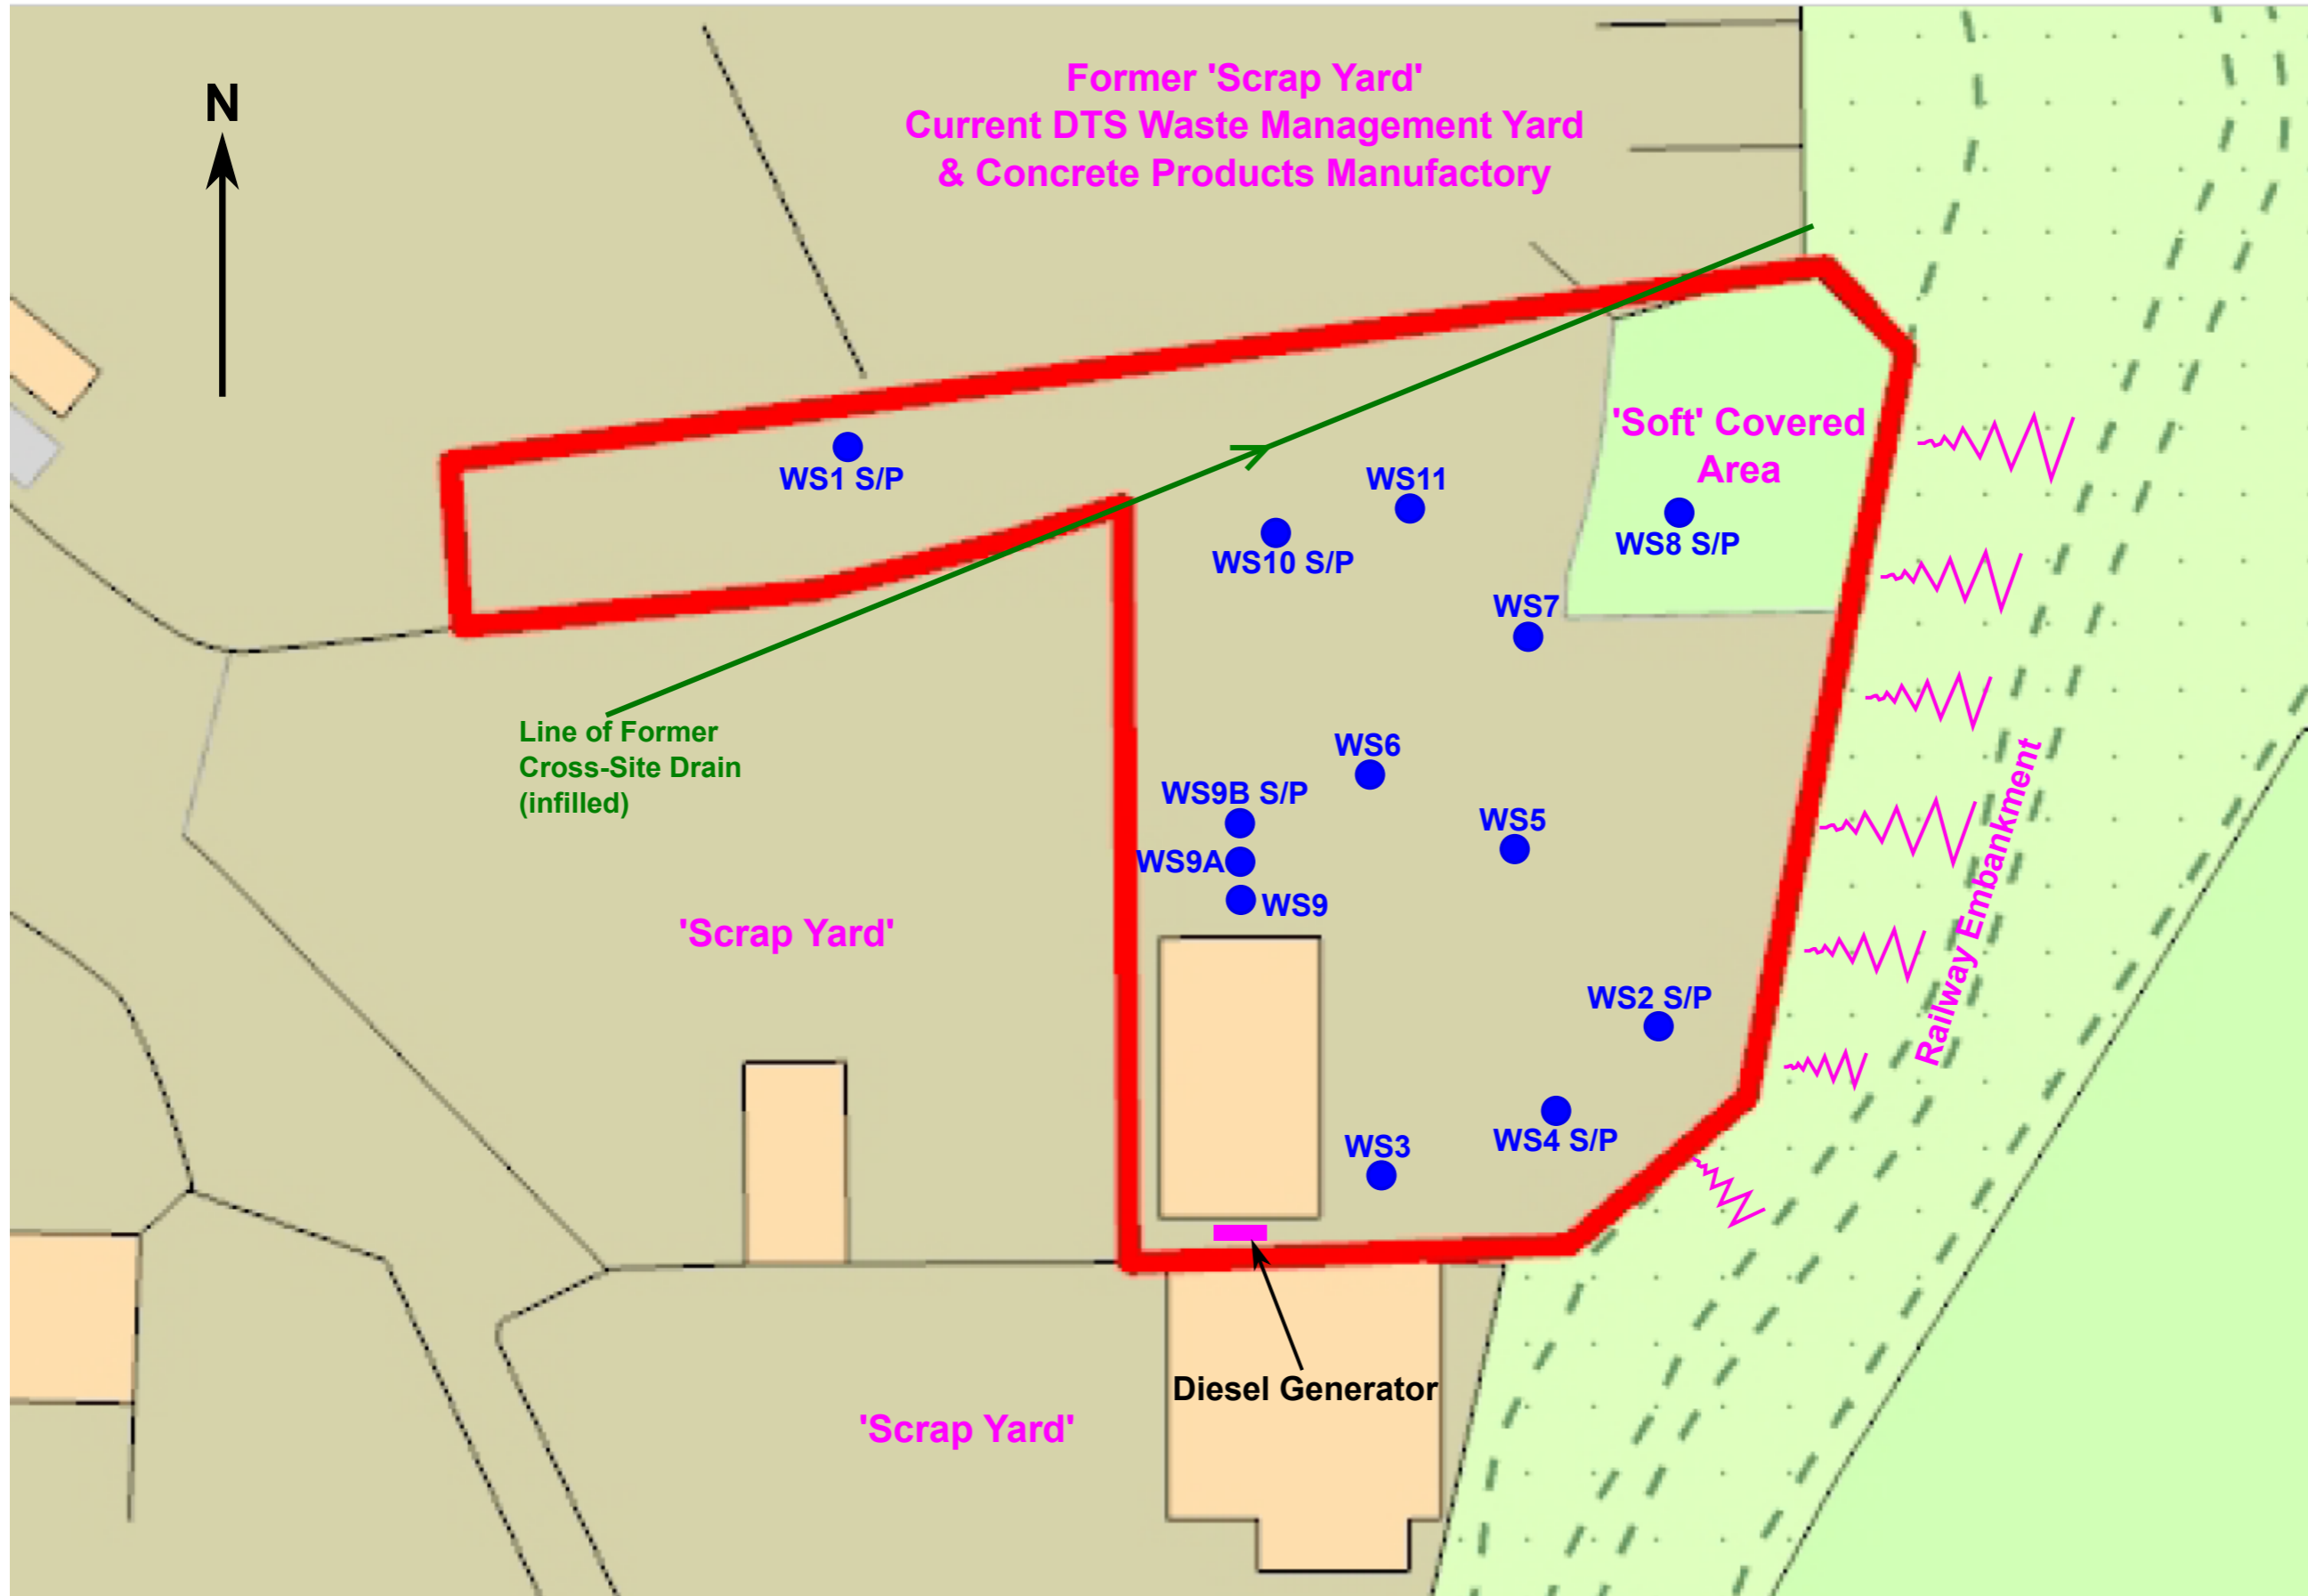
- KEY**
- Windowless Sampler Borehole
 - S/P** Monitoring Standpipe Installed
