| Project Name: TRINITY ACADEMY | | | | Client: WATERMAN I&E | | | | Date: 24/09/2020 - 25/09/2020 | | | | | |
| Location: BARNSELEY | | | | Contractor: | | | | Co-ords: E433397.02 N405663.01 | | | | | |
| Project No. : 20063 | | | | Crew Name: | | | | Drilling Equipment: | | | | | |

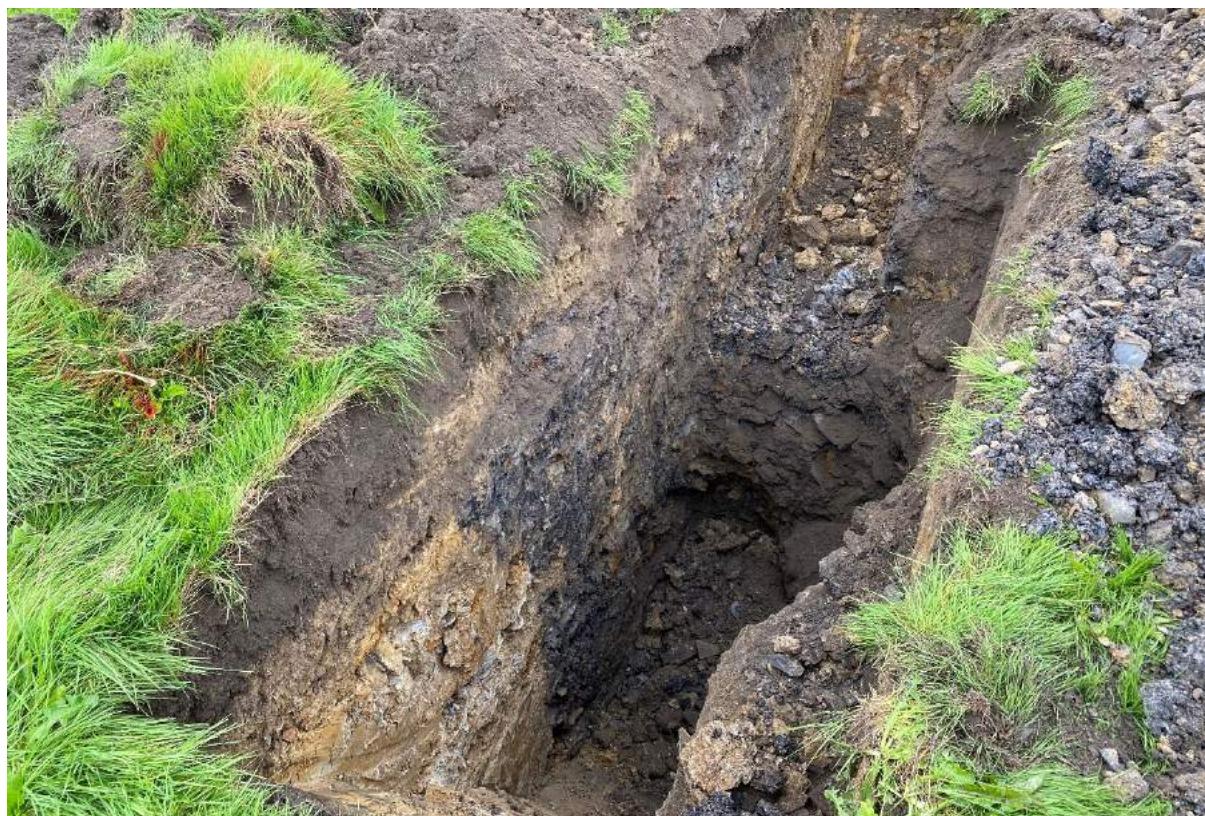
Photograph 36 – TP110 Showing change between natural and infilled shaft.

Remarks: 1. Pit sides unstable and collapsing. 2. No groundwater encountered. 3. Suspected mine shaft observed with colliery spoil infilling c.2.5m wide.
