**REPORT C1634  
JUNE 2008**

**GEOENVIRONMENTAL APPRAISAL  
AND REMEDIATION STRATEGY**

**for land off  
SHEFFIELD ROAD, BIRDWELL**

**prepared for  
HARTWOOD ESTATES LTD**

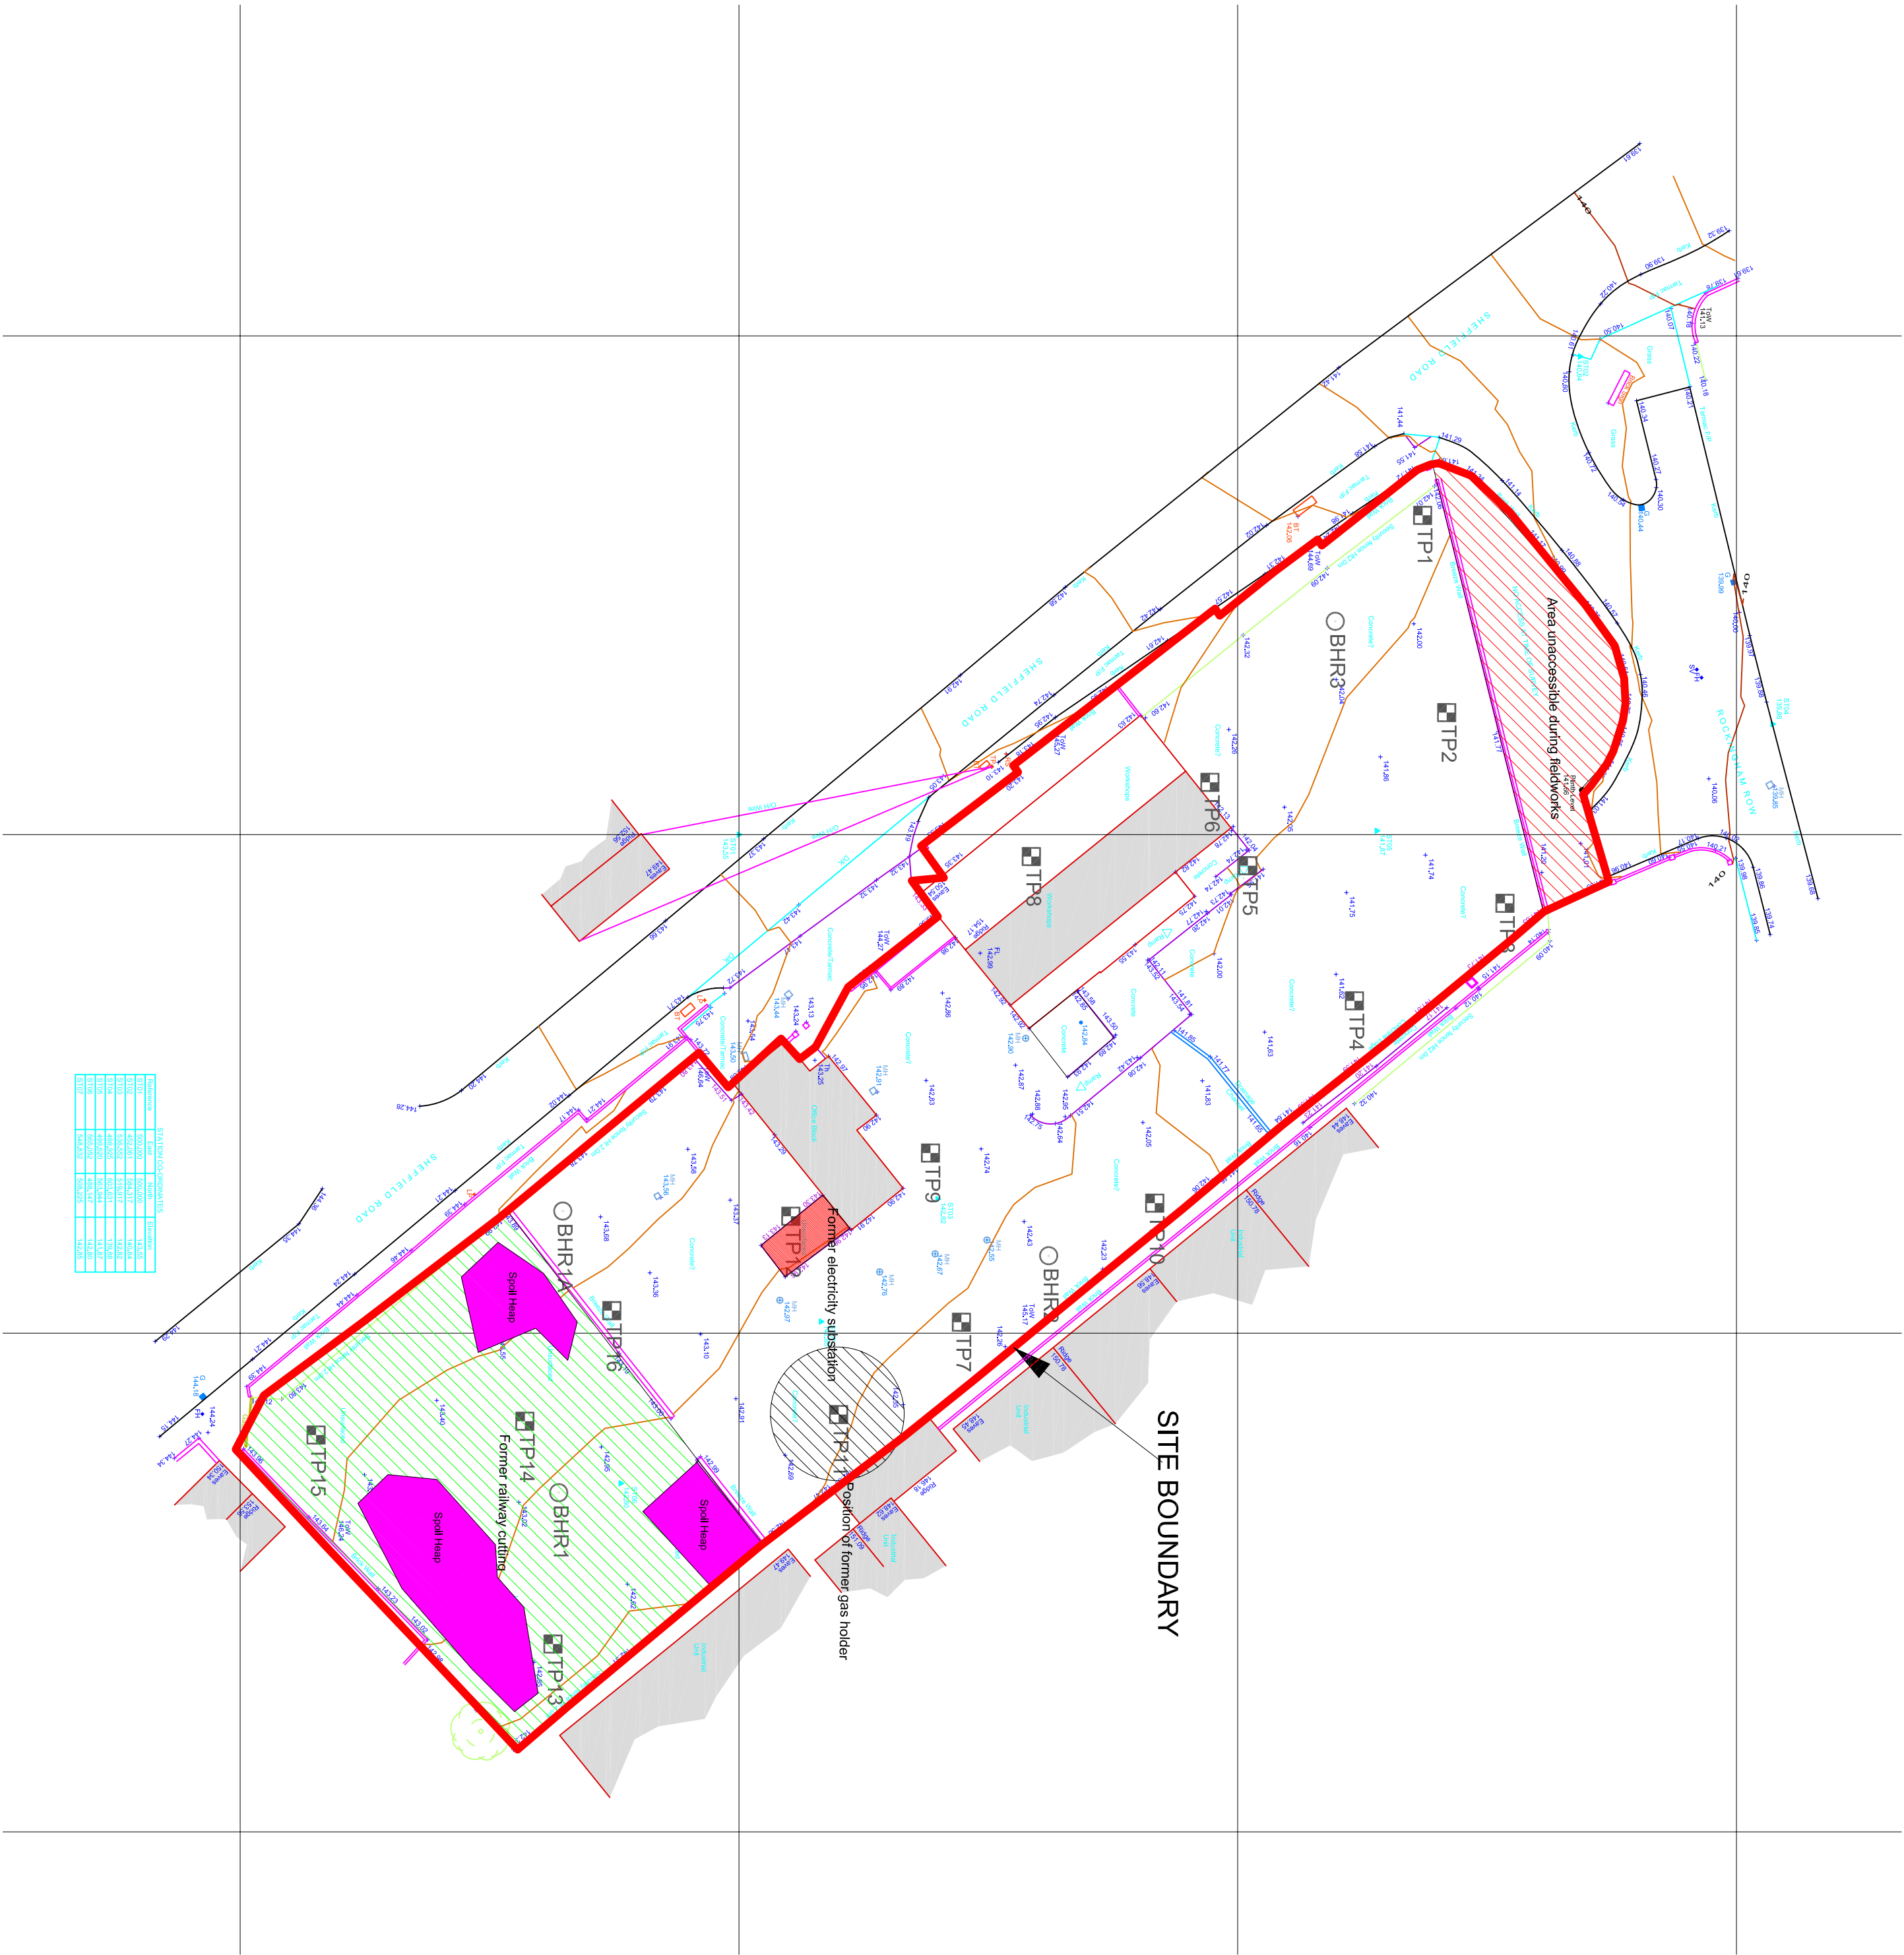
Exploratory hole locations were determined by Sirius, in order to produce a representative over view of shallow ground conditions across the site.

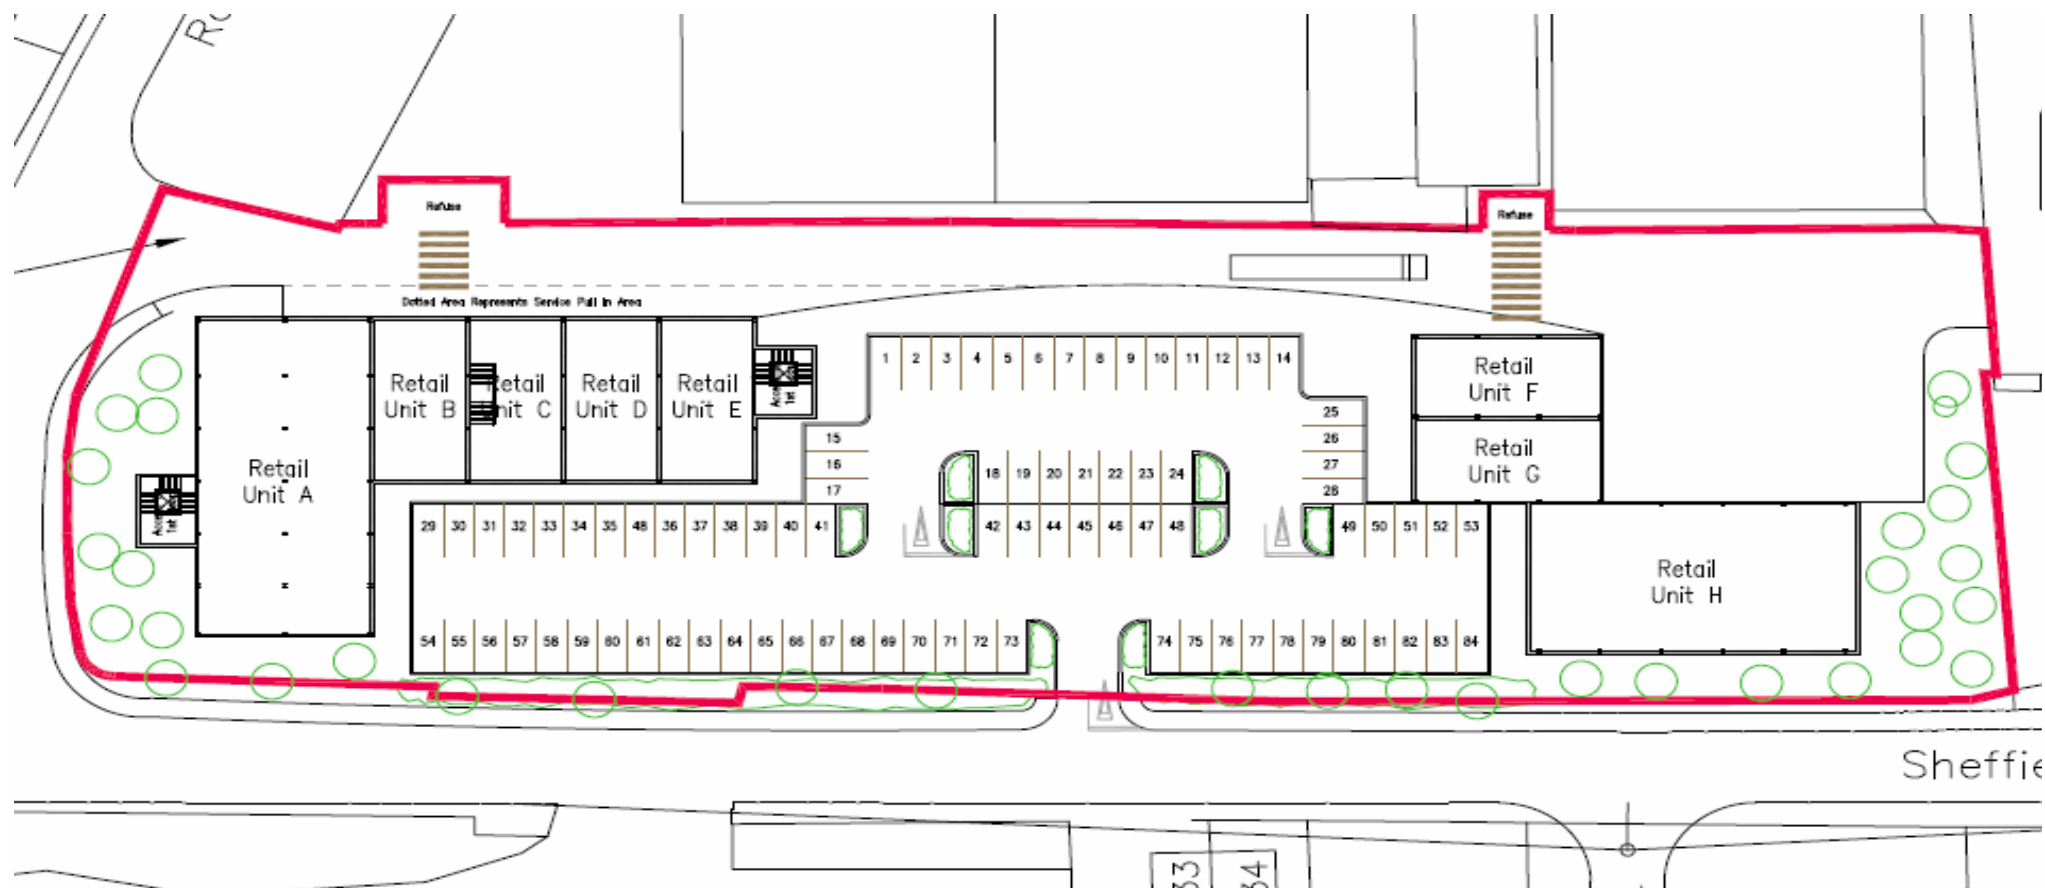
**Proposed Development  
plan**

It is assumed in the production of this report that the site is to be redeveloped with a number of low rise commercial/industrial units in the south eastern and north western areas of site with associated car parking, access roads and areas of soft landscaping. For the purpose of this report, it is assumed that levels will remain broadly as existed at the time of the investigation. If these assumptions are incorrect, the conclusions and recommendations presented in this report may need to be revised.

- Where the proposed development spans the backfilled railway cutting (Unit H on the provisional layout), foundations depths will be shallow in the north west and deeper in the south east towards the centre of the cutting. Pad and Stem foundations eg. concrete filled manhole rings, could be founded on the underlying bedrock in the deeper areas of fill and prove a more cost effective solution than piles or vibro replacement. As with piled foundations, ground beams will be required for this solution.

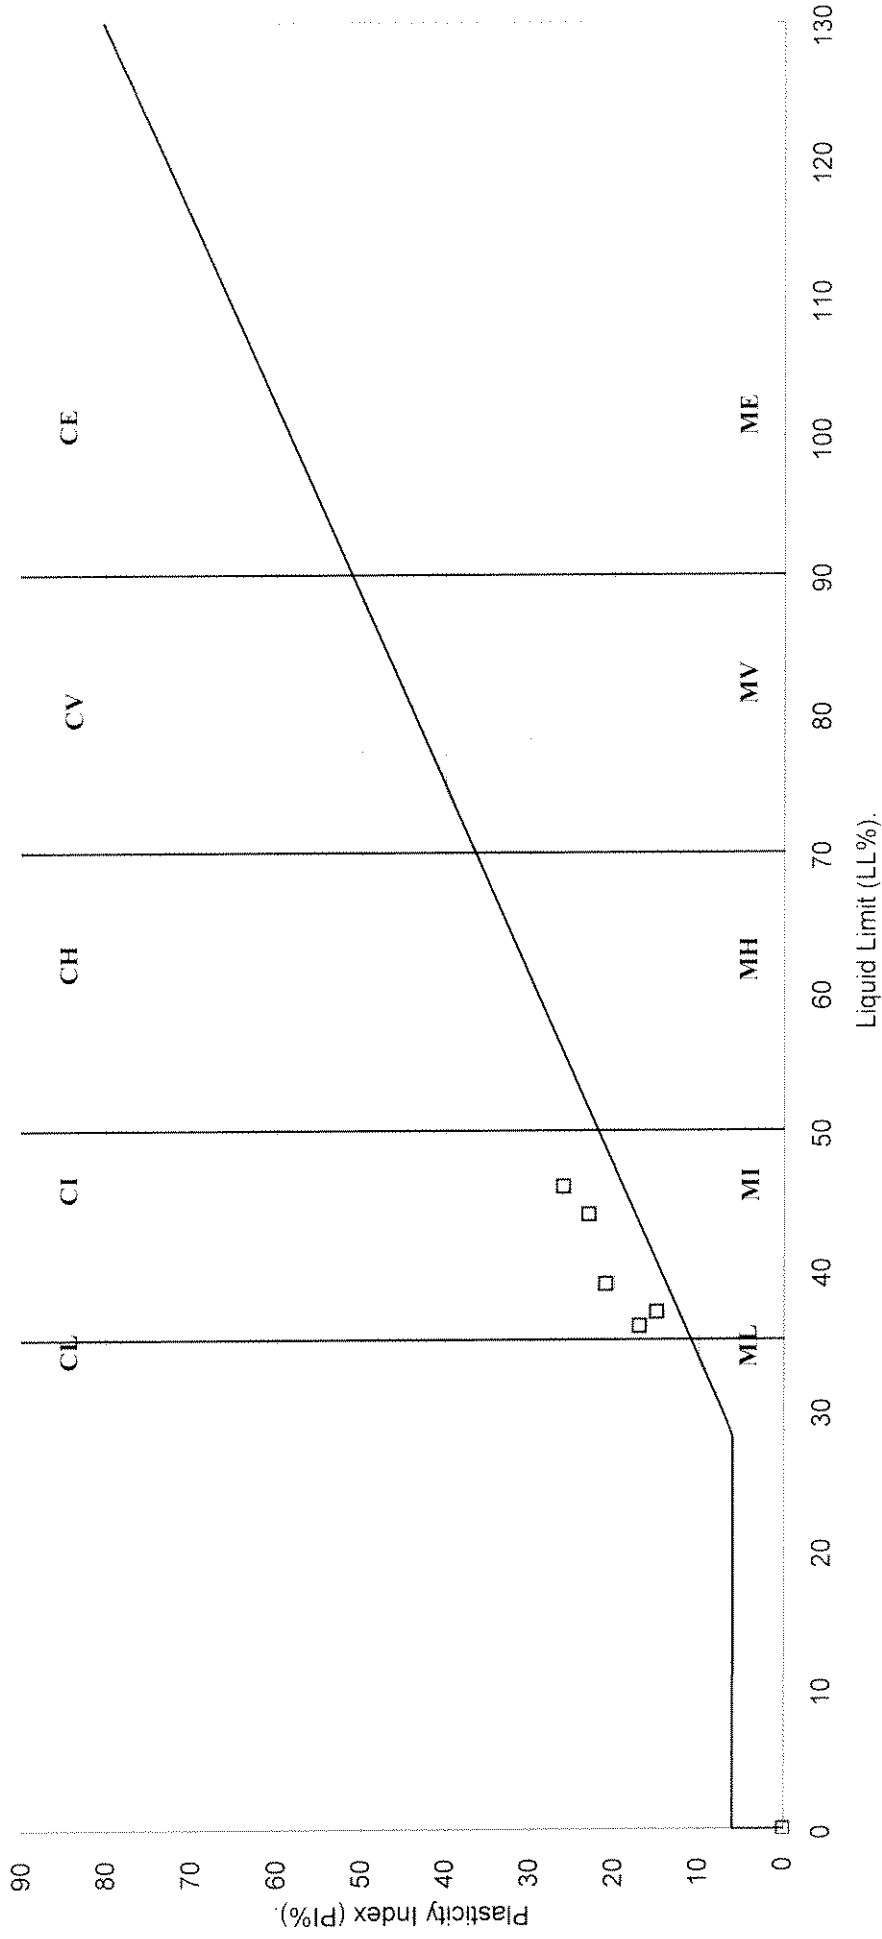
# PLASTICITY CHART FOR CASAGRANDE CLASSIFICATION.

- Five moisture contents.
- Determination of Atterberg limits on five samples.
