# REMEDICATION VERIFICATION REPORT

Lidl, Mapplewell

Client: Grupotec

616.02  
June 2019

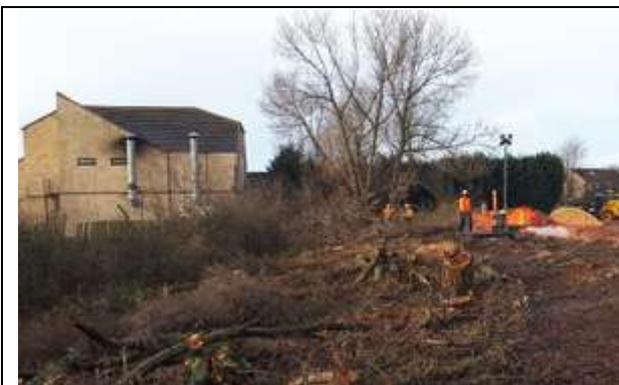
Vegetation clearance underway (6<sup>th</sup> February 2019)

Minimal vegetative cover was present on-site, although some small shrubs and trees in areas of former landscaping were scraped up with excavators and removed to the west of the site for stockpiling prior to off-site disposal.

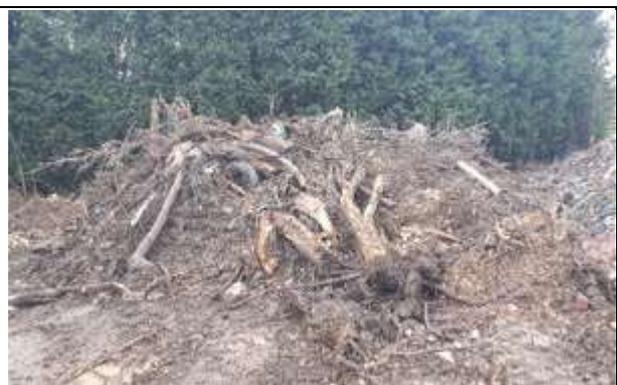
Vegetation, shrubs etc scraped off the site surface and stockpiled ready for disposal (6<sup>th</sup> February 2019)

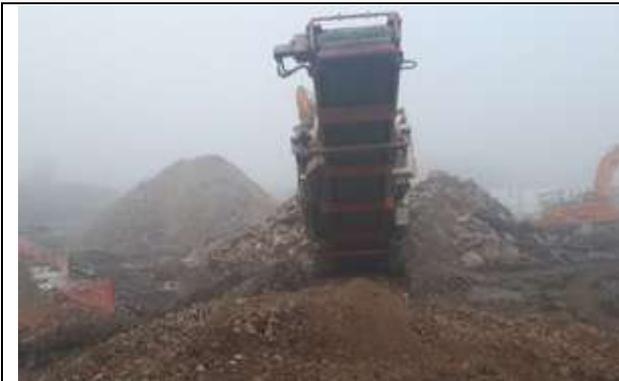
Mobile plant crusher on-site crushing site derived brick and concrete (31 January 2019)

Concrete slabs across the site area were broken out using mechanical excavators fitted with hydraulic breakers during January and February 2019. The concrete was stockpiled and subsequently run through a crusher operating with a mobile plant licence.

Shallow foundations were grubbed up using mechanical plant and the arising concrete was also stockpiled for crushing. In addition a previously un-encountered in-ground concrete chamber was discovered in the eastern area of the site (former storage tank for carbon dye). The contents of the chamber were excavated and stockpiled on-site and treated as unforeseen contamination. The chamber was subsequently broken up using a hydraulic breaker, before being stockpiled ready for subsequent crushing.

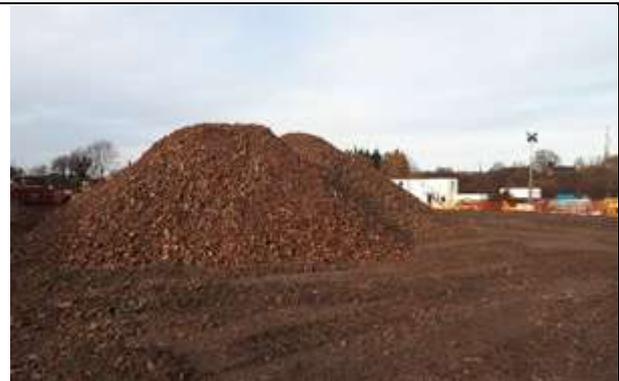
Stockpiles of site derived crushed brick and concrete (6<sup>th</sup> February 2019)

The site won crushed concrete was subsequently used to construct a piling mat over the Class 2C fill material.

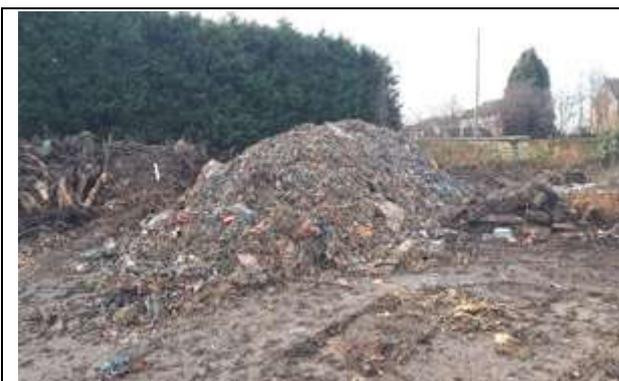
Excavated rubber waste stockpiled for disposal (6<sup>th</sup> February 2019)

The area in the far east of the site (known to contain historical landfill material) was excavated and the arisings comprised waste rubber products / off-cuts and production waste associated with the site's historic use. Where these materials encroached onto the site they were excavated and placed in a designated stockpile for off-site disposal. The materials were sampled by Remada and dispatched for laboratory analysis to enable the waste stream to be classified prior to disposal off-site.

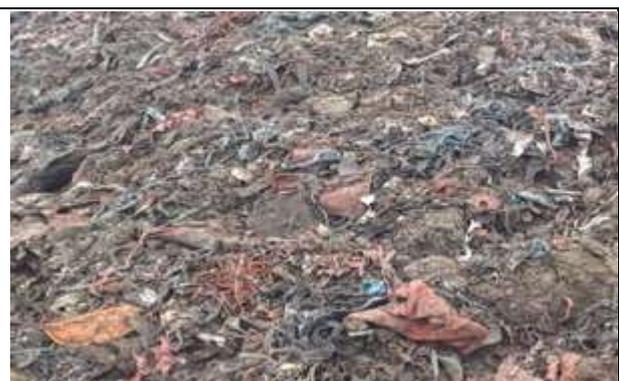
Rubber waste containing hot water bottles etc (6<sup>th</sup> February 2019)

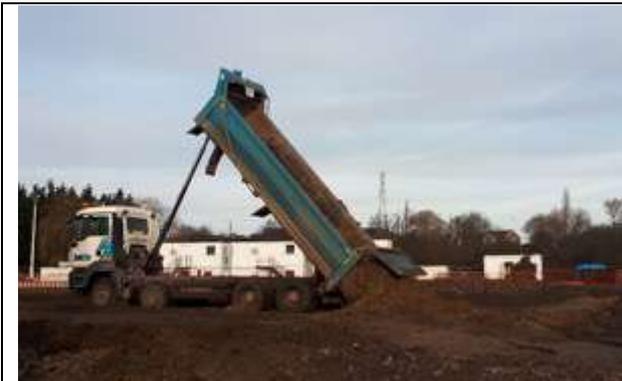
Emplacement of imported 2C fill underway in store footprint area (6<sup>th</sup> February 2019)

The Remada Geoenvironmental Engineer attended site to inspect the placement and compaction of deliveries made on 31<sup>st</sup> January and 6<sup>th</sup> February 2019. The material was described as typically a brown sandy gravelly clay containing minor constituents of limestone, coal, brick, concrete, mudstone and siltstone with occasional fragments of plastic sheet.

The imported 2C material was observed across the entire site to have excessive moisture content and during compaction the vibrating roller displaced the material laterally during each pass; this was not an issue in terms of engineering properties as the proposed store is founded on pile / ring beam foundations thus not bearing on the fill material.

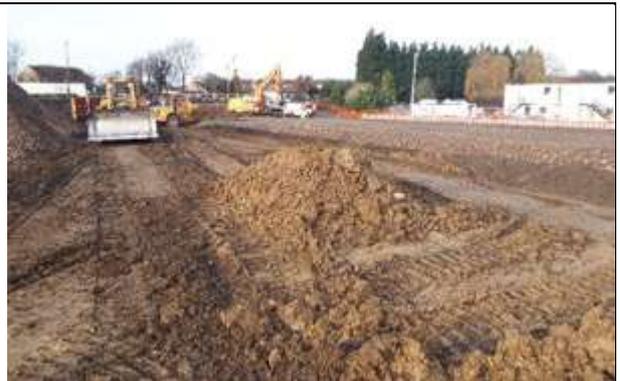
Emplacement of imported 2C fill underway in car park area (6<sup>th</sup> February 2019)

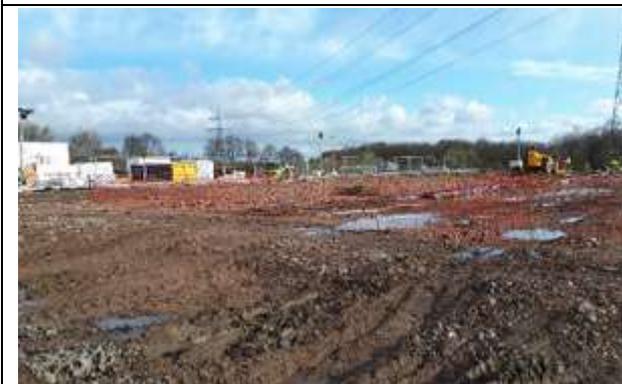
Site surface mid-way through 2C fill placement (6<sup>th</sup> February 2019)

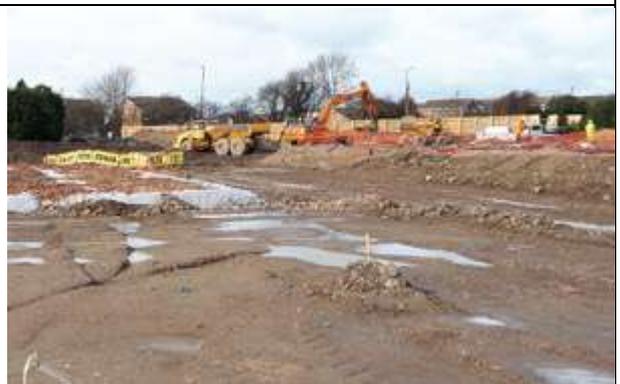
Site surface mid-way through 2C fill placement (6<sup>th</sup> February 2019)

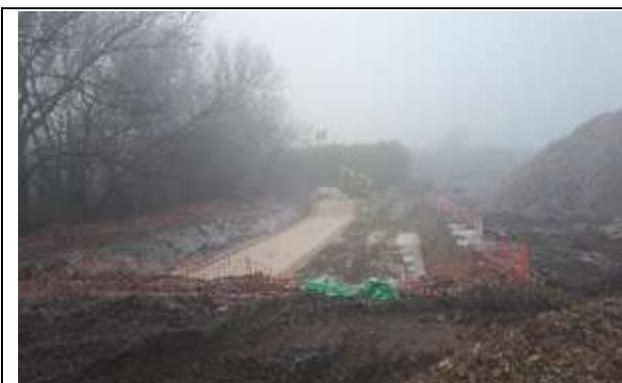
Completed soakaway excavation with laying of geotextile underway (31<sup>st</sup> January 2019).

A large excavation was undertaken in the southern area of the site below the proposed car park; a layer of geotextile was laid coarse 40-80.

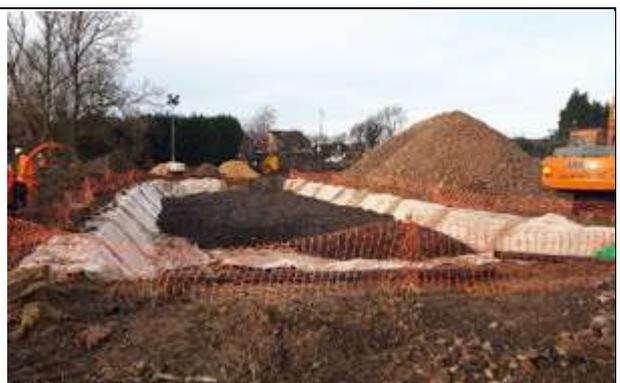
Completion of geotextile lining with emplacement of 40-80 stone underway (6<sup>th</sup> February 2019).

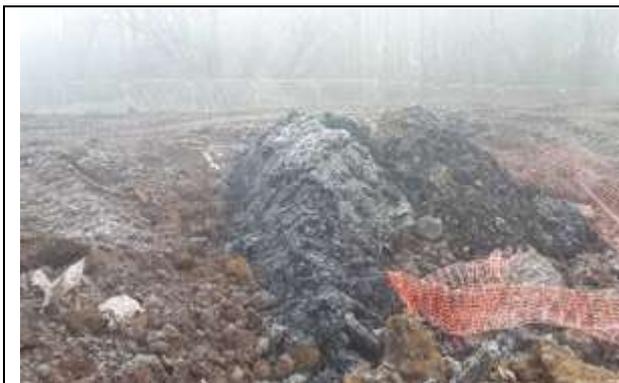
Concrete chamber containing black sludge believed to be from the rubber dyeing process (31<sup>st</sup> January 2019)

During excavation works, a concrete in-ground holding chamber was encountered in the east of the site. A thick black sludge was found within the chamber, believed to comprise residues from the rubber manufacturing (dyeing) process. The sludge was excavated, set aside and sampled on the 31<sup>st</sup> January 2019 for chemical analysis to confirm its composition and origin. The sludge material was later relocated on-site (observed by the Remada Geoenvironmental Engineer on 6<sup>th</sup> February 2019) pending laboratory test results to enable its disposal.

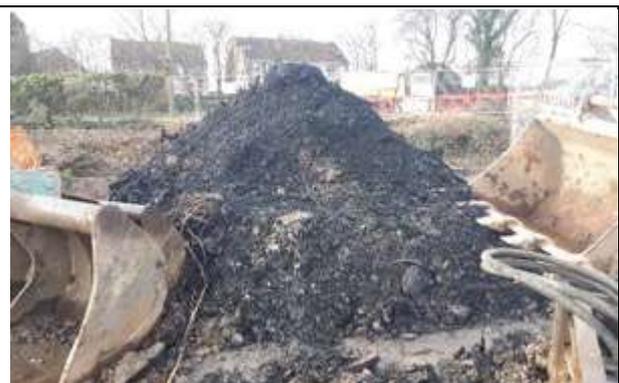
Stockpile of black sludge segregated and stored in isolation ready for disposal (6<sup>th</sup> February 2019)

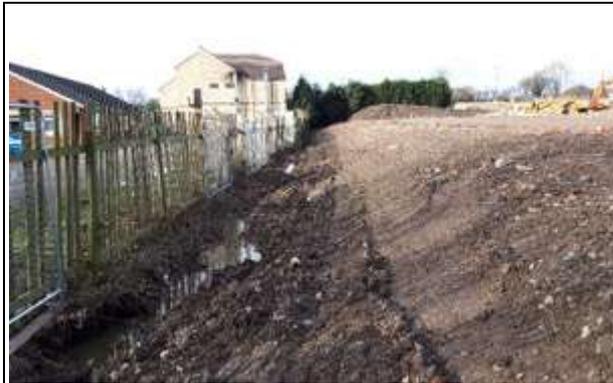
View across site along southern boundary facing west on completion of finished remediation level completed with imported 2C fill material

The 2C material was also inspected by the Remada Geo-Environmental Engineer on completion of its placement (prior to placement of 6F2 capping) on March 15th 2019. The material was locally firm and soft underfoot.

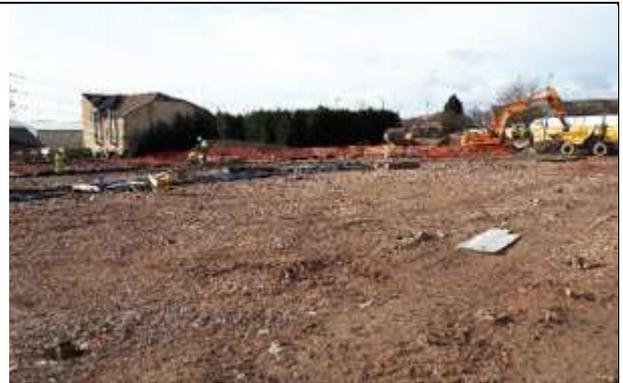
General view of central area of the site showing finished remediation levels with imported 2C fill at the surface

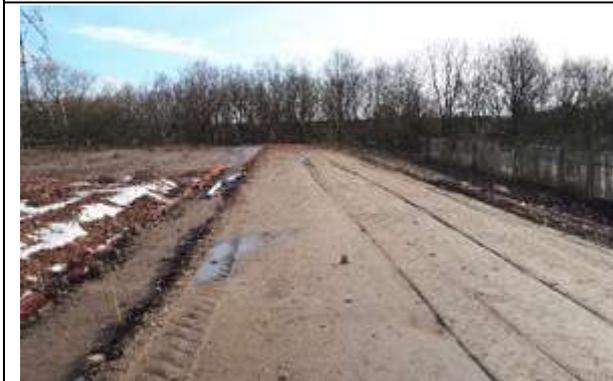
View across site towards east showing finished remediation level completed with imported 2C fill material

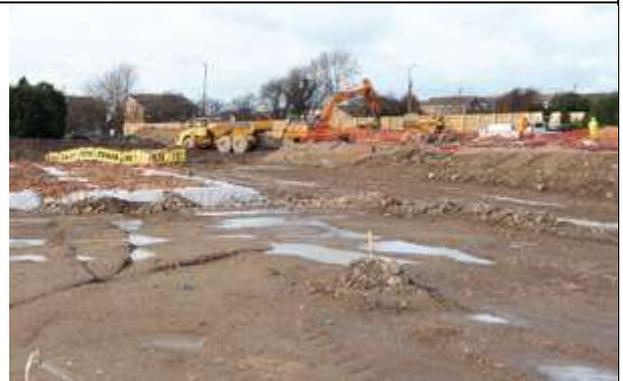
View across central part of site showing finished remediation ground levels comprising imported 2C fill

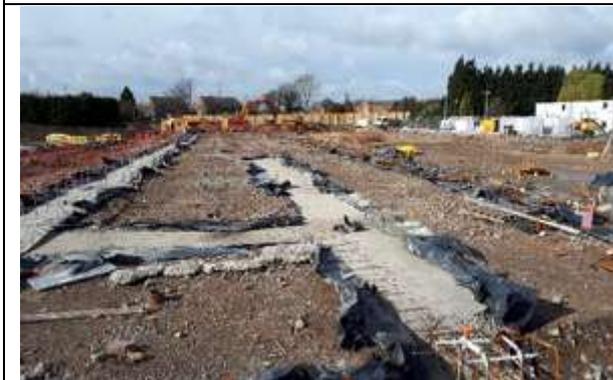
Finished remediation levels below store footprint showing ring beam installation underway (15<sup>th</sup> March 2019)

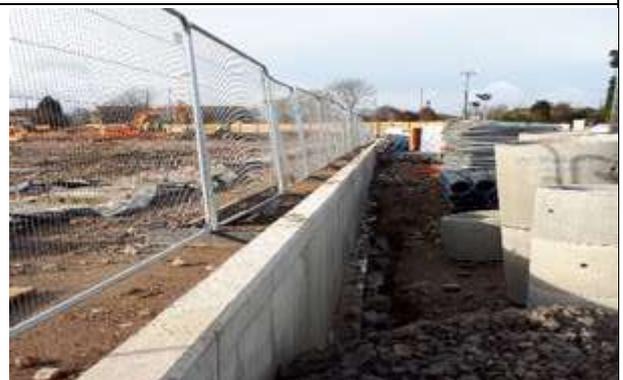
Finished remediation levels (left) to the south of the retaining wall below store footprint (15<sup>th</sup> March 2019)

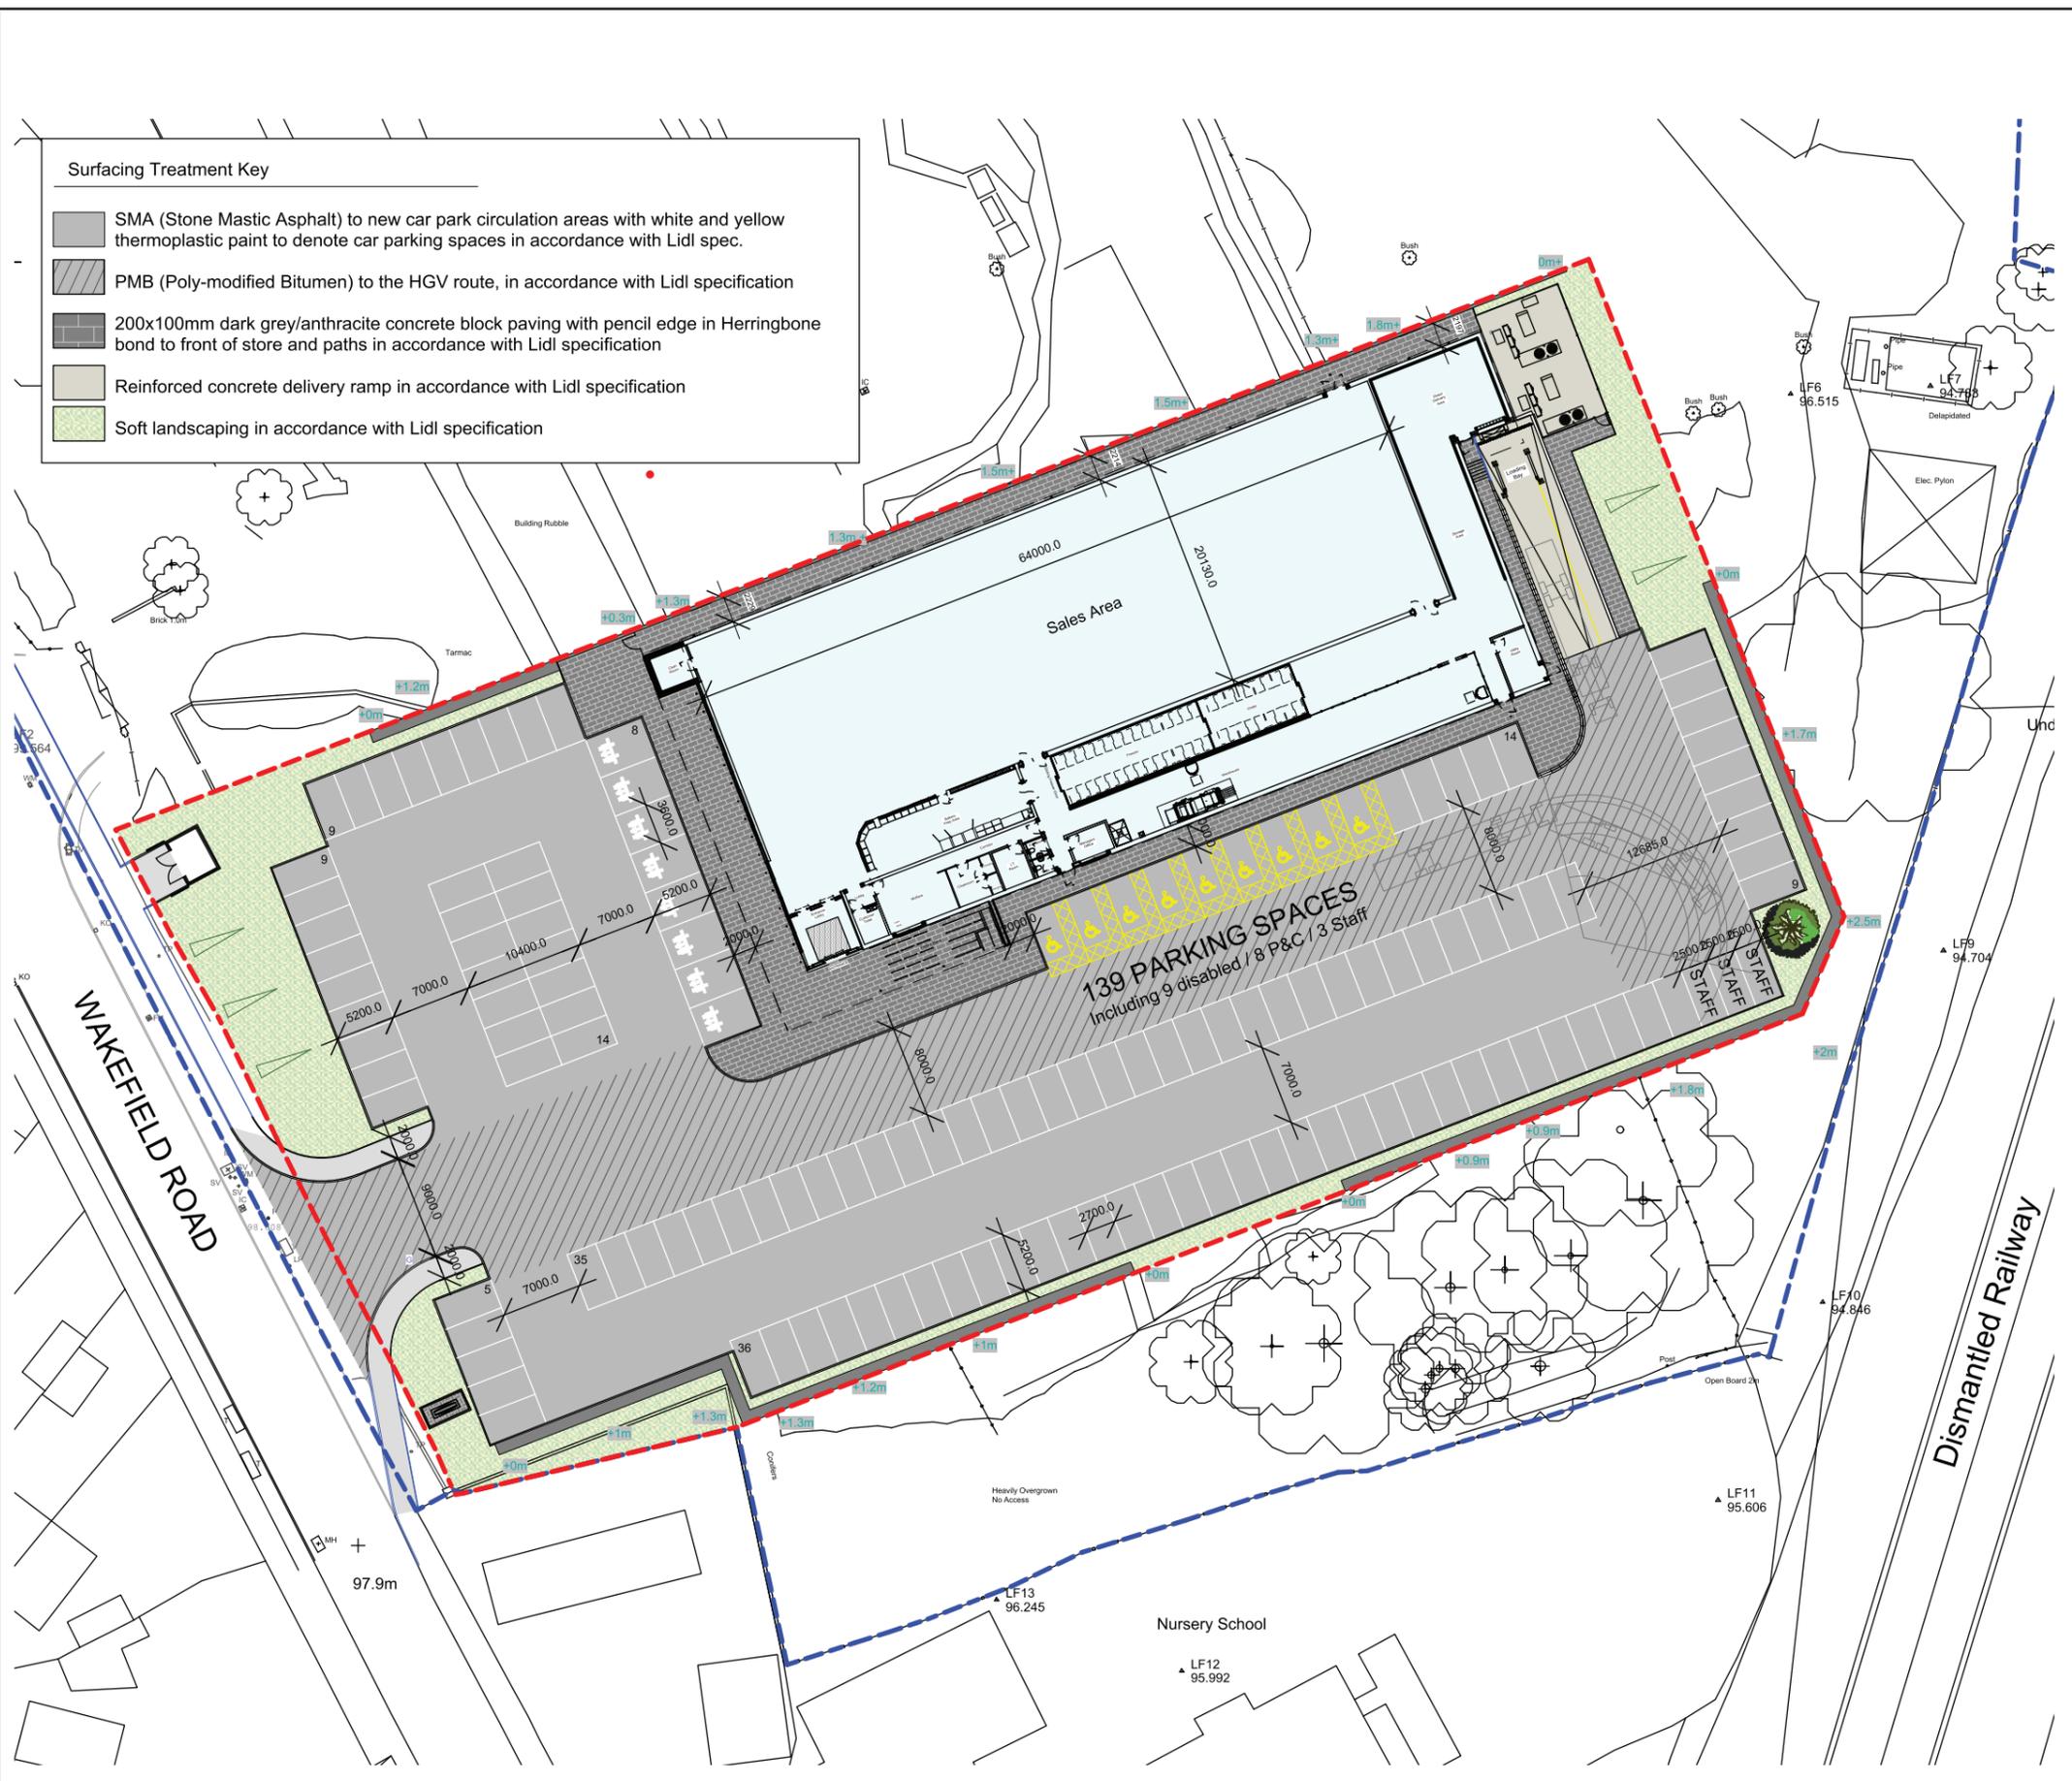
BASED ON LIDL SPEC DRAWING LD(13)-GF-01 - Ground Floor - Setting Out Plan

The proposed layout is indicated at **Figure 1**.
