| Project Name: Cudworth Parkway | | | | | Project No.<br>4674 | | Co-ords: 439067.48 - 410369.85 | | Hole Type<br>WS | | |
| Location: Barnsley | | | | | Level: 77.10 | | Scale<br>1:20 | | Logged By<br>LB | | |
| Client: Fenwood Estates Limited | | | | | Dates: 04/04/2024 - 04/04/2024 | | | | | | |

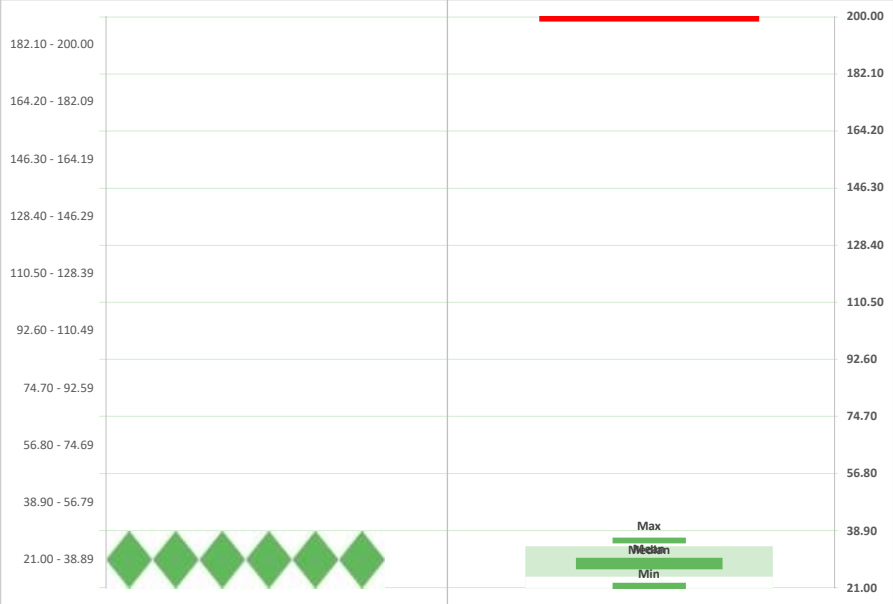
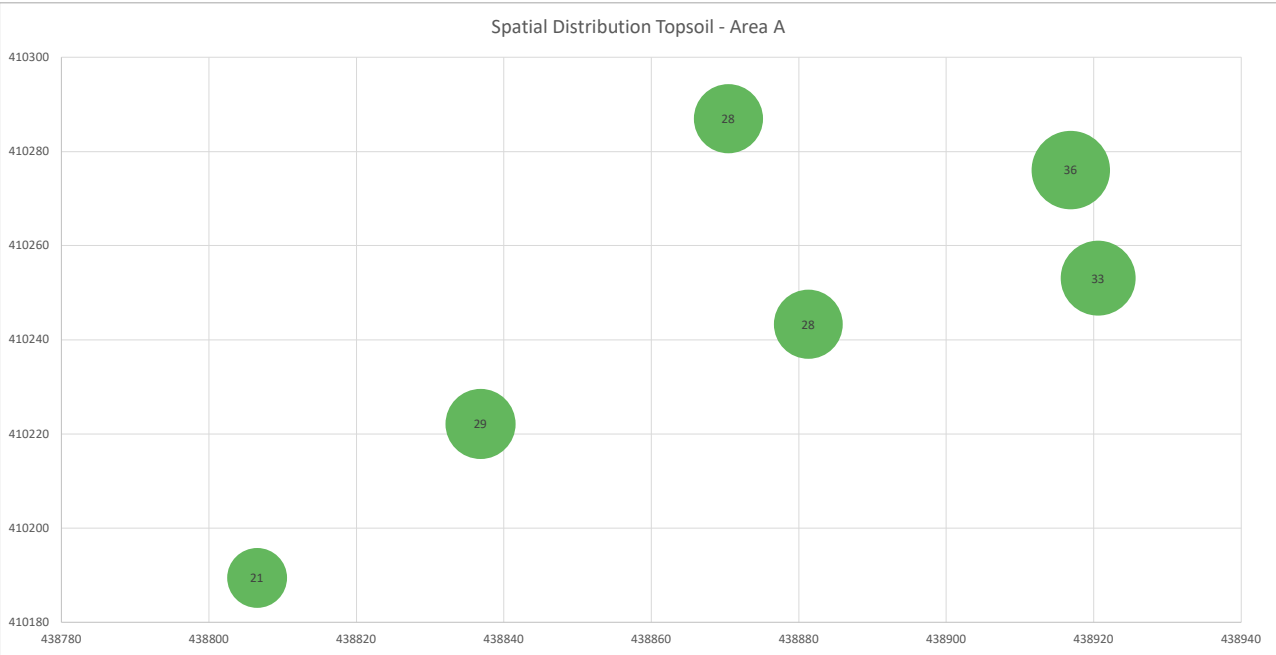
Upper Confidence Level for chart 95%

Spatial distribution can show sampling clusters based on ground type it **does not** identify areas of contamination

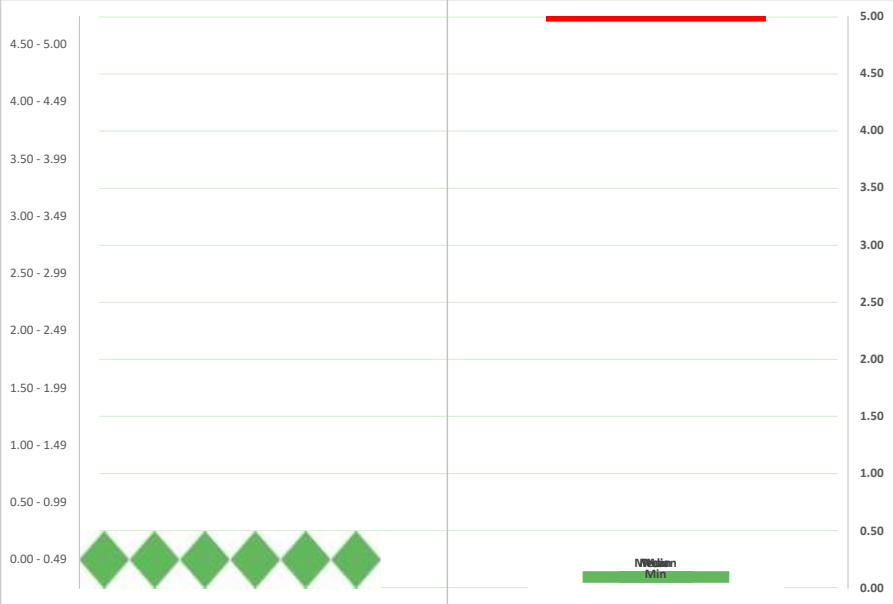
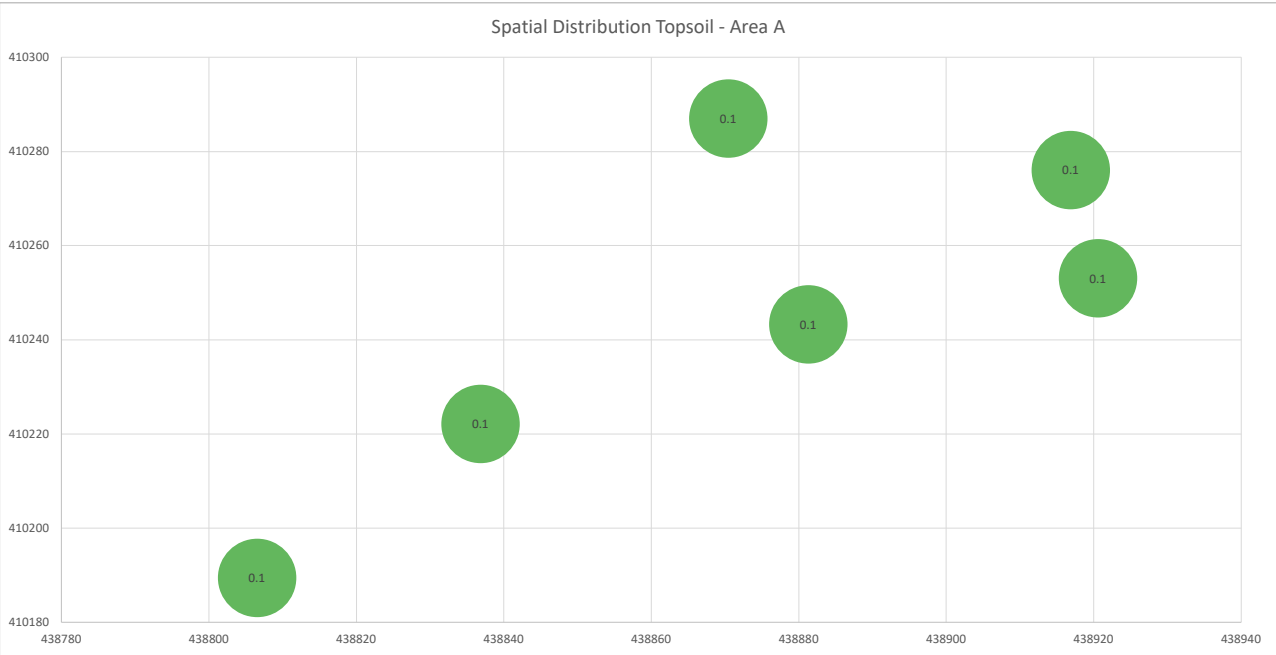
Upper Confidence Level for chart 95%

Spatial distribution can show sampling clusters based on ground type it **does not** identify areas of contamination
