Premier Foods
Fish Dam Lane
Carlton
Barnsley
S71 3HQ

27 July 2023
PE Ref: I2010

Premier Foods Trial Pit & Manhole Report

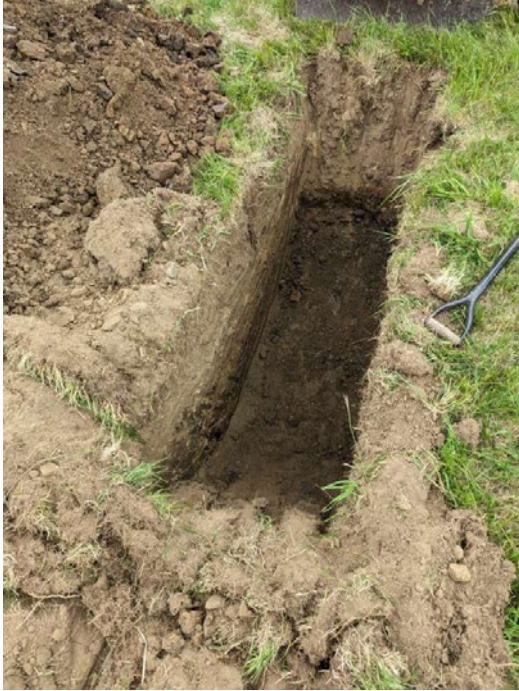
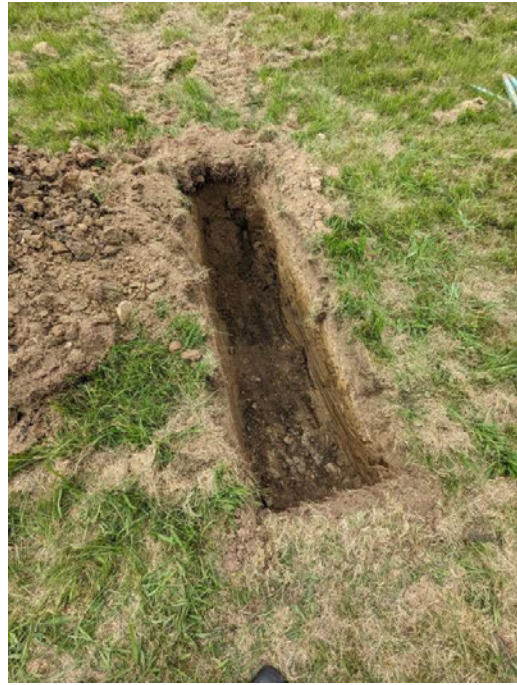
Fig 1. Trial pits 1 & 4

All four trial pits once dug, revealed no pipework or clay drains, in fact nothing was immediately obvious that could have activated the ground penetrating radar used for the Topographical survey (Fig 1).

The radar picks up changes in ground density which can be difficult to define. It could simply be a change in ground make-up rather than anything man-made that has been purposely installed or unintentionally left underground. SP Engineering dug the trial pits by hand initially but had to revert to using machinery as the ground became denser and more difficult to dig by hand.

We are confident the linear features in Geotec's report are mostly changes in ground density rather than any manmade feature buried in the ground.
