## **PHASE 1: DESK TOP STUDY REPORT**

**MR SIMON FRITH  
PROPOSED RESIDENTIAL DEVELOPMENT  
KNABBS HILL FARM  
CLAYTON LANE  
THURNSCOE  
ROTHERHAM  
S63 0BG**

**Project No: 08-034**

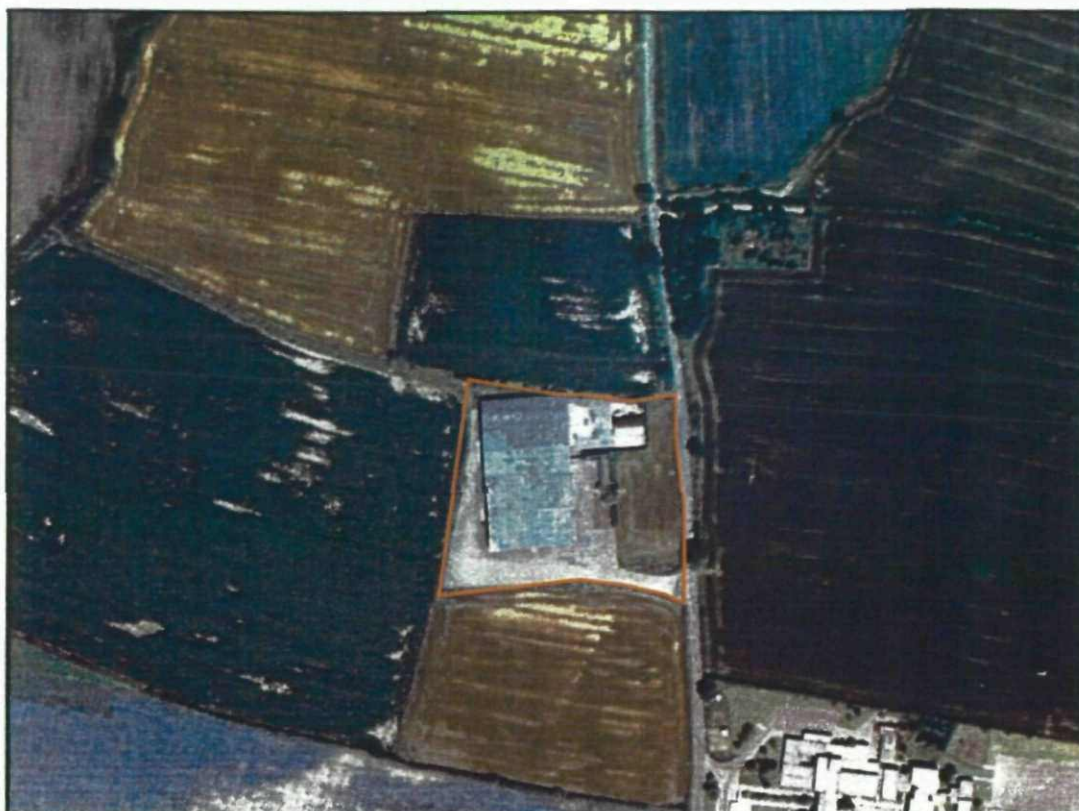
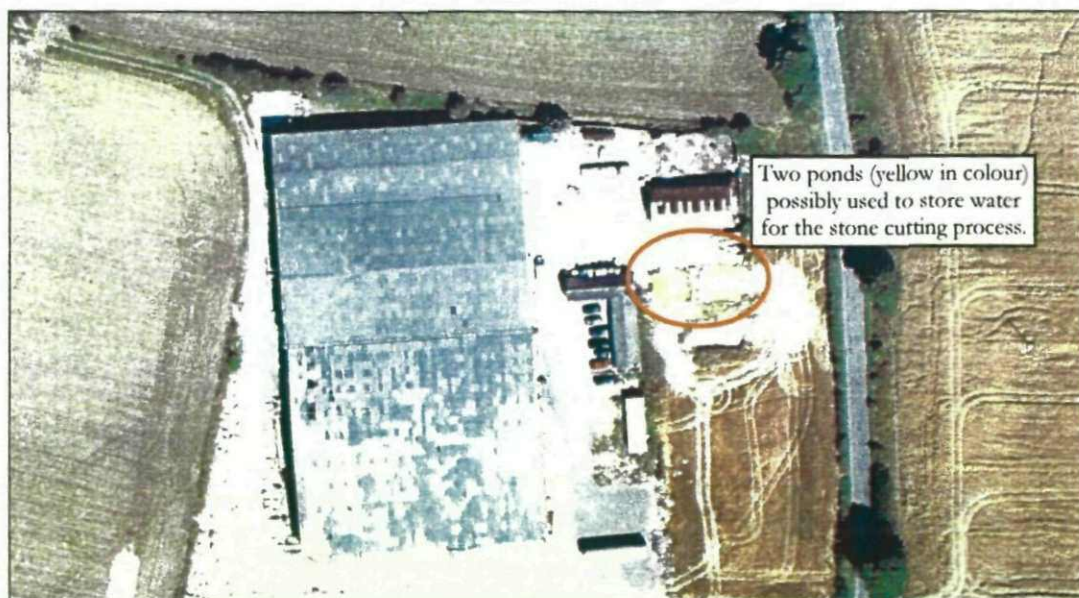
## Aerial Photographs

| <b>Site Surface(s):</b> | According to the aerial photograph the site surface is hardstanding along the access roads with a grassed area along the eastern edge of the site. |

| SURFACE WATER FEATURE | Location | Comments |
|---|---|---|
| Ponds, Lakes, etc. | One recorded within c.250m. | 2 no. ponds recorded on site, anticipated to be man made, have a 'yellow' appearance on the aerial photograph indicating they are possible used as part of the stone cutting process. |
