# **GROUND INVESTIGATION REPORT**

## **PENNY PIE PARK / POGMOOR RECREATION GROUND FOOTBRIDGE**

**Location: Barnsley**

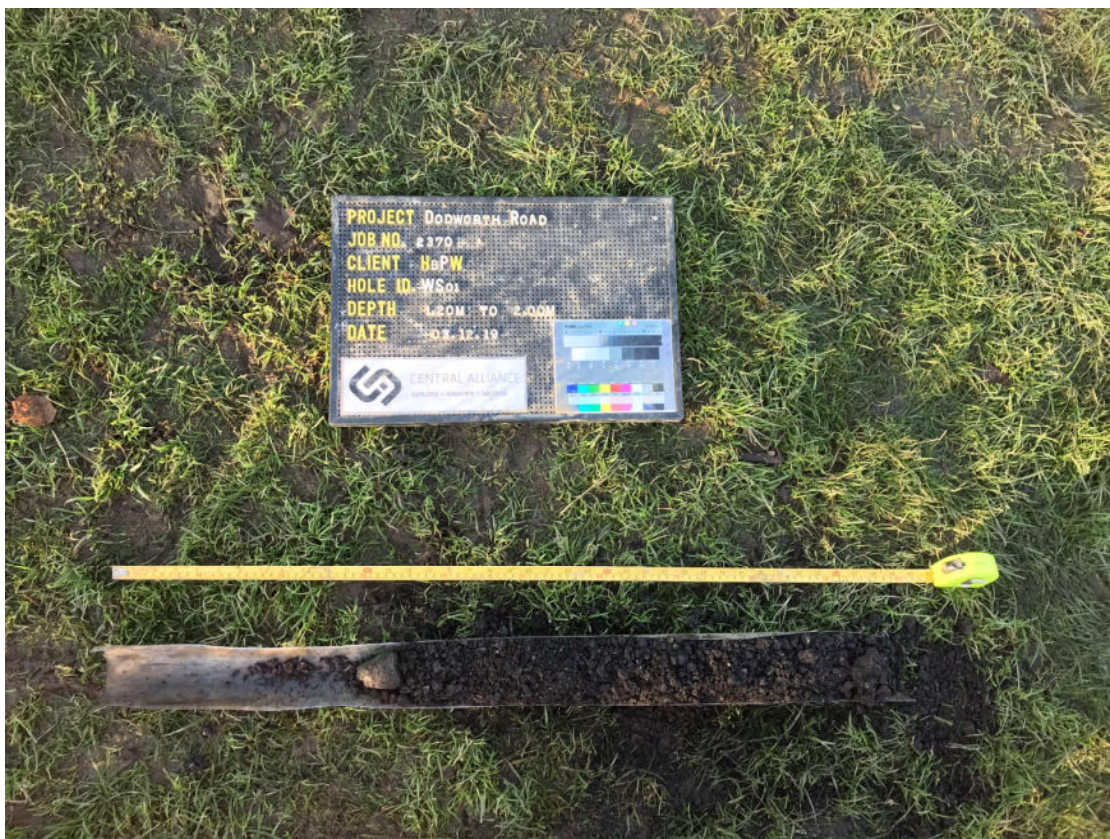
PHOTOGRAPH 1 – WS01– 1.20m to 2.00m bgl

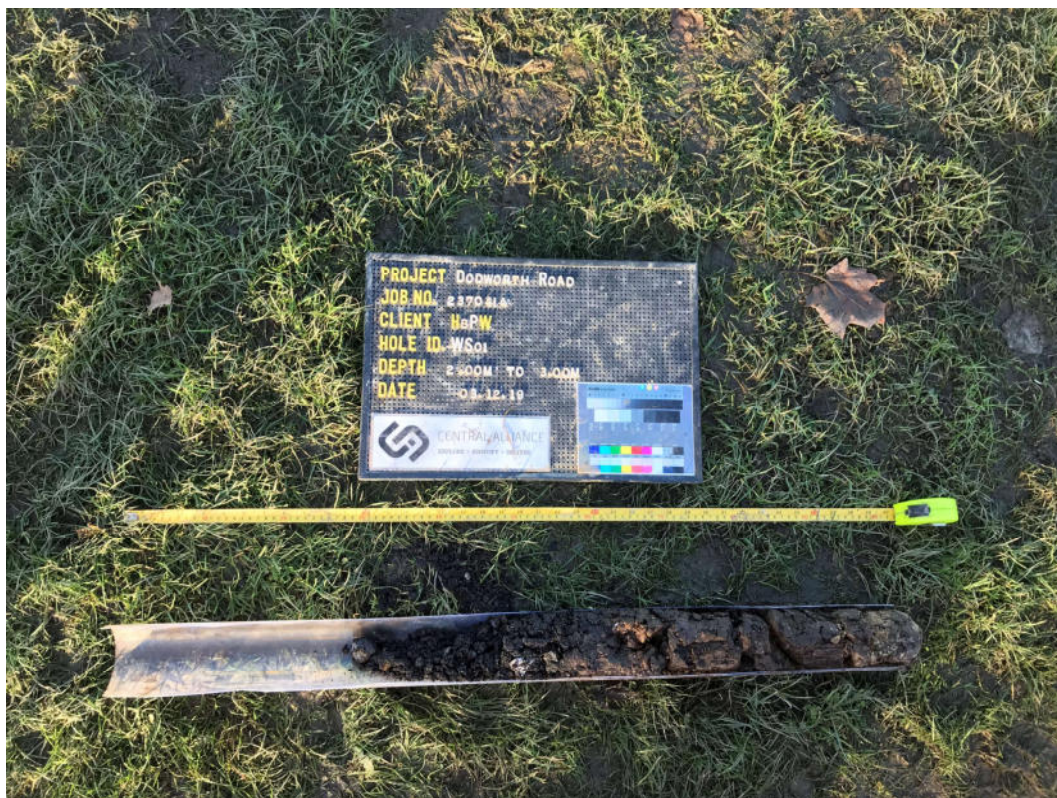
PHOTOGRAPH 2 – WS01– 2.00m to 3.00m bgl

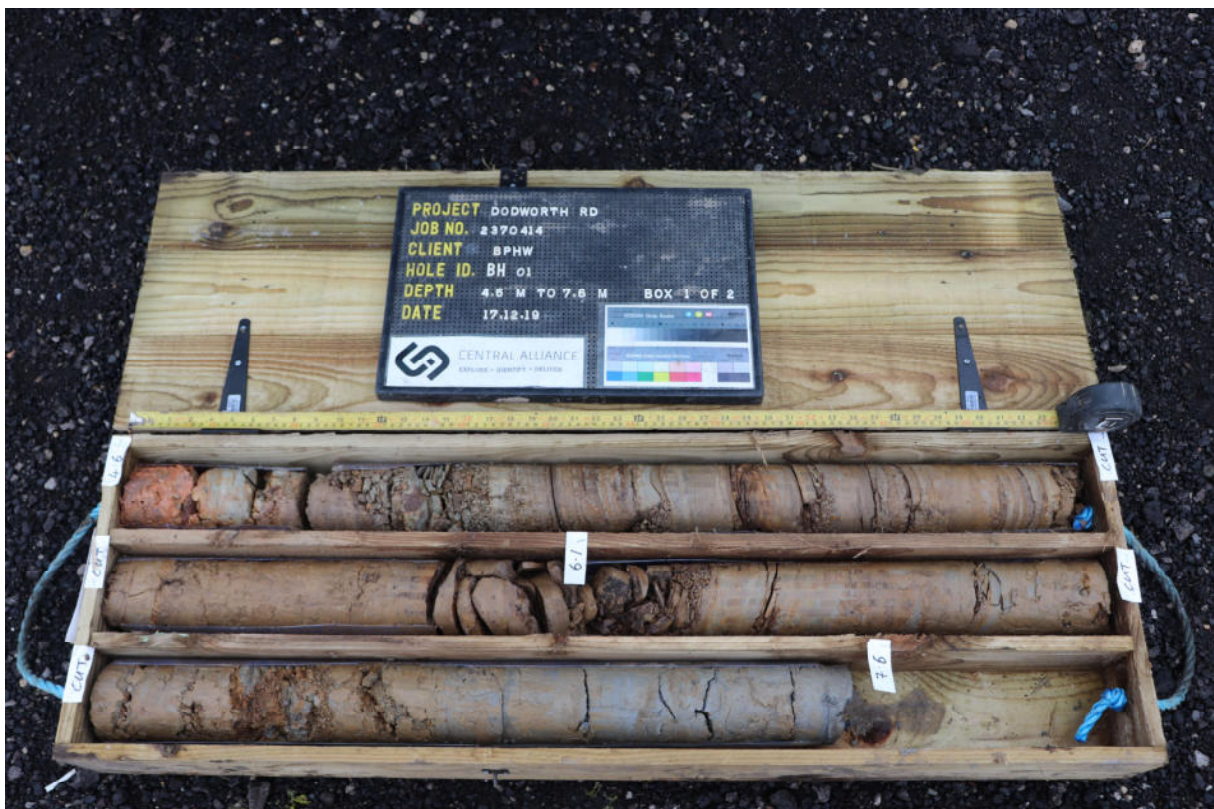
PHOTOGRAPH 33 – BH01– 4.60m- 7.60m bgl

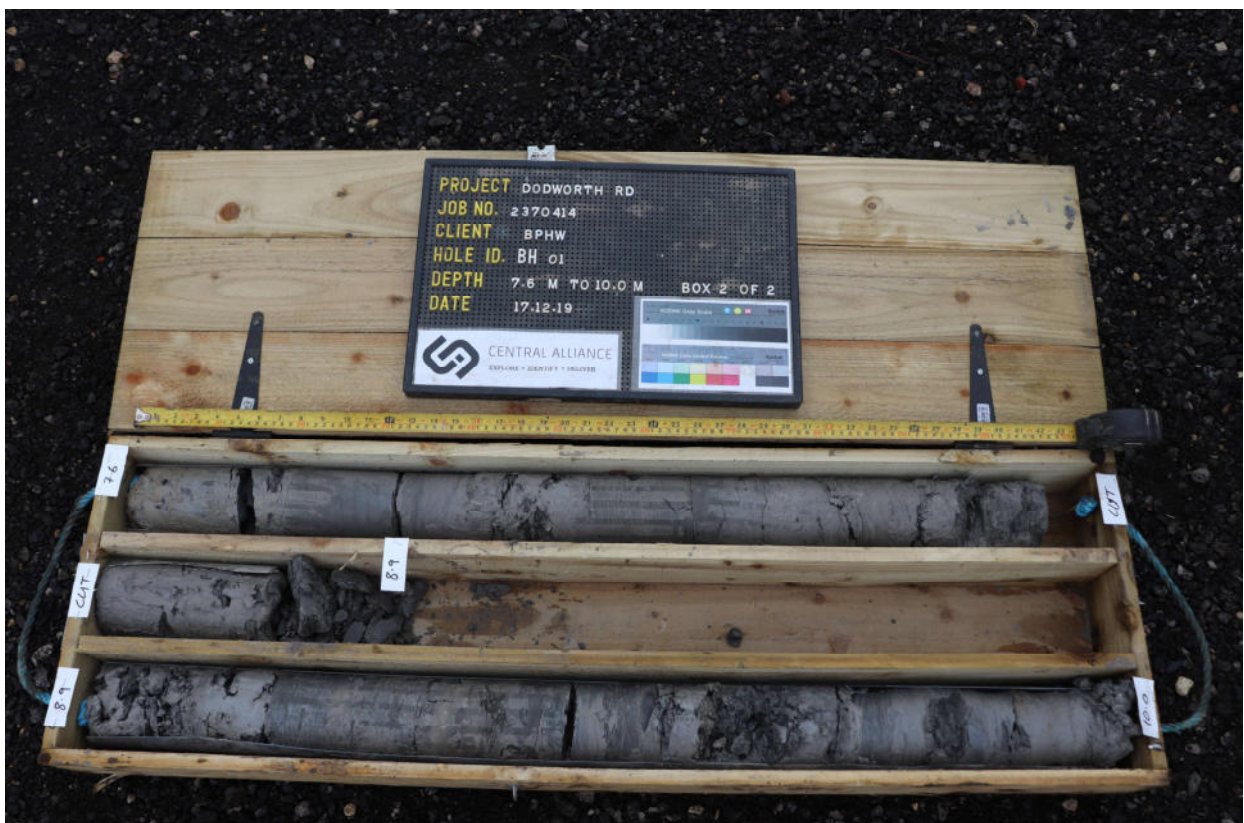
PHOTOGRAPH 34 – BH01- 7.60m- 10.00m bgl

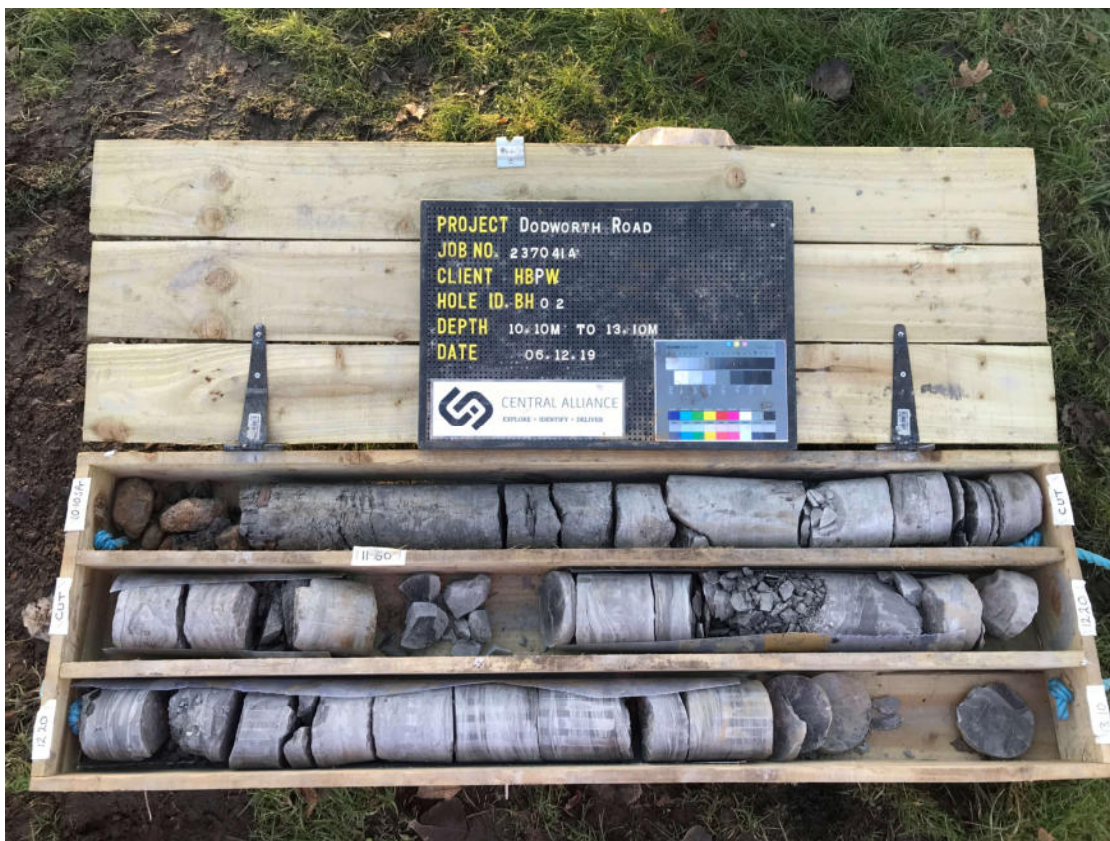
PHOTOGRAPH 35 – BH02– 10.10m- 13.10m bgl

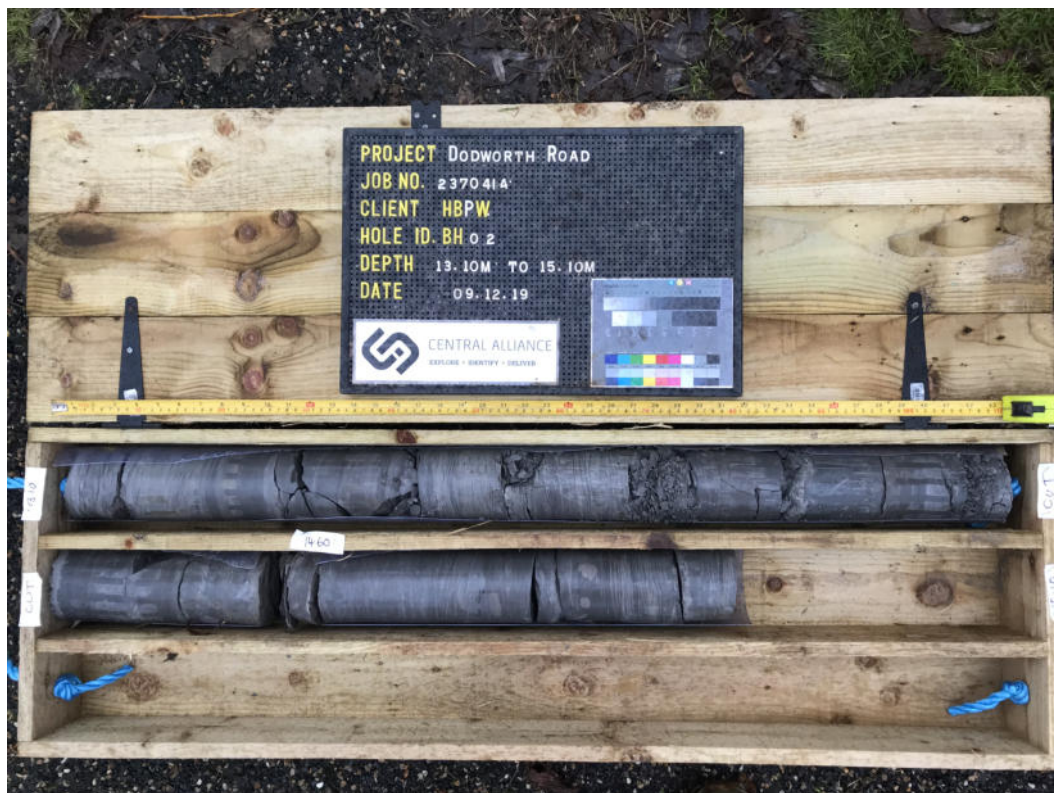
PHOTOGRAPH 36 – BH02- 13.10m- 15.10m bgl

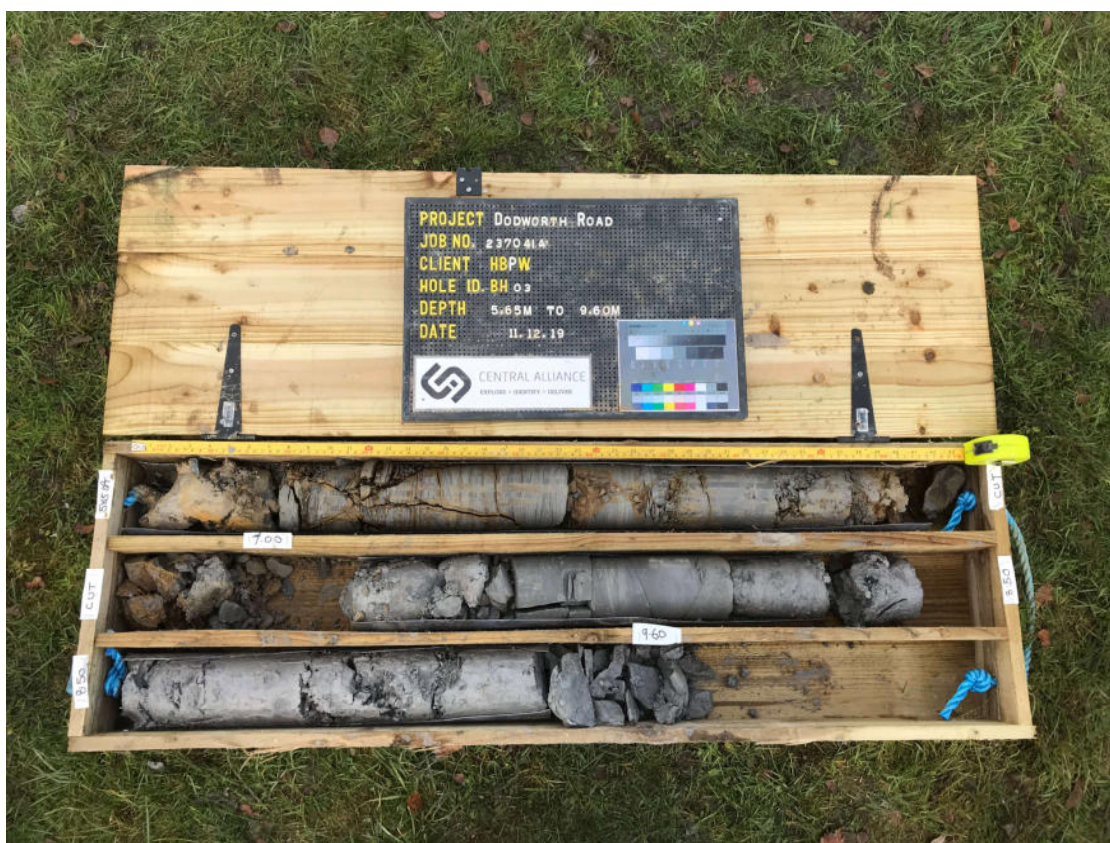
PHOTOGRAPH 37 – BH03– 5.65m- 9.60m bgl

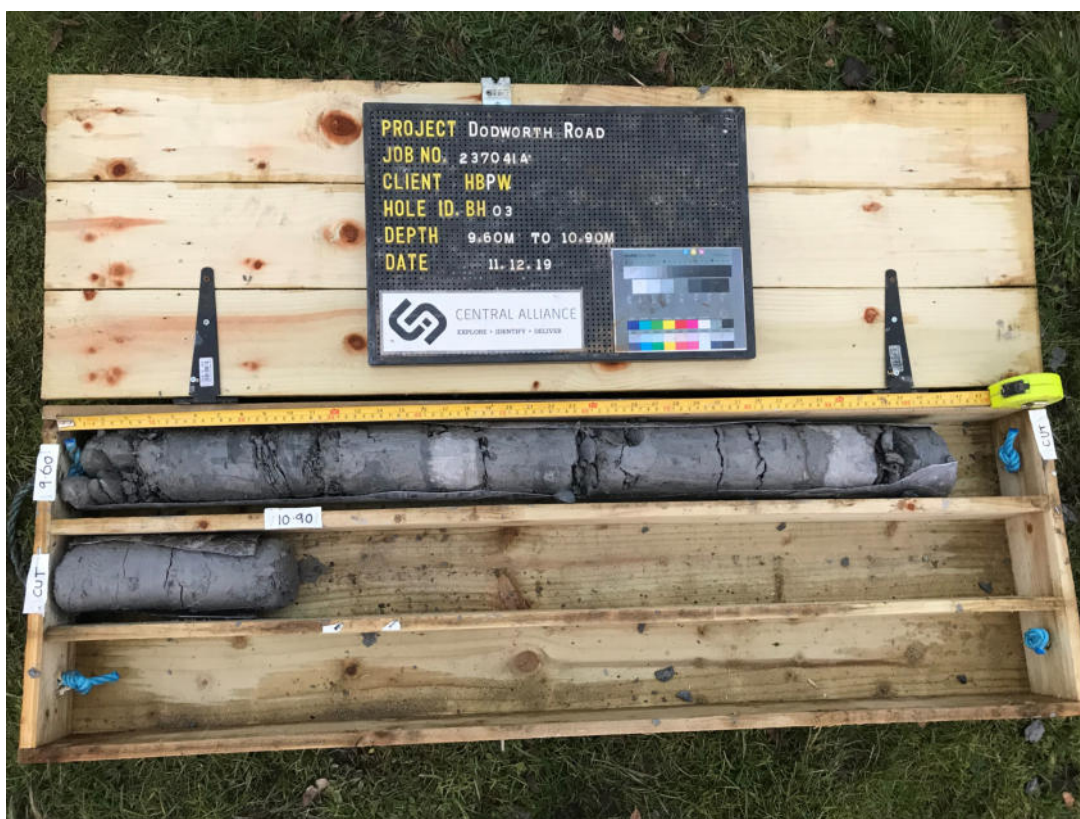
PHOTOGRAPH 38 – BH03- 9.60m- 10.90m bgl

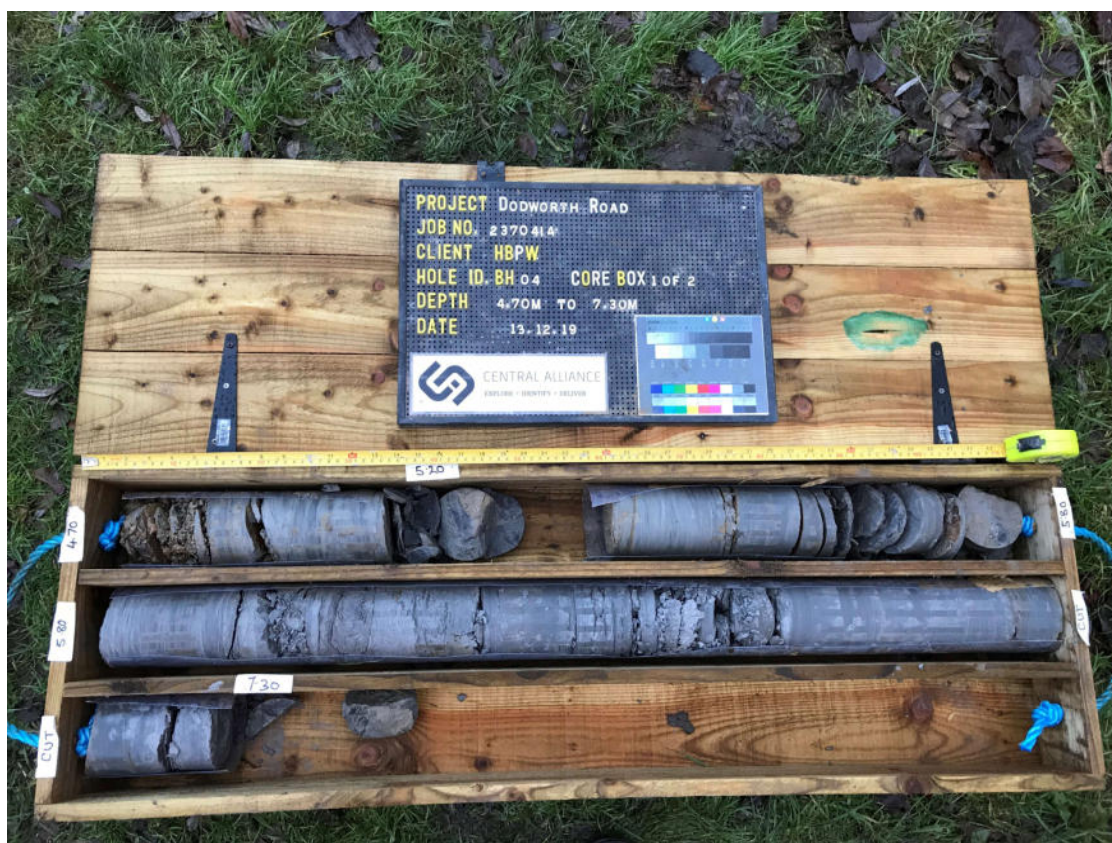
PHOTOGRAPH 39 – BH04– 4.70m- 7.30m bgl

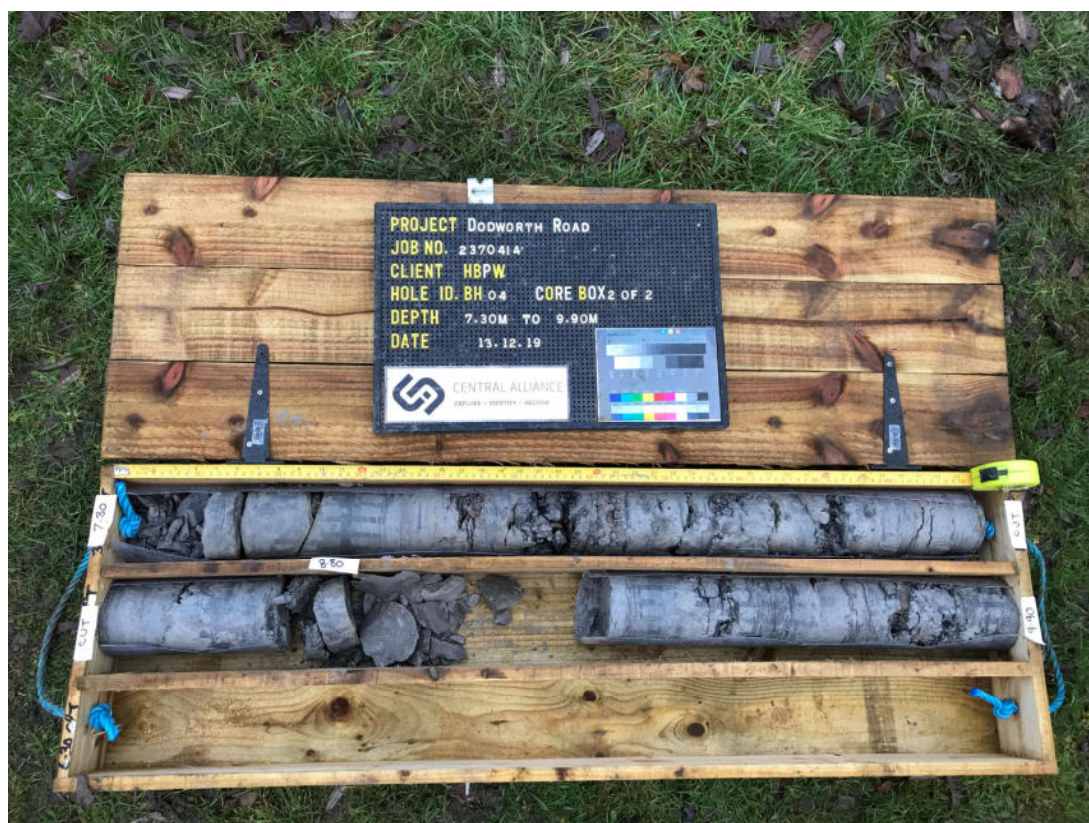
PHOTOGRAPH 40 – BH04- 7.30m- 9.90m bgl

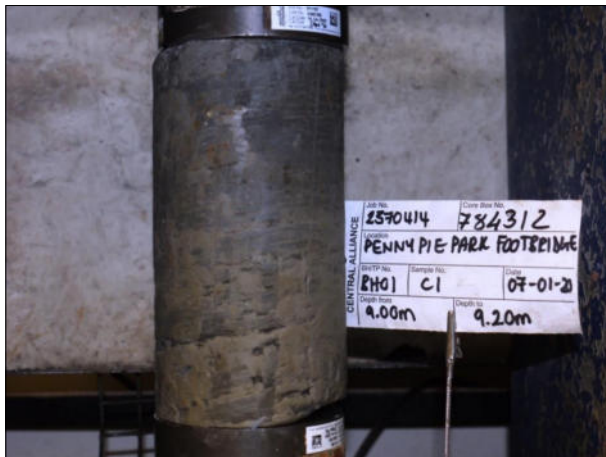
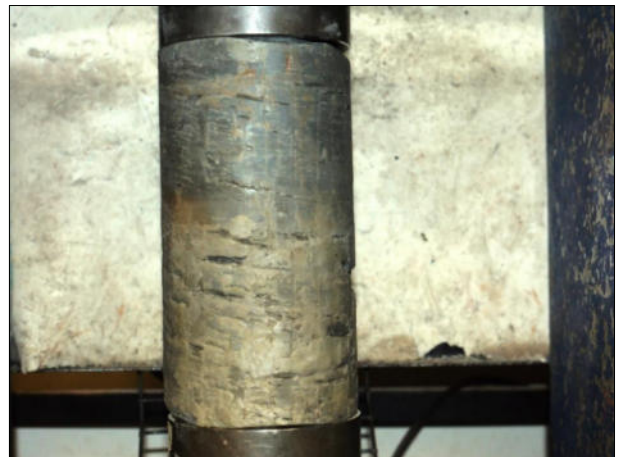
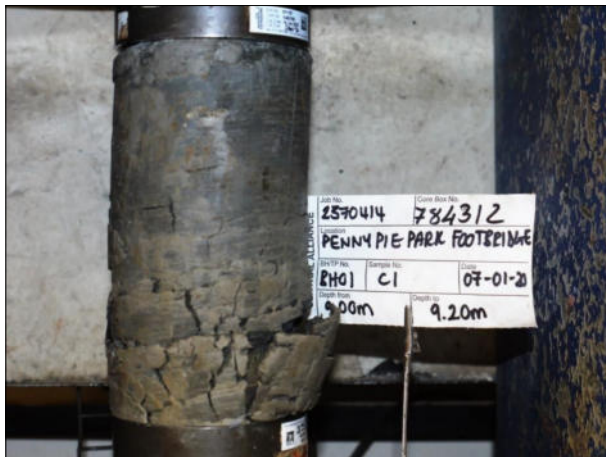
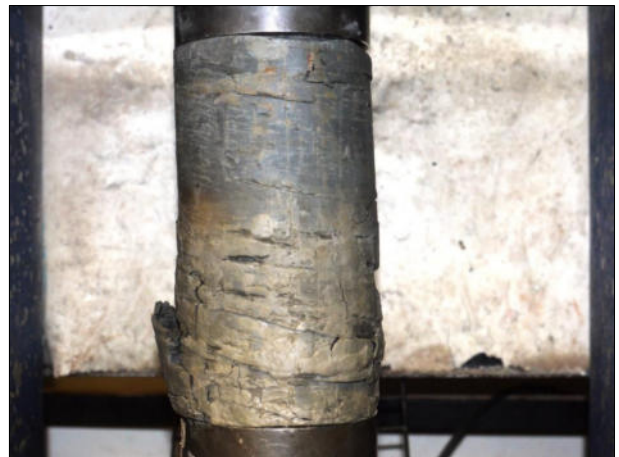
Remarks: **Too soft to measure tolerances**

Front view (pre-test)

Rear view (pre-test)

Front view (post-test)

Rear view (post-test)

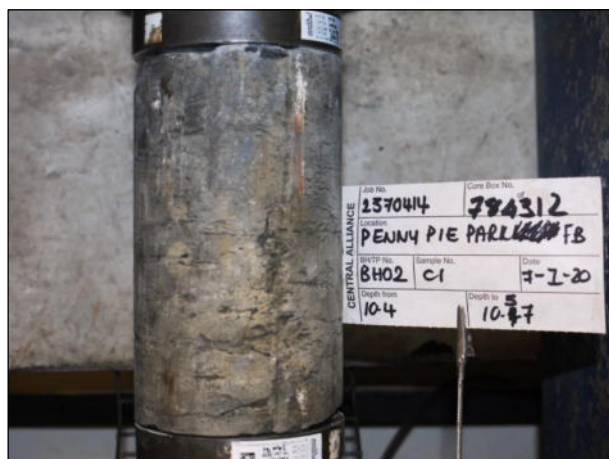
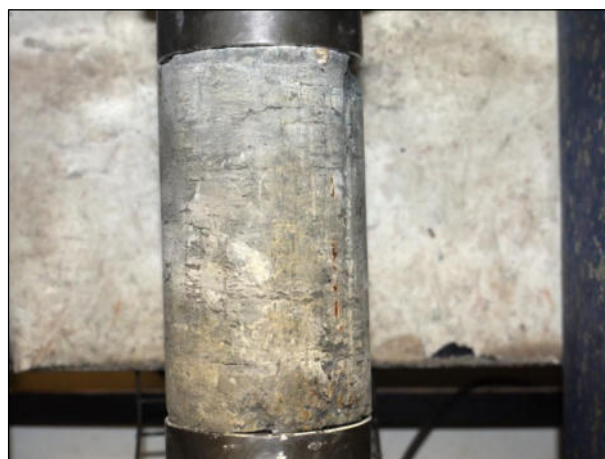
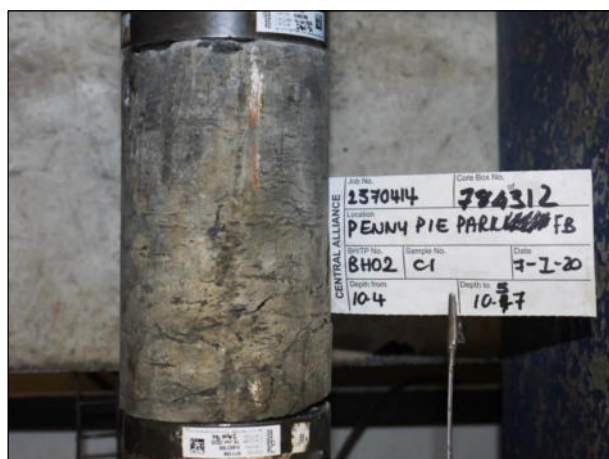
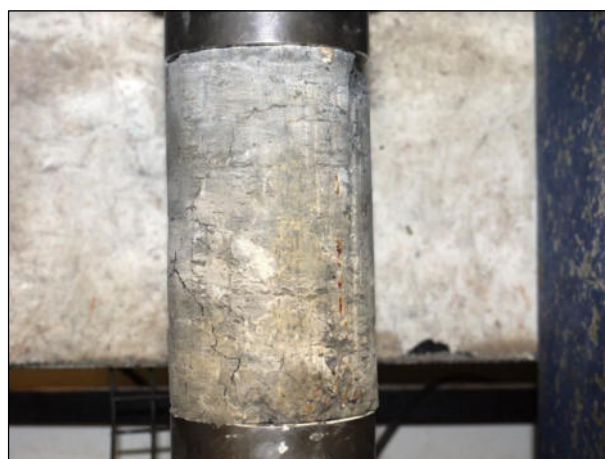
Remarks: **Too soft to measure tolerances**

Front view (pre-test)

Rear view (pre-test)

Front view (post-test)

Rear view (post-test)

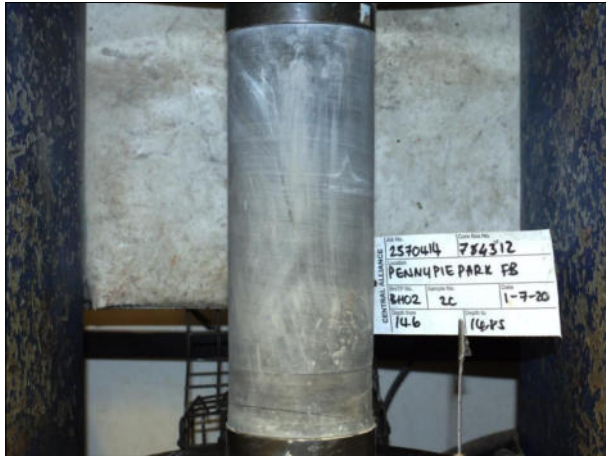
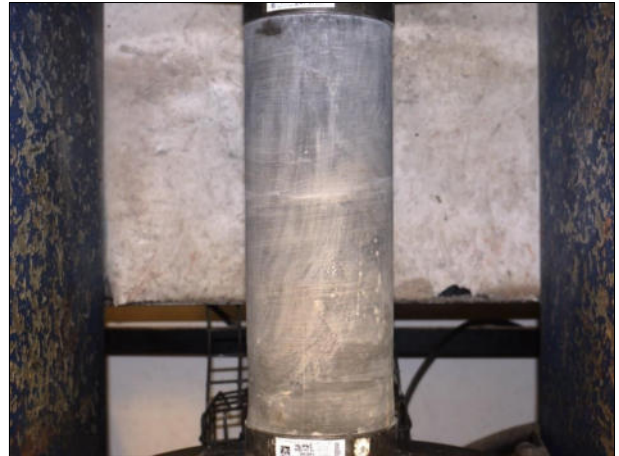
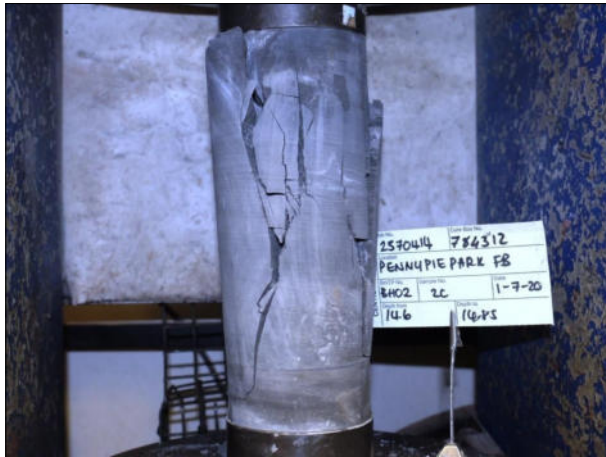
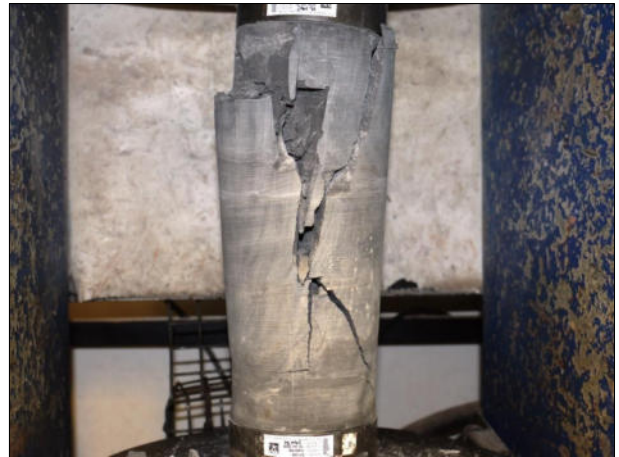
Sample tolerance checks: Straightness: **PASS**. Flatness: **PASS**. Perpendicularity: **PASS**.

Front view (pre-test)

Rear view (pre-test)

Front view (post-test)

Rear view (post-test)

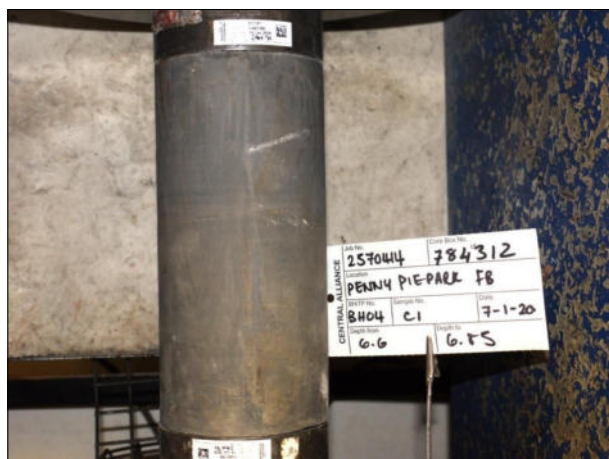
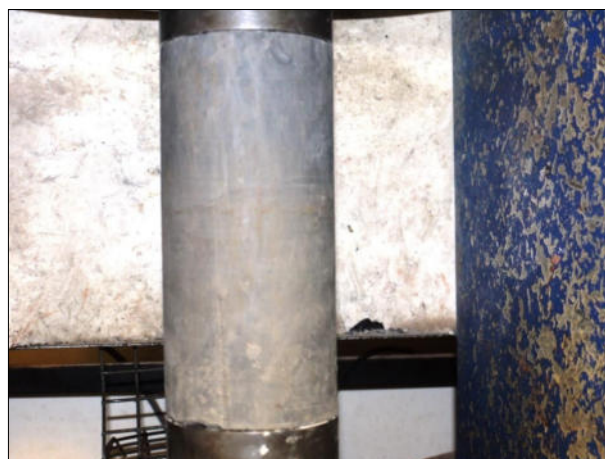
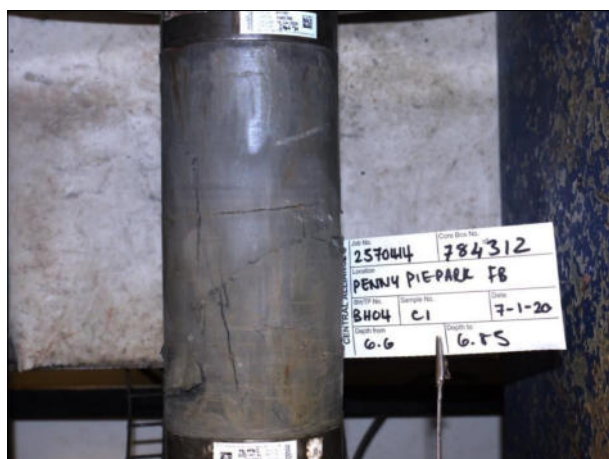
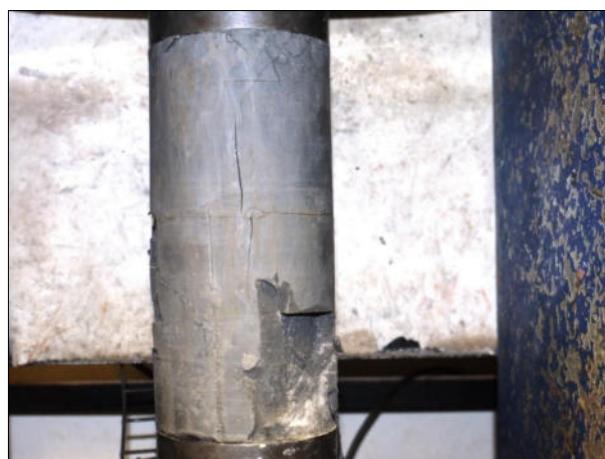
Sample tolerance checks: Straightness: **PASS**. Flatness: **PASS**. Perpendicularity: **PASS**.

Front view (pre-test)

Rear view (pre-test)

Front view (post-test)

Rear view (post-test)
