**HEALD HEAD COTTAGE, CAWTHORNE,  
BARNSELY**

**DAYTIME BAT SURVEY.**

**Ref No: 210724/1.**

**Date: 30<sup>th</sup> July 2021.**

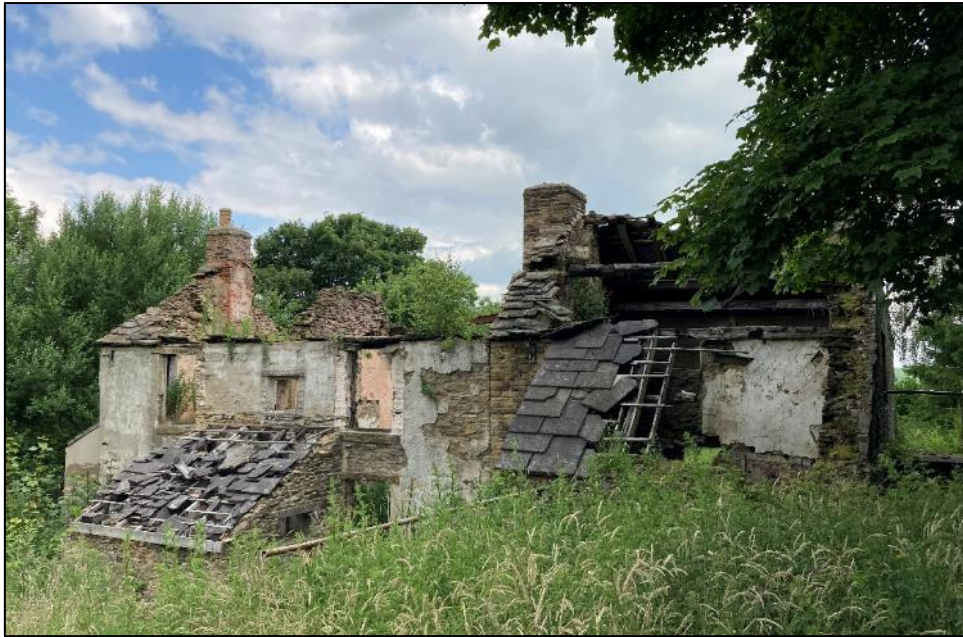
3.2.5. The cottage is in a dilapidated state with most of the roof and its supporting structures having collapsed due in part to vandalism. The walls of the old cottage are mostly constructed of stone with the chimney stack made from brick. The building has three associated lean-to structures on its northern and western aspects. The photograph below shows the western aspect of the building.

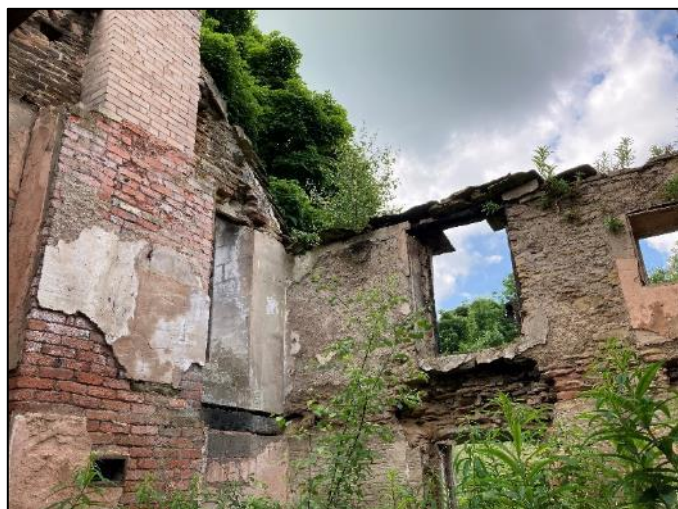
3.3.1. The walls of building are in a poor condition with many crevices and cracks both on the exterior and interior. The opening of the ventilation shaft on the chimney stack likely has a sizeable cavity behind it, which could provide good roosting potential for a small number of bats, see right photograph.

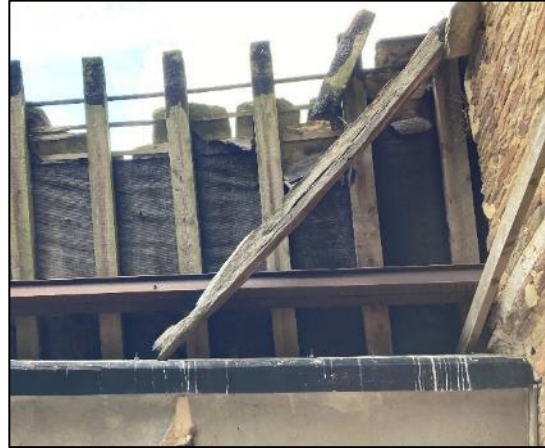
3.3.3. Despite much of the roof tiles and their supporting structures missing from the building, what remains is felt lined, see right photograph, but still unlikely to support roosting bats in high numbers. The stone roof tiles atop the gable ends, and much of the end tiles, are raised, slipped or missing entirely providing opportunities for crevice dwellings bats to use such spaces in low numbers.

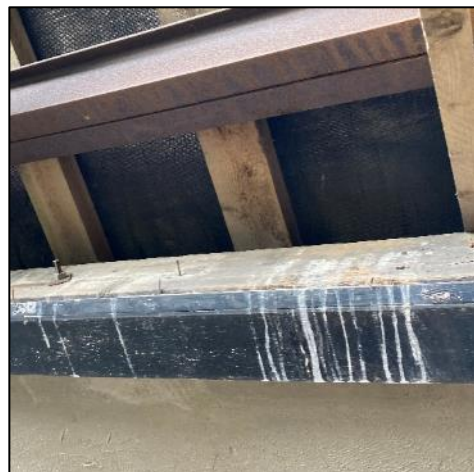
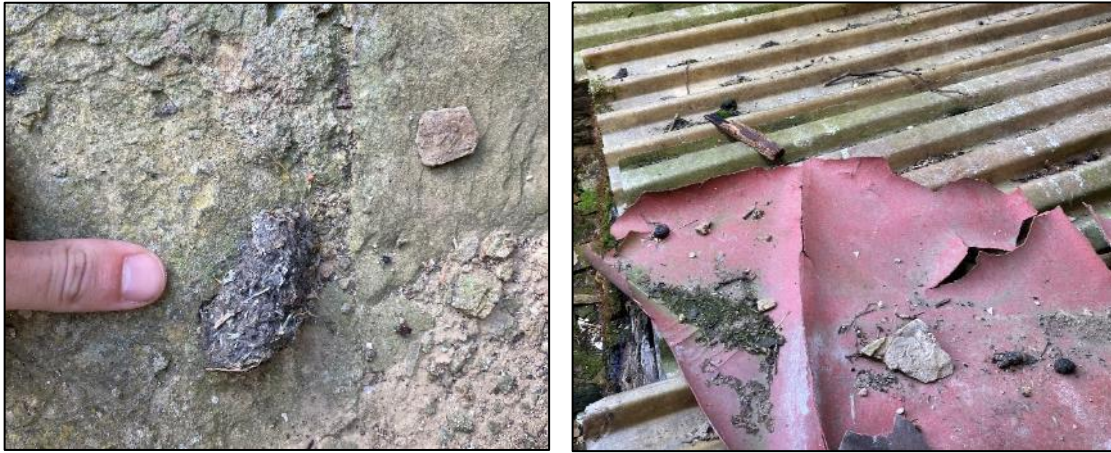
3.3.6. A timber support beam spanning the length of the most complete section of roof at the south-east corner was stained from bird faecal matter, see right photograph. Below this were the remains of the first floor which consisted of a few plastic corrugated sheets. Barn Owl (*Tyto alba*) pellets were found in the entrance way and scattered on the plastic sheets with fresher pellets identified on the latter, see photographs below.

3.3.7. The findings of the Barn Owl field signs described above suggest the survey area is used by owls on at least a semi regular basis given the recordings of pellets at different ages on site. No nest was identified during the survey but much of the first floor at the south-east corner of the building, where the droppings and pellets were found, was lacking sufficient structural integrity to safely inspect all cavities in this area.

5.2. A second visit for a dusk survey would also help in determining whether any Barn Owls are currently using the building and the location of any potential nests.
