**42 PARK AVENUE, ROYSTON.**

**EXTENDED PHASE I HABITAT SURVEY.**

**Ref No:- 160519.**

**Date:- 6<sup>th</sup> May 2016.**

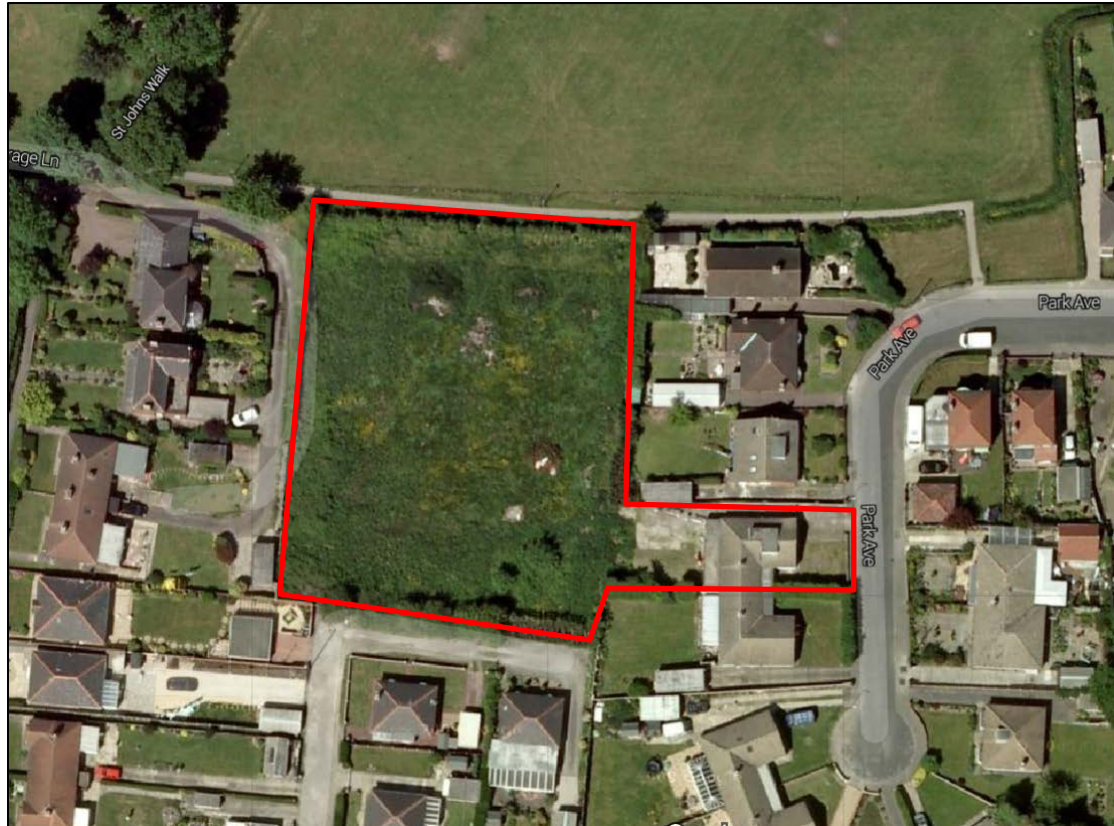
3.2.1. The survey area is 42 Park Avenue, Royston and an area of land to the rear of the property. The aerial photograph below shows the survey area.

3.2.2. The bungalow is currently empty and the land behind the house has been cleared with bare ground and a number of piles of turf and rubbish remaining on the site.

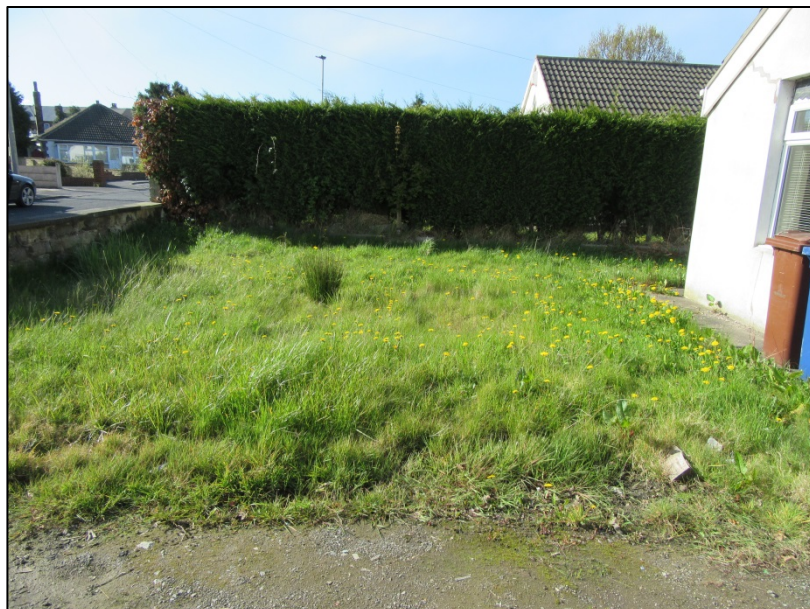
3.3.2.1. At the front of the bungalow is a small area of lawn which has become overgrown as it has not been mown. This is mainly common lawn grass species including perennial rye grass (*Lolium perenne*), annual meadow grass (*Poa annua*) and common bent (*Agrostis capillaris*). Other species are present, including dandelion (*Taraxacum officinale*), dock (*Rumex acetosella*) and creeping buttercup (*Ranunculus Repens*).

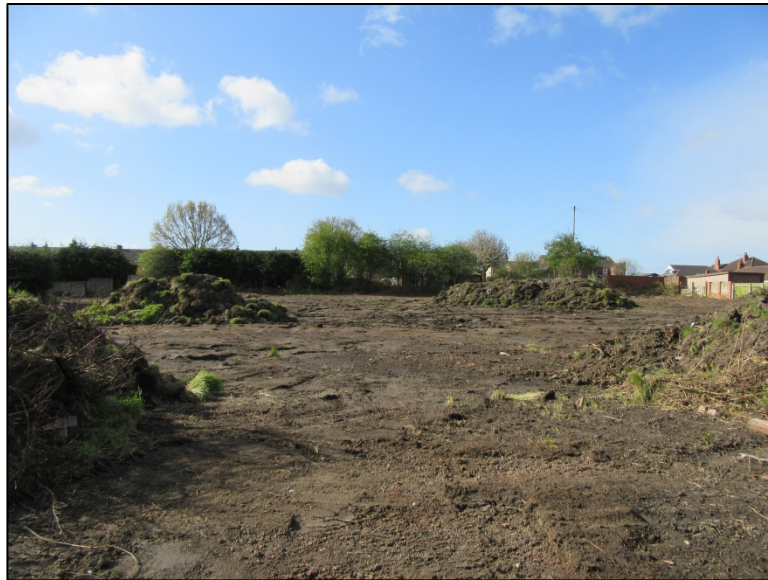
3.3.3.1. The main area of the site has been cleared creating a number of piles of turf and debris and leaving the site as bare soil. There are a few species of plant growing at the edges of the cleared area, mainly dandelion (*Taraxacum officinale*), dock (*Rumex acetosella*), nettle (*Urtica dioica*), thistle (*Cirsium sp(p)*) and bramble (*Rubus fruticosus*). There is also an area of concrete by the bungalow, a concrete drive along the northern side of the bungalow with a concrete area at the rear of the property.

3.3.3.2. Photograph looking southwest across the site.

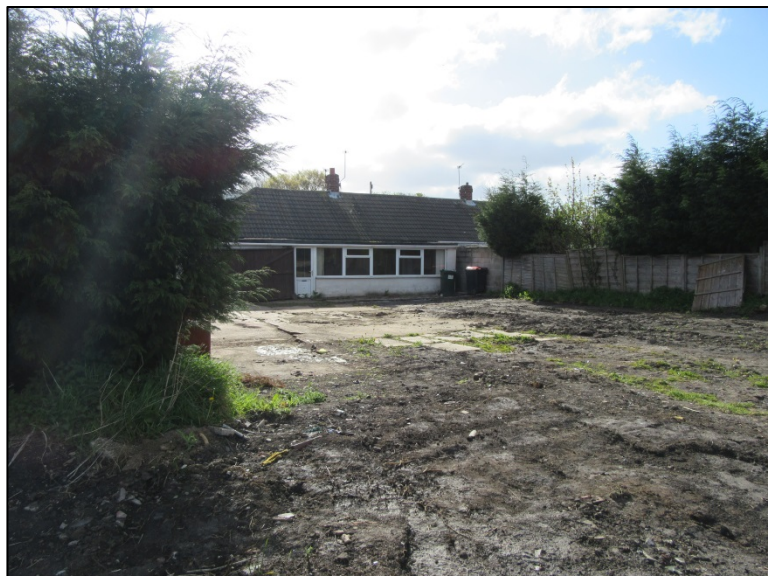
3.3.3.3. Photograph looking at the rear of the bungalow.

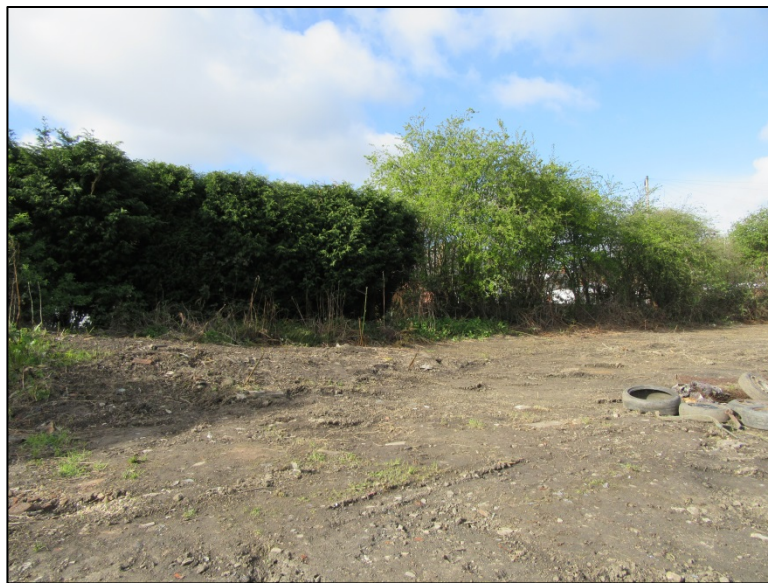
3.3.4.2. The southern and western boundaries are hedgerows, which are in part conifer and part hawthorn (*Crataegus monogyna*). The Northern and eastern boundaries are conifer hedgerows. There are also conifer hedgerows along the north and south boundaries of the bungalow.

3.3.4.3. Photograph showing the southern hedgerow.

5.1. It is recommended that where possible the hedgerows, which are habitats of principal importance, remain unaffected by the proposed development. If the works will impact on the hedgerows it is recommended that the local authority is contacted prior to the works in these areas commencing.

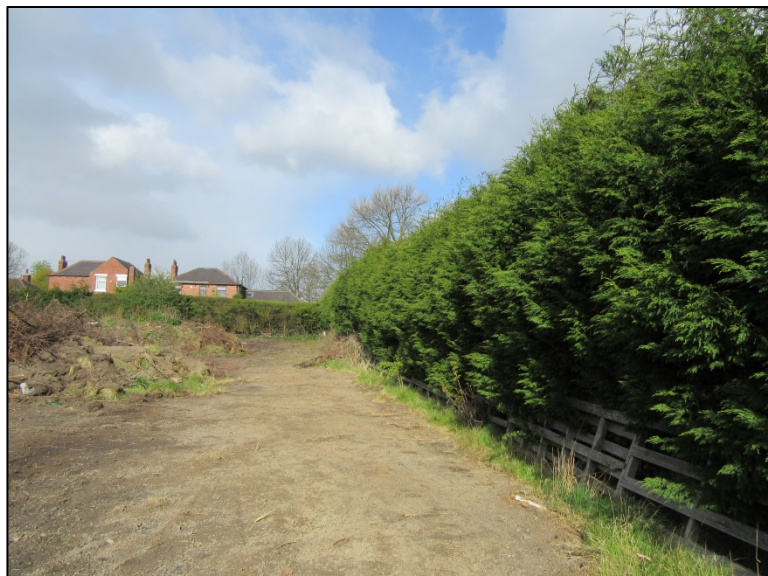
3.3.4.4. Photograph showing the northern hedgerow.

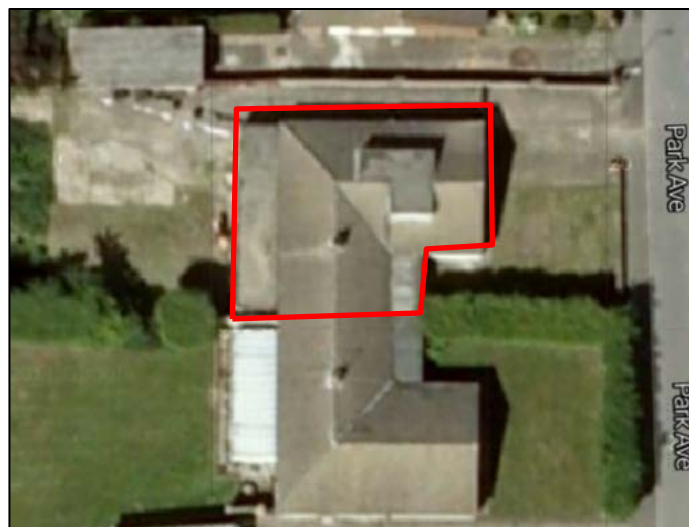
3.3.8.2. The bungalow is constructed of brick with white painted rendering and a pitched roof covered with pan tiles, which has a 90 degree turn. There are also two areas of flat felt roof, one on the western side extending the full length of the building and a small area on the eastern side of the building. The aerial photograph below shows the surveyed building and the layout of the roof.

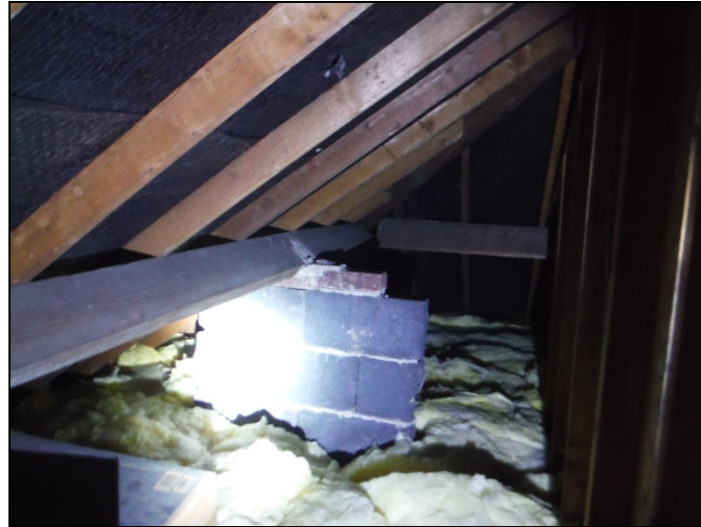
3.3.8.3. The bungalow has a loft space on the western elevation and a smaller loft space on the northern elevation. The loft consists of timber supports, breeze block walls, insulation on the floor and is felt lined. There is an area of the loft to the southern end of the building that has been fully plaster boarded up. The photograph below shows part of the loft space.

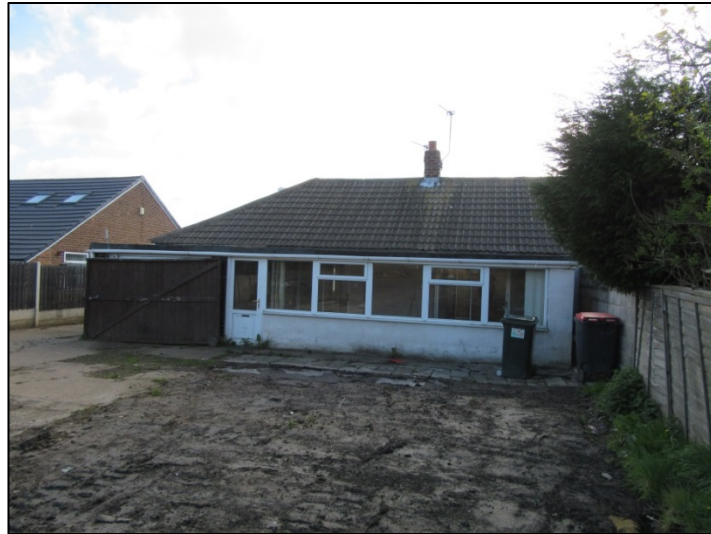
3.3.8.5. The roof has no missing or slipped tiles although there are gaps under the ridge tiles on the eastern and western elevations due to missing pointing. There is also a gap next to the chimney on the western side of the building.

3.3.8.8. Photograph showing the rear, western side, of the bungalow.

5.2. It is recommended that a further bat survey is carried out of the bungalow in line with the Bat Conservation Trust (BCT) Good Practice Guidelines, which requires a dusk emergence bat survey. The survey should use sufficient surveyors to ensure that all areas of the building are covered during the survey.

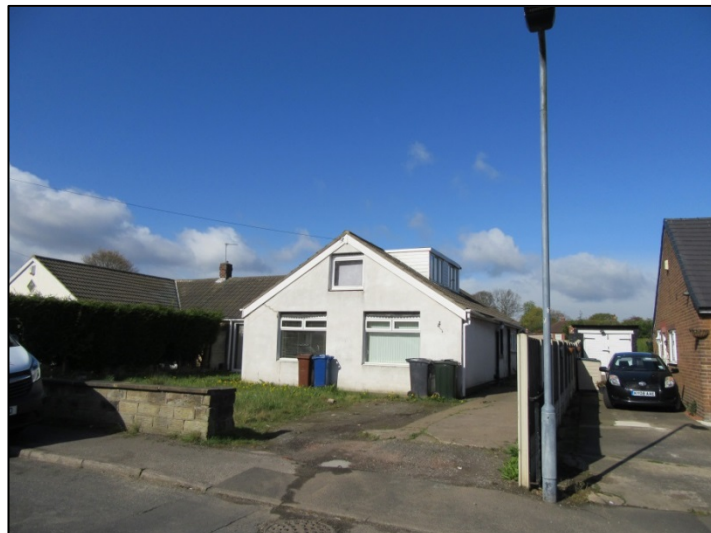
3.3.8.4. The building is generally in good condition with no cracks or gaps in the external walls.

3.3.8.9. Photograph showing the front, eastern side, of the bungalow.

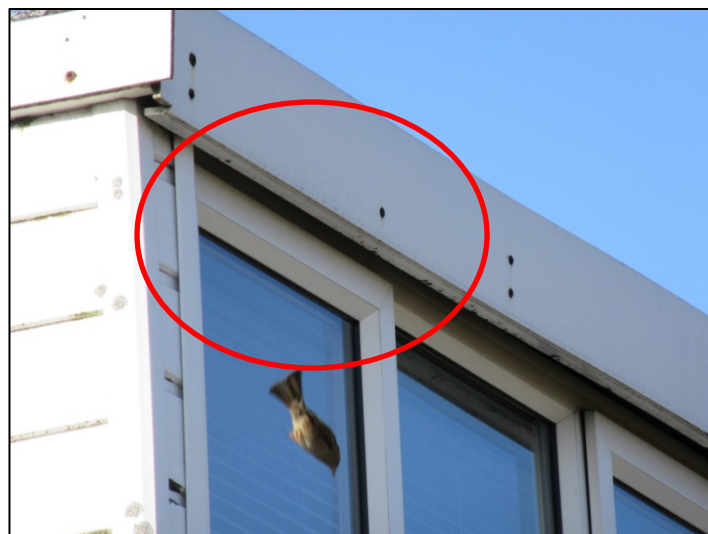
3.3.8.6. On the eastern section of the roof there is a dormer window on both the southern and northern elevations, both with flat roofs. There is a gap under the edge of the flat roof of the northern dormer window.

3.4.6.1. The bungalow provides opportunities for nesting birds and during this survey two active house sparrow nests were identified. One nest was identified under the roof of the northern dormer window with sparrows seen entering and exiting the gaps. The second nest was identified under the windowsill of the upstairs window at the eastern side of the building.

3.4.6.2. Photograph showing a sparrow leaving the gap in the northern dormer window.

5.4. Ideally it is recommended that any work on site to clear vegetation and to demolish the bungalow commences outside the nesting season, which extends from March to September each year.

5.5. Any work that commences during the nesting season must be immediately preceded by a thorough nesting bird survey carried out by a suitably experienced person. Any nests identified must remain undisturbed until the young have fledged from the nest.

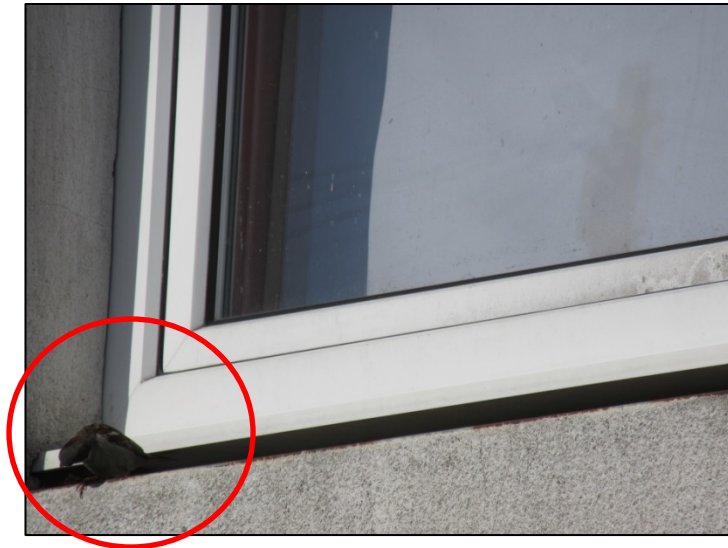
3.3.8.7. All windows and doors are in place and sealed, although sparrows were seen entering a gap under the upstairs windowsill on the eastern side of the bungalow.

3.4.6.3. Photograph showing a sparrow leaving the gap under the upstairs windowsill at the eastern side of the bungalow.

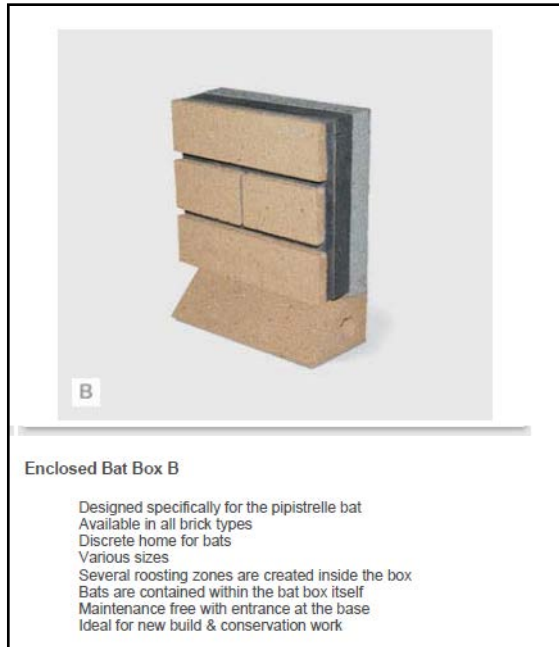
5.8. The following type of bat brick or equivalent will be used and can be purchased to match the outer skin of the new buildings.

5.7. In order to provide biodiversity enhancements in the new buildings it is recommended that bat bricks are installed in a suitable location, high up in a gable end wall. This will enable bats to roost in the outer skin of the cavity wall while not allowing bats into the property.

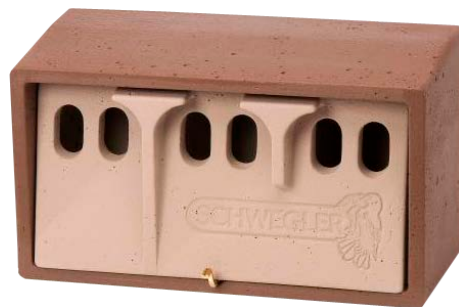
5.10. The following type of sparrow terrace nest box or equivalent will be used can be fixed to the surface of a suitable wall or incorporated into the wall.

5.9. In order to provide biodiversity enhancements in the new buildings it is recommended that sparrow terrace boxes are installed in a suitable location, high up in a gable end wall or under the eaves of the buildings. This will provide opportunities for sparrows to nest as the opportunities in the existing building will be lost.
