## TECHNICAL NOTE

2019s0951  
Smithies geomorphological improvements  
Yorkshire Wildlife Trust  
15th April 2019  
Natasha Todd-Burley  
Matt Hemsworth  
Geomorphological walkover and  
proposed channel improvements

## 1 Introduction

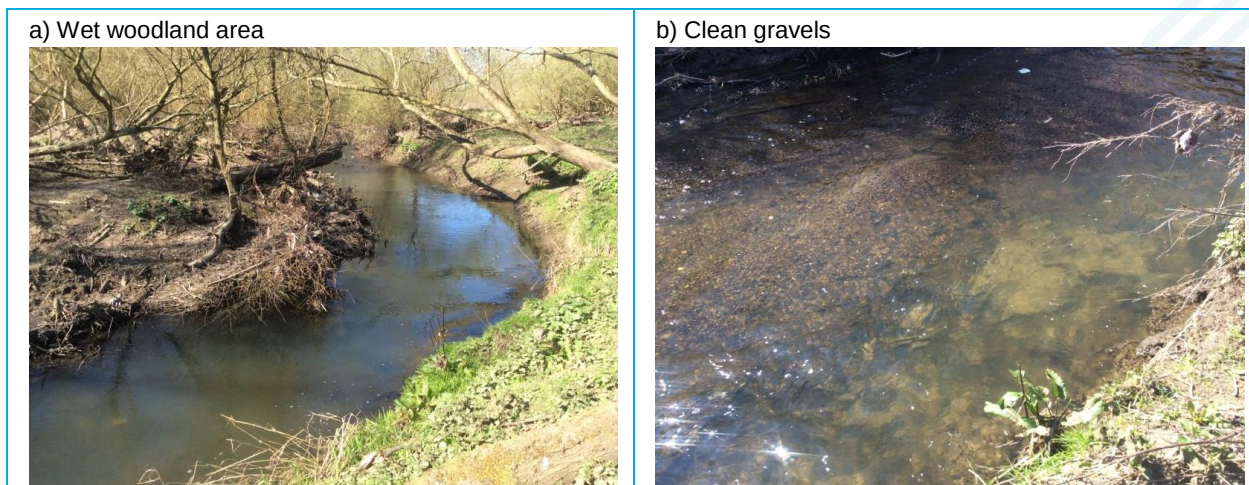
**Figure 2-3: Conditions within the upstream extent of the site**

Further upstream towards the top end of the site, and beyond into the surrounding farmland, the hydromorphology of the river improves substantially. The right bank floodplain connectivity is good and there is a large area of wet woodland in the vicinity of the palaeo channel on the right bank floodplain associated with the old river course. The river in this location provides an excellent analogue section for understanding the improvements that could be made downstream. The river width is narrower and more varied through this section (Figure 2-3a) and flow velocity is faster than in the downstream portion of the site. As a result, the river bed exhibits more diversity, with riffled flow over gravel deposits in places (Figure 2-3b).

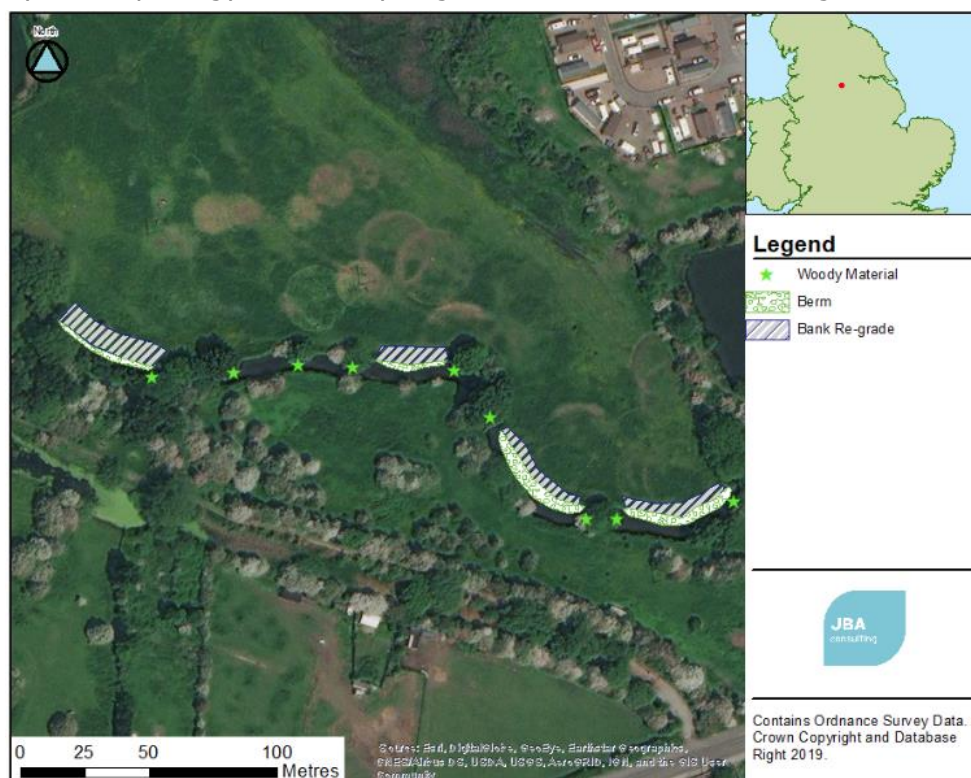
**Figure 3-1: Proposed improvements for the downstream reach**

Improvements have been proposed for the downstream section of the site where the hydromorphology is severely degraded, as summarised in Figure 3-1.

Narrowing the channels with berms formed from fine sediment will improve low flow velocities through the reach and increase in-channel flow diversity, helping to flush fine sediments from the bed. The berm elevation should be set so that the surface of the berm is above low flow water levels (typically Q95-Q80 flow levels). The berms should be stabilised with suitable planting and/or green protection measures until they have established to prevent erosion of the features.

Re-grading the banks will improve floodplain connectivity and improve the riparian habitat by decreasing the slope of the bank. The material removed by battening back the slope could be used to form the berm features that have been proposed to narrow the channel. The banks should be stabilised with suitable planting and/or green protection measures until they have established to prevent erosion.

Introducing woody material in the channel will help to improve in-channel hydromorphological diversity. Woody material locally narrows the channel, causing locally significant increases in shear stress and erosion/scour during flood events, as well as local flow impoundment and sediment aggradation upstream.
