**THURNSCOE  
ROTHERHAM  
HIGHWAY CONDITION SURVEY**

| <b>On Behalf Of:</b> | Keepmoat Homes |
| <b>Inspection Date:</b> | 20 <sup>th</sup> September 2017 |
| <b>JLES Project Reference:</b> | N/227/Thurnscoe/Cs |

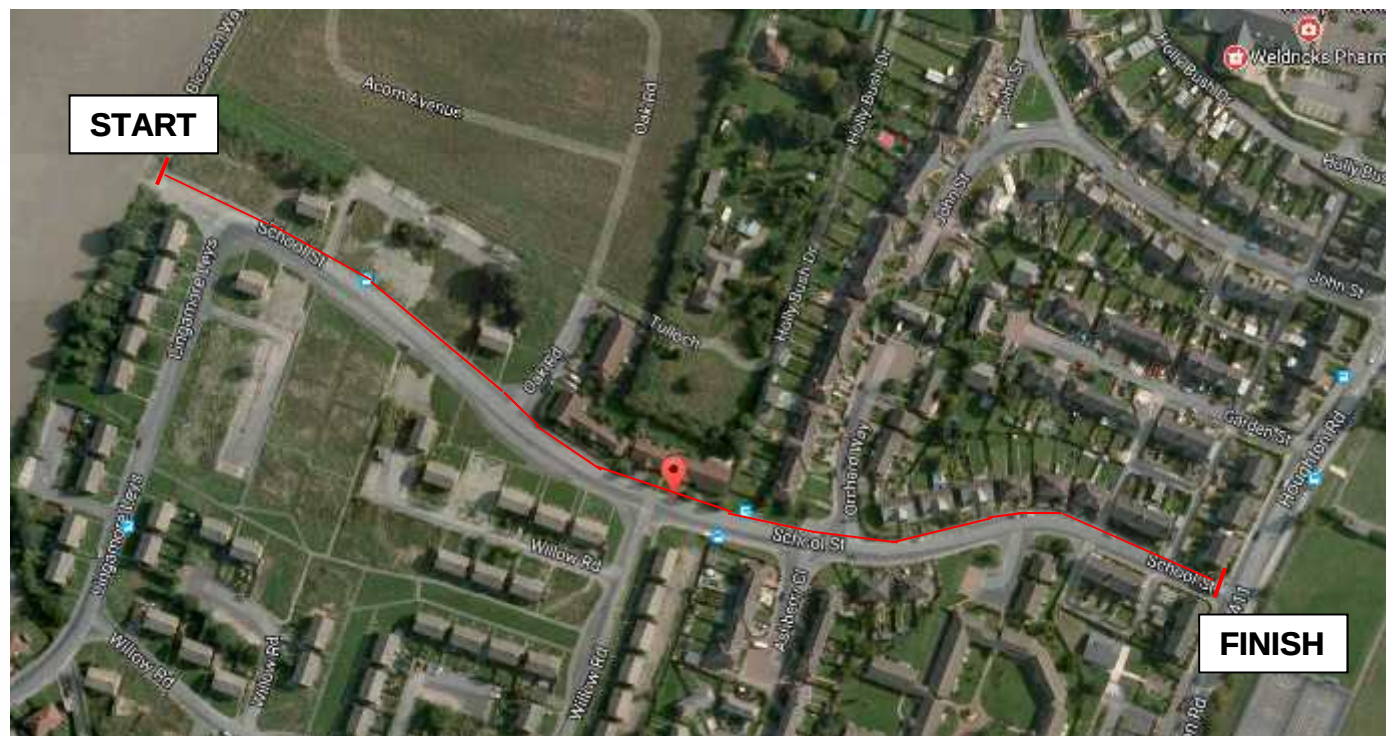
### FOOTPATH CONDITION SURVEY EXTENTS

Northern section of footpath survey leads North (see plan below).

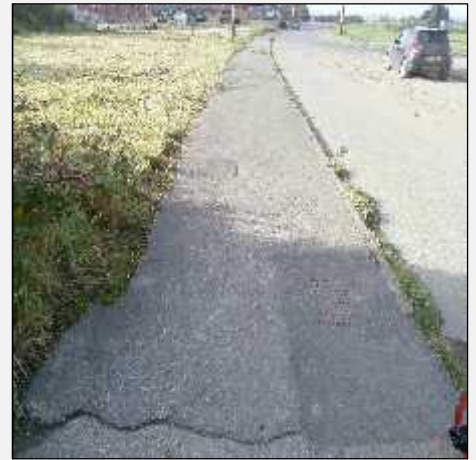
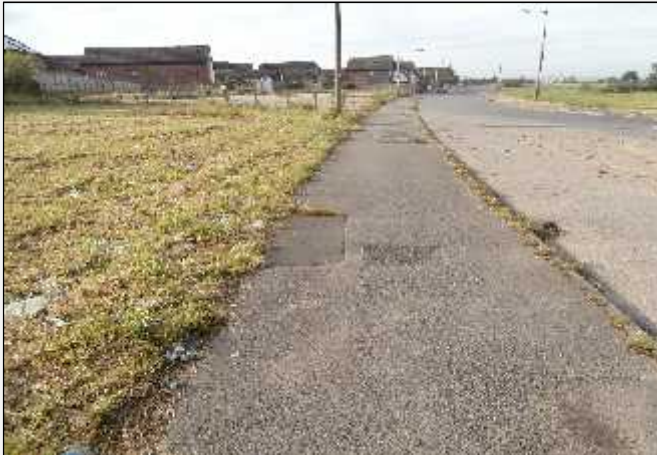
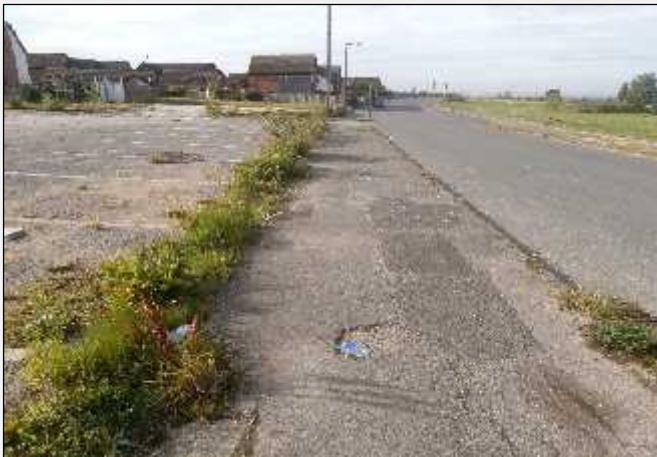
| OBSERVATION: | <div>A) Footpath surface course is showing signs of wear / cracking.</div> <div>B) Re-instatements present within the footpath are showing signs of failure.</div> <div>C) Numerous damaged kerbs along the footpath.</div> |
| REMEDIAL WORKS RATING: | <div><div><div>1</div><div>2</div><div>3</div><div>4</div><div>5</div><div>6</div><div>7</div><div>8</div><div>9▼</div><div>10</div></div><div>LOWMEDIUMHIGH</div></div> <div></div> |

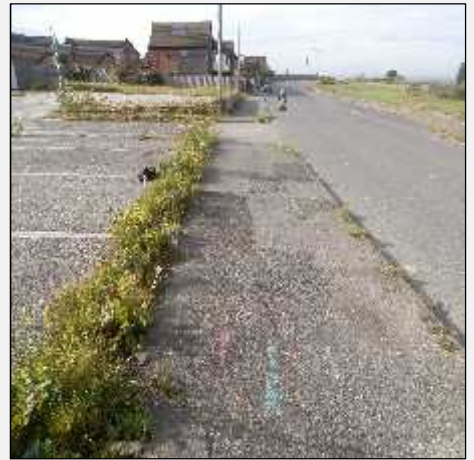
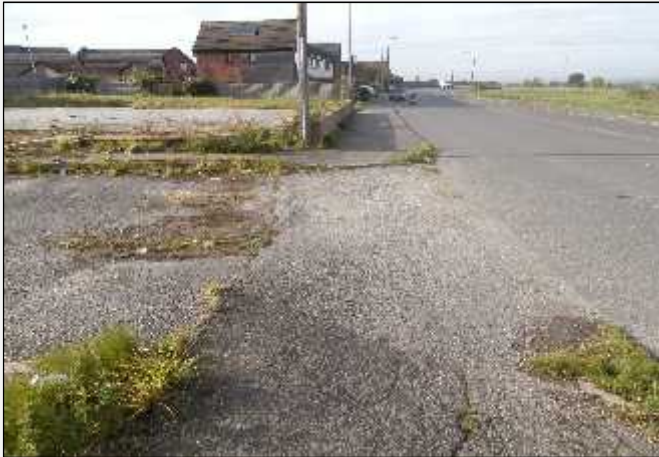
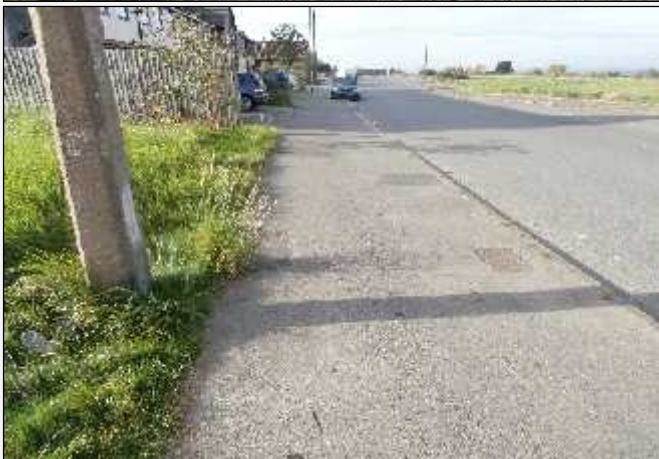
| OBSERVATION: | A) Footpath surface course is showing signs of wear / cracking.<br>B) Re-instatements present within the footpath are showing signs of failure.<br>C) Weed / vegetation growth encroaching onto the footpath.<br>D) Numerous damaged kerbs along the footpath. | | | | | | | | | |
| REMEDIAL WORKS RATING: | 1 | 2 | 3 | 4 | 5 | 6 | 7 | 8 | 9▼ | 10 |

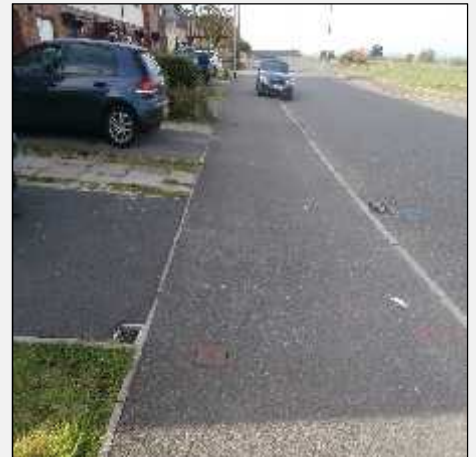
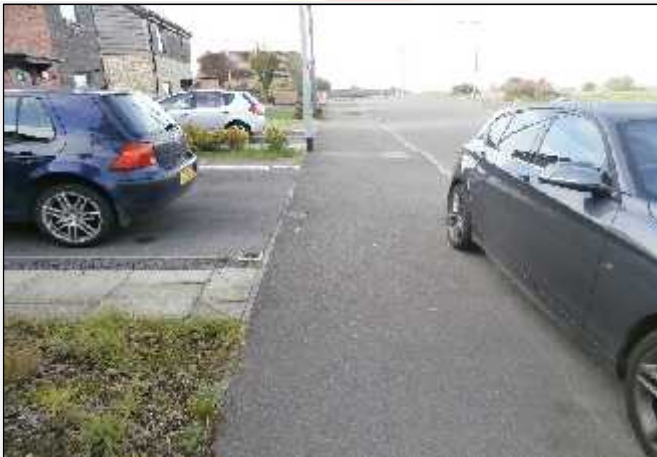
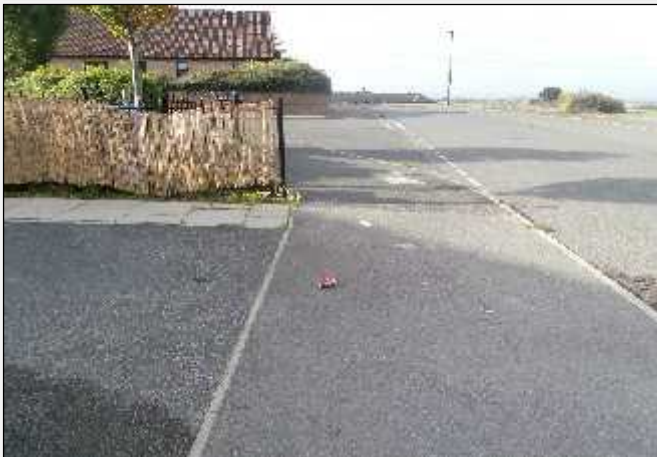
| OBSERVATION: | A) Footpath surface course appears to be in a good condition.<br>B) 2No utility boxes present within the footpath, showing no defects. | | | | | | | | | |
| REMEDIAL WORKS RATING: | 1 | 2 | 3▼ | 4 | 5 | 6 | 7 | 8 | 9 | 10 |

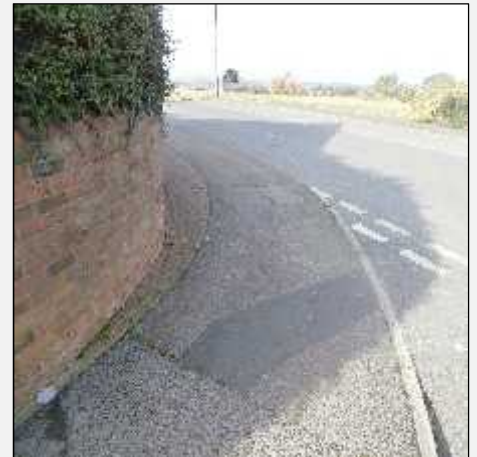
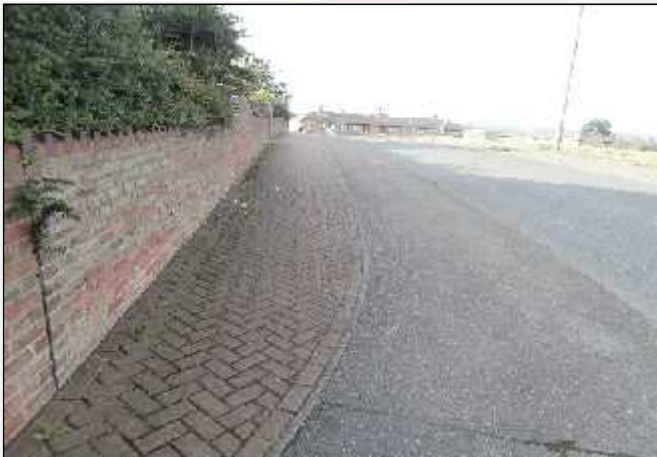
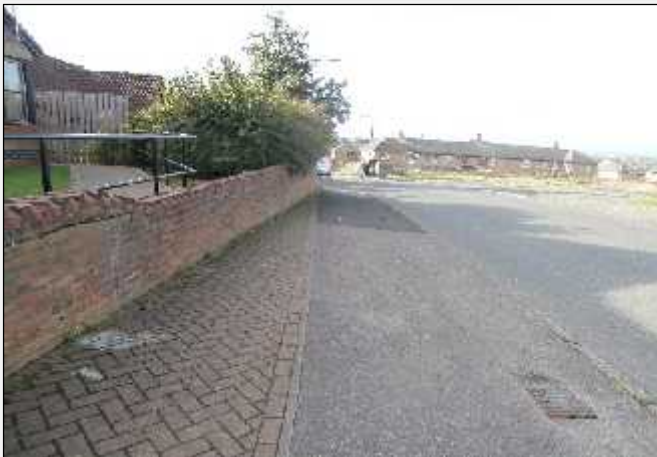
| OBSERVATION: | <div>A) Footpath surface course is showing signs of wear.</div> <div>B) Re-instatements present within the footpath appear to be in a good condition.</div> <div>C) 2No utility boxes present within the footpath, showing no defects.</div> <div>D) Numerous damaged kerbs along the footpath.</div> | | | | | | | | | |
| REMEDIAL WORKS RATING: | 1 | 2 | 3 | 4 | 5 | 6▼ | 7 | 8 | 9 | 10 |

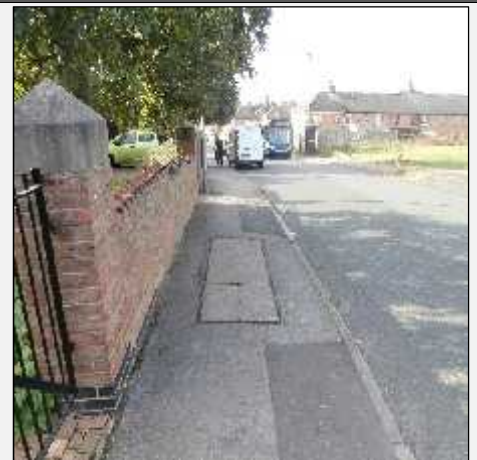
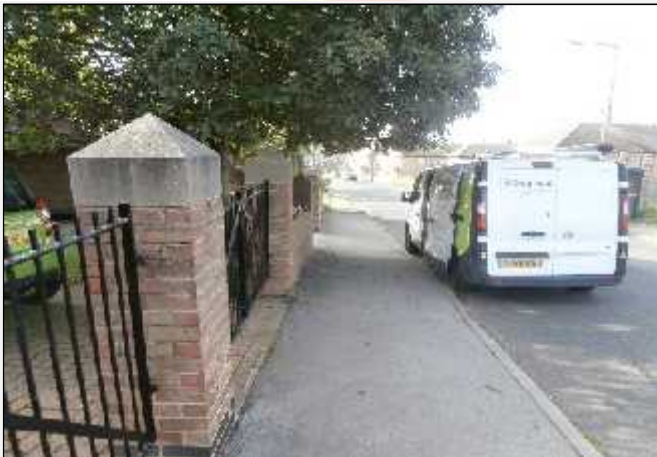
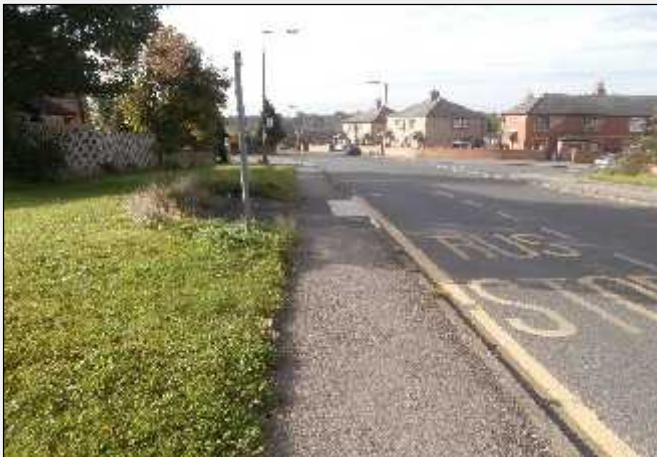
| OBSERVATION: | A) Footpath surface course is showing signs of wear.<br>B) Reinstatements present within the footpath appear to be in a good condition.<br>C) 3Ne utility boxes present within the footpath, showing no defects.<br>D) Weed growth present along the footpath. | | | | | | | | | |
| REMEDIAL WORKS RATING: | 1 | 2 | 3 | 4 | 5 | 6▼ | 7 | 8 | 9 | 10 |

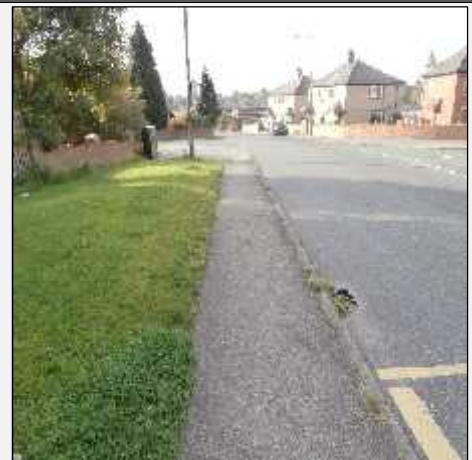
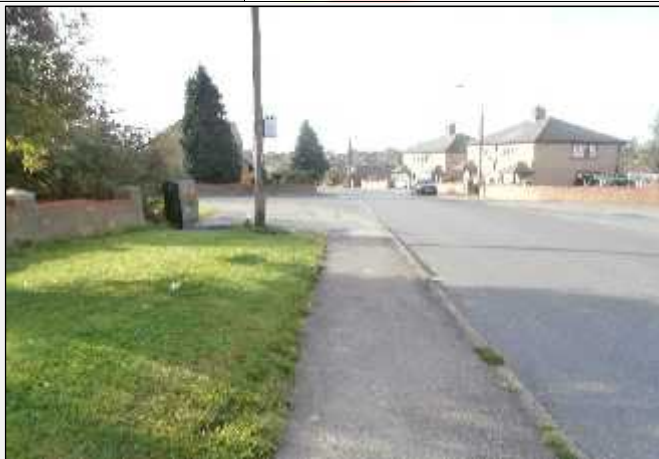
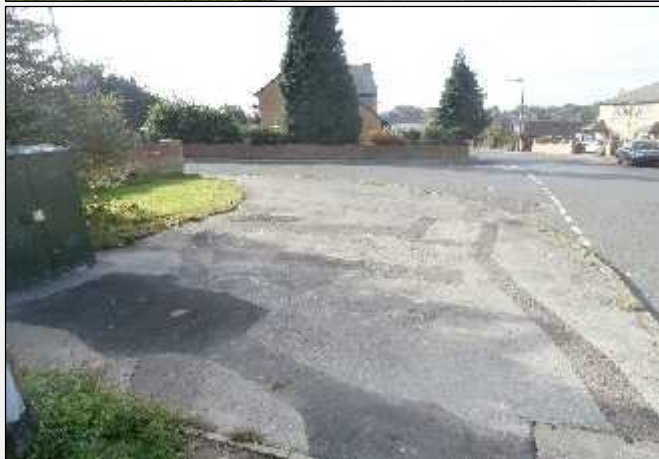
| OBSERVATION: | A) Footpath surface course is showing signs of wear.<br>B) Re-instatements present within the footpath are showing signs of failure.<br>C) Weed growth present along the footpath. | | | | | | | | | |
| REMEDIAL WORKS RATING: | 1 | 2 | 3 | 4 | 5 | 6▼ | 7 | 8 | 9 | 10 |

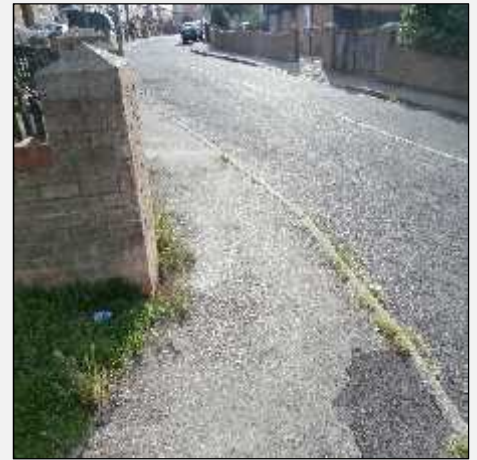
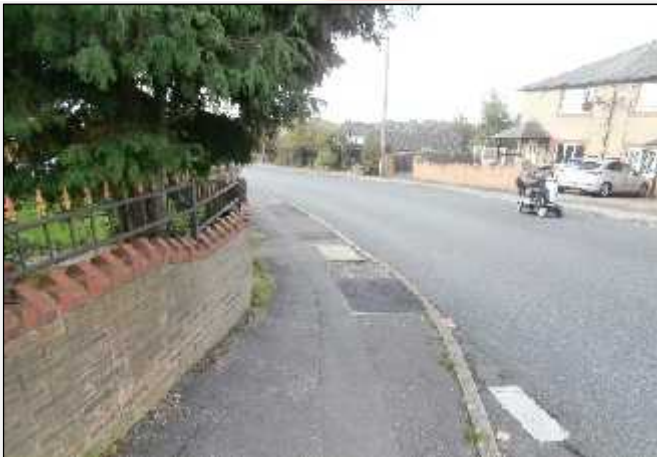
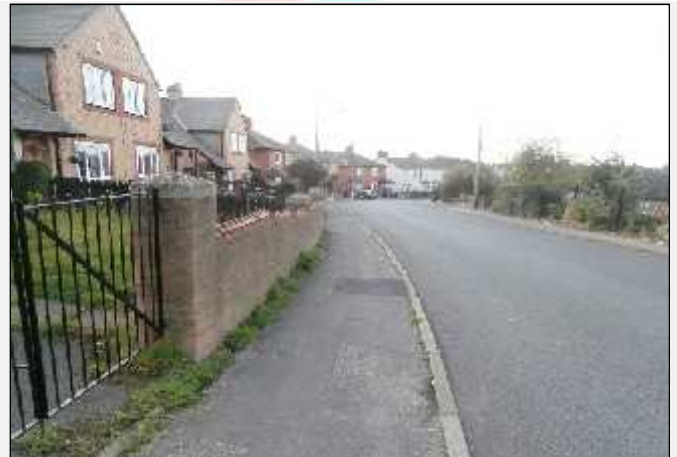
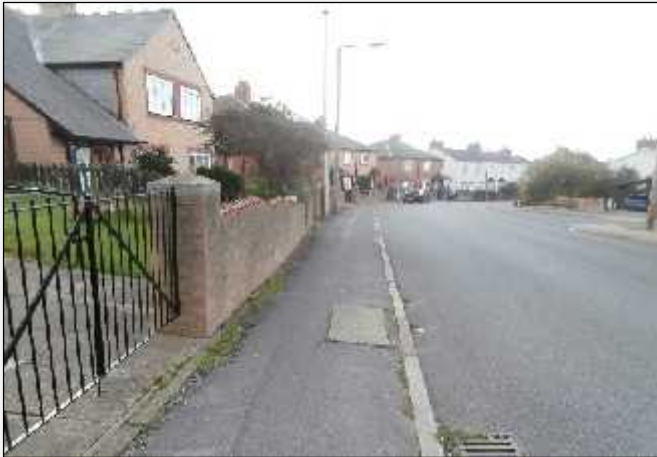
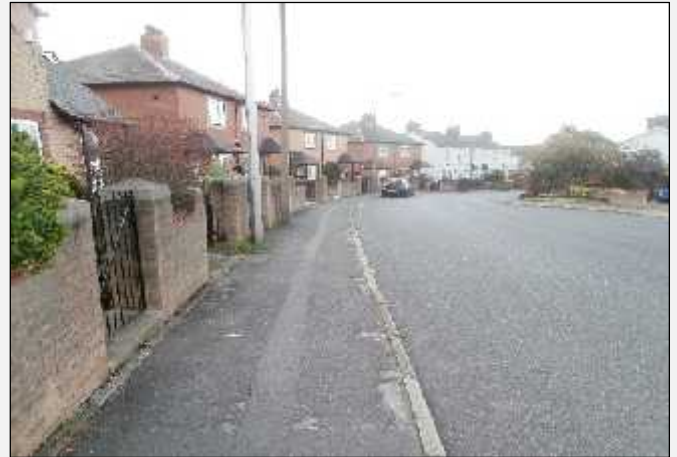
| OBSERVATION: | <div>A) Footpath surface course is showing signs of wear / cracking.</div> <div>B) Reinstatements present within the footpath are showing signs of failure.</div> <div>C) Weed growth present along the footpath.</div> <div>D) Numerous damaged kerbs along the footpath.</div> | | | | | | | | | |
| REMEDIAL WORKS RATING: | 1 | 2 | 3 | 4 | 5 | 6 | 7▼ | 8 | 9 | 10 |

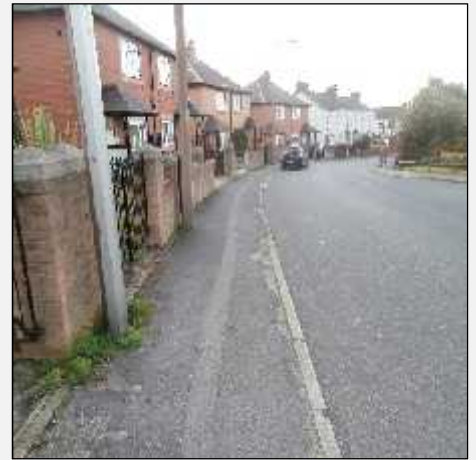
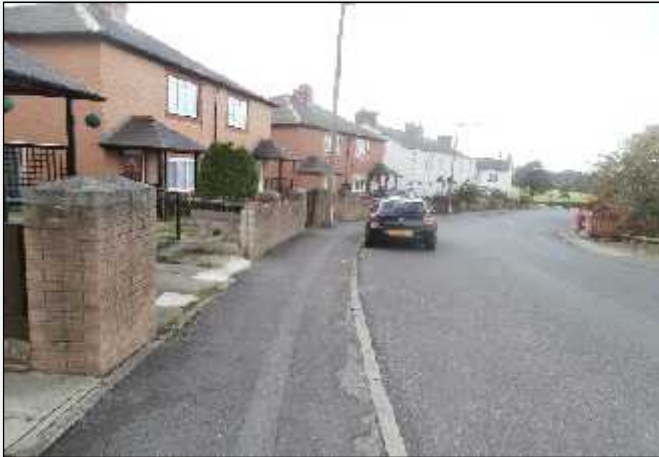
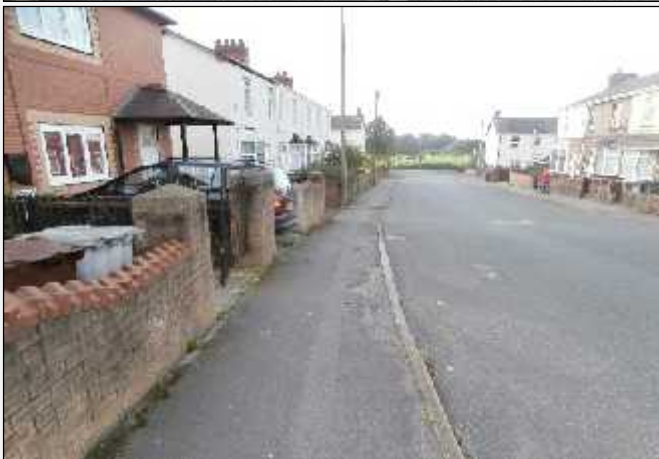
| OBSERVATION: | A) Footpath surface course is showing signs of wear / cracking.<br>B) Weed growth present along the footpath.<br>C) Numerous damaged kerbs along the footpath. | | | | | | | | | |
| REMEDIAL WORKS RATING: | 1 | 2 | 3 | 4 | 5 | 6 | 7▼ | 8 | 9 | 10 |

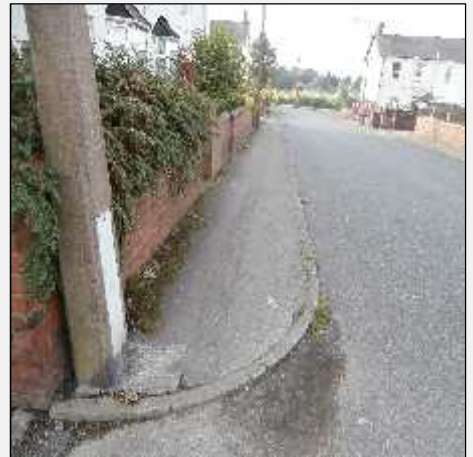
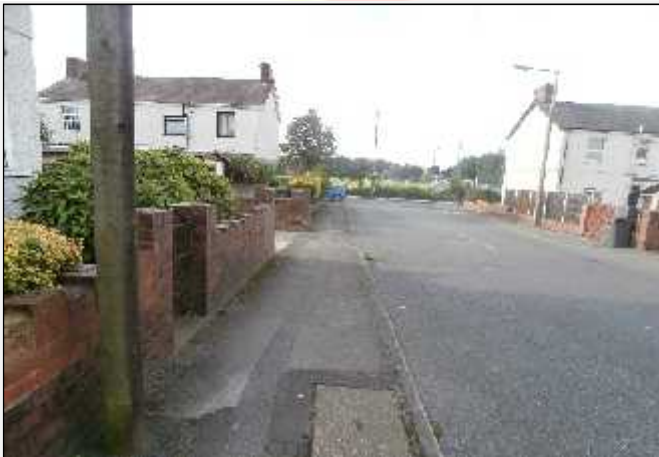
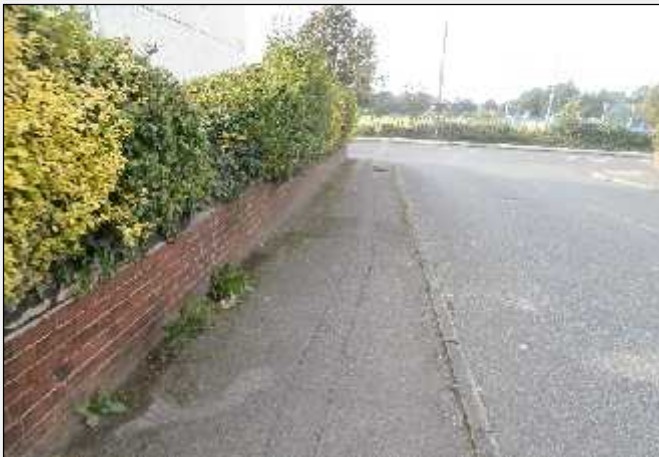
| OBSERVATION: | A) Footpath surface course is showing signs of wear / cracking.<br>B) Weed growth present along the footpath.<br>C) Numerous damaged kerbs along the footpath. | | | | | | | | | |
| REMEDIAL WORKS RATING: | 1 | 2 | 3 | 4 | 5 | 6 | 7 ▼ | 8 | 9 | 10 |

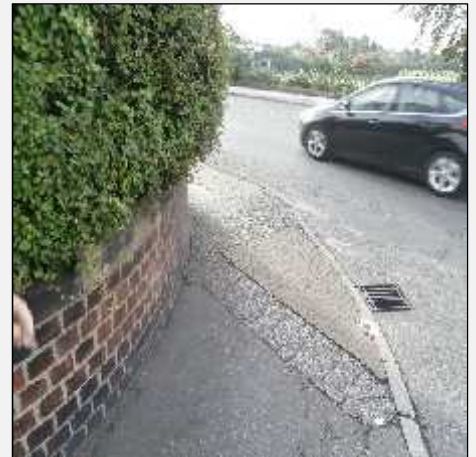
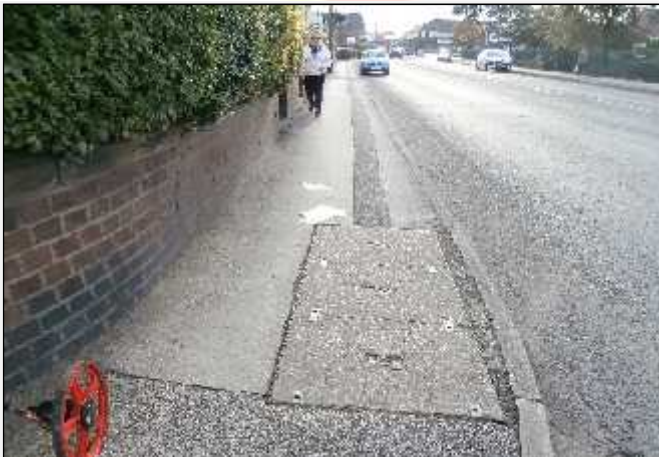
| OBSERVATION: | A) Footpath surface course is showing signs of wear.<br>B) Numerous damaged kerbs along the footpath. | | | | | | | | | |
| REMEDIAL WORKS RATING: | 1 | 2 | 3 | 4 | 5▼ | 6 | 7 | 8 | 9 | 10 |

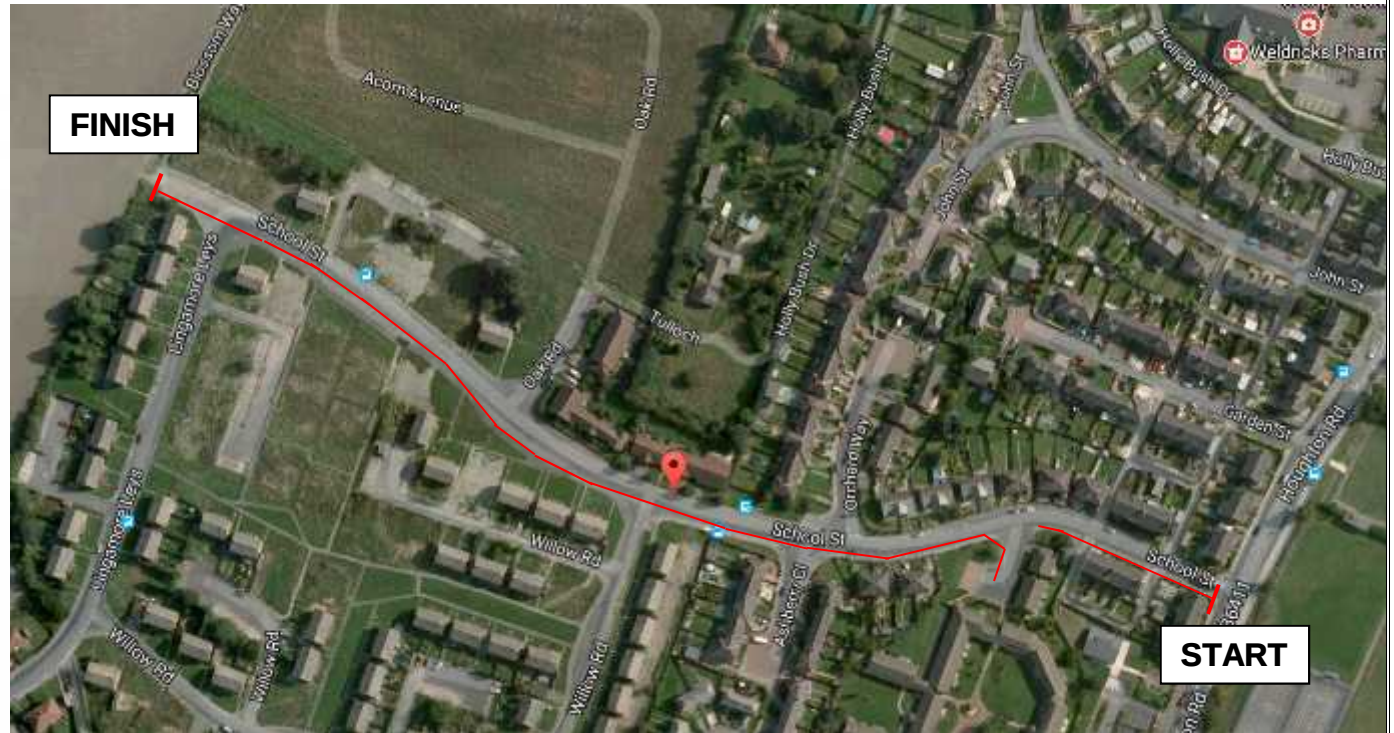
#### FOOTPATH CONDITION SURVEY EXTENTS

Southern section of footpath survey leads South (see plan below).

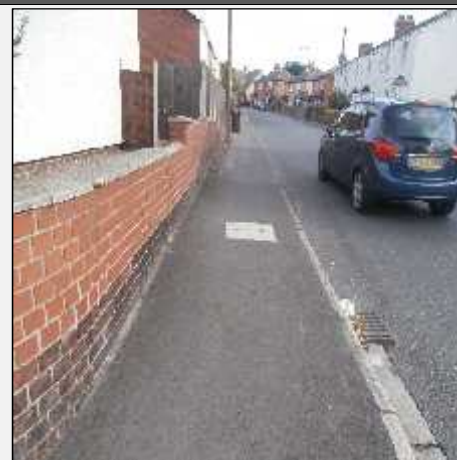
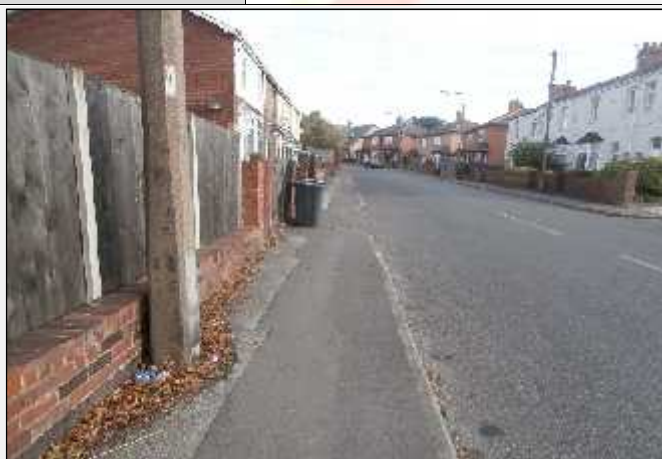
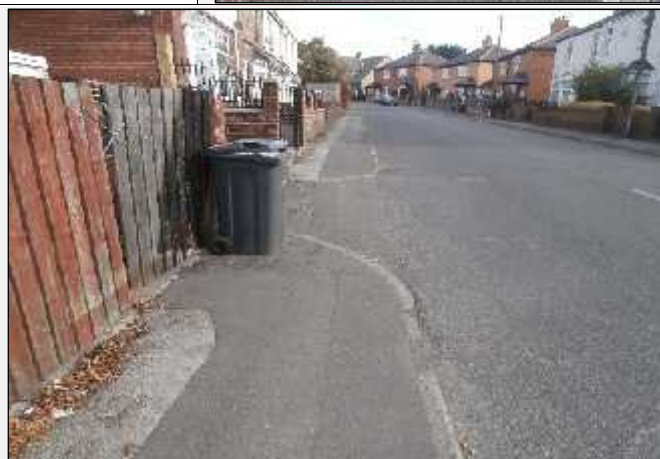
| OBSERVATION: | A) Footpath surface course is showing signs of wear.<br>B) Numerous damaged kerbs along the footpath. | | | | | | | | | |
| REMEDIAL WORKS RATING: | 1 | 2 | 3 | 4 | 5 | 6▼ | 7 | 8 | 9 | 10 |

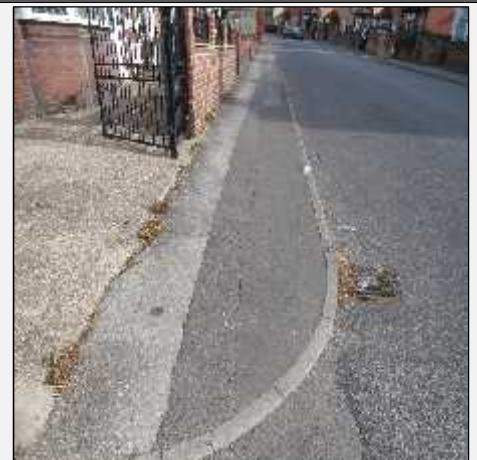
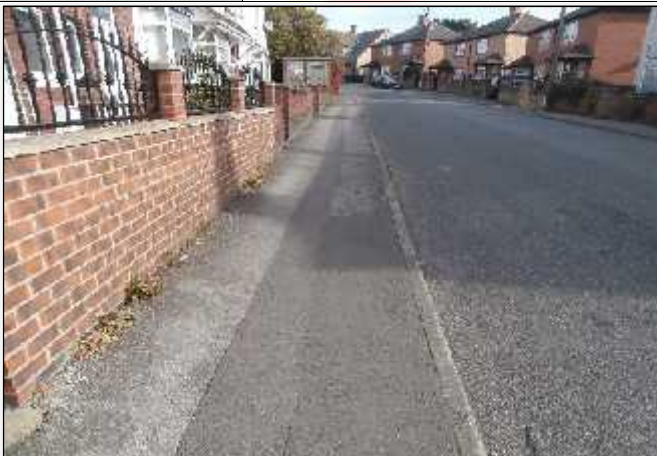
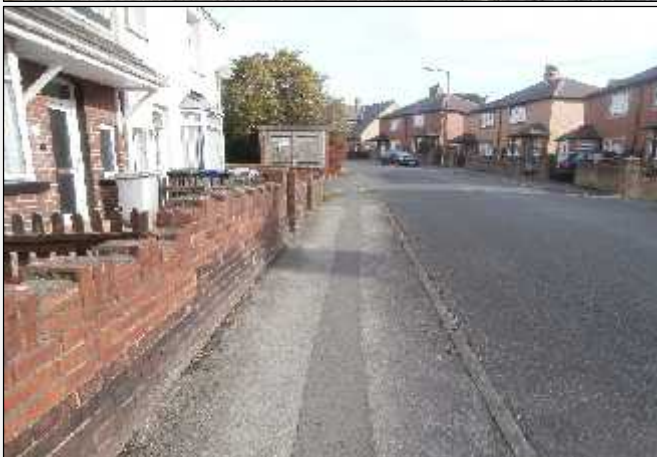
| OBSERVATION: | A) Footpath surface course is showing signs of wear / cracking.<br>B) Numerous damaged kerbs along the footpath. | | | | | | | | | |
| REMEDIAL WORKS RATING: | 1 | 2 | 3 | 4 | 5 | 6▼ | 7 | 8 | 9 | 10 |

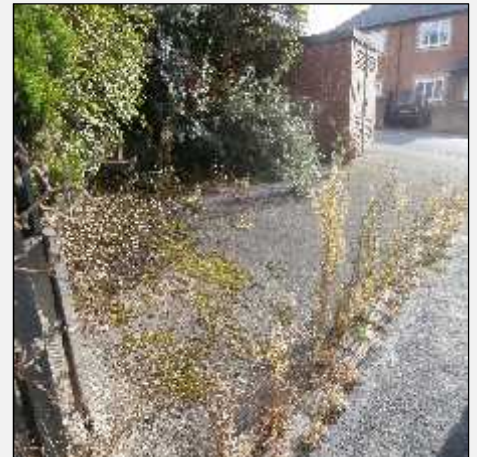
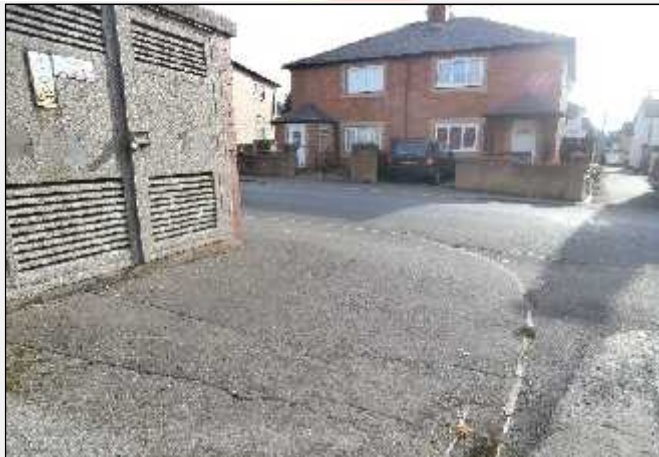
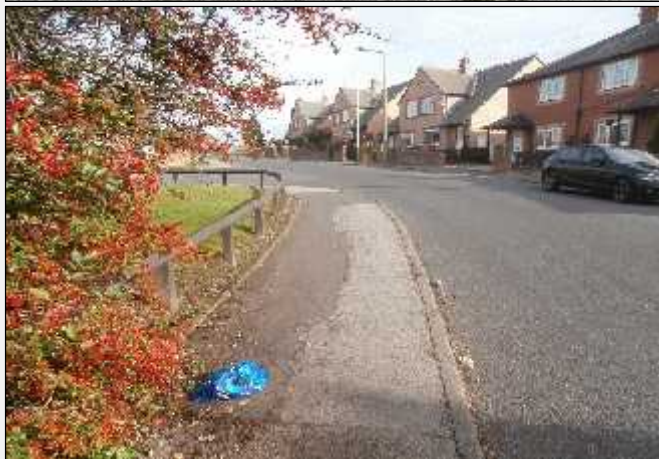
| OBSERVATION: | A) Footpath surface course is showing signs of wear / cracking.<br>B) Weed / vegetation growth encroaching onto the footpath.<br>C) Numerous damaged kerbs along the footpath. | | | | | | | | | |
| REMEDIAL WORKS RATING: | 1 | 2 | 3 | 4 | 5 | 6 | 7 ▼ | 8 | 9 | 10 |

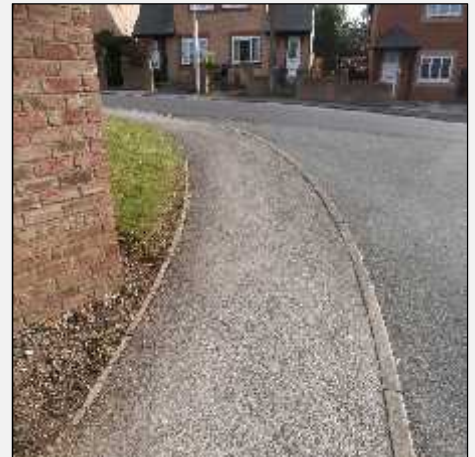
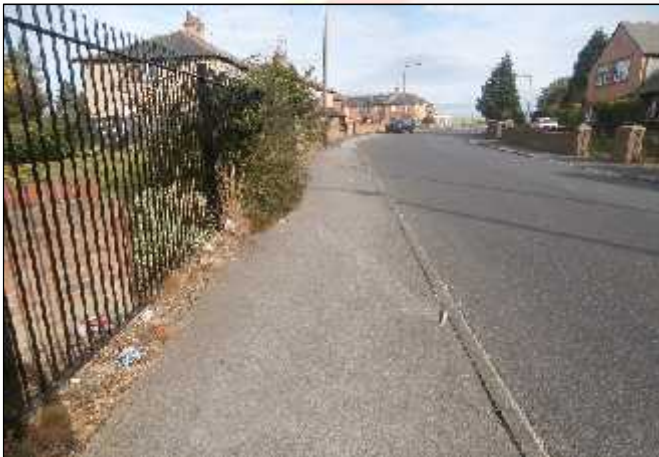
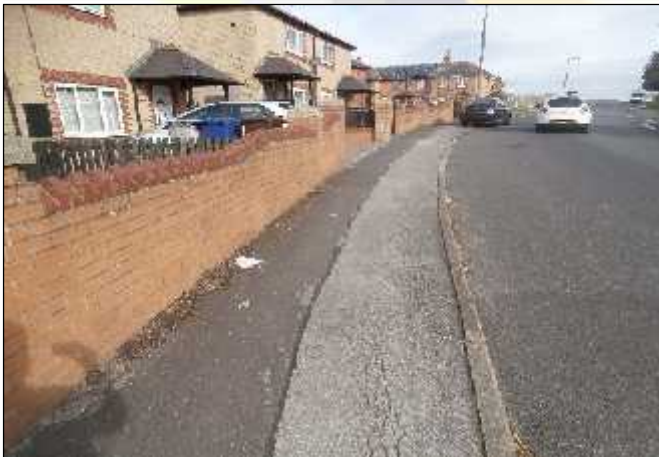
| OBSERVATION: | A) Footpath surface course is showing signs of wear / cracking.<br>B) Weed / vegetation growth encroaching onto the footpath.<br>C) Re-instatement present along the footpath is showing signs of failure. | | | | | | | | | |
| REMEDIAL WORKS RATING: | 1 | 2 | 3 | 4 | 5 | 6▼ | 7 | 8 | 9 | 10 |

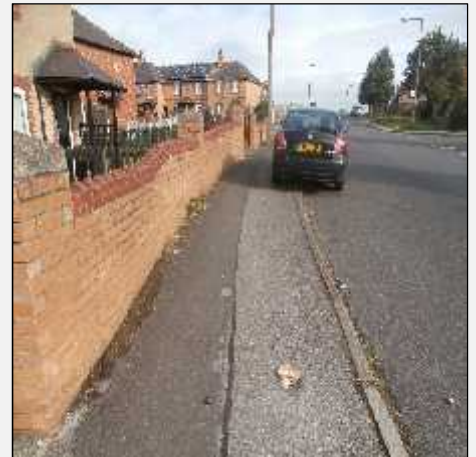
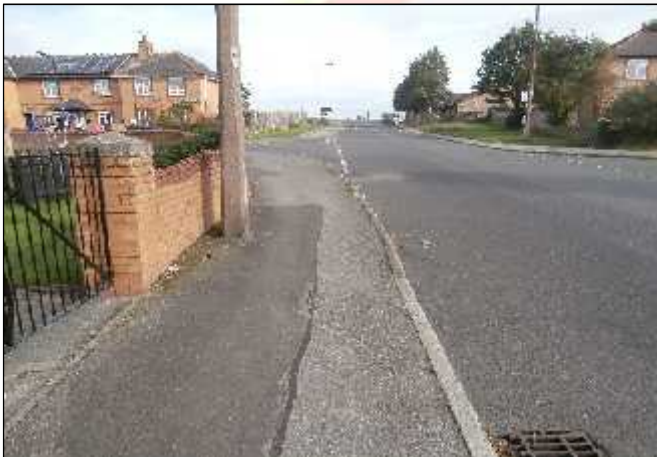
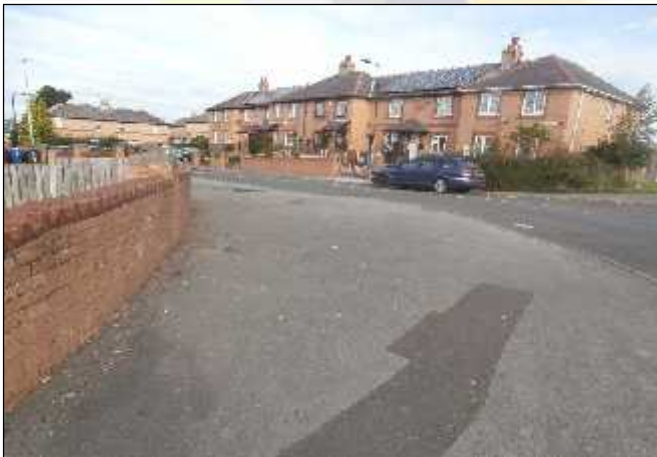
| OBSERVATION: | A) Footpath surface course is showing signs of wear.<br>B) Re-instatements present within the footpath are showing signs of failure.<br>C) Weed growth present along the footpath. | | | | | | | | | |
| REMEDIAL WORKS RATING: | 1 | 2 | 3 | 4 | 5 | 6▼ | 7 | 8 | 9 | 10 |

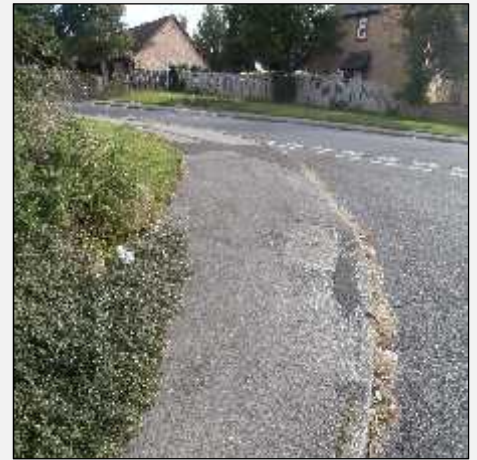
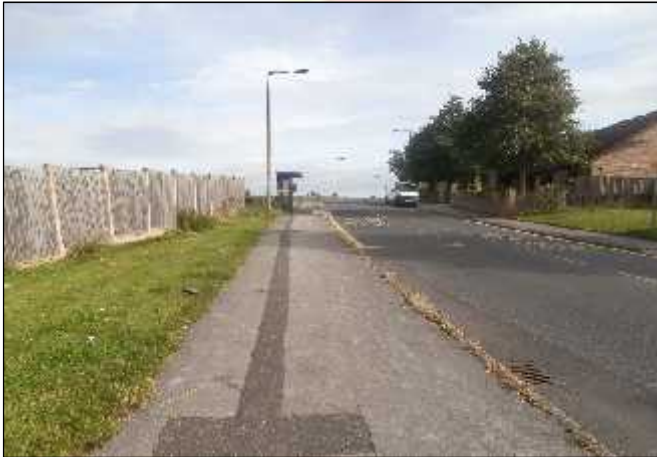
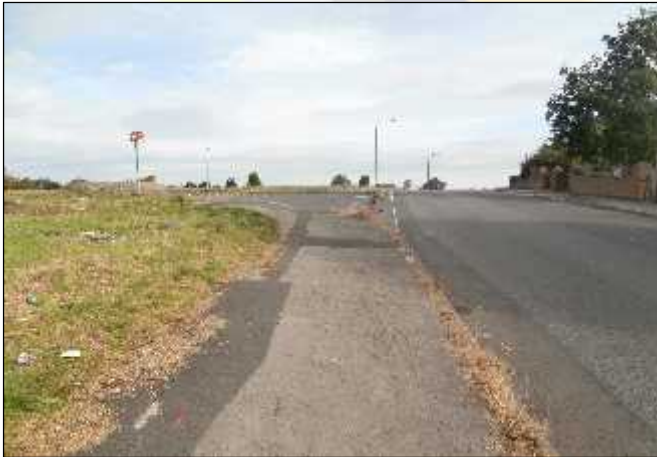
| OBSERVATION: | A) Footpath surface course is showing signs of wear / cracking.<br>B) Re-instatements present within the footpath are showing signs of failure.<br>C) Weed / vegetation growth encroaching onto the footpath.<br>D) Numerous damaged kerbs along the footpath. | | | | | | | | | |
| REMEDIAL WORKS RATING: | 1 | 2 | 3 | 4 | 5 | 6 | 7▼ | 8 | 9 | 10 |

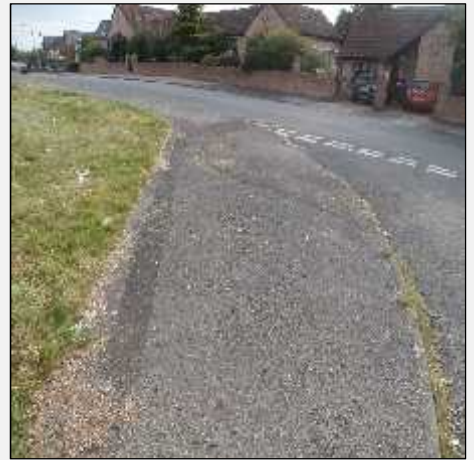
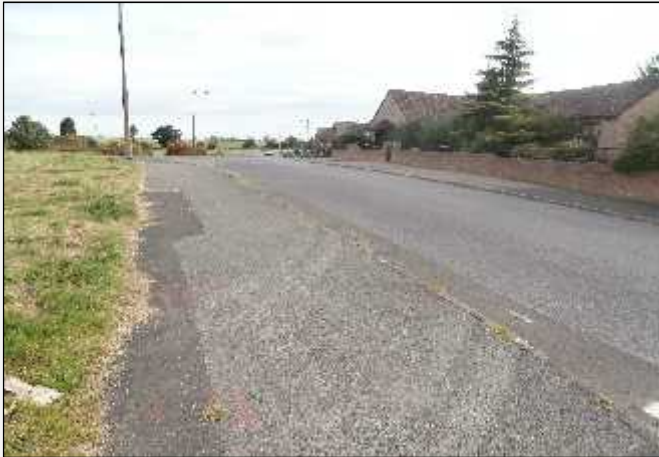
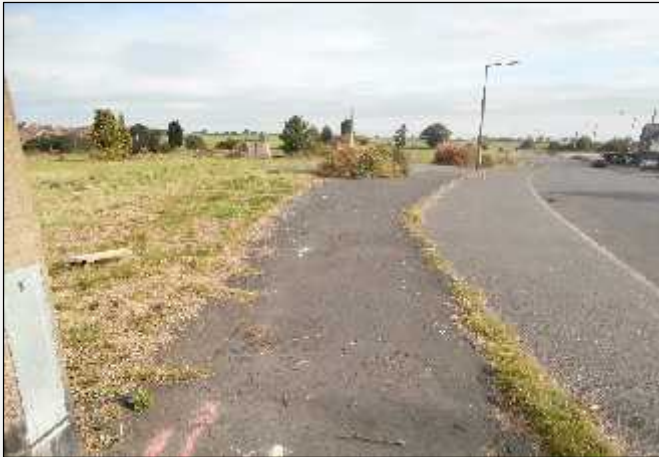
| OBSERVATION: | A) Footpath surface course is showing signs of wear / cracking.<br>B) Re-instatements present within the footpath are showing signs of failure.<br>C) Weed / vegetation growth encroaching onto the footpath. | | | | | | | | | |
| REMEDIAL WORKS RATING: | 1 | 2 | 3 | 4 | 5 | 6 | 7▼ | 8 | 9 | 10 |

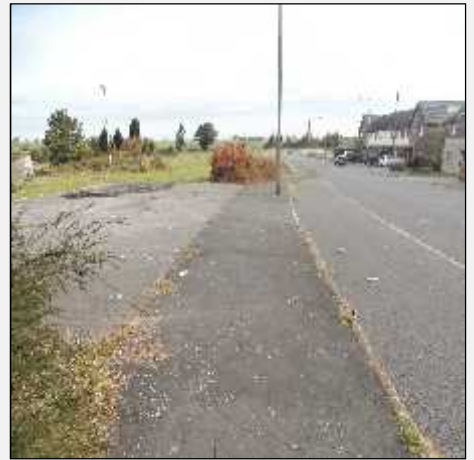
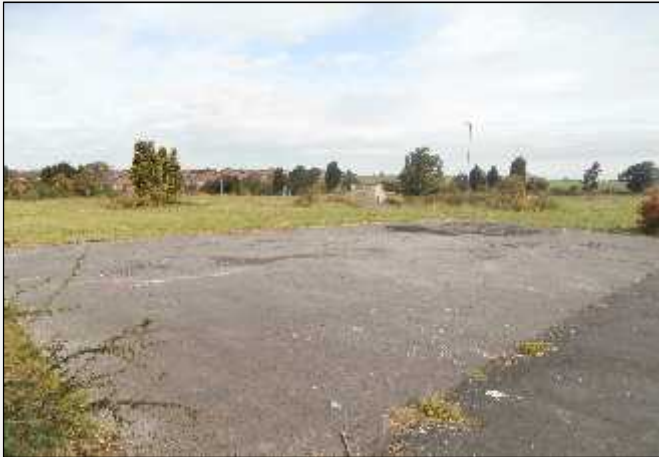
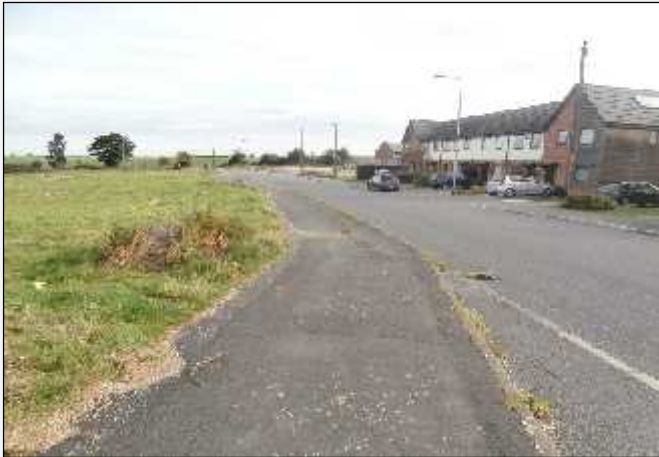
| OBSERVATION: | A) Footpath surface course is showing signs of wear / cracking.<br>B) Re-instatements present within the footpath are showing signs of failure.<br>C) Weed / vegetation growth encroaching onto the footpath. | | | | | | | | | |
| REMEDIAL WORKS RATING: | 1 | 2 | 3 | 4 | 5 | 6 | 7 ▼ | 8 | 9 | 10 |

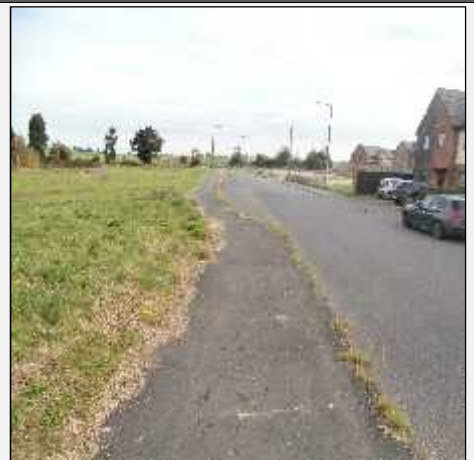
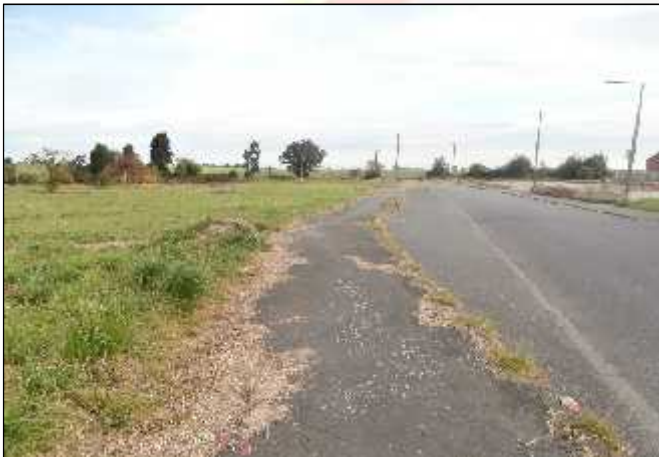
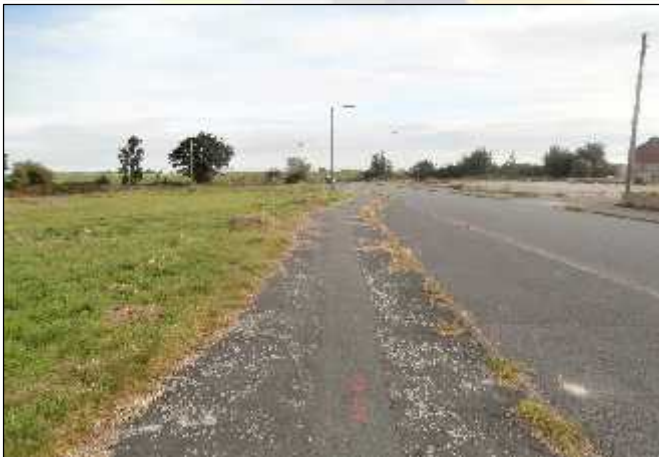
| OBSERVATION: | A) Footpath surface course is showing signs of wear / cracking.<br>B) Re-instatement present within the footpath is showing signs of failure.<br>C) Weed growth present along the footpath. | | | | | | | | | |
| REMEDIAL WORKS RATING: | 1 | 2 | 3 | 4 | 5 | 6 | 7▼ | 8 | 9 | 10 |

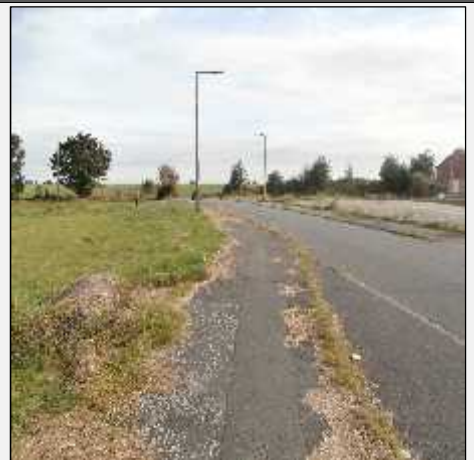
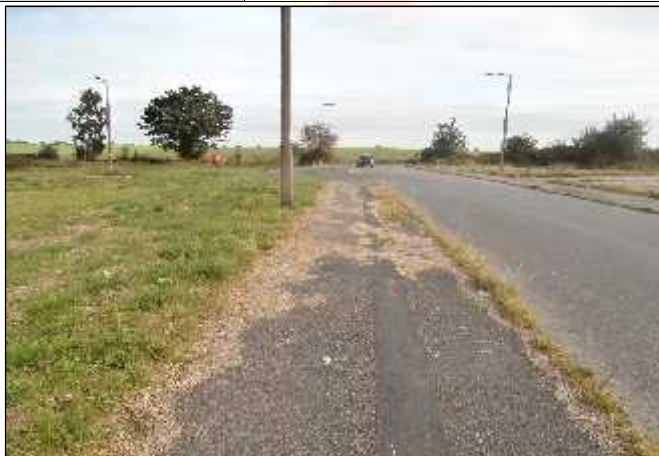
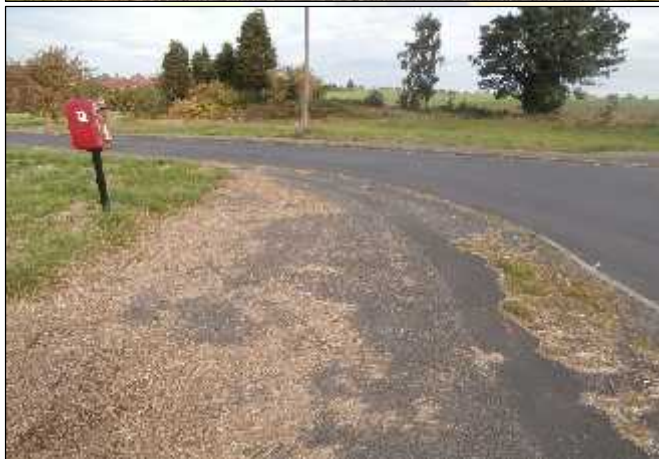
| OBSERVATION: | A) Footpath surface course is showing signs of wear / cracking.<br>B) Re-instatement present within the footpath is showing signs of failure.<br>C) Weed growth present along the footpath. | | | | | | | | | |
| REMEDIAL WORKS RATING: | 1 | 2 | 3 | 4 | 5 | 6 | 7▼ | 8 | 9 | 10 |

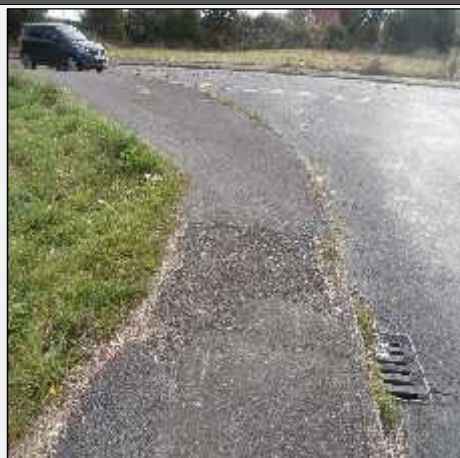
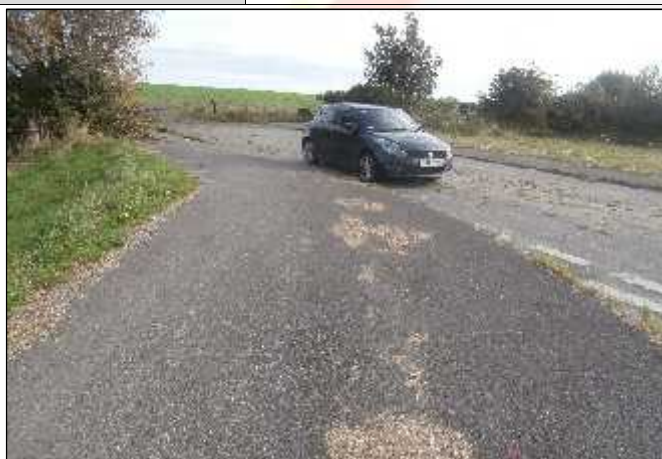
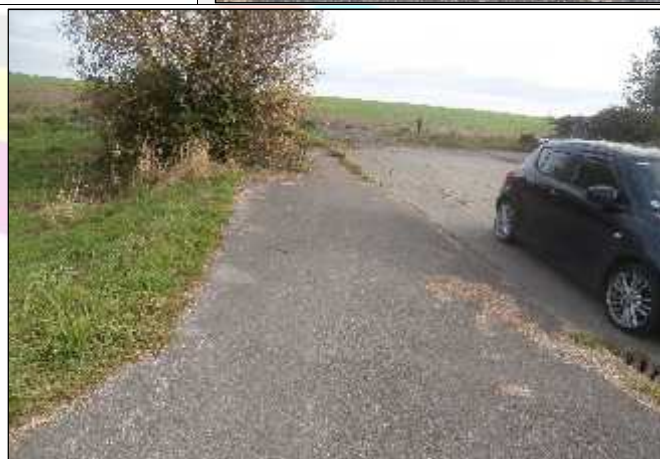
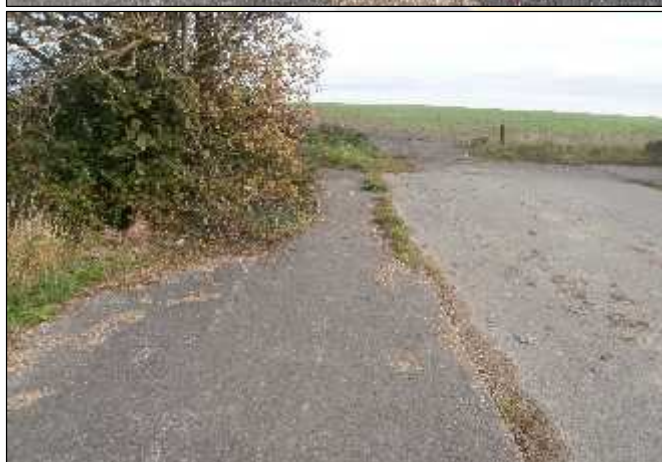
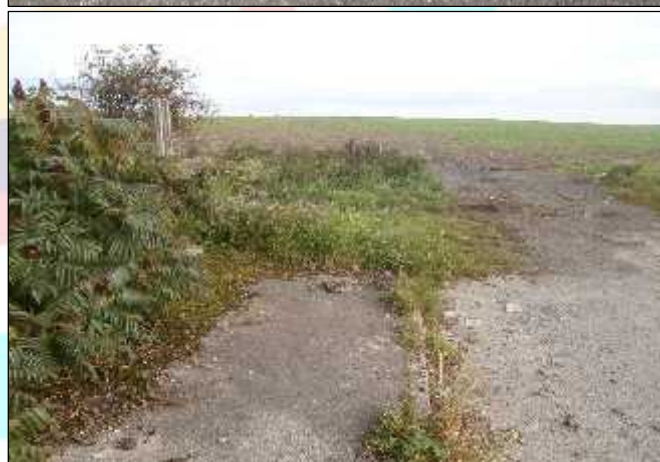
## ITEM 21

| LOCATION: | Southern section of footpath heading North, 0-30m. | | | | | | | | | | |
| OBSERVATION: | A) Footpath surface course is showing signs of wear / cracking.<br>B) Weed growth present along the footpath. | | | | | | | | | | |
