**THURNSCOE  
ROTHERHAM  
HIGHWAY CONDITION SURVEY**

| <b>On Behalf Of:</b> | Keepmoat Homes |
| <b>Inspection Date:</b> | 20 <sup>th</sup> September 2017 |
| <b>JLES Project Reference:</b> | N/227/Thurnscoe/Cs |

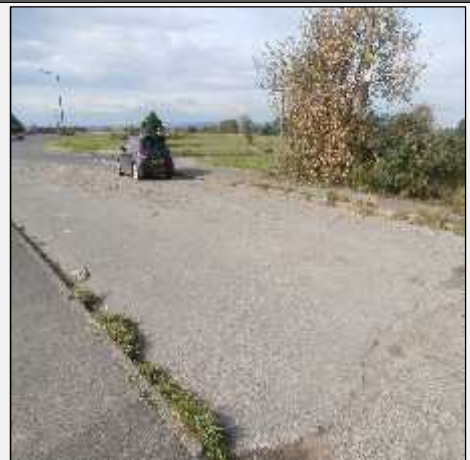
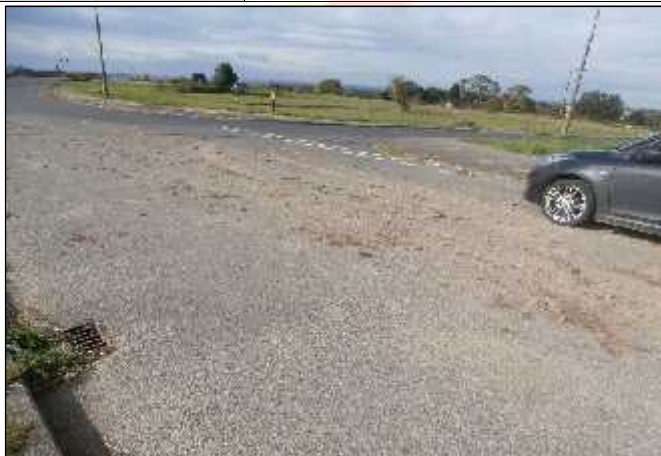
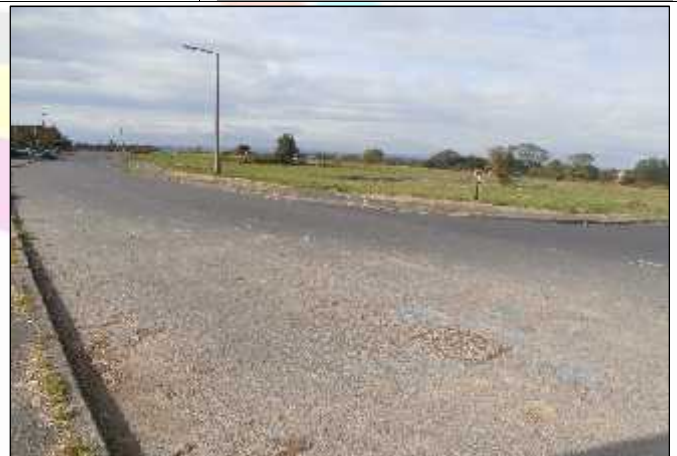
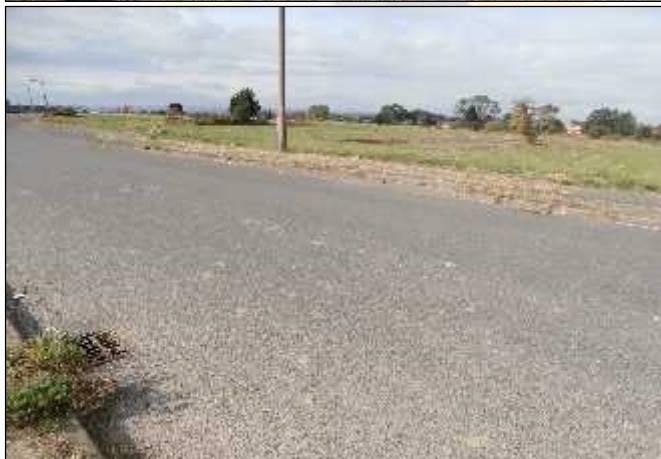
| OBSERVATION: | A) Carriageway surface course is showing signs of wear.<br>B) 1N <sub>2</sub> sunken gully present within the carriageway. | | | | | | | | | |
| REMEDIAL WORKS RATING: | 1 | 2 | 3 | 4 | 5 | 6 | 7▼ | 8 | 9 | 10 |

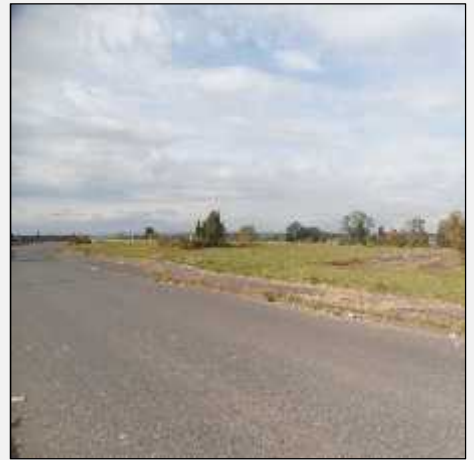
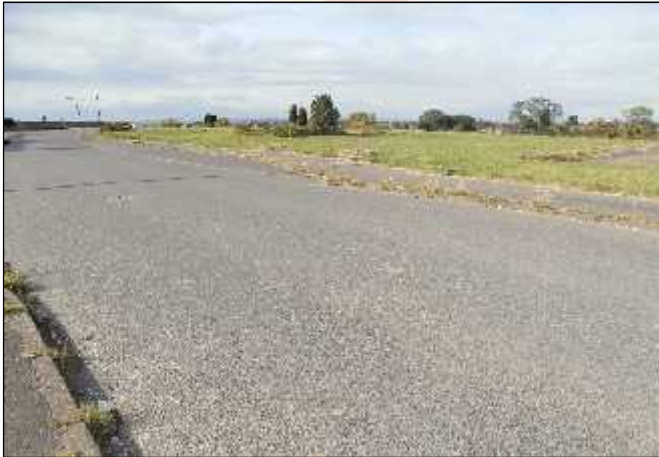
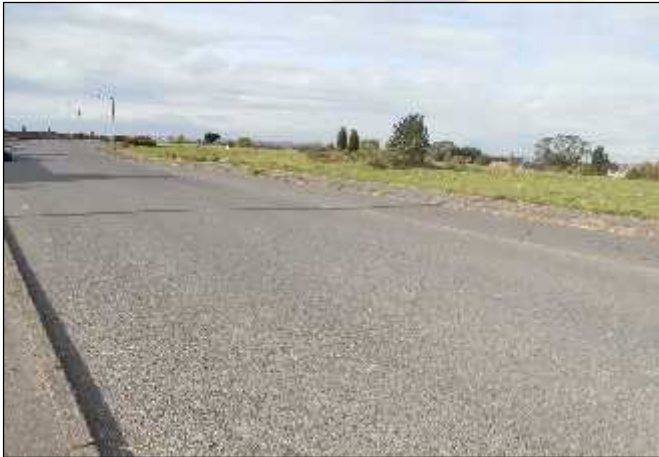
| OBSERVATION: | Carriageway surface course is showing signs of wear. | | | | | | | | | |
| REMEDIAL WORKS RATING: | 1 | 2 | 3 | 4 | 5 | 6▼ | 7 | 8 | 9 | 10 |

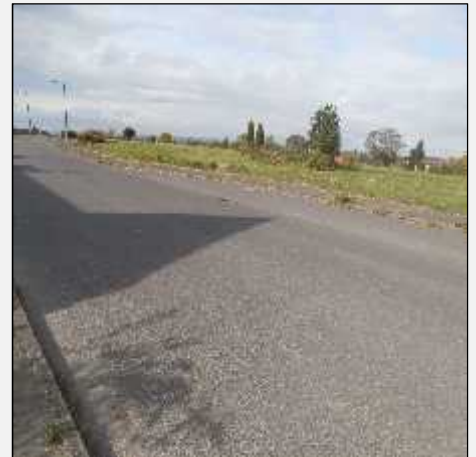
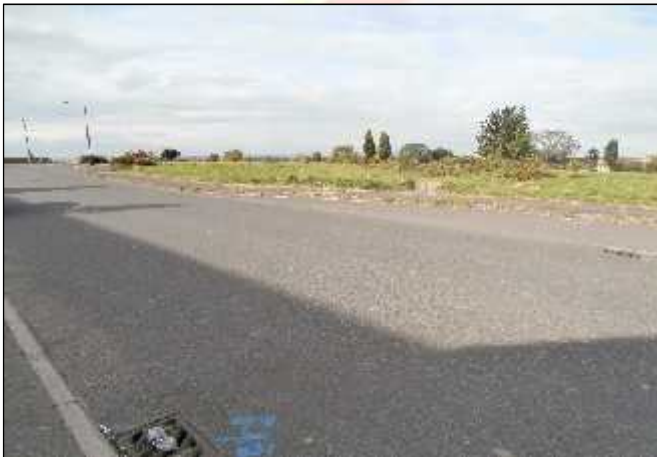
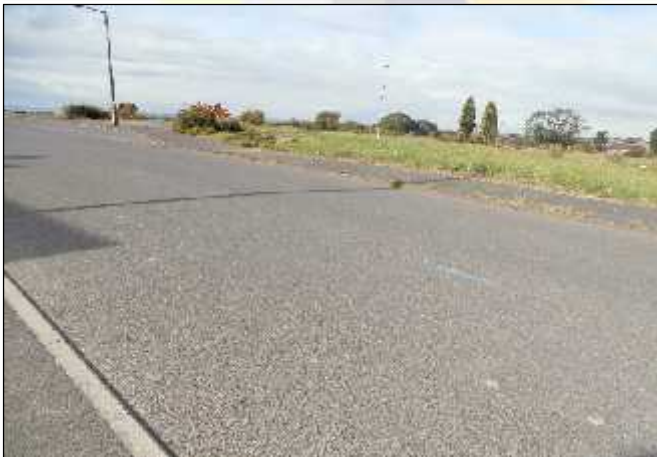
| OBSERVATION: | Carriageway surface course is showing signs of wear. | | | | | | | | | |
| REMEDIAL WORKS RATING: | 1 | 2 | 3 | 4 | 5 | 6▼ | 7 | 8 | 9 | 10 |

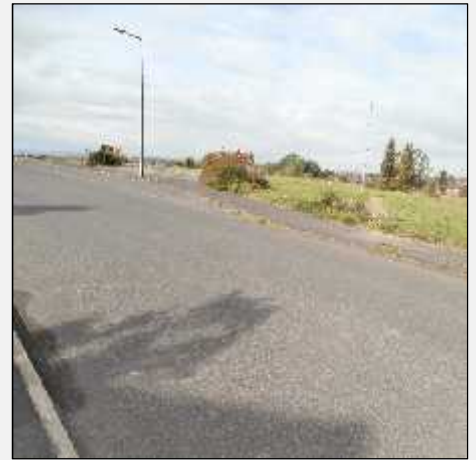
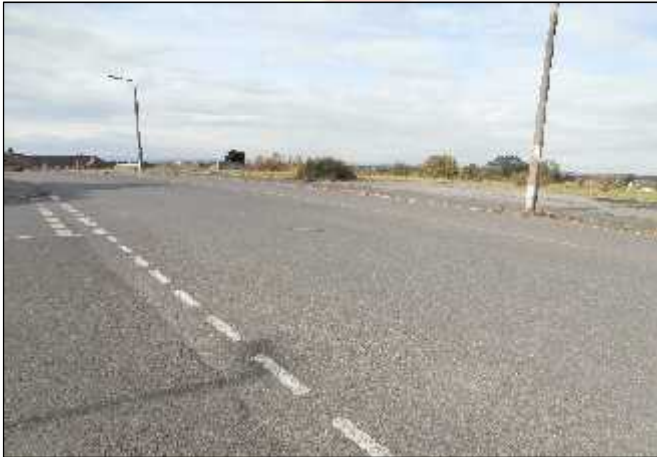
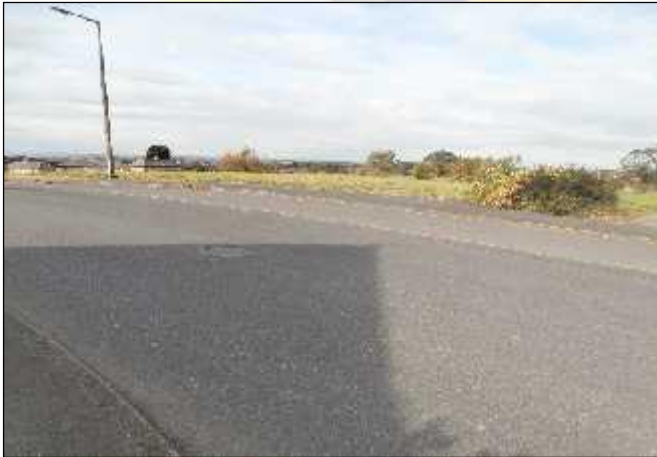
| OBSERVATION: | A) Carriageway surface course is showing signs of wear.<br>B) Road markings are beginning to wear / fade. | | | | | | | | | |
| REMEDIAL WORKS RATING: | 1 | 2 | 3 | 4 | 5 | 6 ▼ | 7 | 8 | 9 | 10 |

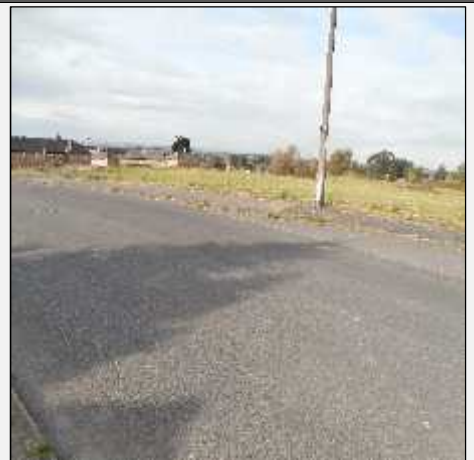
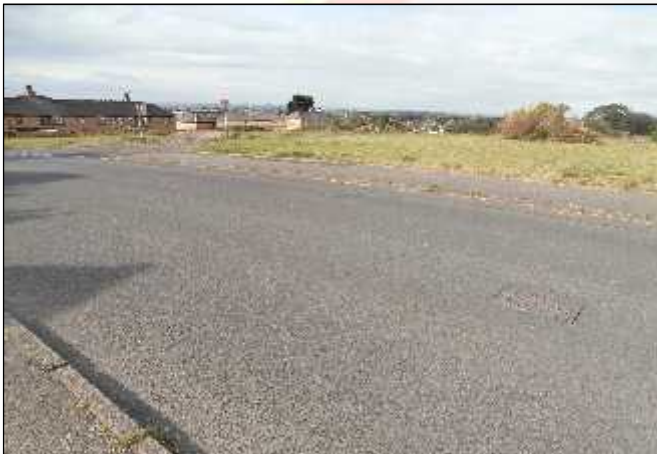
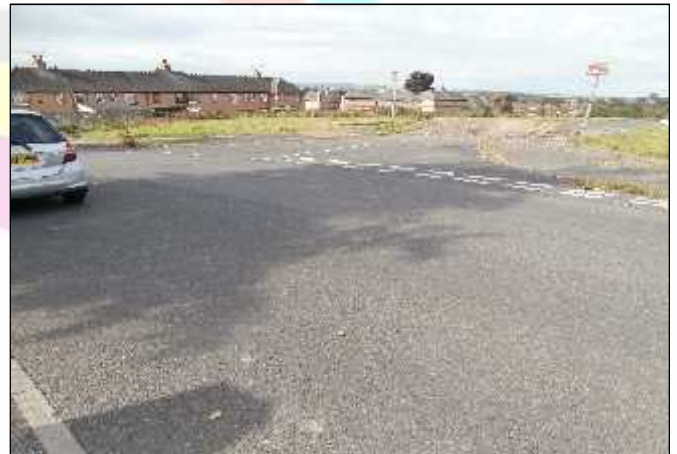
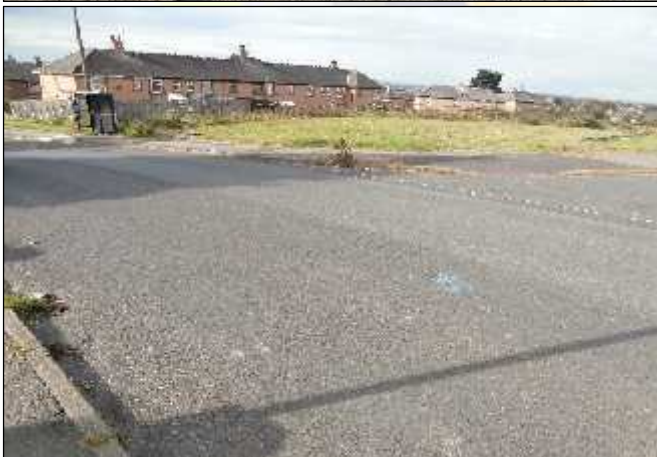
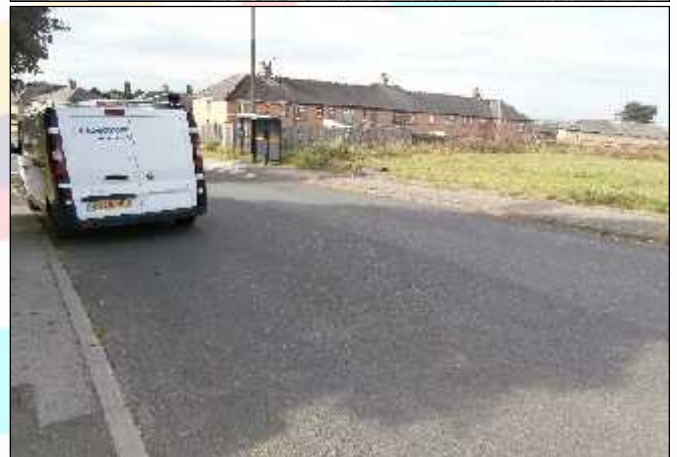
| OBSERVATION: | A) Carriageway surface course is showing signs of wear.<br>B) Road markings are in a good condition. | | | | | | | | | |
| REMEDIAL WORKS RATING: | 1 | 2 | 3 | 4 | 5 | 6▼ | 7 | 8 | 9 | 10 |

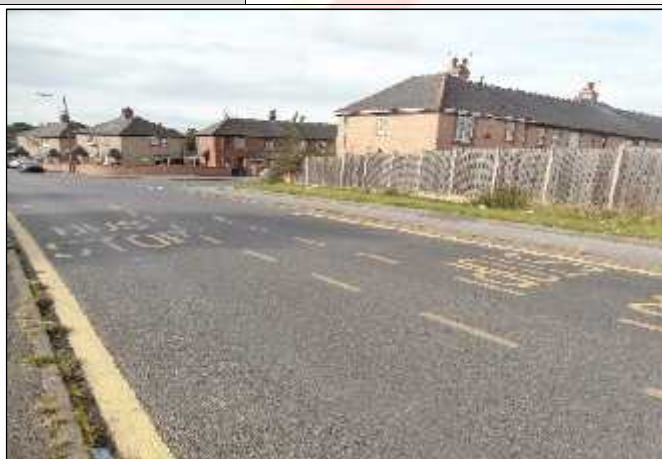
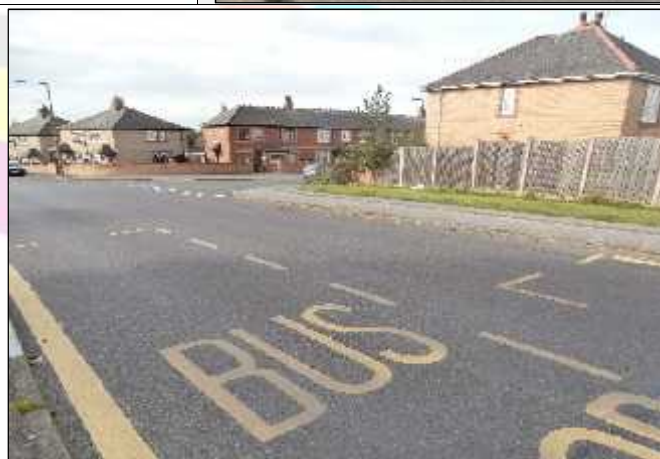
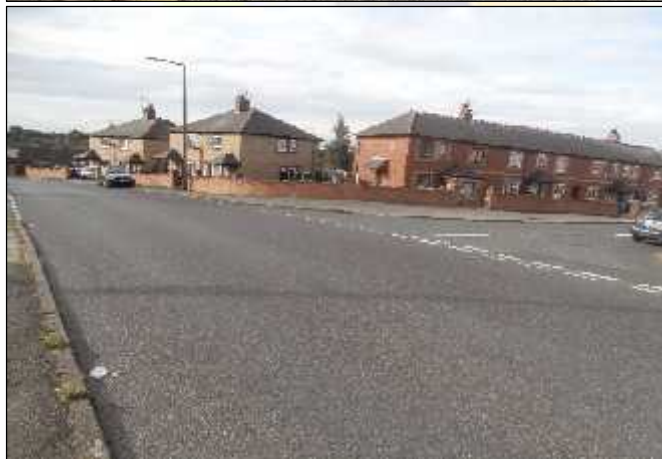
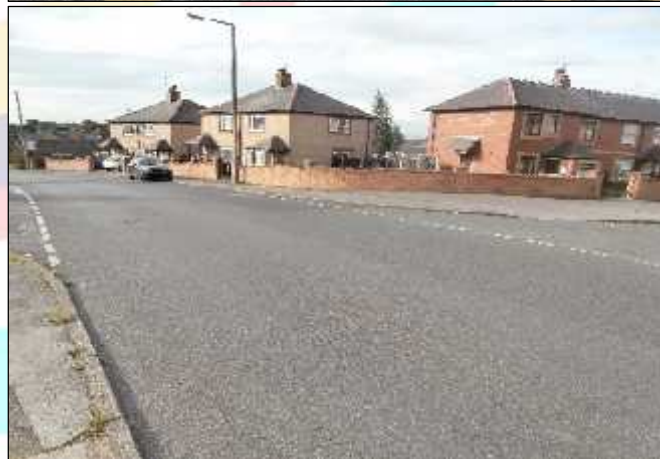
| OBSERVATION: | A) Carriageway surface course is showing signs of wear.<br>B) Road markings are in a good condition. | | | | | | | | | | |
| REMEDIAL WORKS RATING: | 1 | 2 | 3 | 4 | 5▼ | 6 | 7 | 8 | 9 | 10 | |

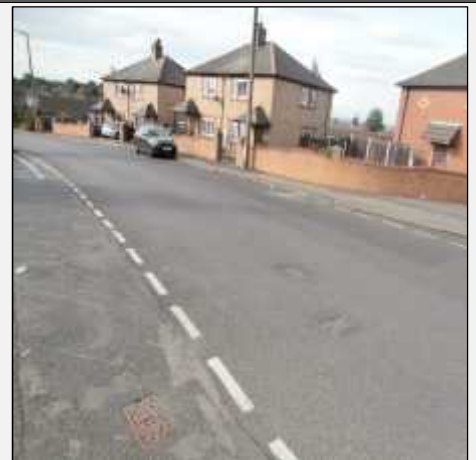
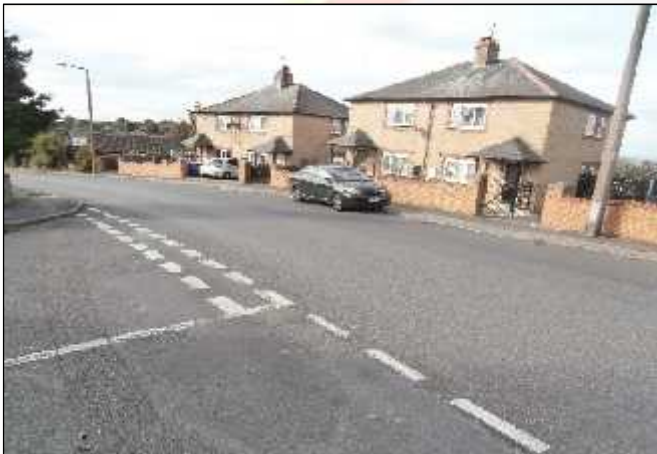
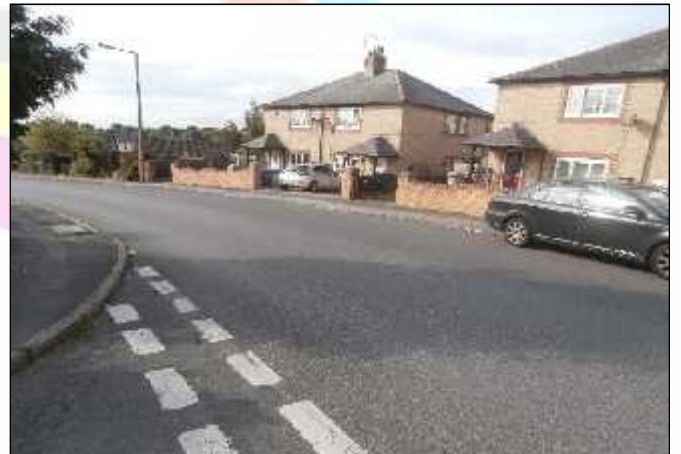
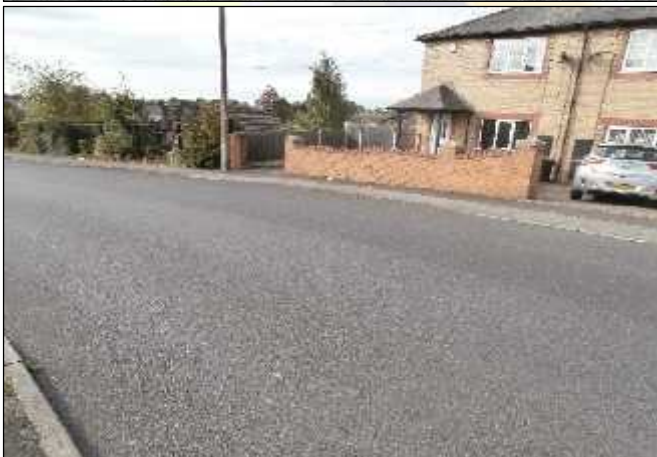
| OBSERVATION: | A) Carriageway surface course is showing signs of wear.<br>B) Road markings are in a good condition. | | | | | | | | | |
| REMEDIAL WORKS RATING: | 1 | 2 | 3 | 4 | 5 | 6▼ | 7 | 8 | 9 | 10 |

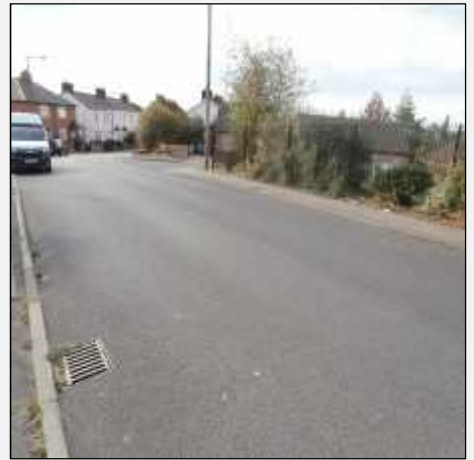
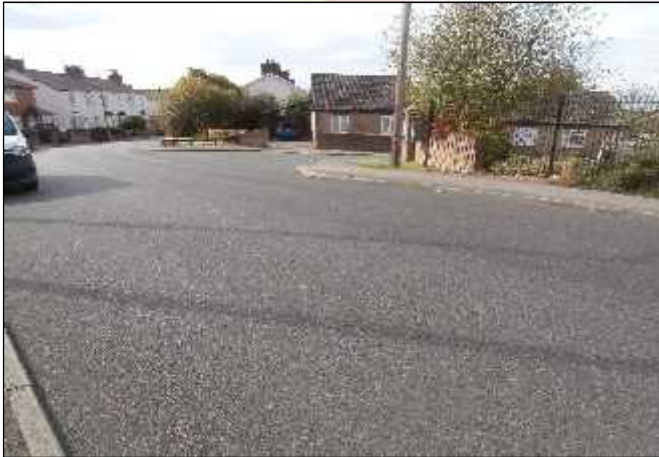
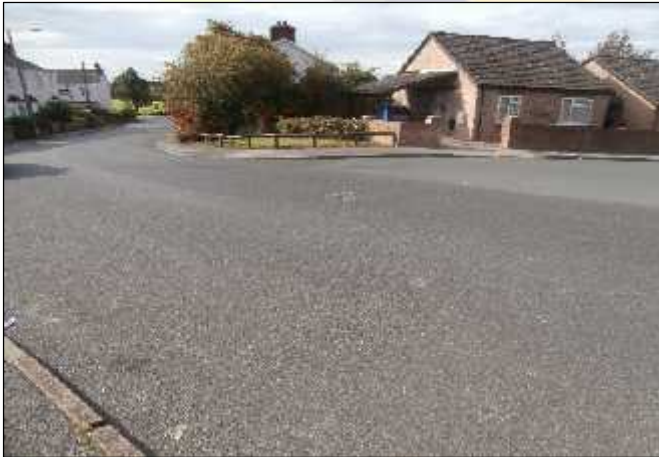
| OBSERVATION: | Carriageway surface course is showing signs of wear. | | | | | | | | | |
| REMEDIAL WORKS RATING: | 1 | 2 | 3 | 4 | 5 | 6▼ | 7 | 8 | 9 | 10 |

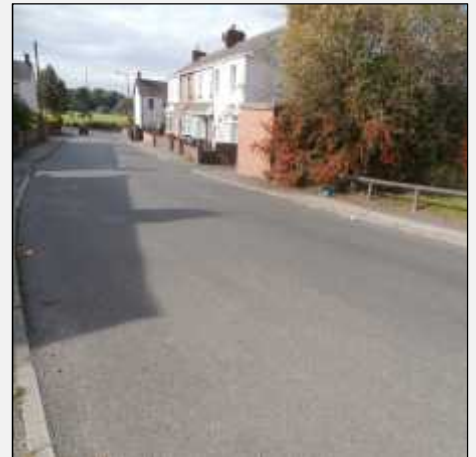
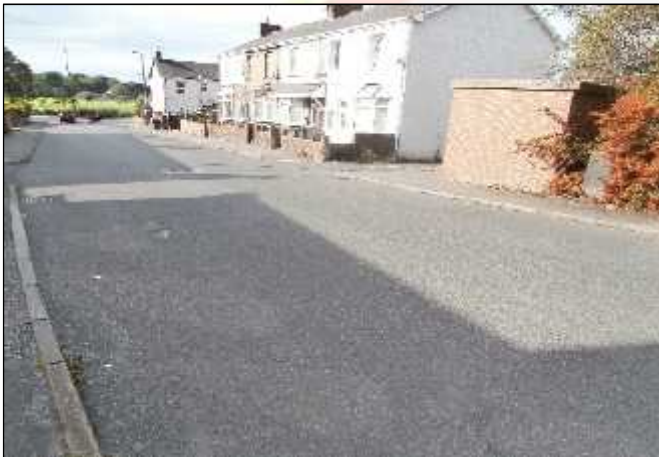
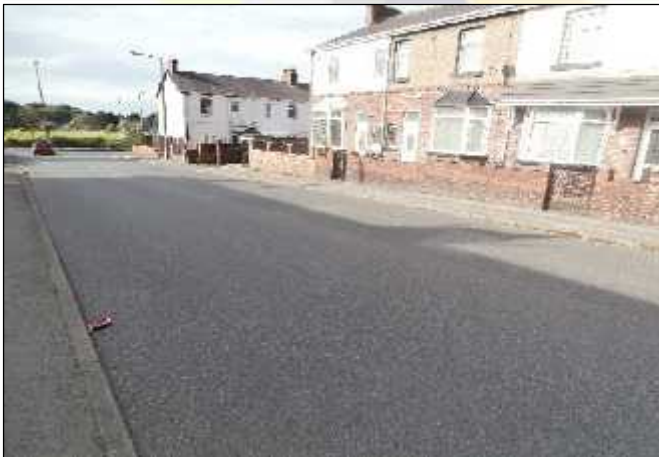
| OBSERVATION: | Carriageway surface course is showing signs of wear. | | | | | | | | | |
| REMEDIAL WORKS RATING: | 1 | 2 | 3 | 4 | 5 | 6▼ | 7 | 8 | 9 | 10 |

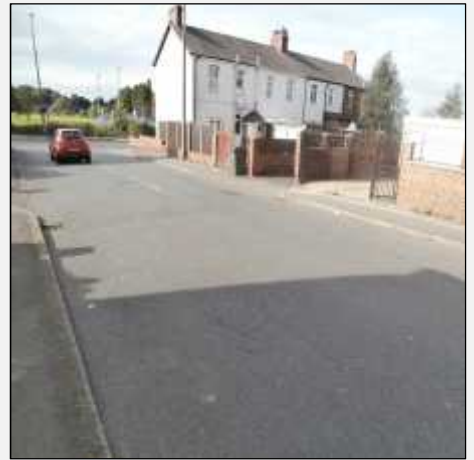
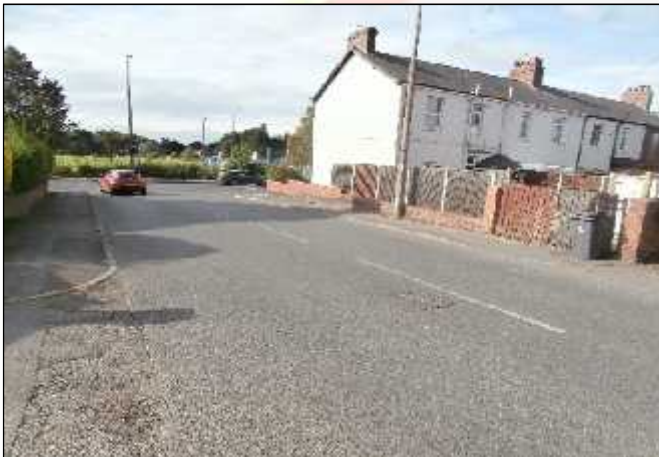
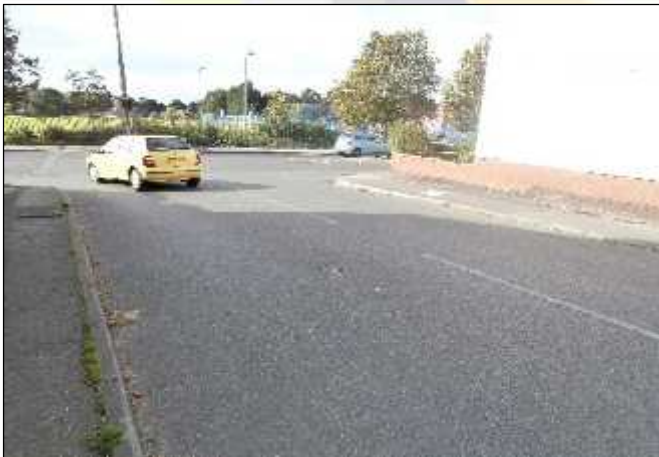
| OBSERVATION: | A) Carriageway surface course is showing signs of wear.<br>B) Road markings are beginning to wear / fade. | | | | | | | | | |
| REMEDIAL WORKS RATING: | 1 | 2 | 3 | 4 | 5 | 6▼ | 7 | 8 | 9 | 10 |

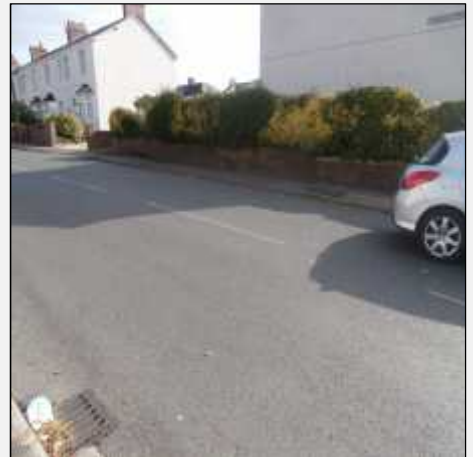
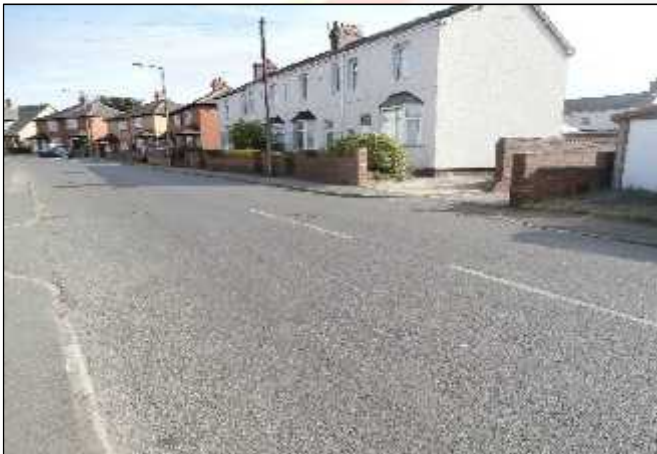
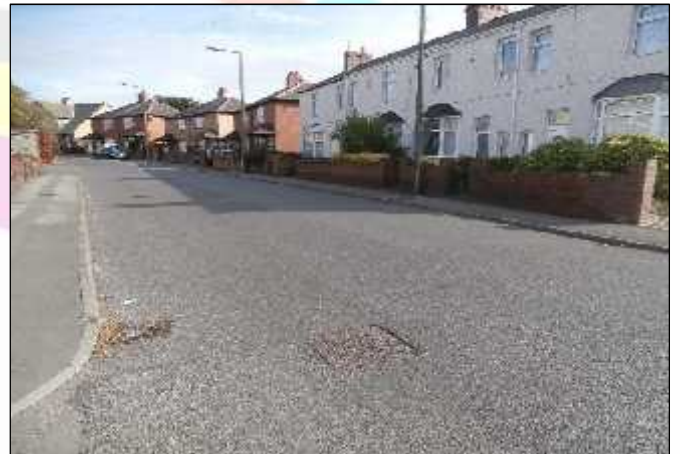
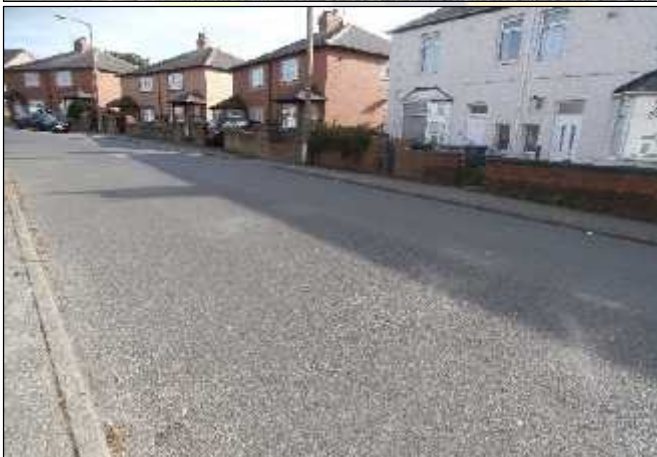
| OBSERVATION: | A) Carriageway surface course is showing signs of wear.<br>B) Road markings are beginning to wear / fade. | | | | | | | | | |
| REMEDIAL WORKS RATING: | 1 | 2 | 3 | 4 | 5 | 6▼ | 7 | 8 | 9 | 10 |

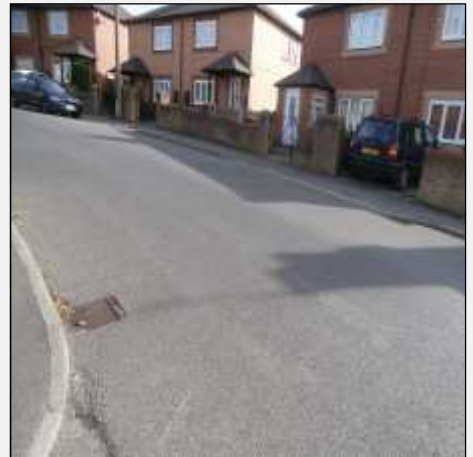
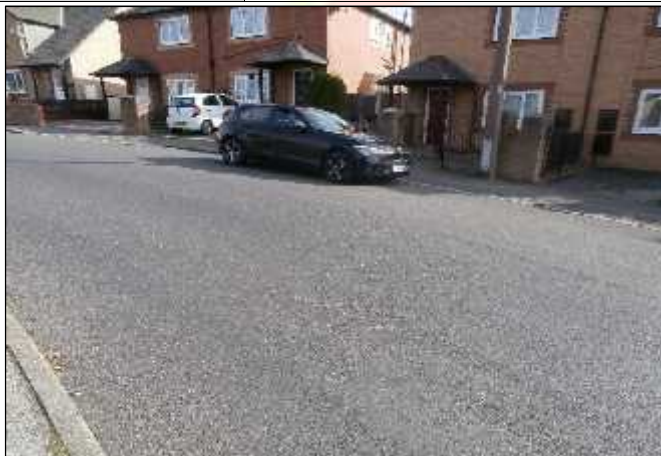
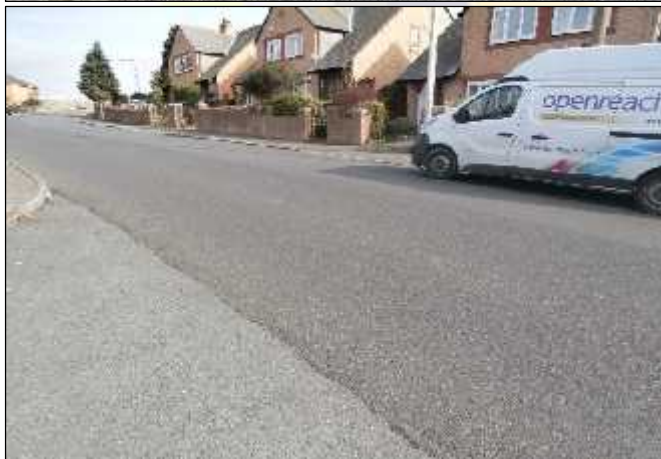
| OBSERVATION: | Carriageway surface course is showing signs of wear. | | | | | | | | | |
| REMEDIAL WORKS RATING: | 1 | 2 | 3 | 4 | 5 | 6▼ | 7 | 8 | 9 | 10 |

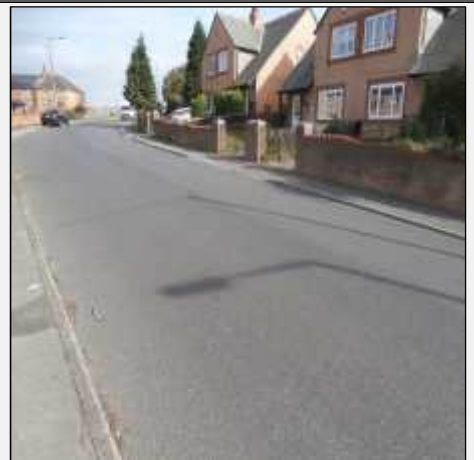
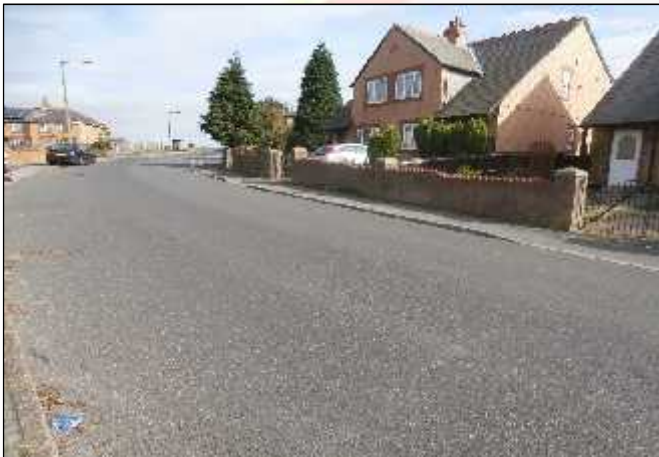
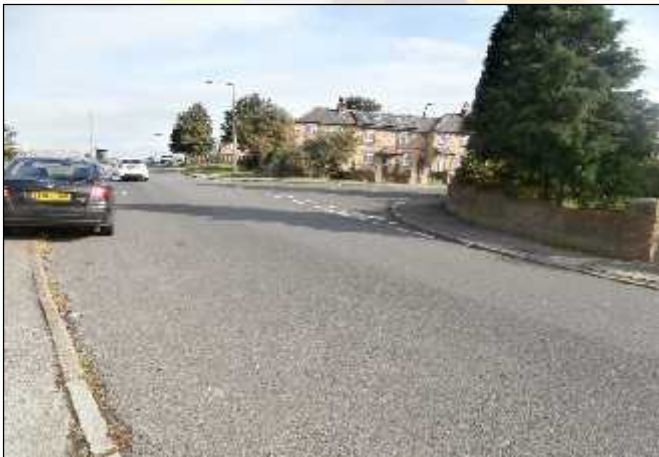
| OBSERVATION: | A) Carriageway surface course is showing signs of wear.<br>B) Road markings are in a good condition. | | | | | | | | | |
| REMEDIAL WORKS RATING: | 1 | 2 | 3 | 4 | 5 | 6▼ | 7 | 8 | 9 | 10 |

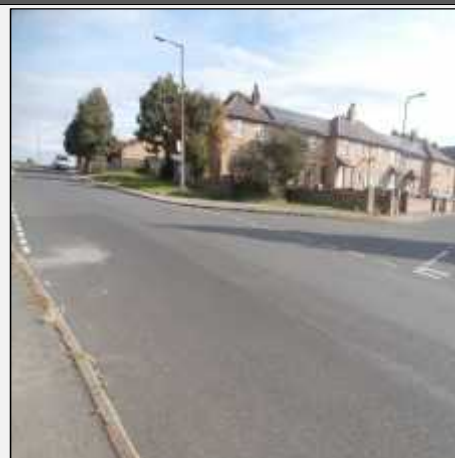
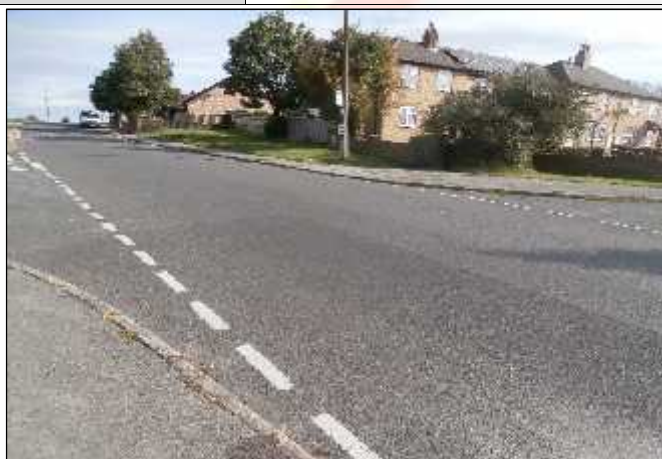
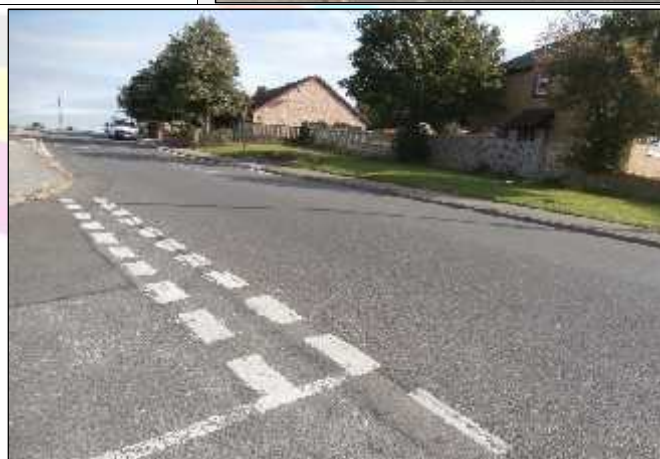
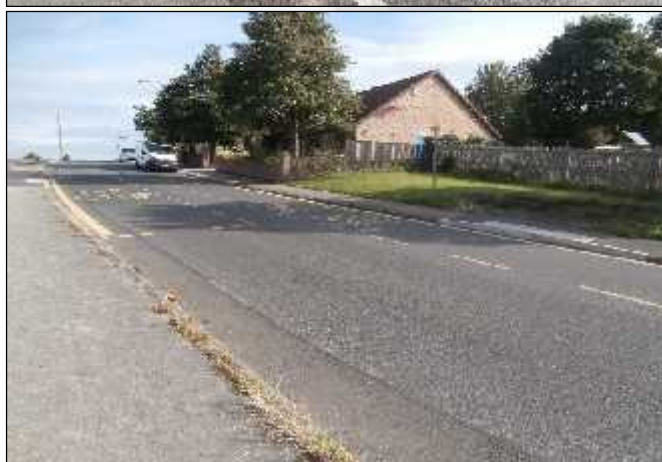
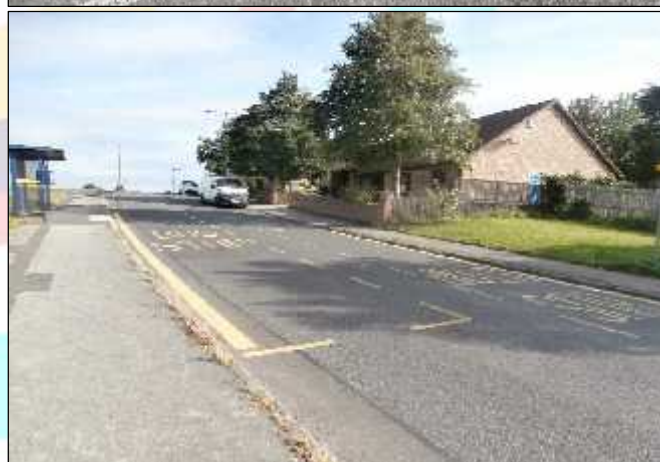
| OBSERVATION: | A) Carriageway surface course is showing signs of wear.<br>B) Road markings are beginning to wear / fade. | | | | | | | | | |
| REMEDIAL WORKS RATING: | 1 | 2 | 3 | 4 | 5 | 6▼ | 7 | 8 | 9 | 10 |

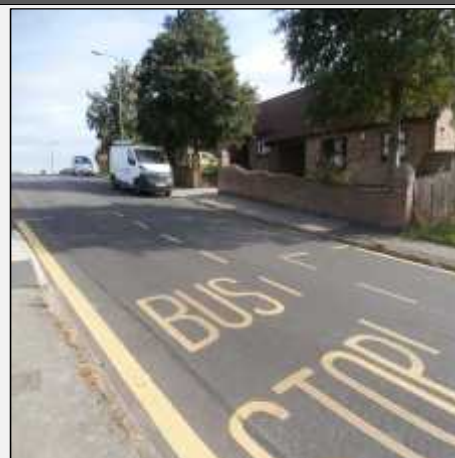
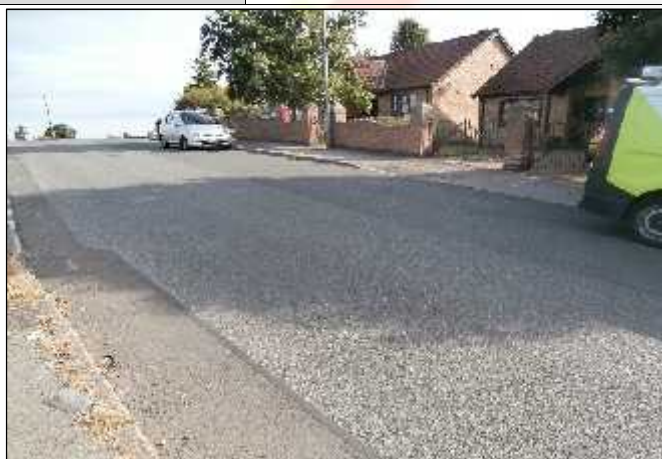
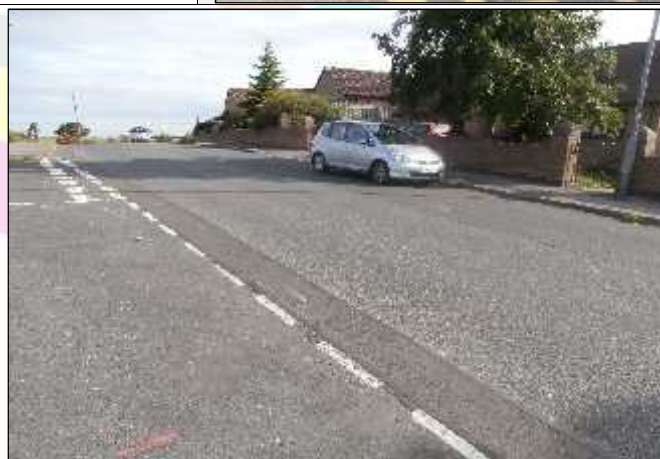
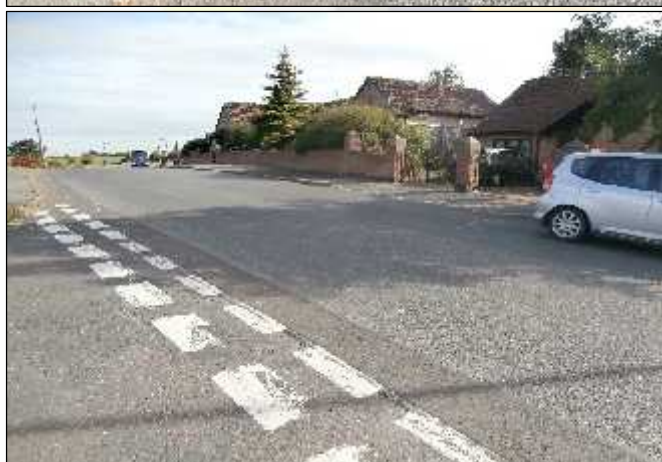
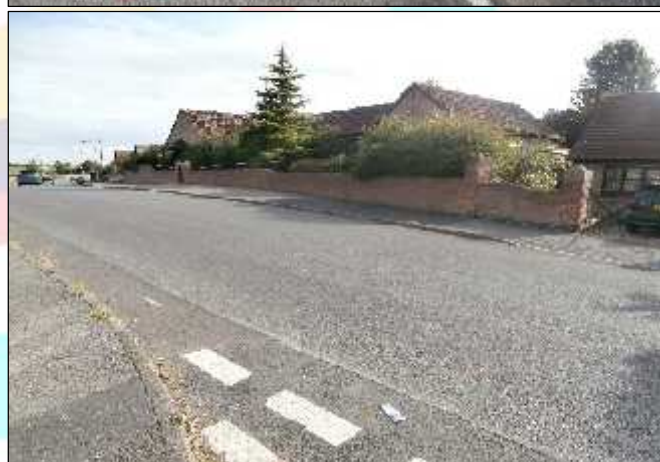
| OBSERVATION: | A) Carriageway surface course is showing signs of wear.<br>B) Road markings are beginning to wear / fade. | | | | | | | | | |
| REMEDIAL WORKS RATING: | 1 | 2 | 3 | 4 | 5 | 6▼ | 7 | 8 | 9 | 10 |

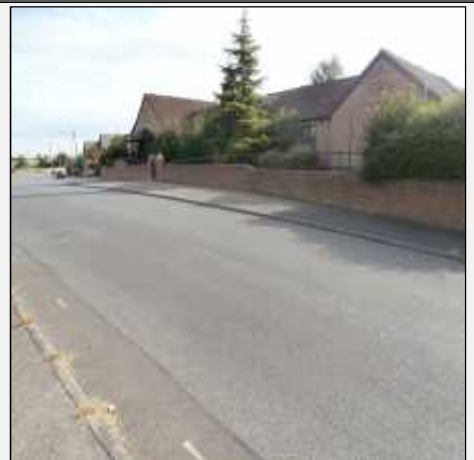
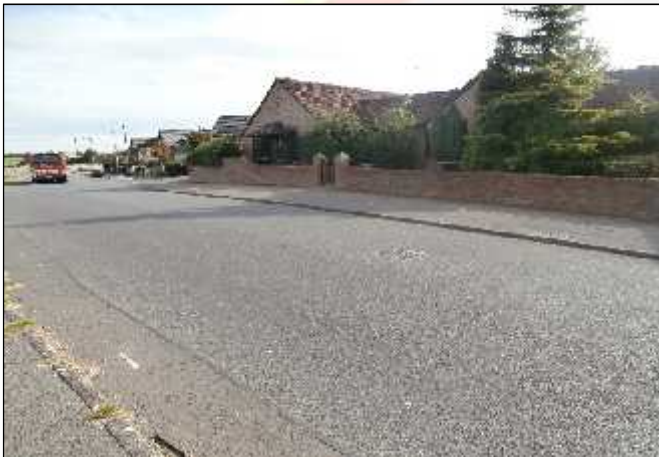
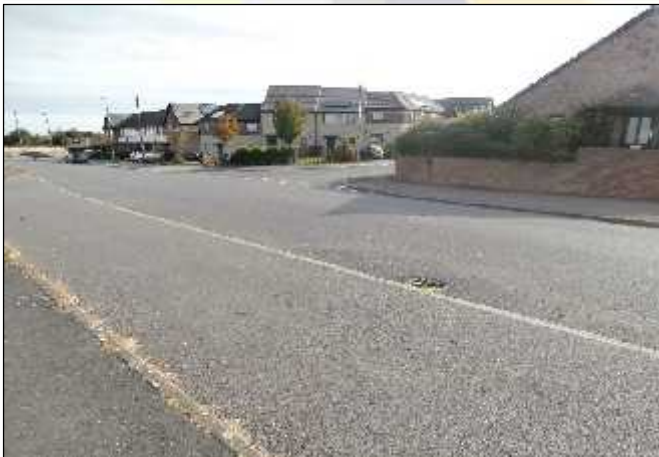
| OBSERVATION: | Carriageway surface course is showing signs of failure. | | | | | | | | | |
| REMEDIAL WORKS RATING: | 1 | 2 | 3 | 4 | 5 | 6 ▼ | 7 | 8 | 9 | 10 |

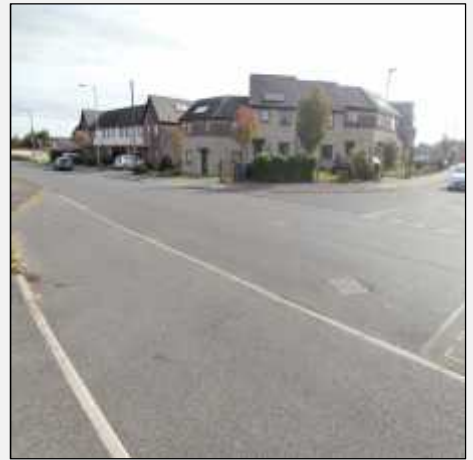
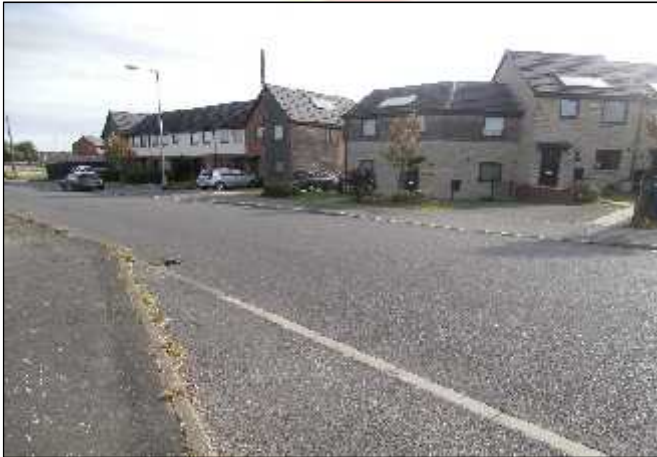
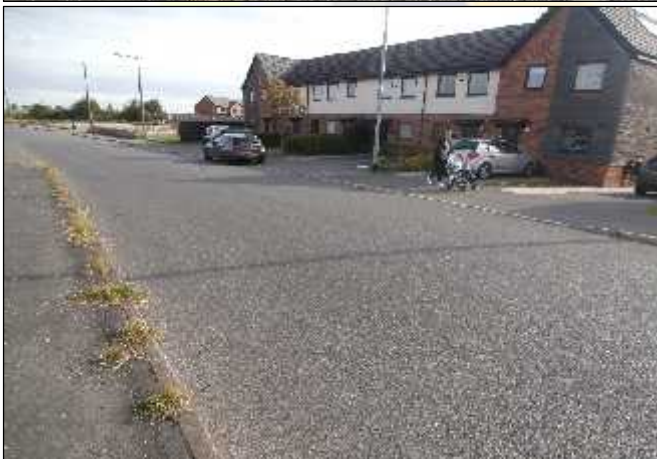
| OBSERVATION: | Carriageway surface course is showing signs of wear. | | | | | | | | | |
| REMEDIAL WORKS RATING: | 1 | 2 | 3 | 4 | 5 | 6▼ | 7 | 8 | 9 | 10 |

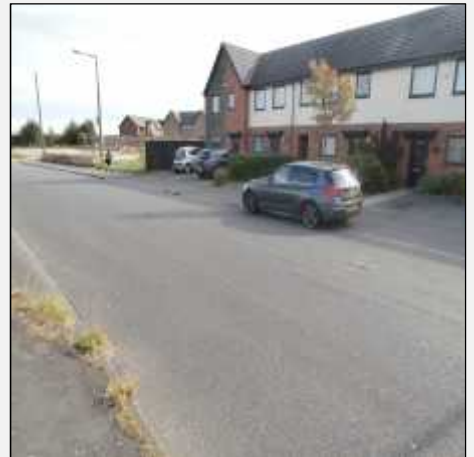
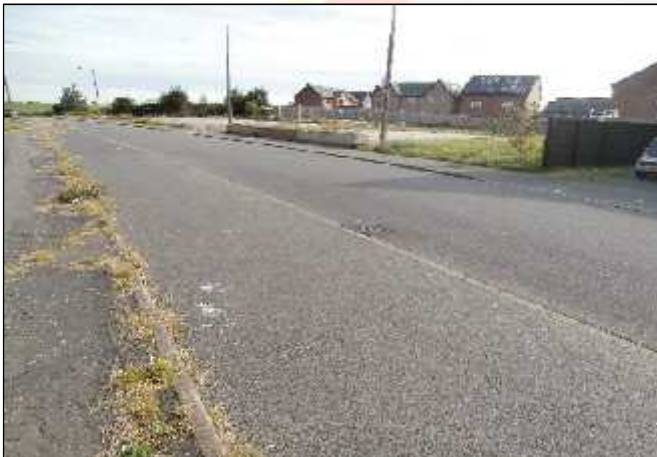
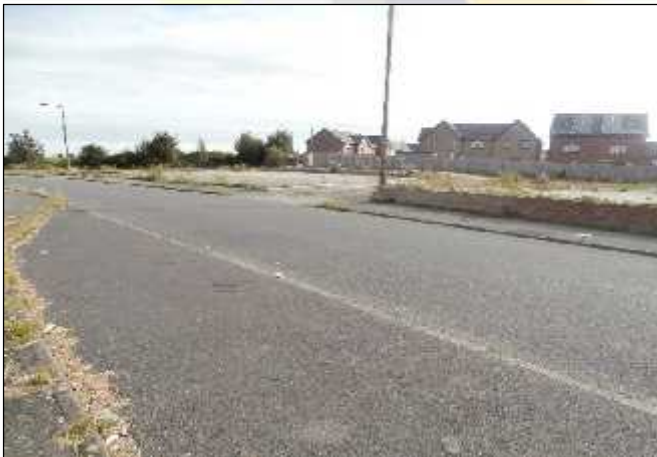
| OBSERVATION: | Carriageway surface course is showing signs of wear. | | | | | | | | | |
| REMEDIAL WORKS RATING: | 1 | 2 | 3 | 4 | 5 | 6▼ | 7 | 8 | 9 | 10 |

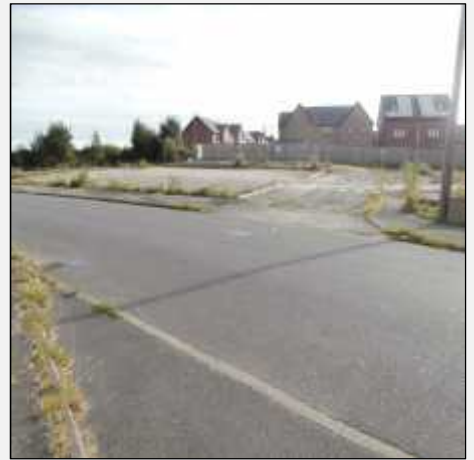
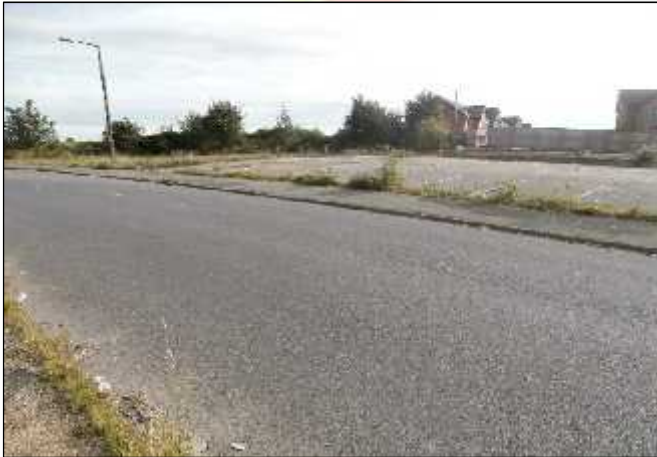
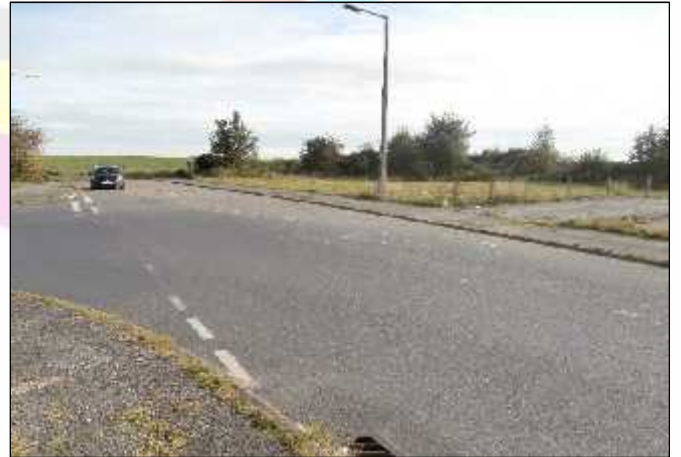
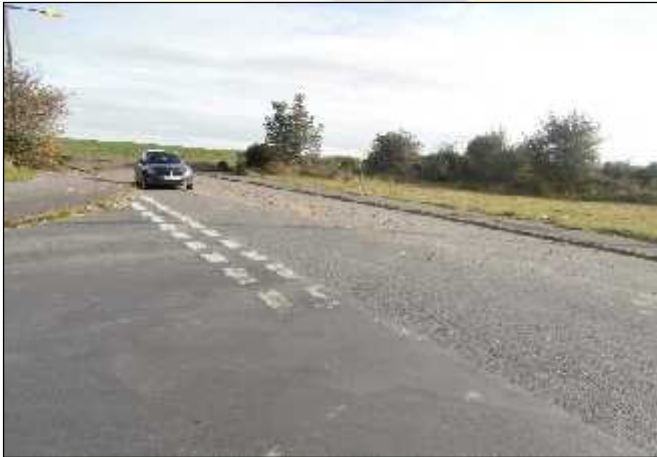
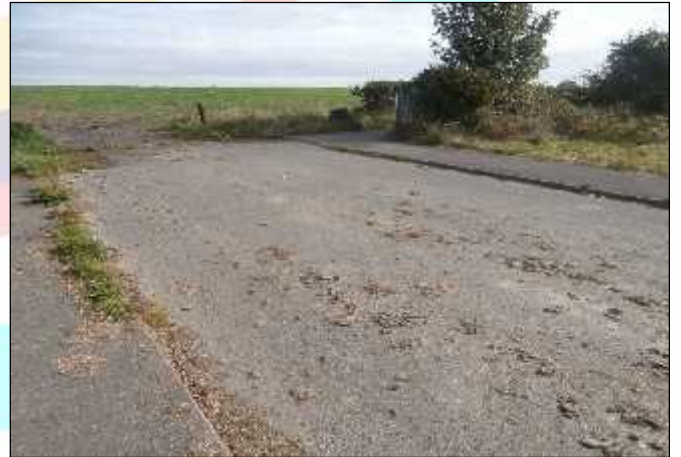
| OBSERVATION: | A) Carriageway surface course is showing signs of wear.<br>B) Road markings are beginning to wear / fade. | | | | | | | | | |
| REMEDIAL WORKS RATING: | 1 | 2 | 3 | 4 | 5 | 6▼ | 7 | 8 | 9 | 10 |

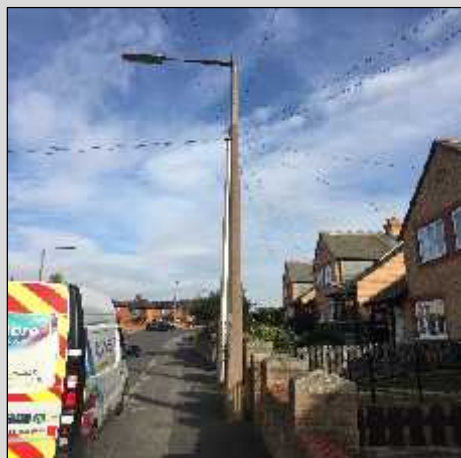
LC4

Ok.

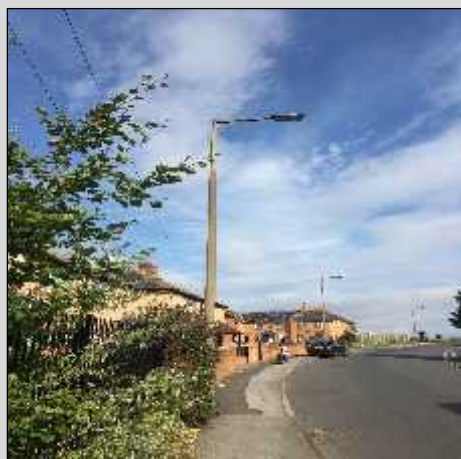
LC5

Ok.

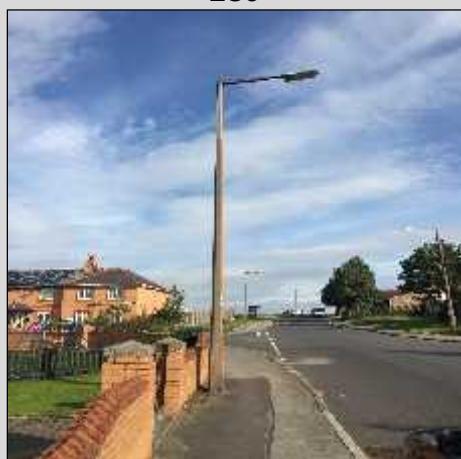
LC6

Ok.

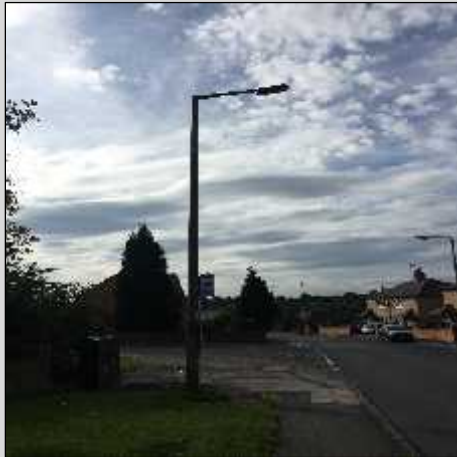
LC7

Ok.

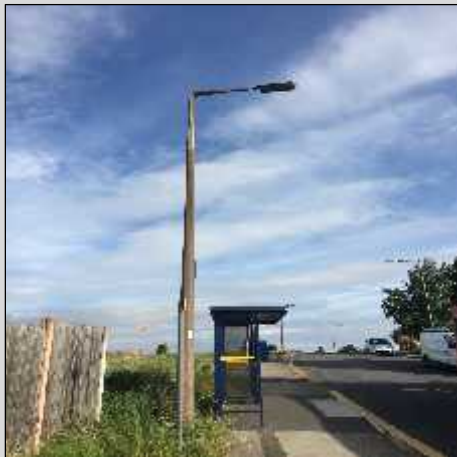
LC8

Ok.

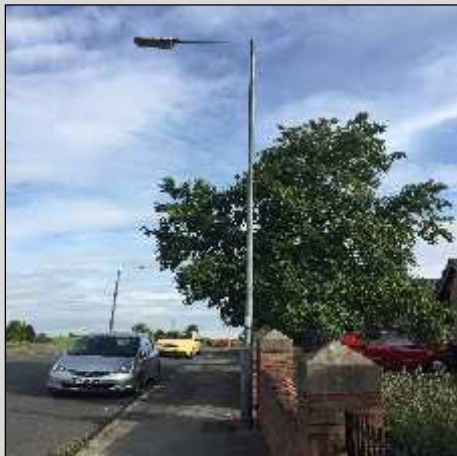
LC9

Ok.

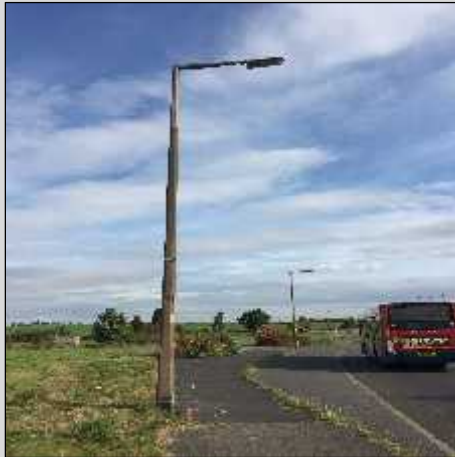
LC10

Ok.

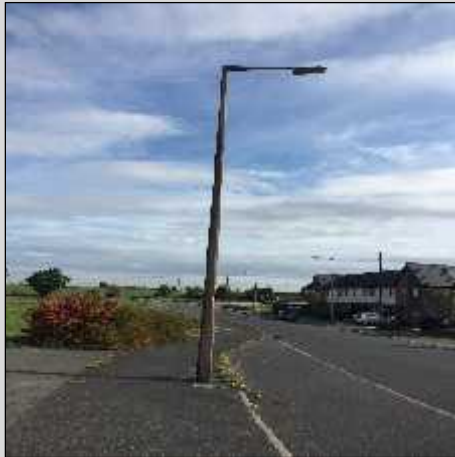
LC11

Ok.

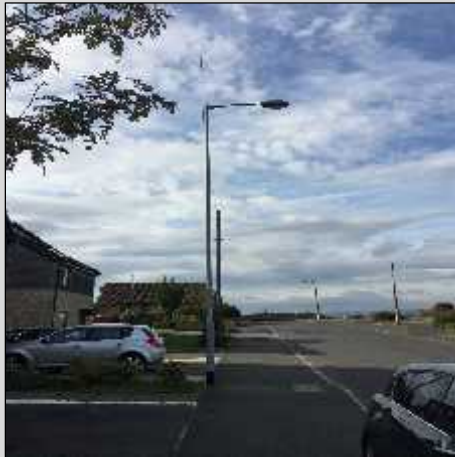
LC12

Ok.

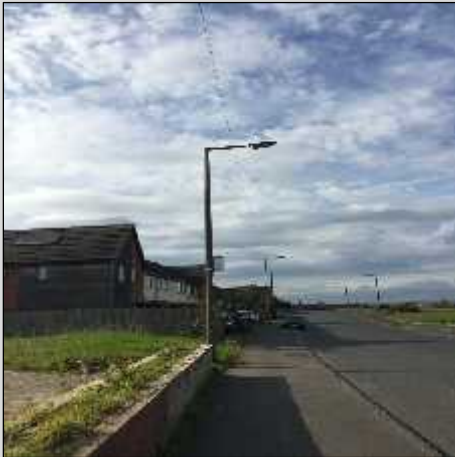
LC13

Ok.

N/A.

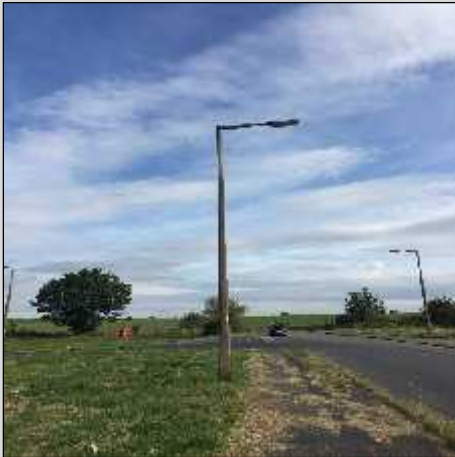
LC14

Ok.

N/A.

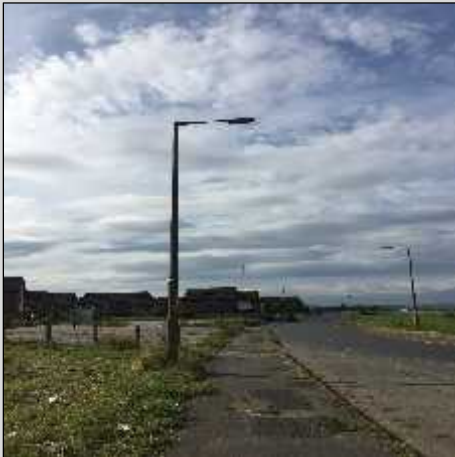
LC15

Ok.

N/A.

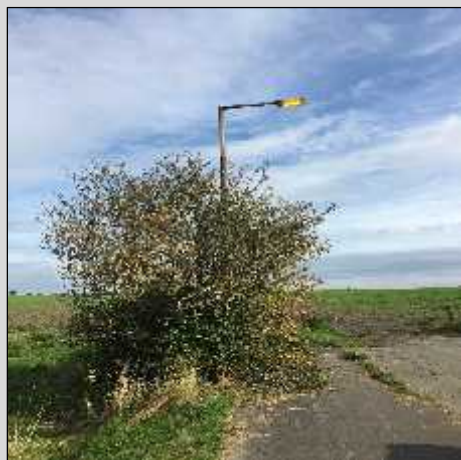
Ok.

The column appears to be day burning.
