GROUND INVESTIGATION REPORT

**24 VIEWLANDS, SILKSTONE COMMON, BARNSELY, S75 4QP
PREPARED FOR JOHNSTONE CONSTRUCTION MANAGEMENT LIMITED**

Project No.	GEOL25-6508	Client	Johnstone Construction Management Limited
Design Team	Tractus:DMA Architectural Design		
Report Type	Ground Investigation Report		
Project Type	Proposed Residential Development		
Site Address	24 Viewlands, Silkstone Common, Barnsley, S75 4QP		
NGR	429351, 404382		
Date	06/05/2025		
Prepared by	Martin Davidson

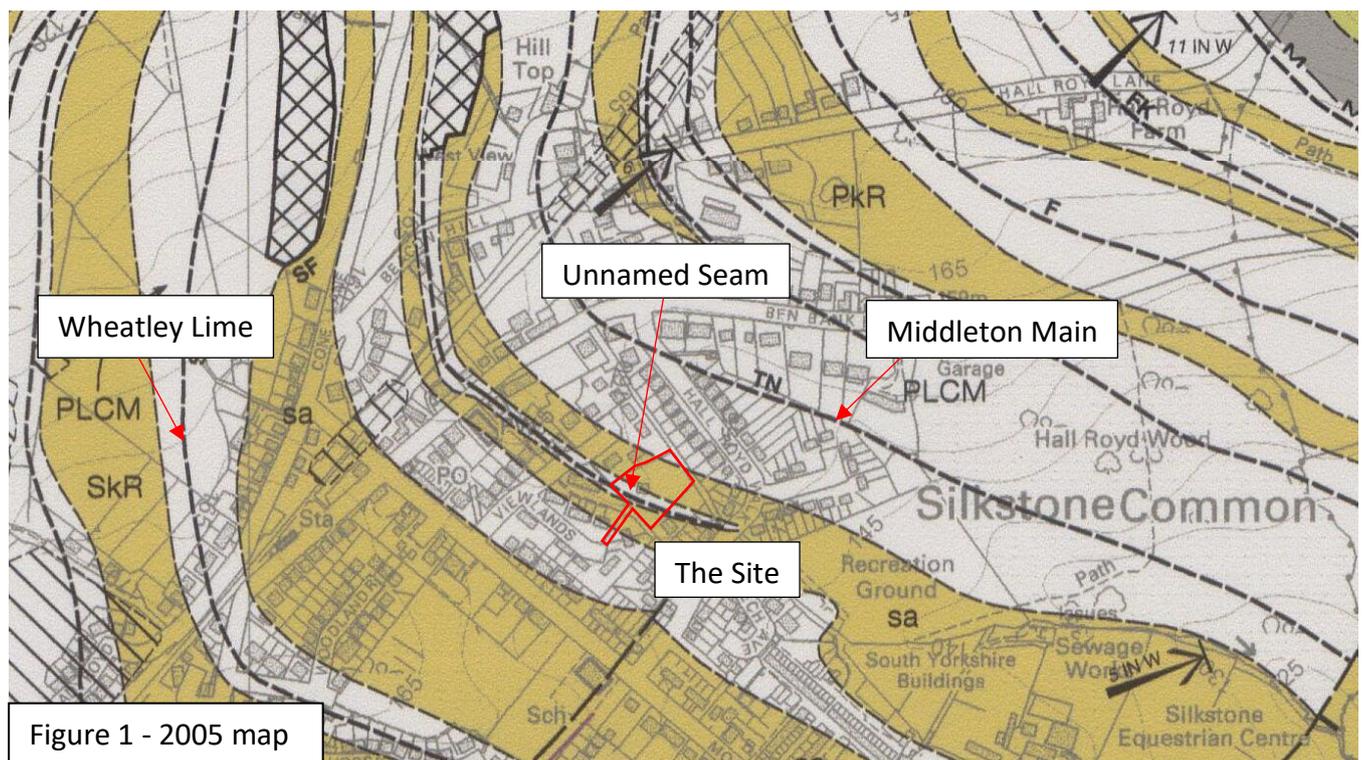
Based on available geological maps produced by the British Geological Survey (BGS) Sheet SE20SE, 1:10,000 scale, the site is shown to be in an area where superficial (drift) deposits are absent, and bedrock deposits are expected to be present at or close to the surface – area of solid outcrop. The bedrock deposits are shown to comprise the Pennine Lower Coal Measures (LCM) Formation deposited between 318 and 319 million years ago during the Carboniferous Period where sandstone deposits are present at rockhead level.

The geological setting based on the 2005 map can be observed within Figure 1 along with the MRA map on Figure 2.

The conjectured subcrop position of a thin unnamed seam 0.30m in thickness is shown within the site, generally trending northwest - southeast and dips in a north-easterly direction.

However, there is a discrepancy in the position of the Middleton Main coal seam (also referred to as the Thornccliffe Coal) on the mapping. On the 1:10,000 sheet dated 2005, the Middleton Main coal seam is placed to the north east of the site boundary, dipping away from the site and with a thickness of 0.4m. The more recent MRA mapping places the Middleton Main coal seam 6.8m to the south west of the site and dipping beneath the site at shallow depth.

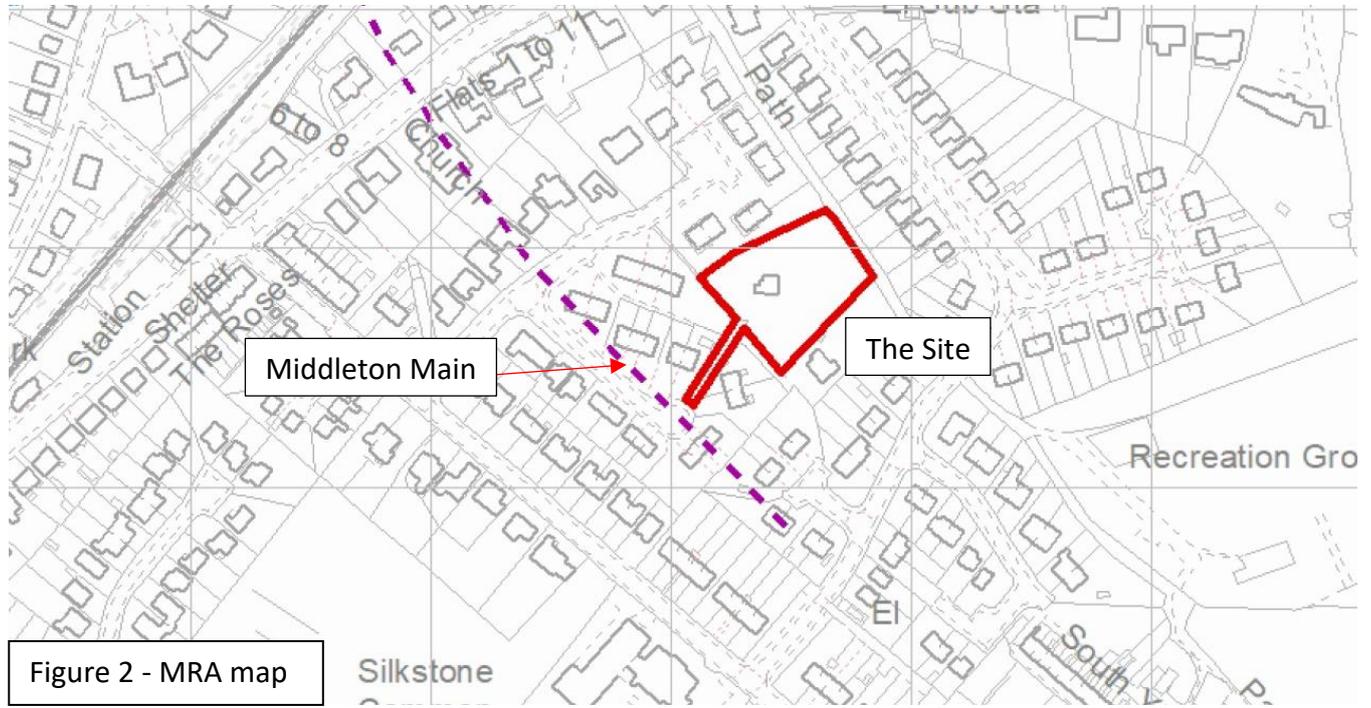
Figure 2 - MRA map

In accordance with the MRA, Consultants Coal Mining Report the Wheatley Lime coal seam (also commonly referred to as the Silkstone Four Foot Coal) is anticipated to be the shallowest worked coal seam present below the site at a depth of 28m below existing site levels with an extraction thickness of 1.35m, last mined in 1926. The Silkstone seam and Whinmoor seam are all also shown as worked beneath the site.

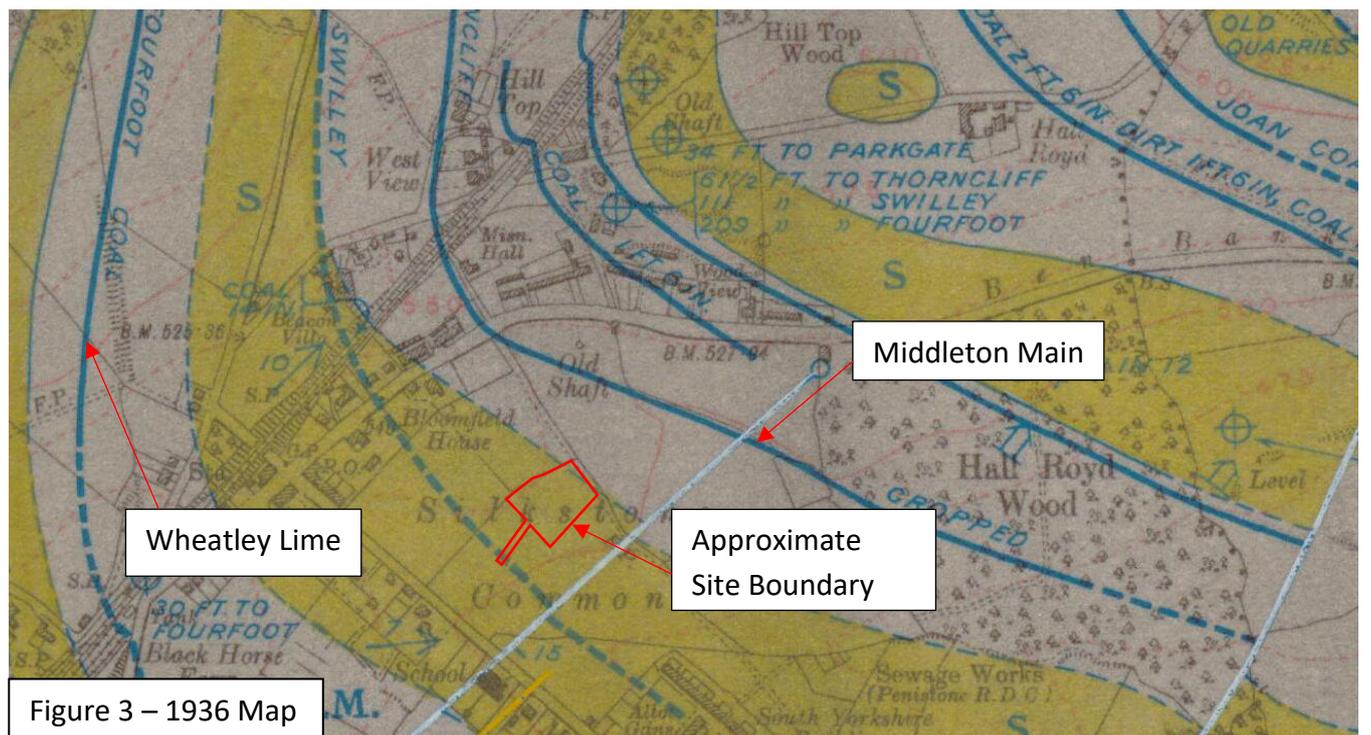
Figure 3 – 1936 Map

Figure 3 shows an extract taken from the County Series Yorkshire Sheet 274SW, 1:10560 scale dated 1936. The map refers to the unnamed seam as the Swilley coal seam 0.36m in thickness and the actual position of the Middleton Main coal seam to the north east of the site.

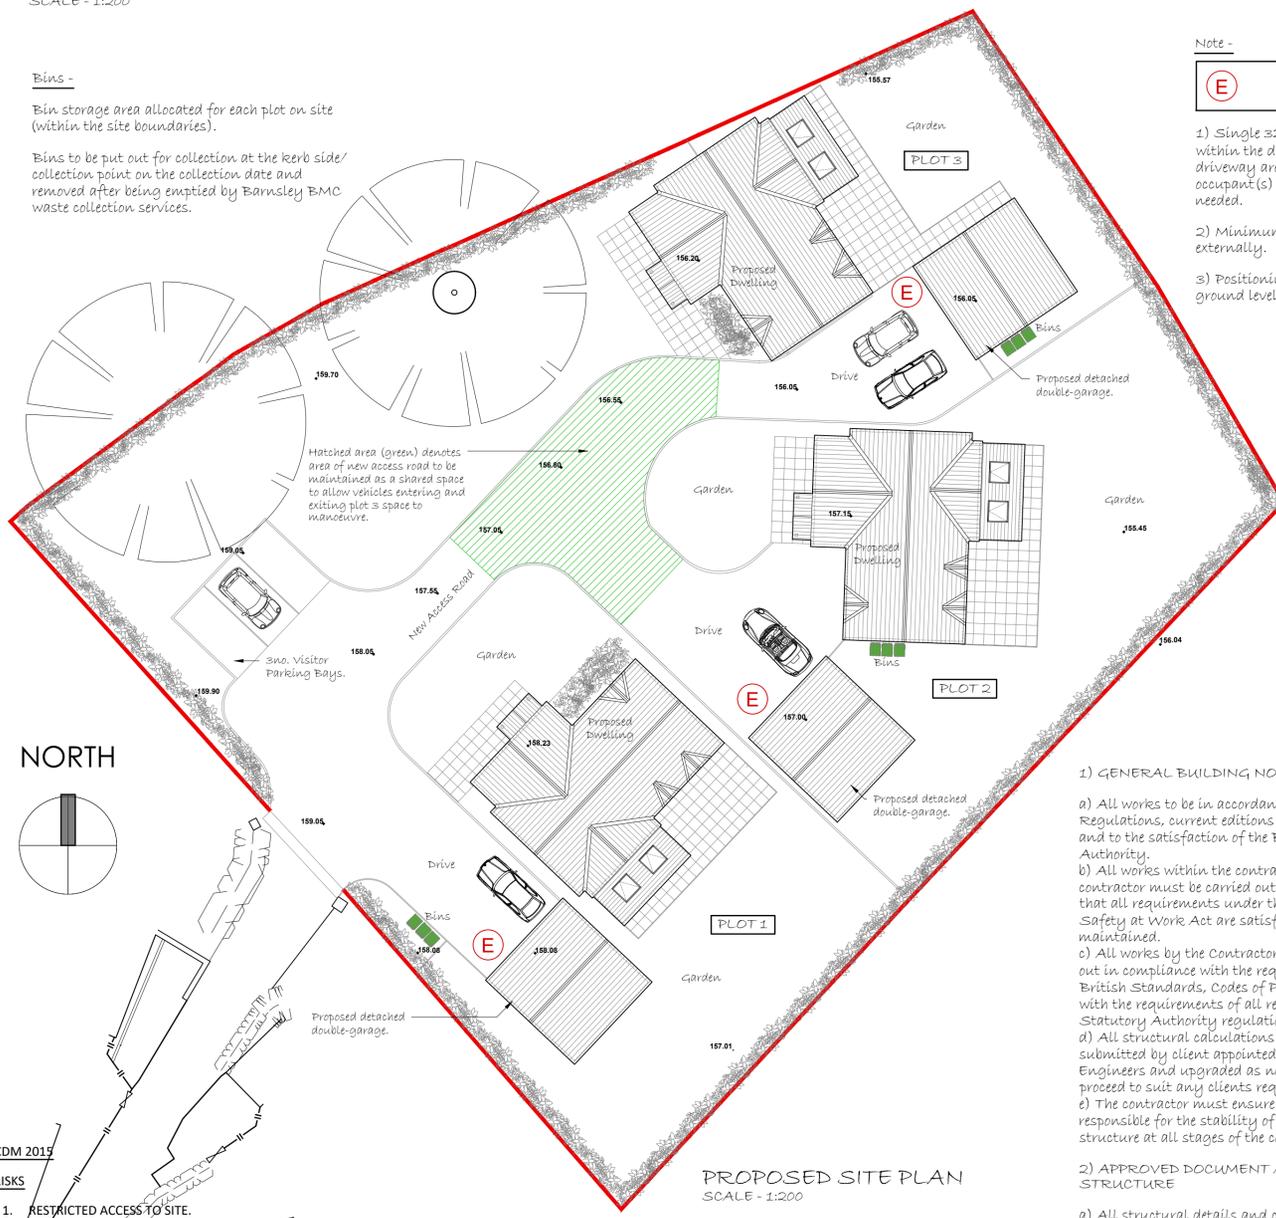
PROPOSED SITE PLAN
SCALE - 1:200

(E) Electric Vehicle Charging Point Location (EVCP)

- 1) Single 32 amp external socket to be installed within the detached garage(s) or adjacent to driveway area/parking spaces allowing occupant(s) to upgrade to a charging pod if needed.
- 2) Minimum IP66 rated socket when positioned externally.
- 3) Positioning of socket to be 1000mm from ground level.

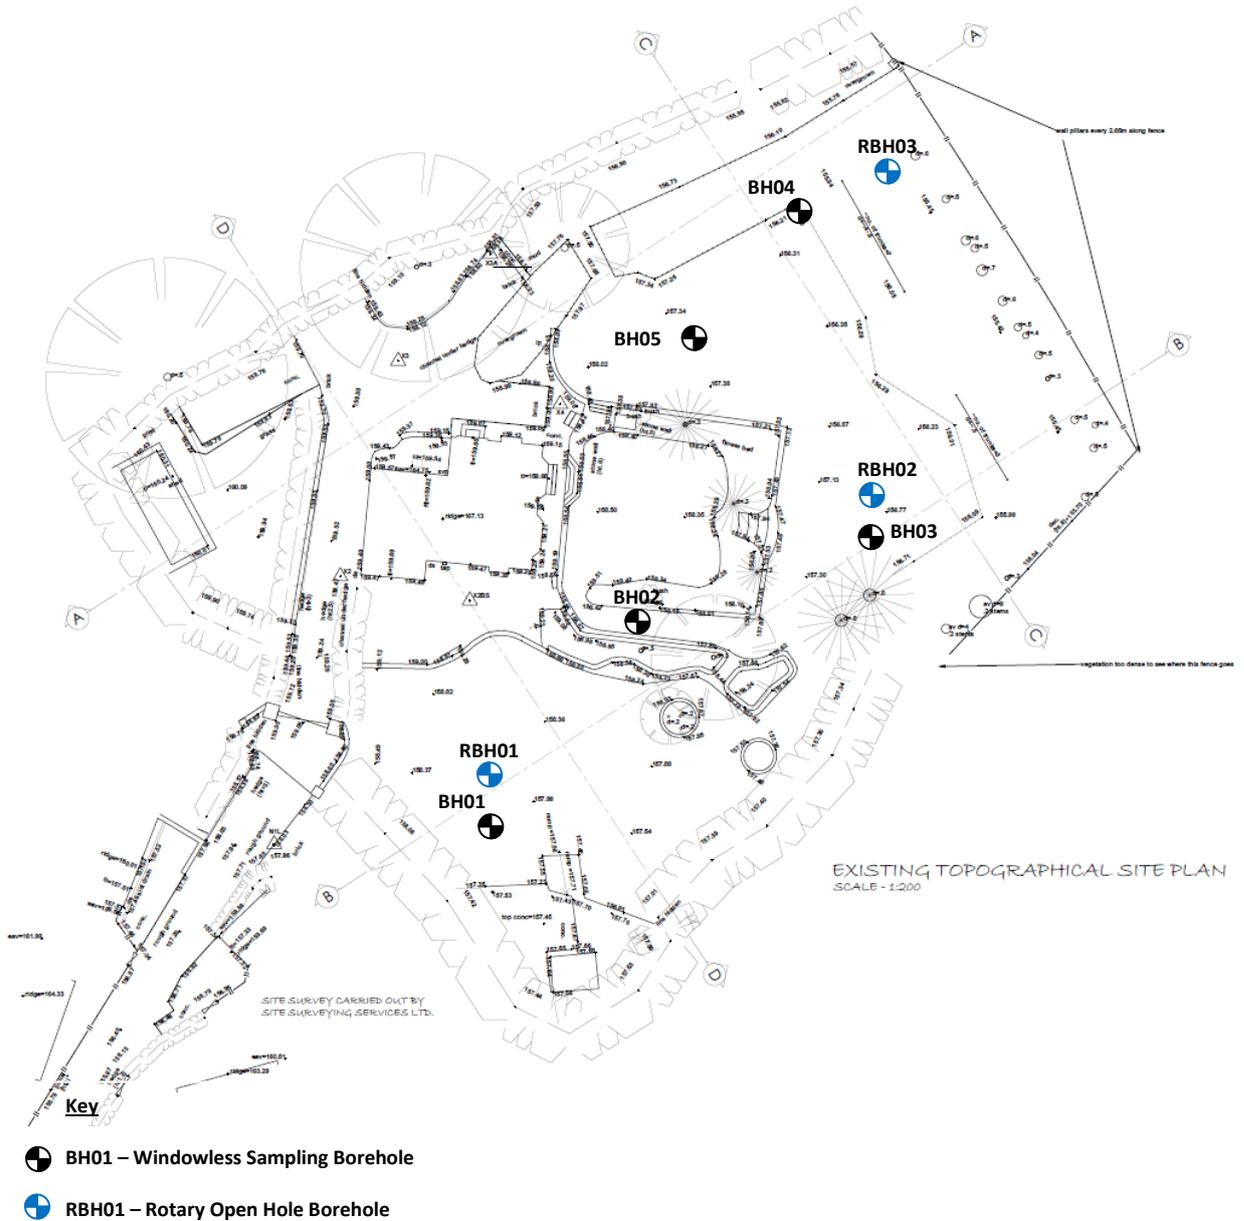
INVESTIGATION LOCATION PLAN

To determine the ground conditions below the site area, the ground investigation works completed by GEOL comprised the sinking of 5 no. windowless sampling boreholes (labelled BH01 to BH05).

Given the nature of the bedrock geology and the findings of the mining risk assessment above, GEOL also completed 3 no. rotary open boreholes (labelled RBH01 to RBH03) using a water flush medium to determine the risks posed to the site from recorded workings in the Silkstone Four Foot (Wheatley Lime) coal seam and to assess the depth to rockhead levels below the site area. A permit (reference 29699) was obtained directly from the MRA to enter or disturb their coal mining related interests prior to undertaking the rotary open hole borehole investigation works, a copy of which can be seen in Appendix II.

Detailed descriptions of the strata encountered during the investigation works, together with the results of all insitu field testing, are presented on the borehole record sheets attached in Appendix II. The borehole positions can be seen on the investigation location plan attached in Appendix II.
