PRELIMINARY GEOENVIRONMENTAL GROUND INVESTIGATION

Barnsley West

4848-JPG-SW-XX-RP-G-0603-S2-P02

July 2019

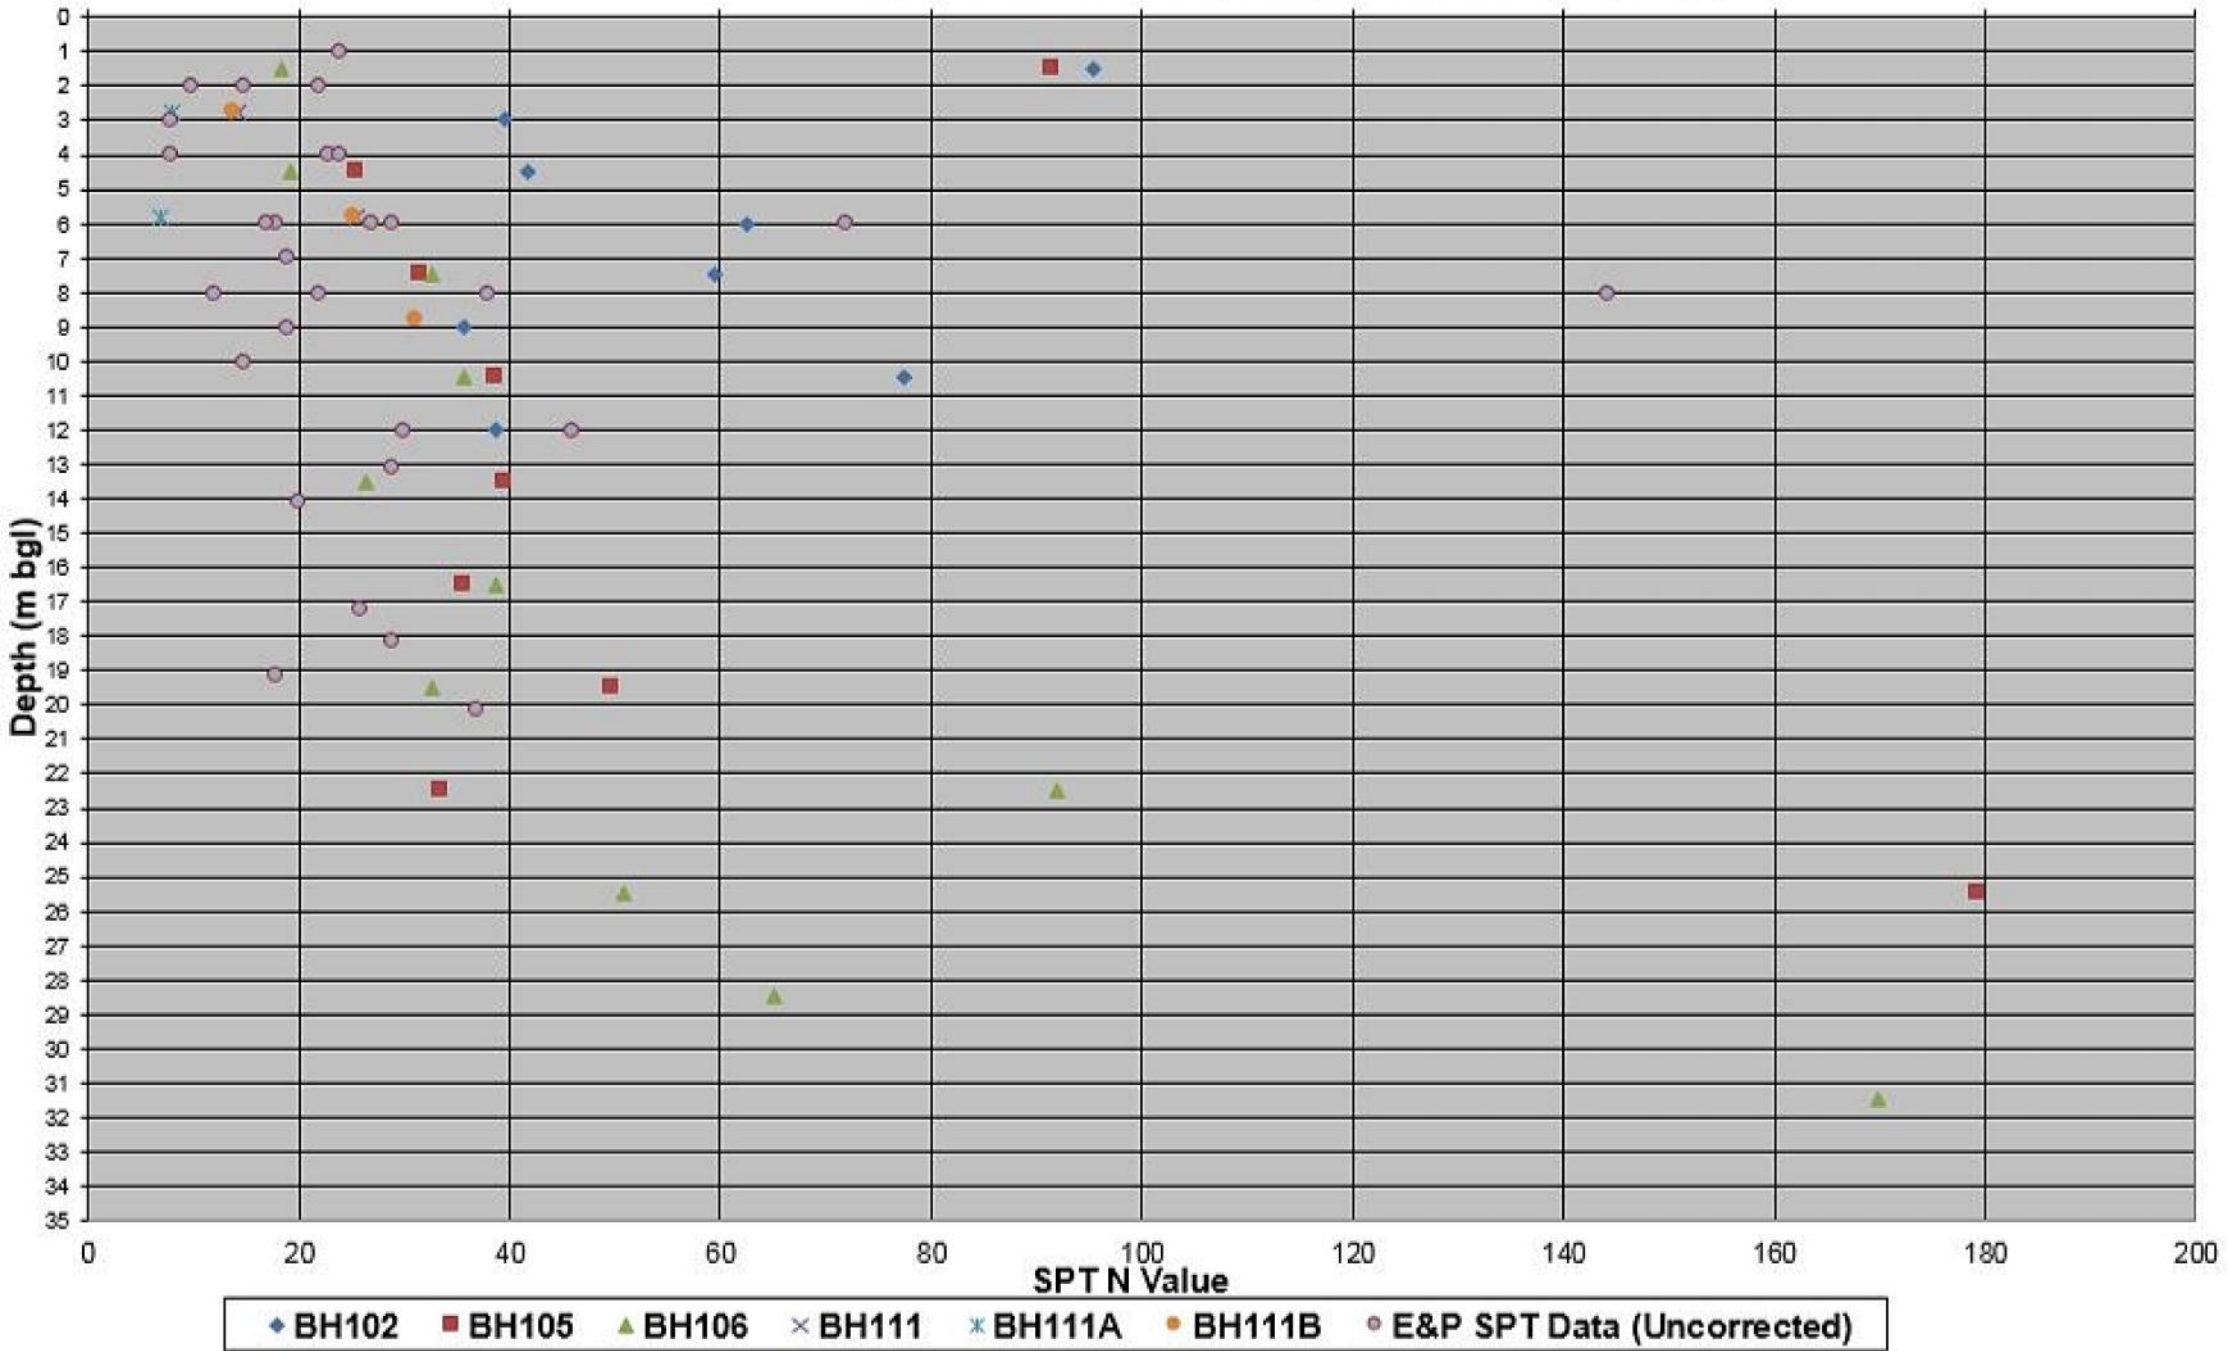
Figure 2: SPT N Value (Extrapolated) vs Depth (m bgl)

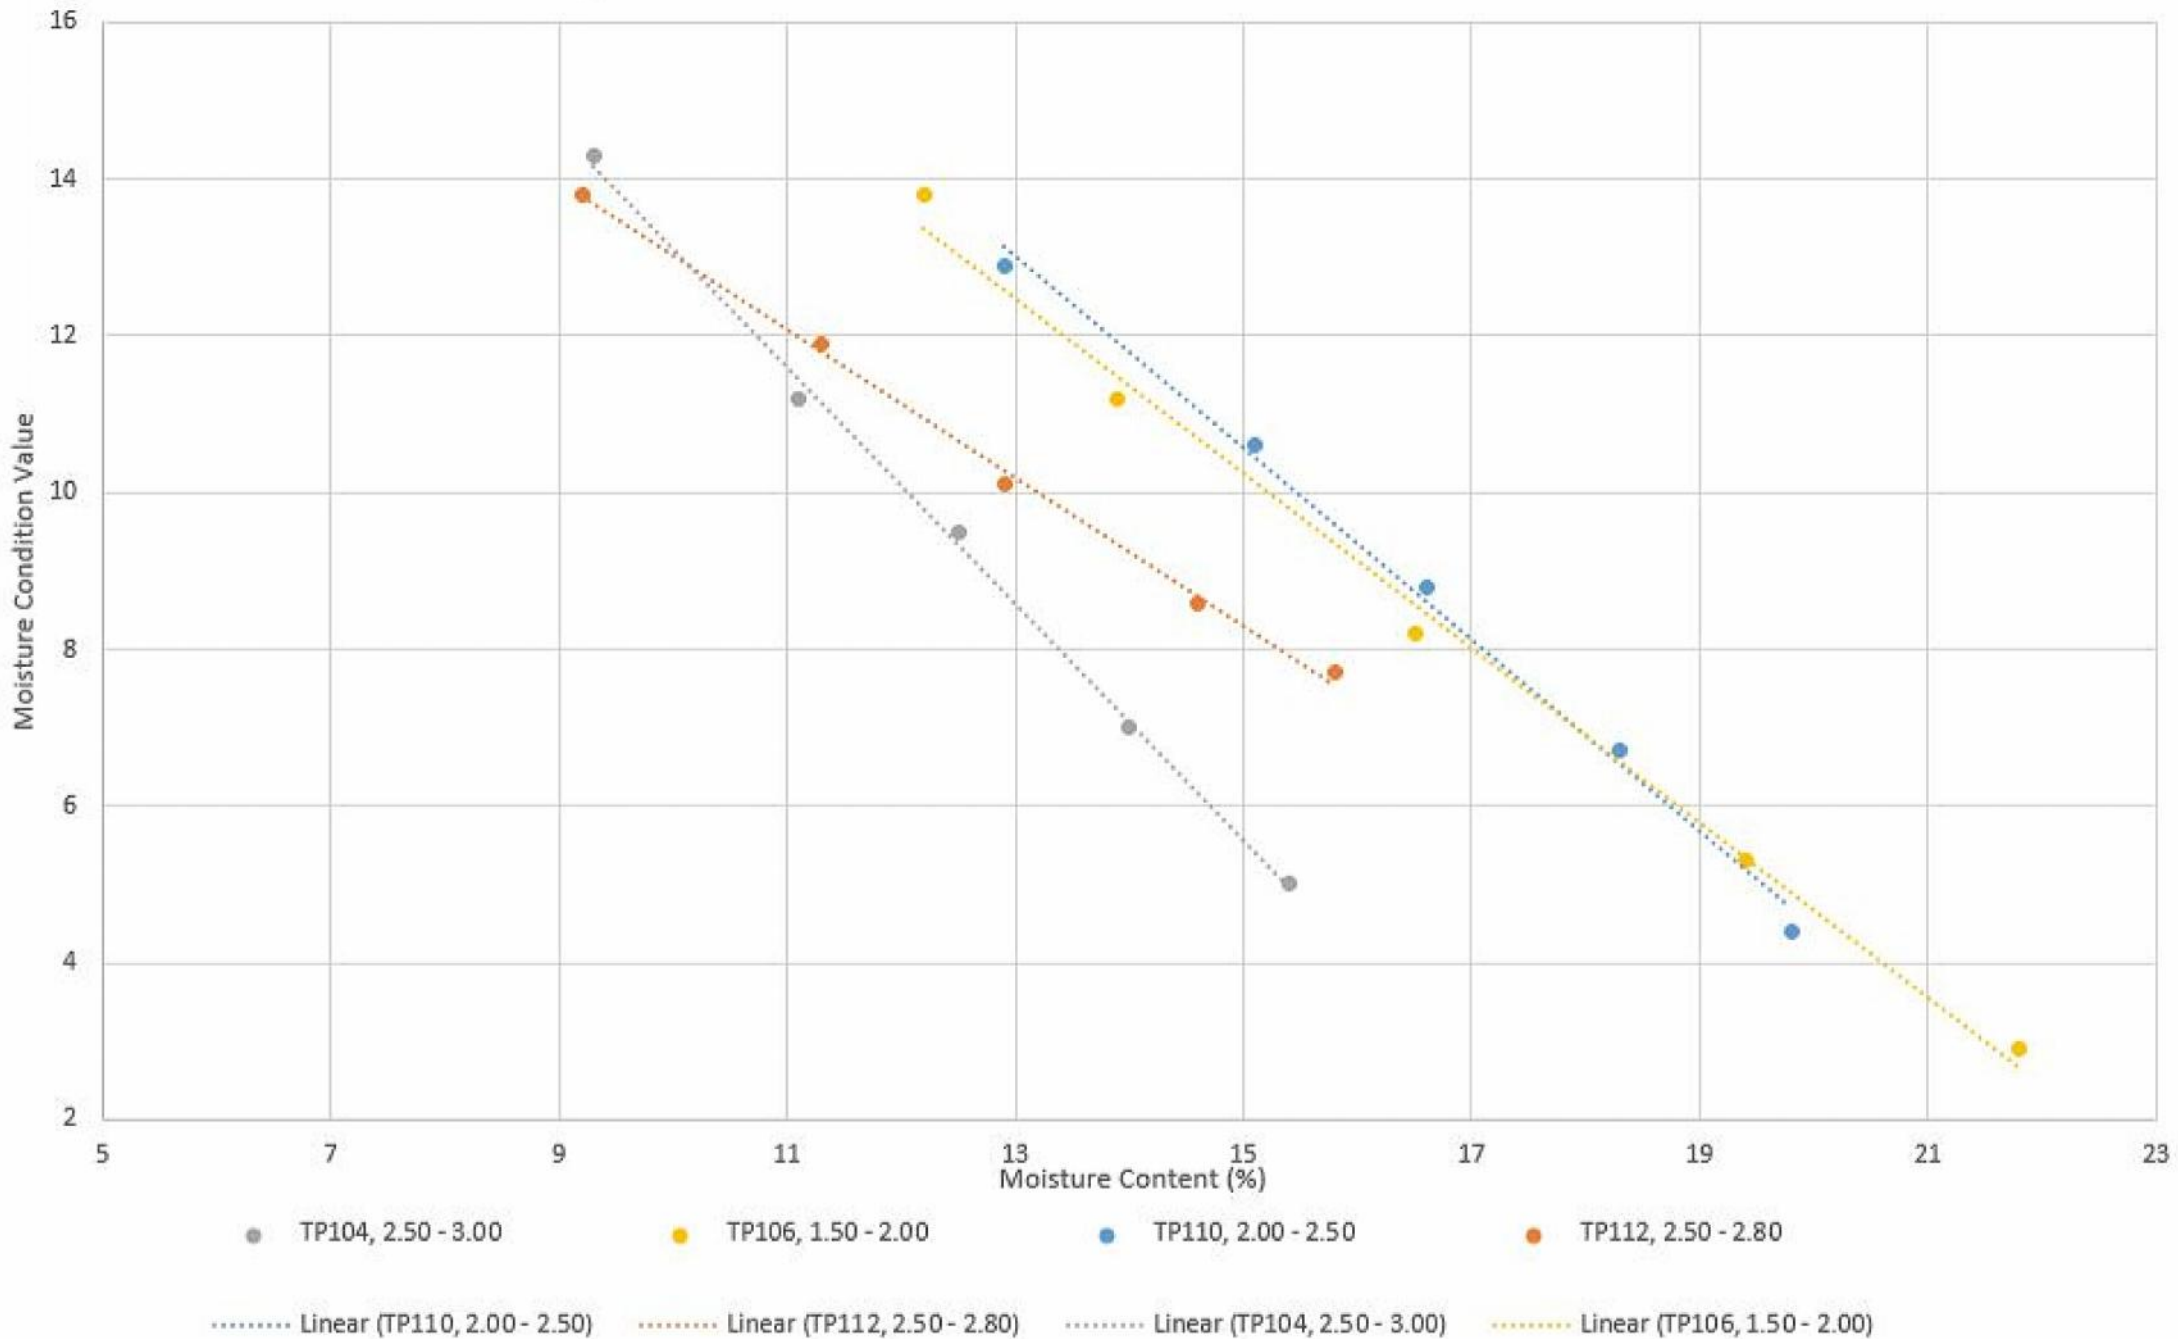
Figure 3: Plot of Moisture Condition Value vs Moisture Content

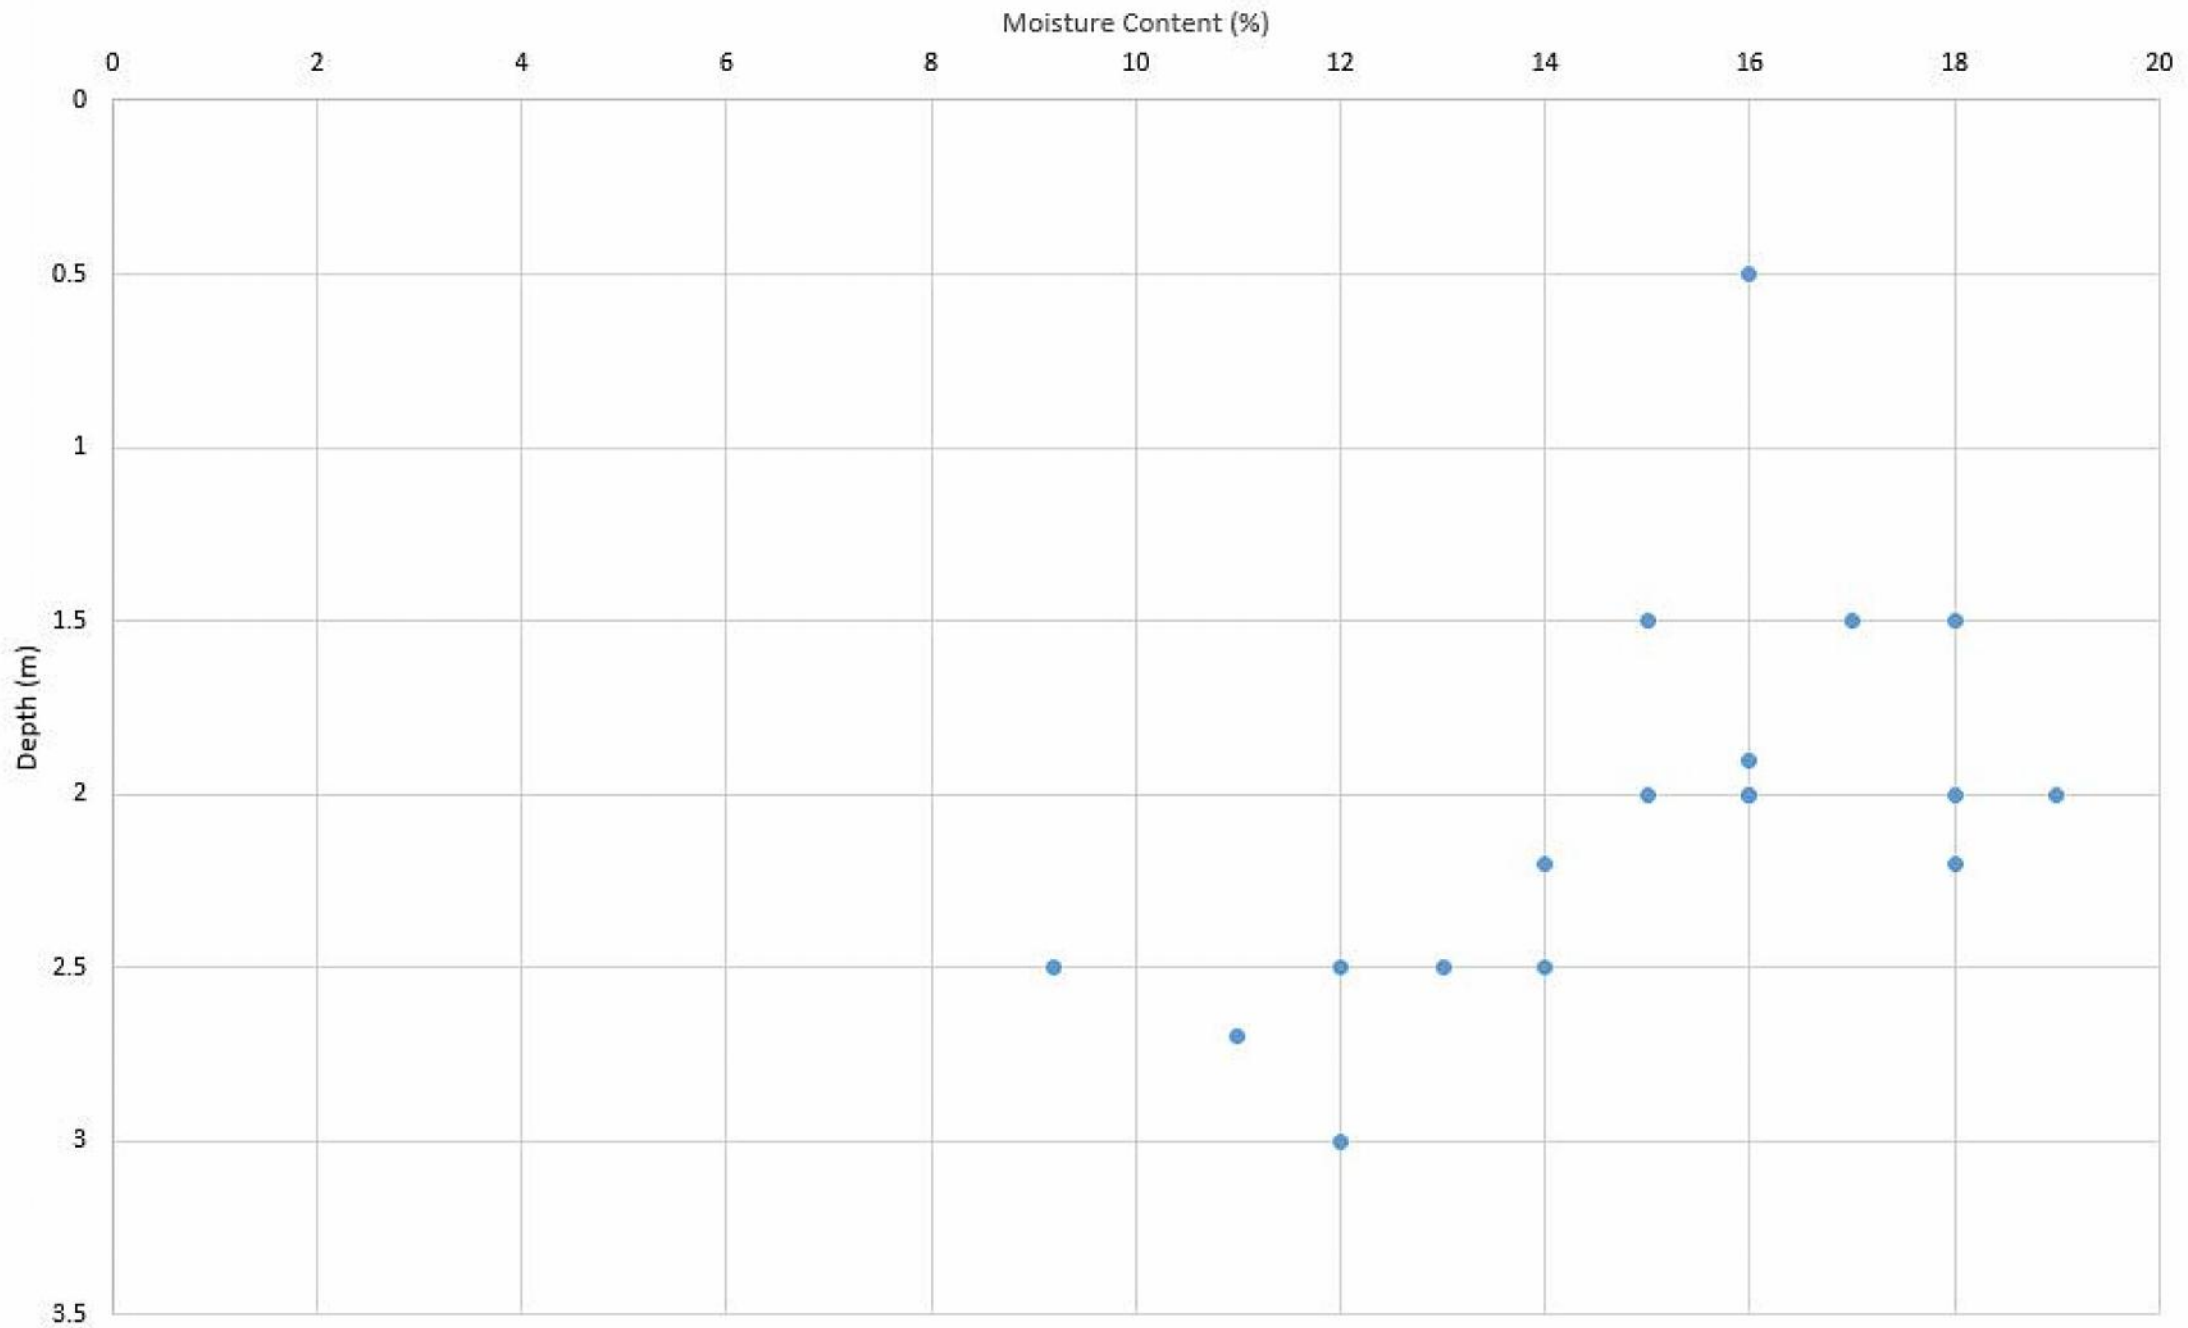
Figure 4: Moisture Content v Depth

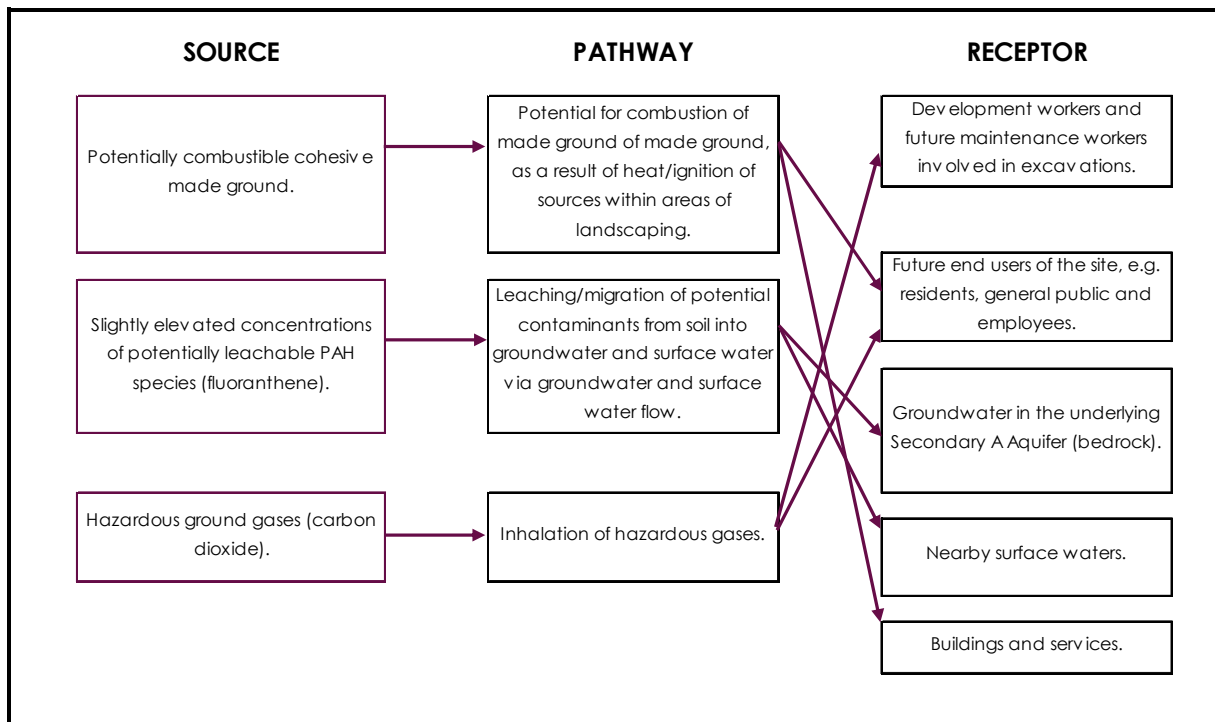
Figure 5 – Conceptual Site Model

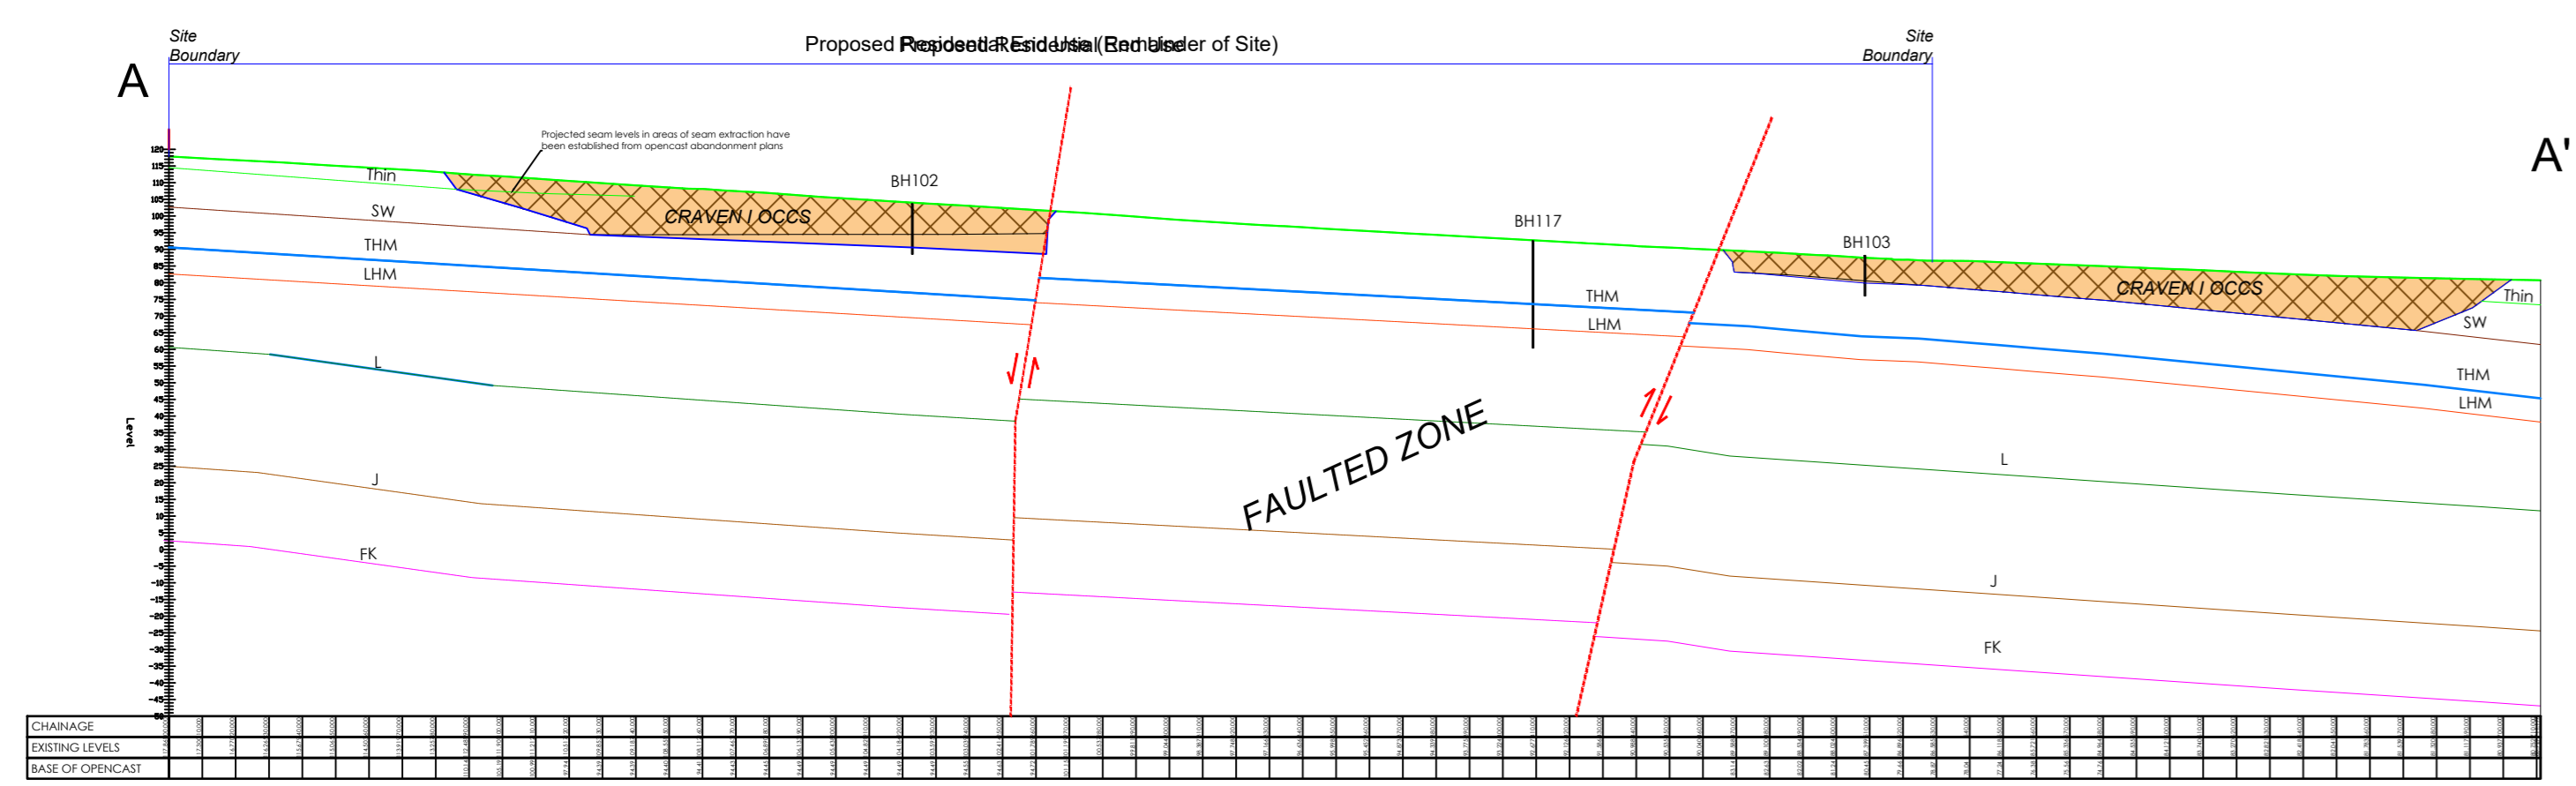
CROSS SECTION A-A', CRAVEN I
 SCALE: 1:2000

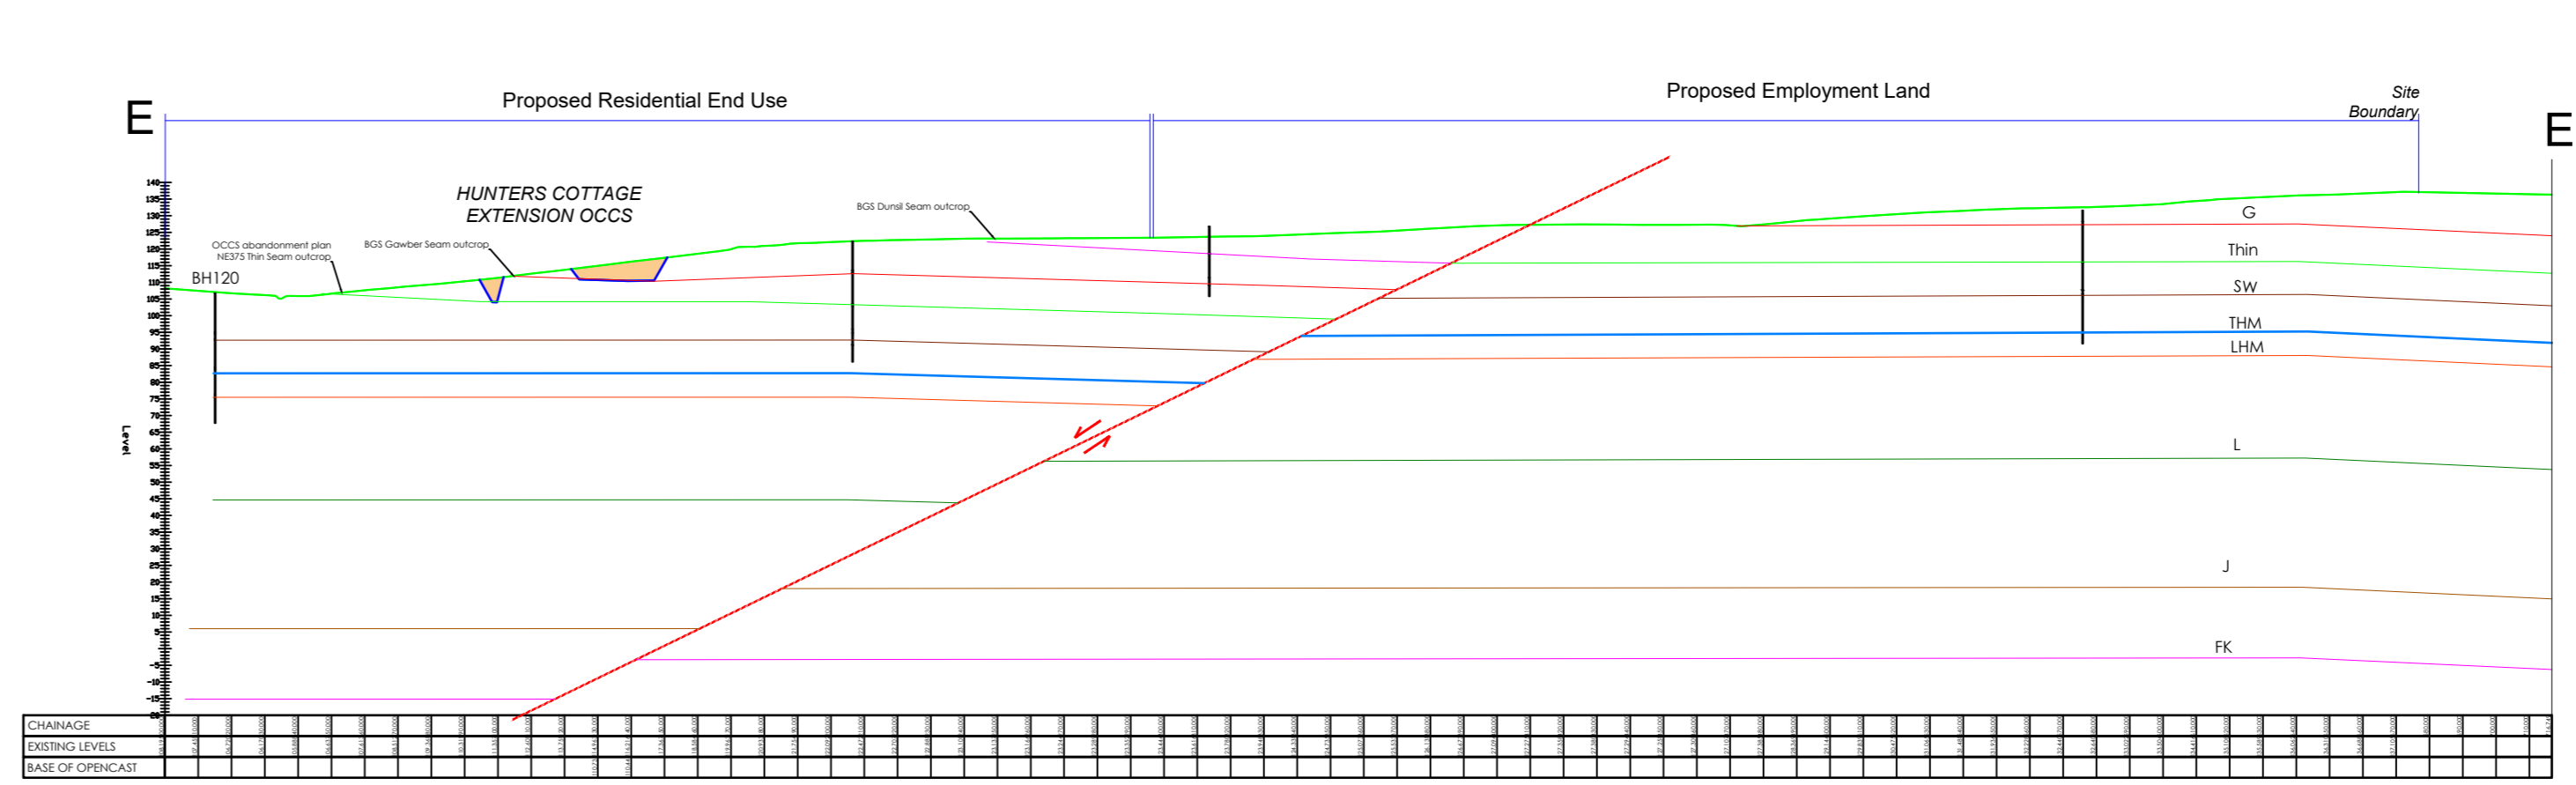
CROSS SECTION E-E'
 HUNTERS COTTAGE EXTENSION
 SCALE: 1:2000

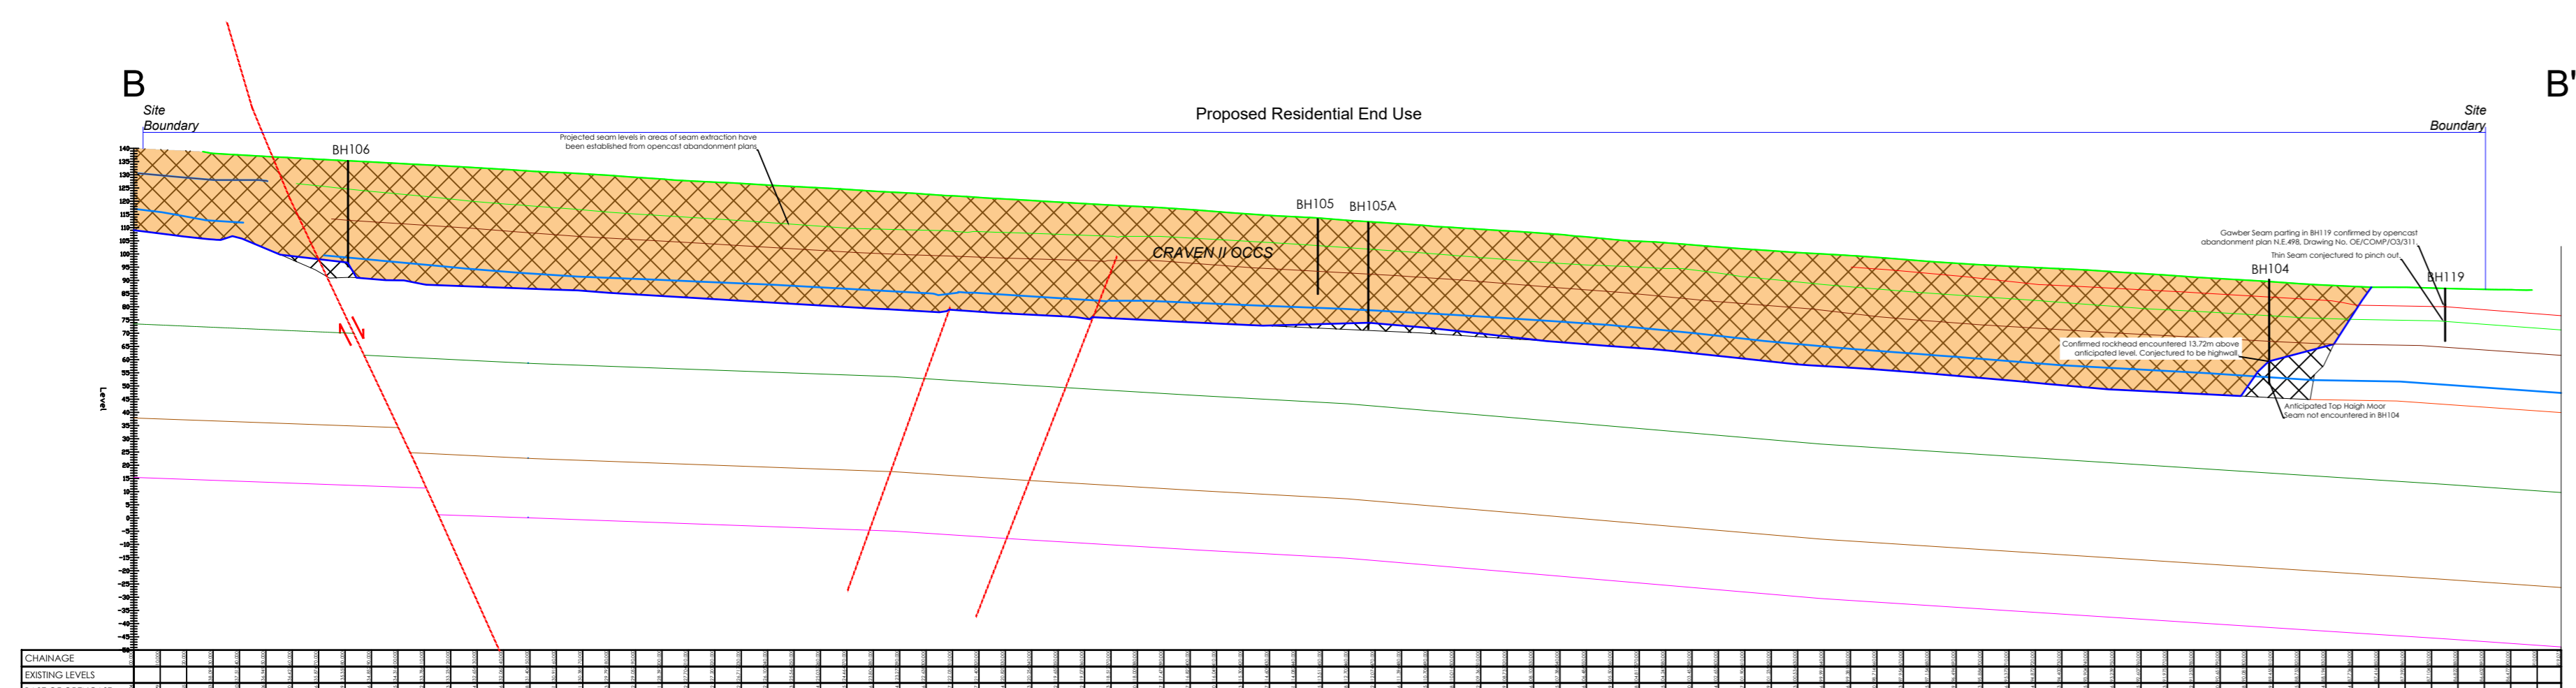
CROSS SECTION B-B', CRAVEN II
 SCALE: 1:2000, DATUM: -50.000

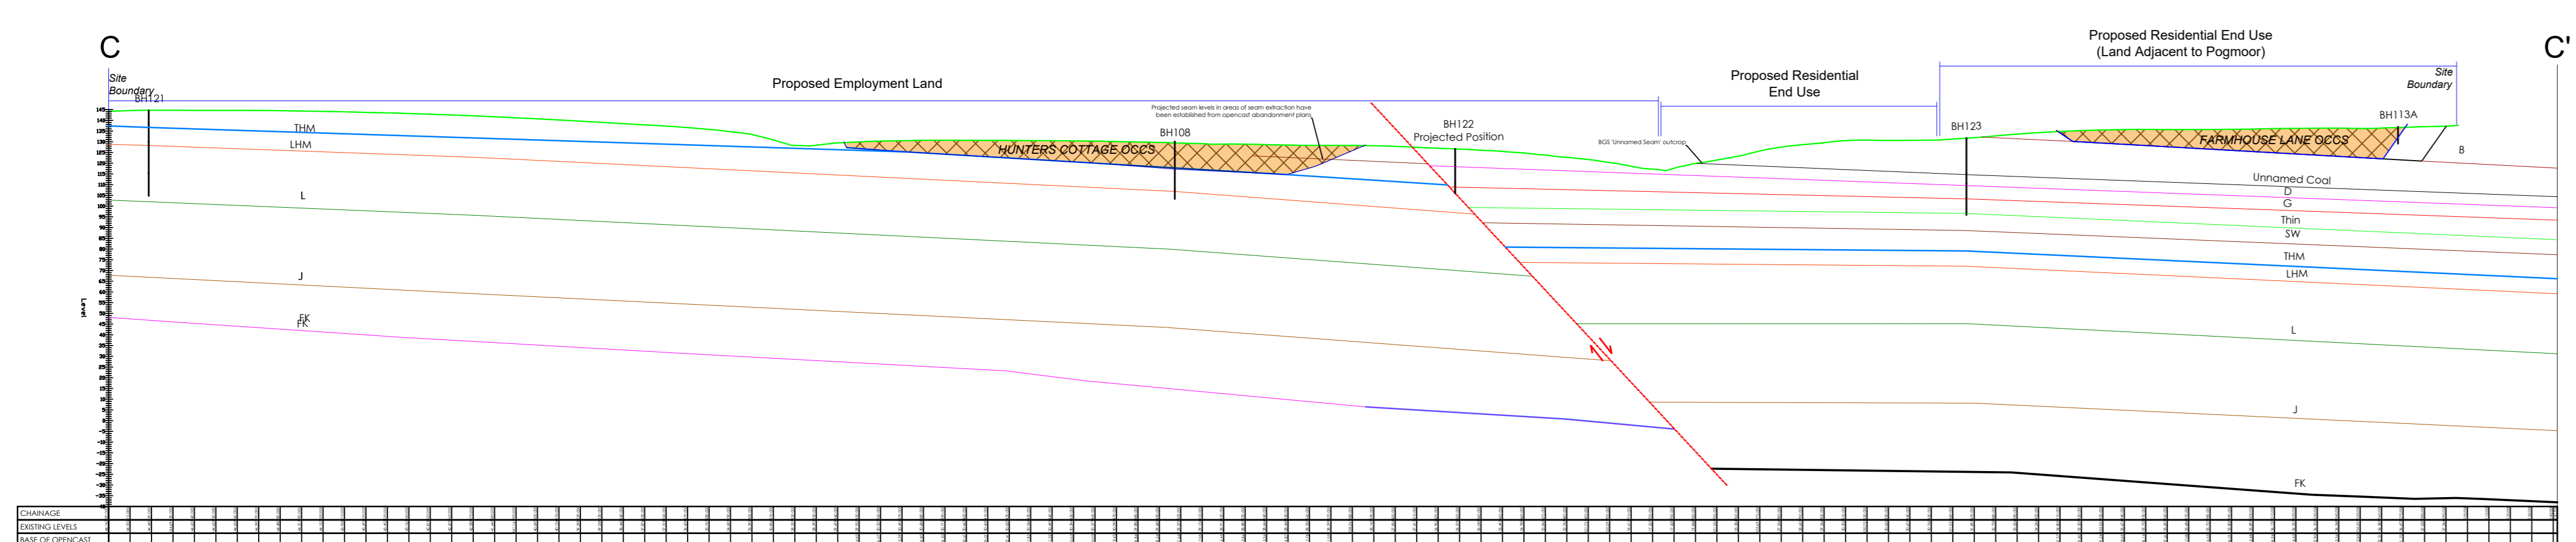
CROSS SECTION C-C'
 POGMOOR & HUNTERS COTTAGE AND EXTENSION
 SCALE: 1:2000

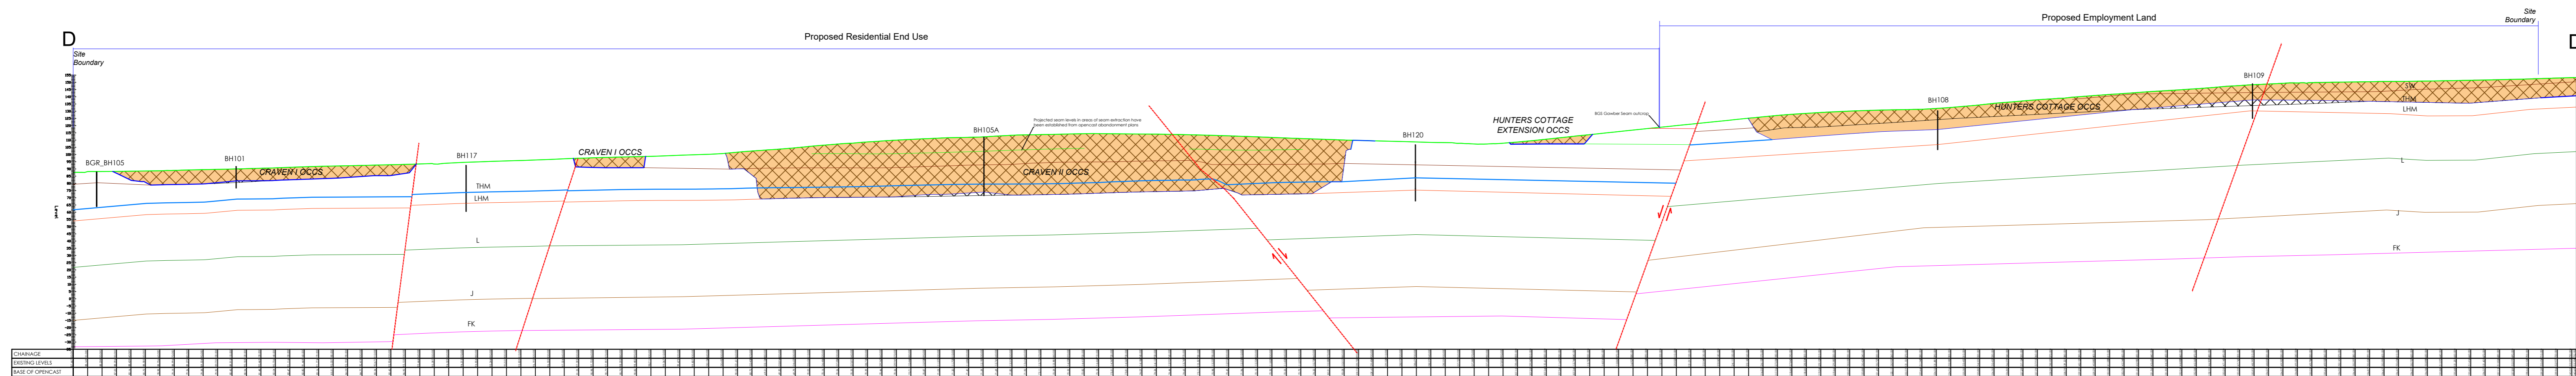
CROSS SECTION D-D'
 SITE OVERVIEW
 SCALE: 1:2000

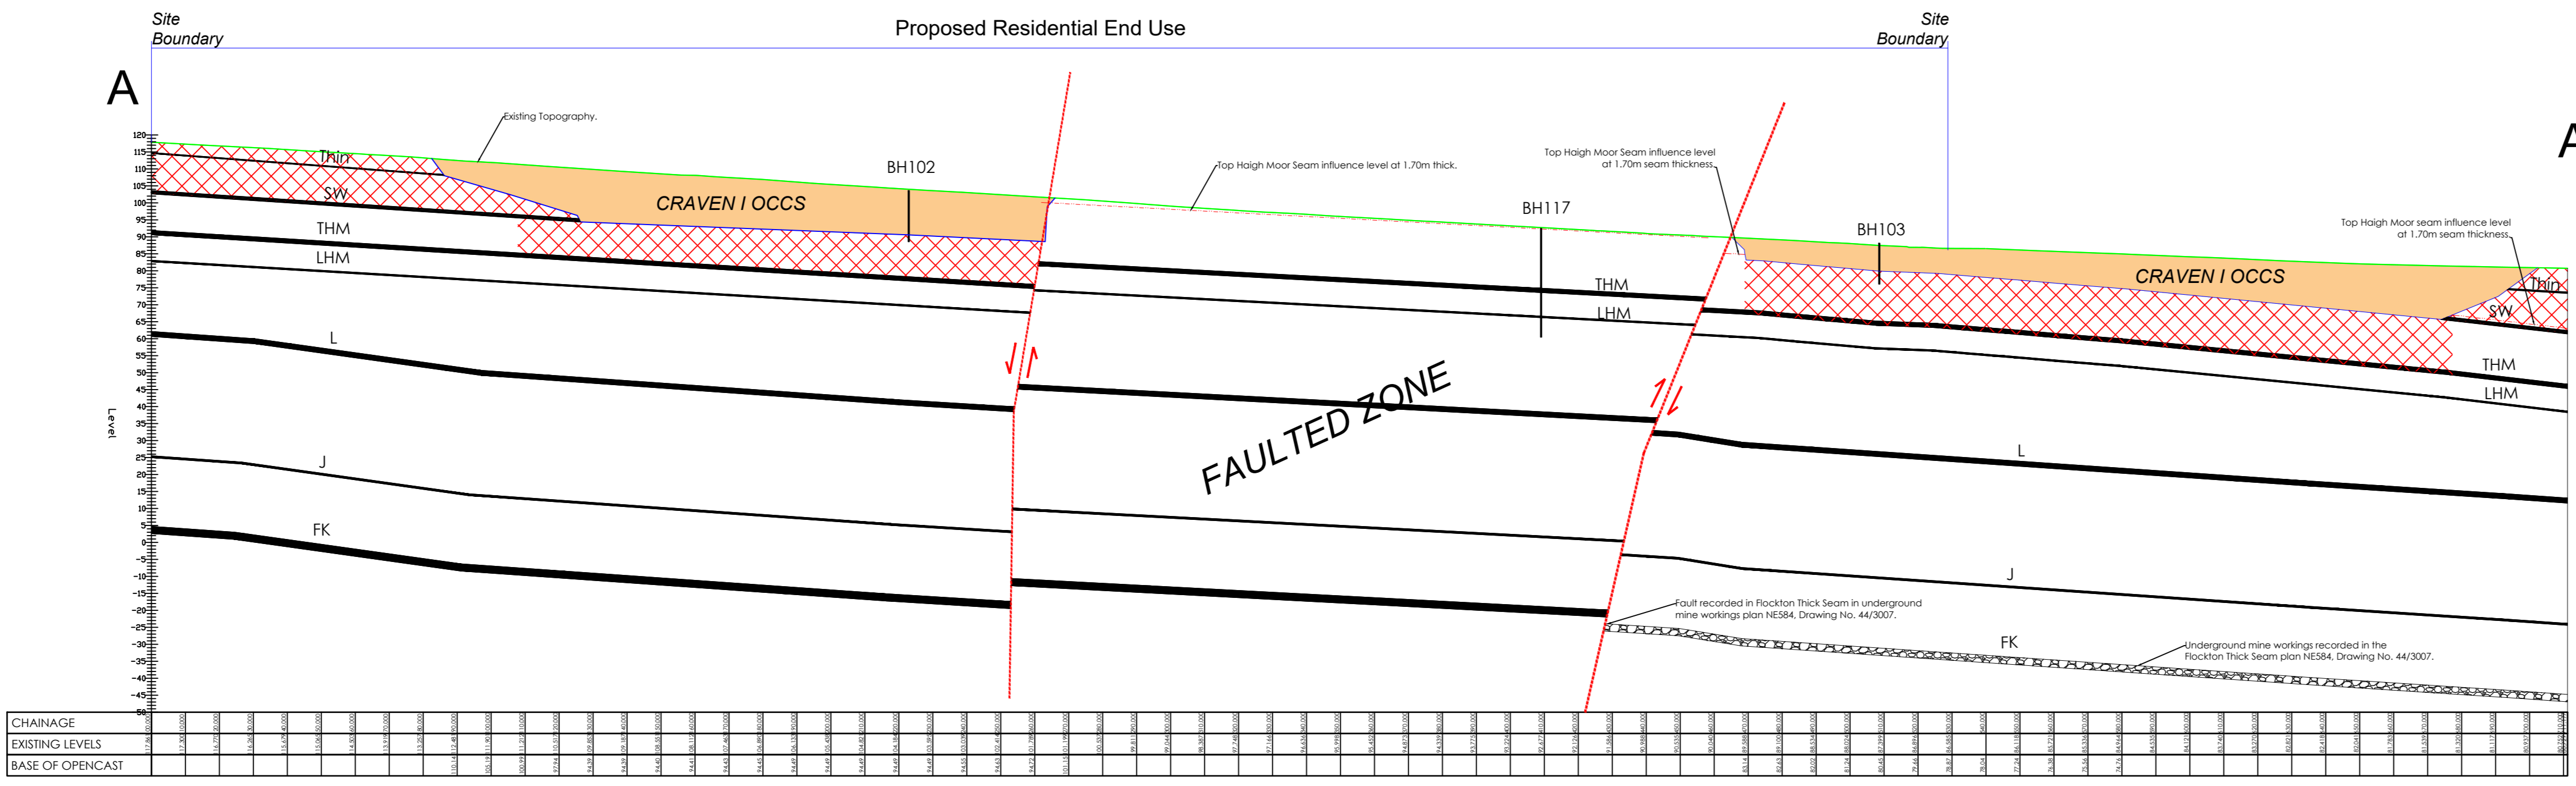
CROSS SECTION A-A', CRAVEN I
 SCALE: 1:1250

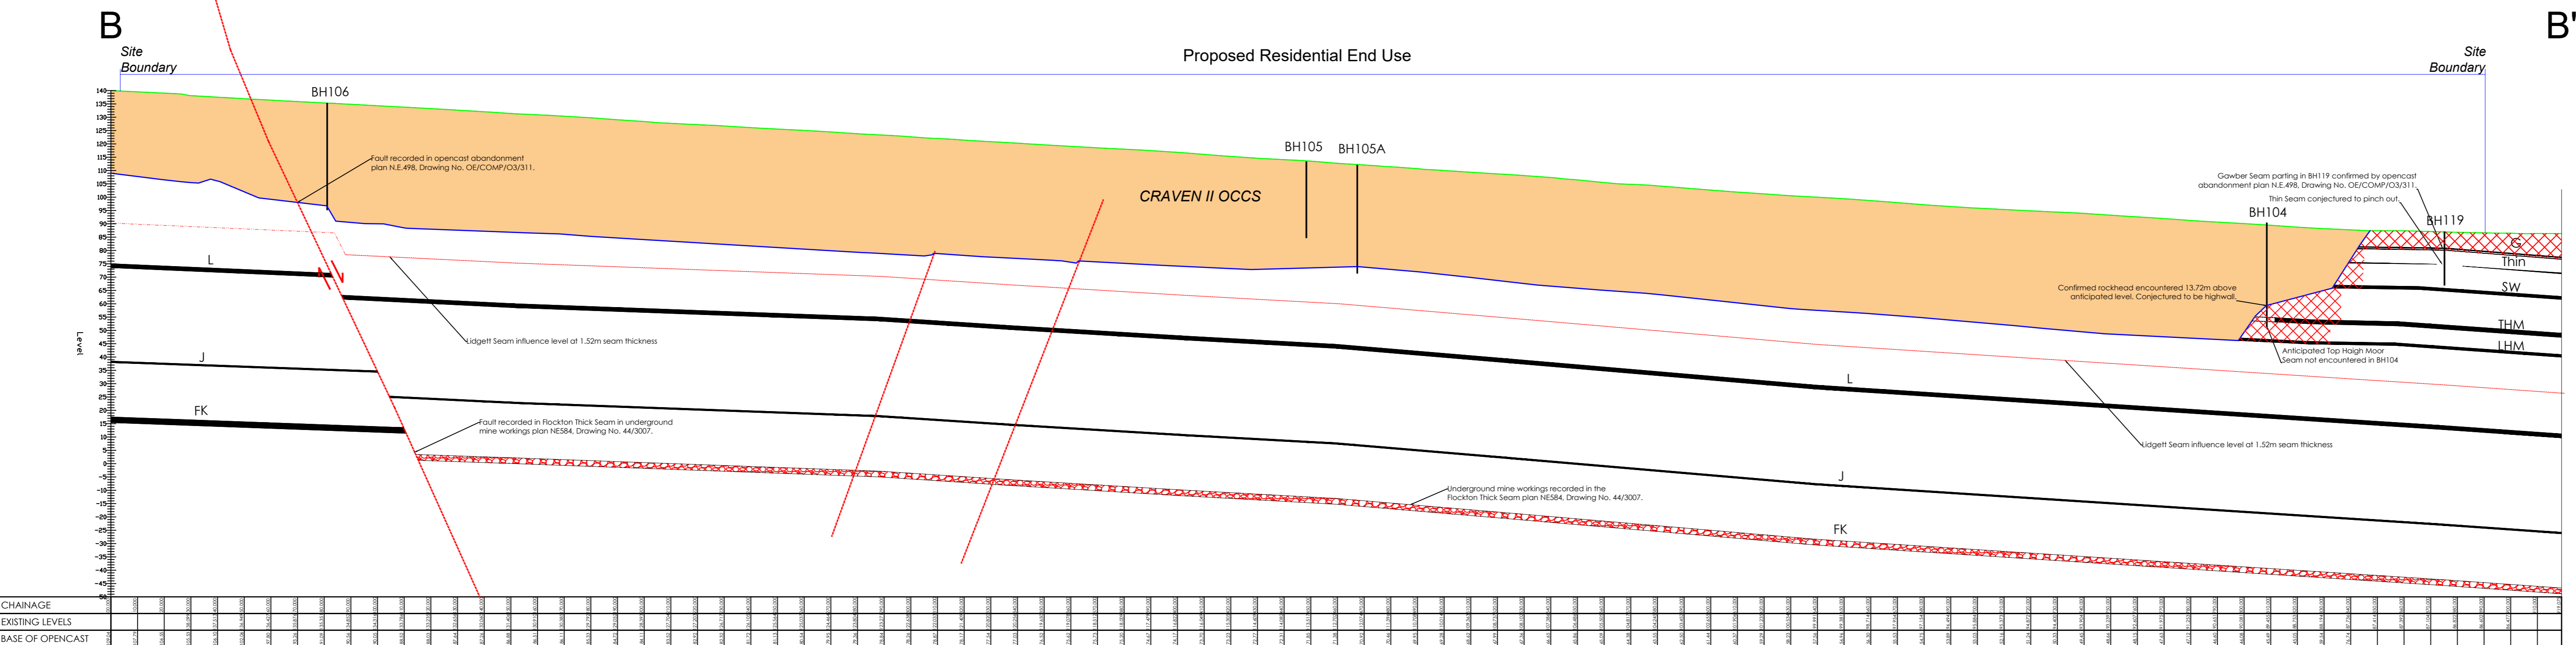
CROSS SECTION B-B', CRAVEN II
 SCALE: 1:1250

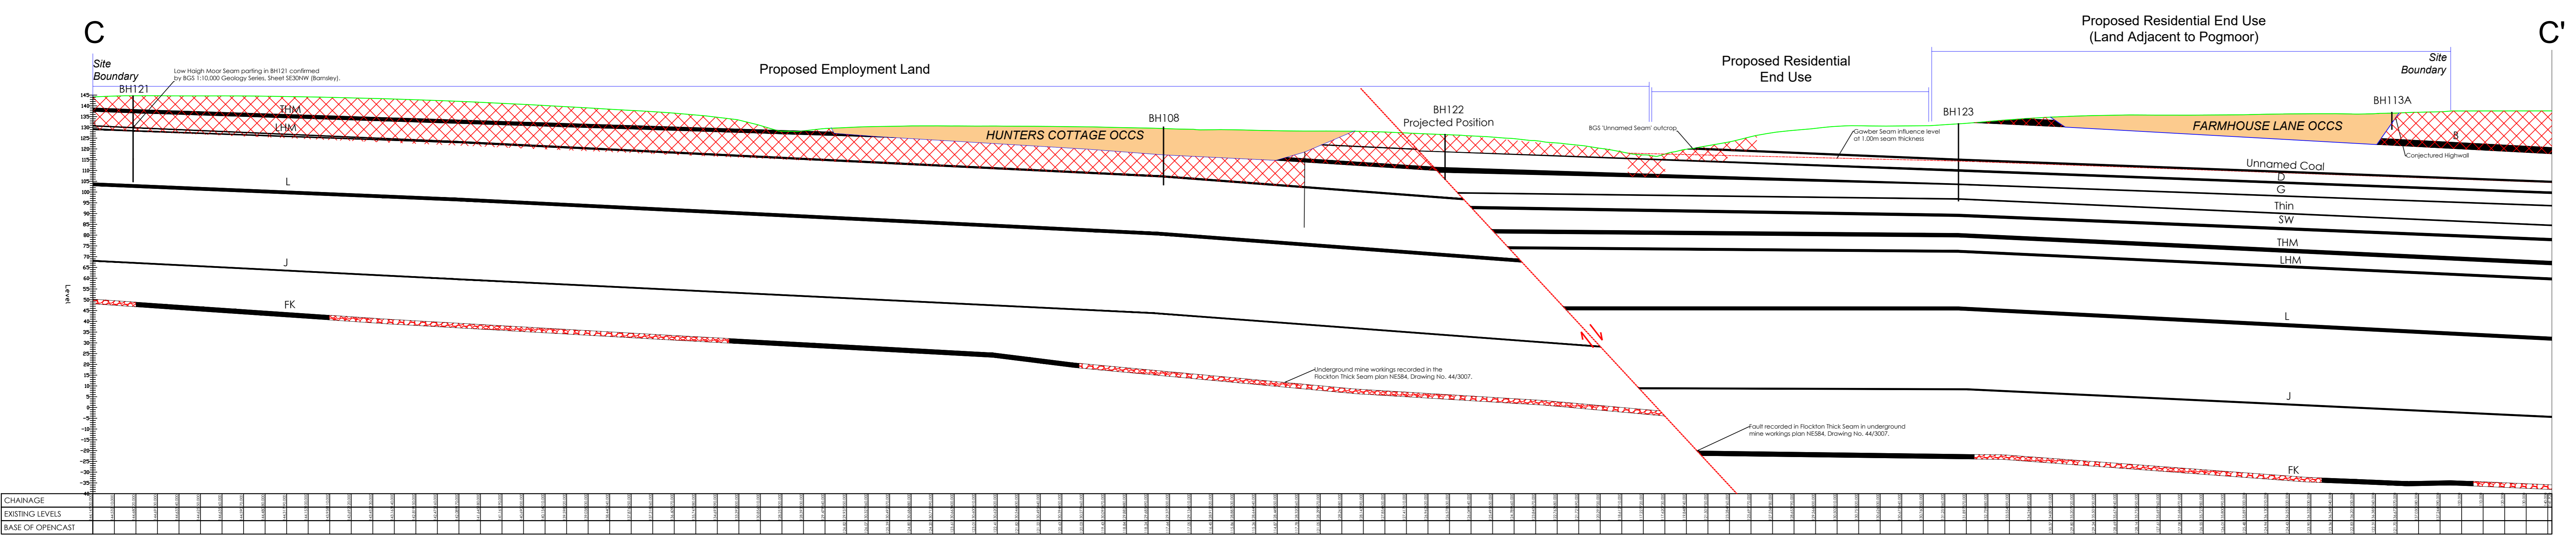
CROSS SECTION C-C'
POGMOOR & HUNTERS COTTAGE AND EXTENSION
 SCALE: 1:1250
