PRELIMINARY GEOENVIRONMENTAL GROUND INVESTIGATION

Barnsley West

4848-JPG-SW-XX-RP-G-0603-S2-P02

July 2019

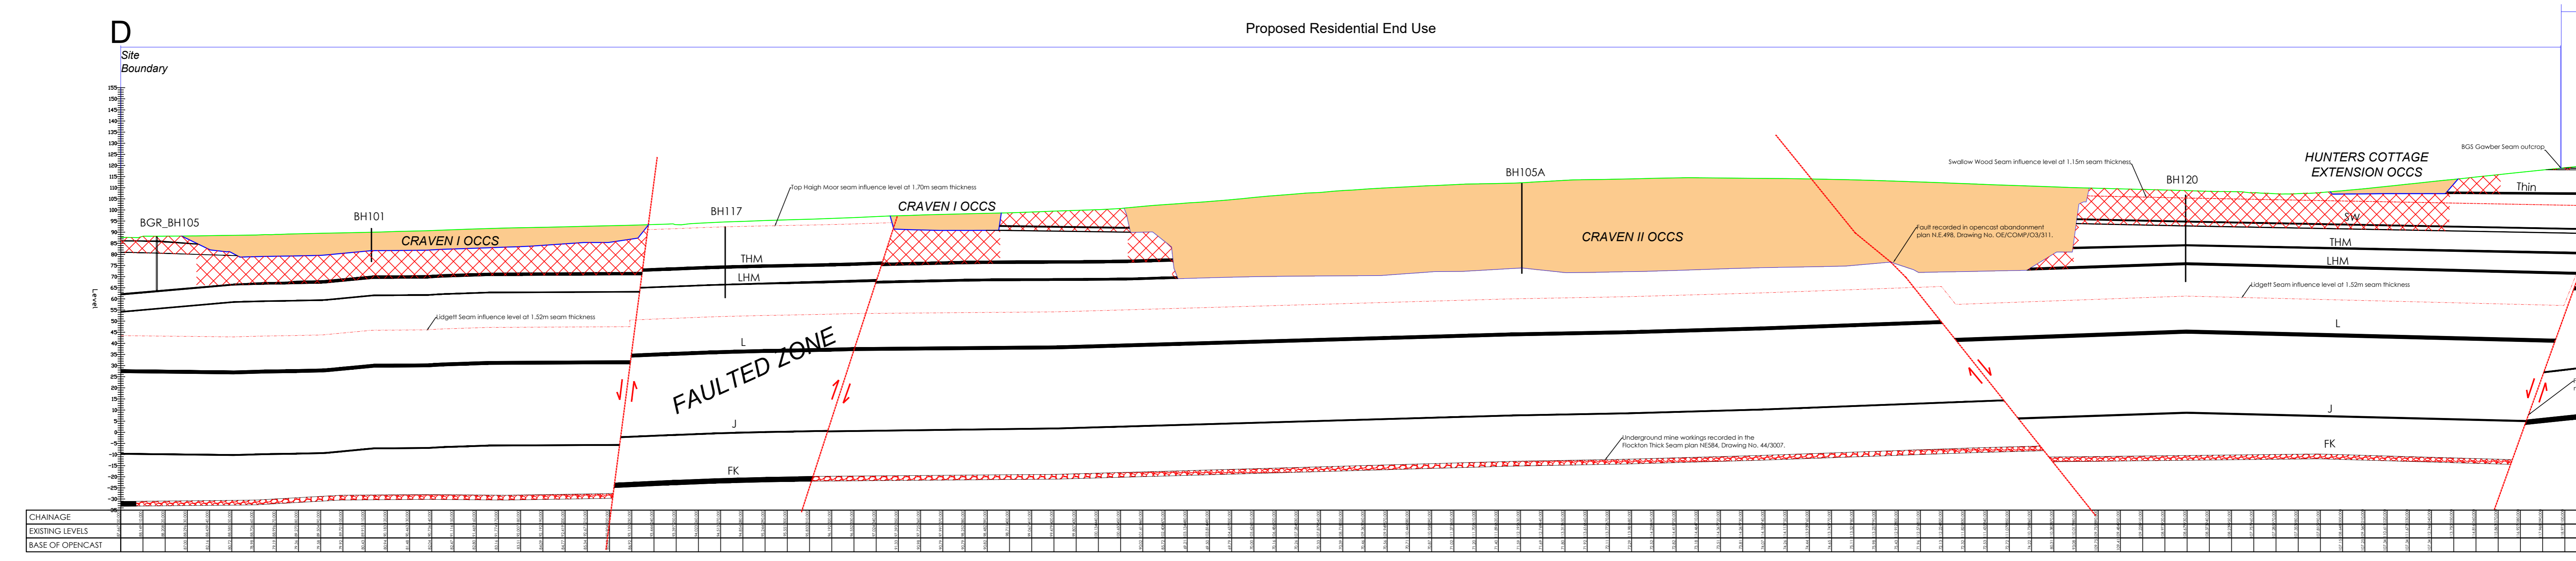
CROSS SECTION D-D'
SITE OVERVIEW
SCALE: 1:1250

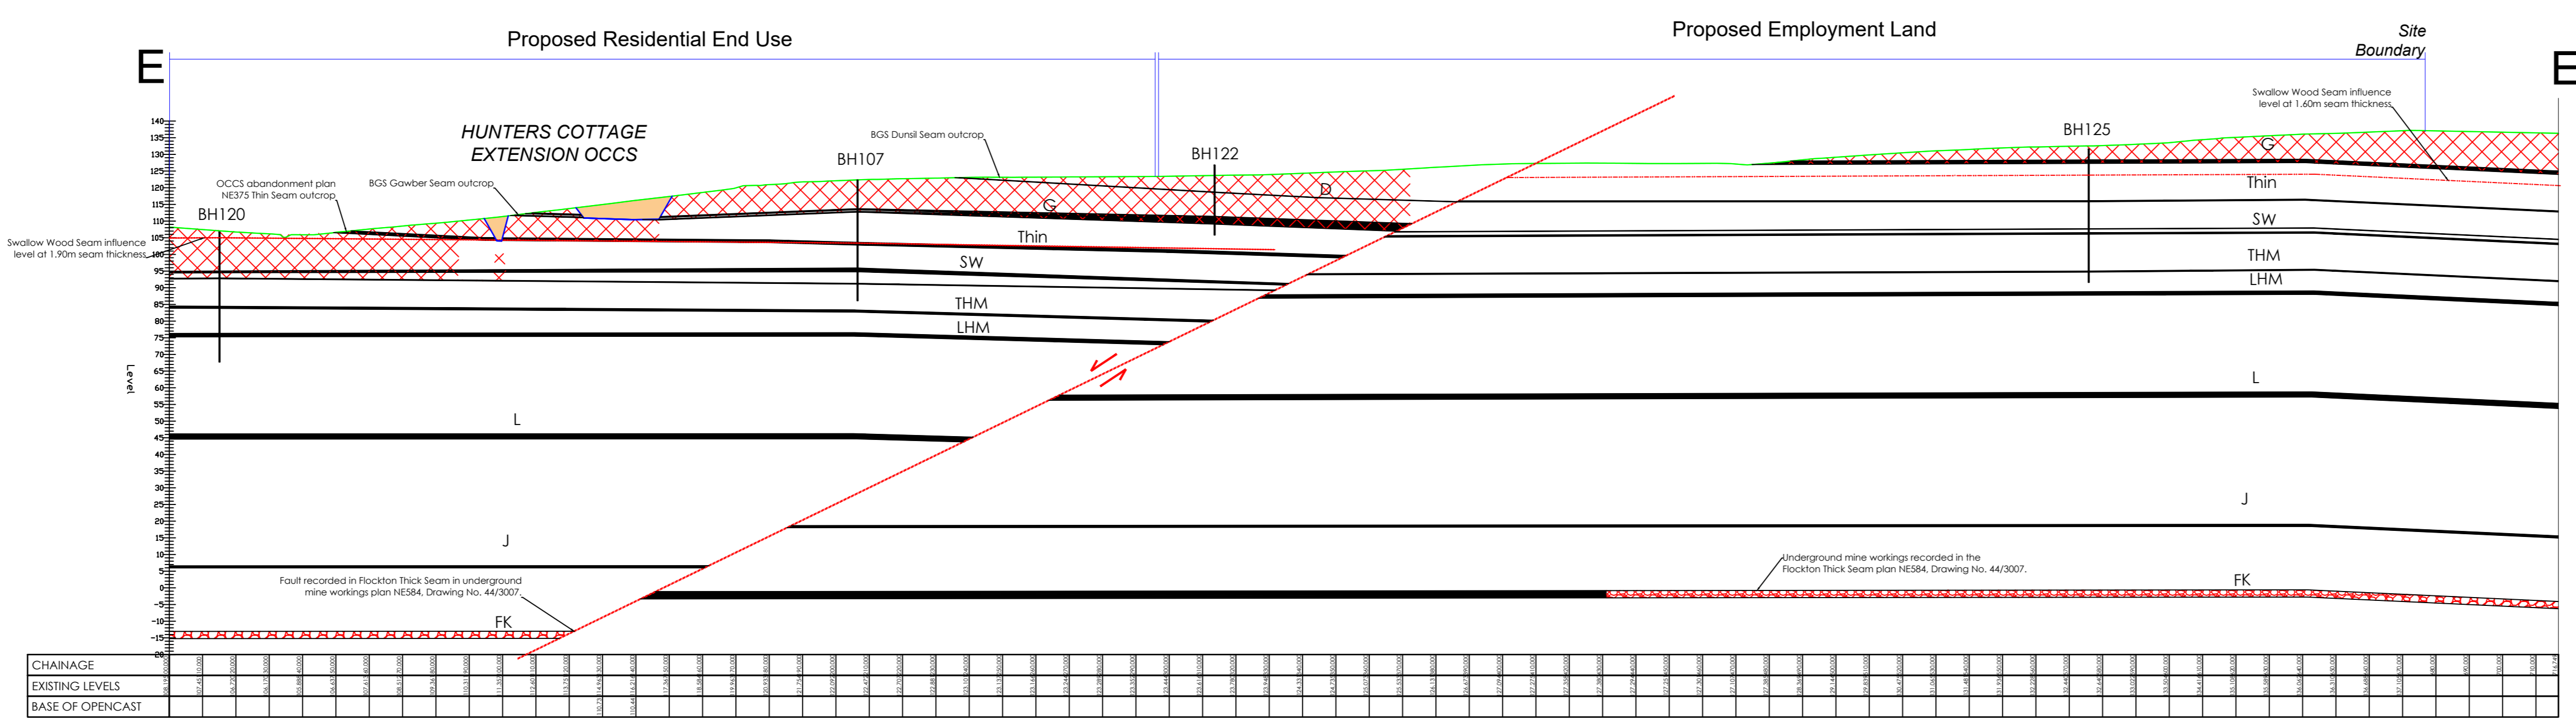
CROSS SECTION E-E'
HUNTERS COTTAGE EXTENSION
SCALE: 1:1250

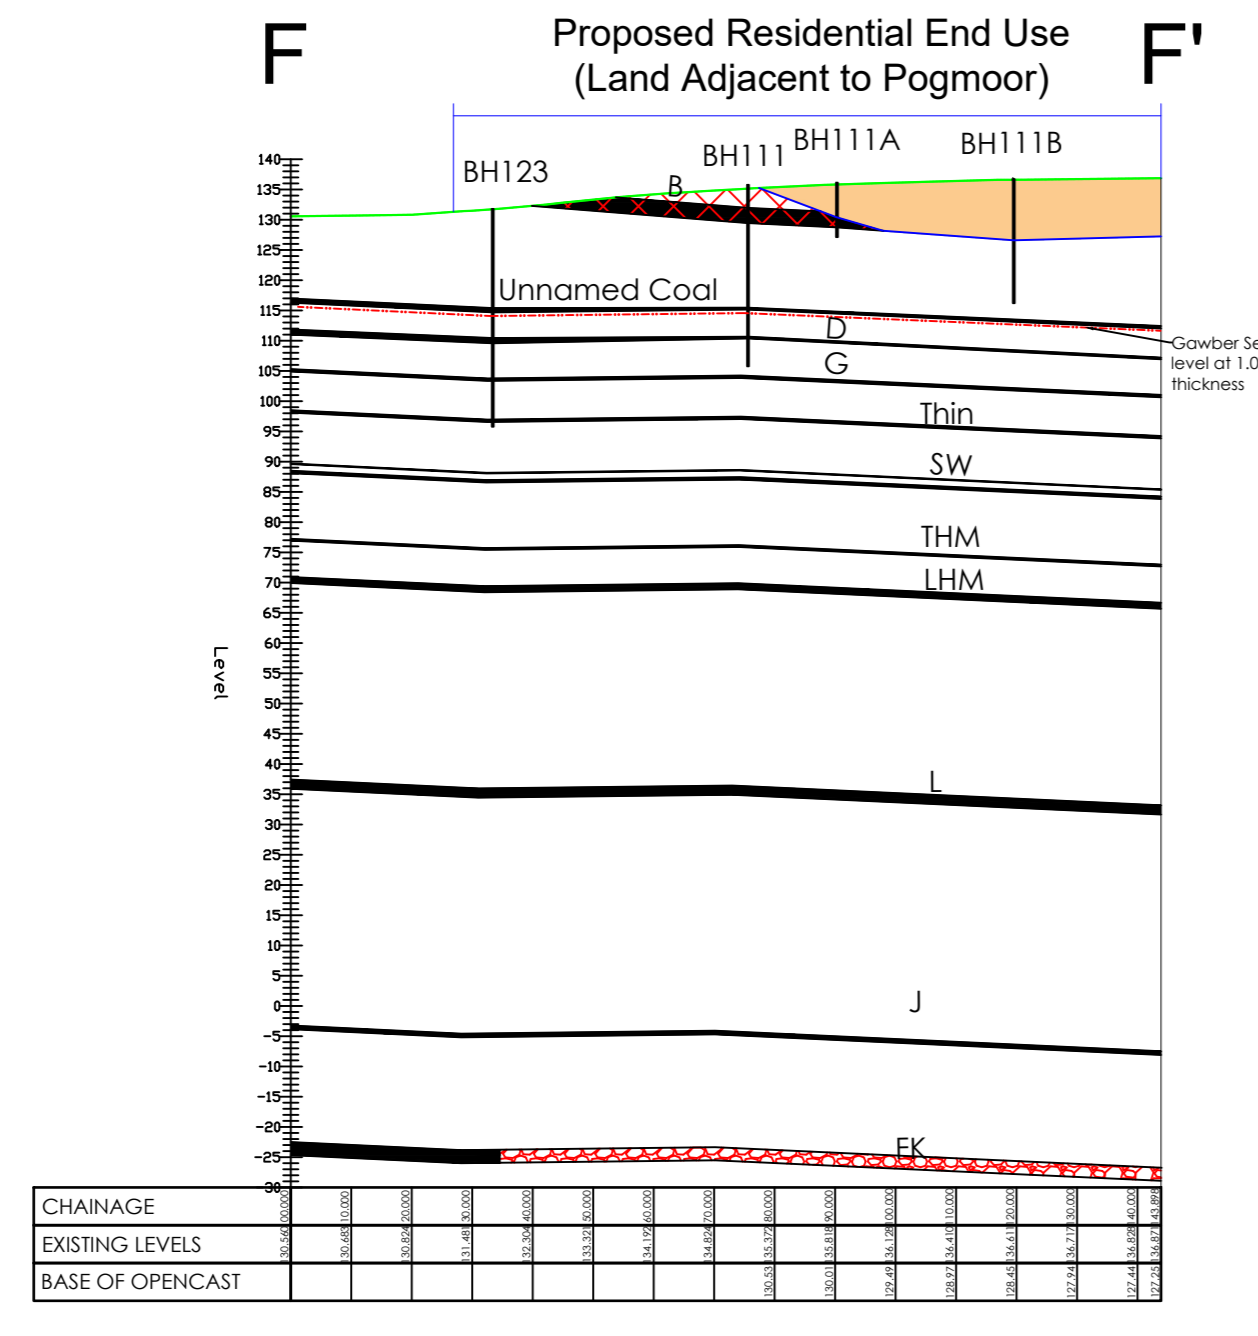
CROSS SECTION F-F'
FARMHOUSE LANE
SCALE: 1:1250

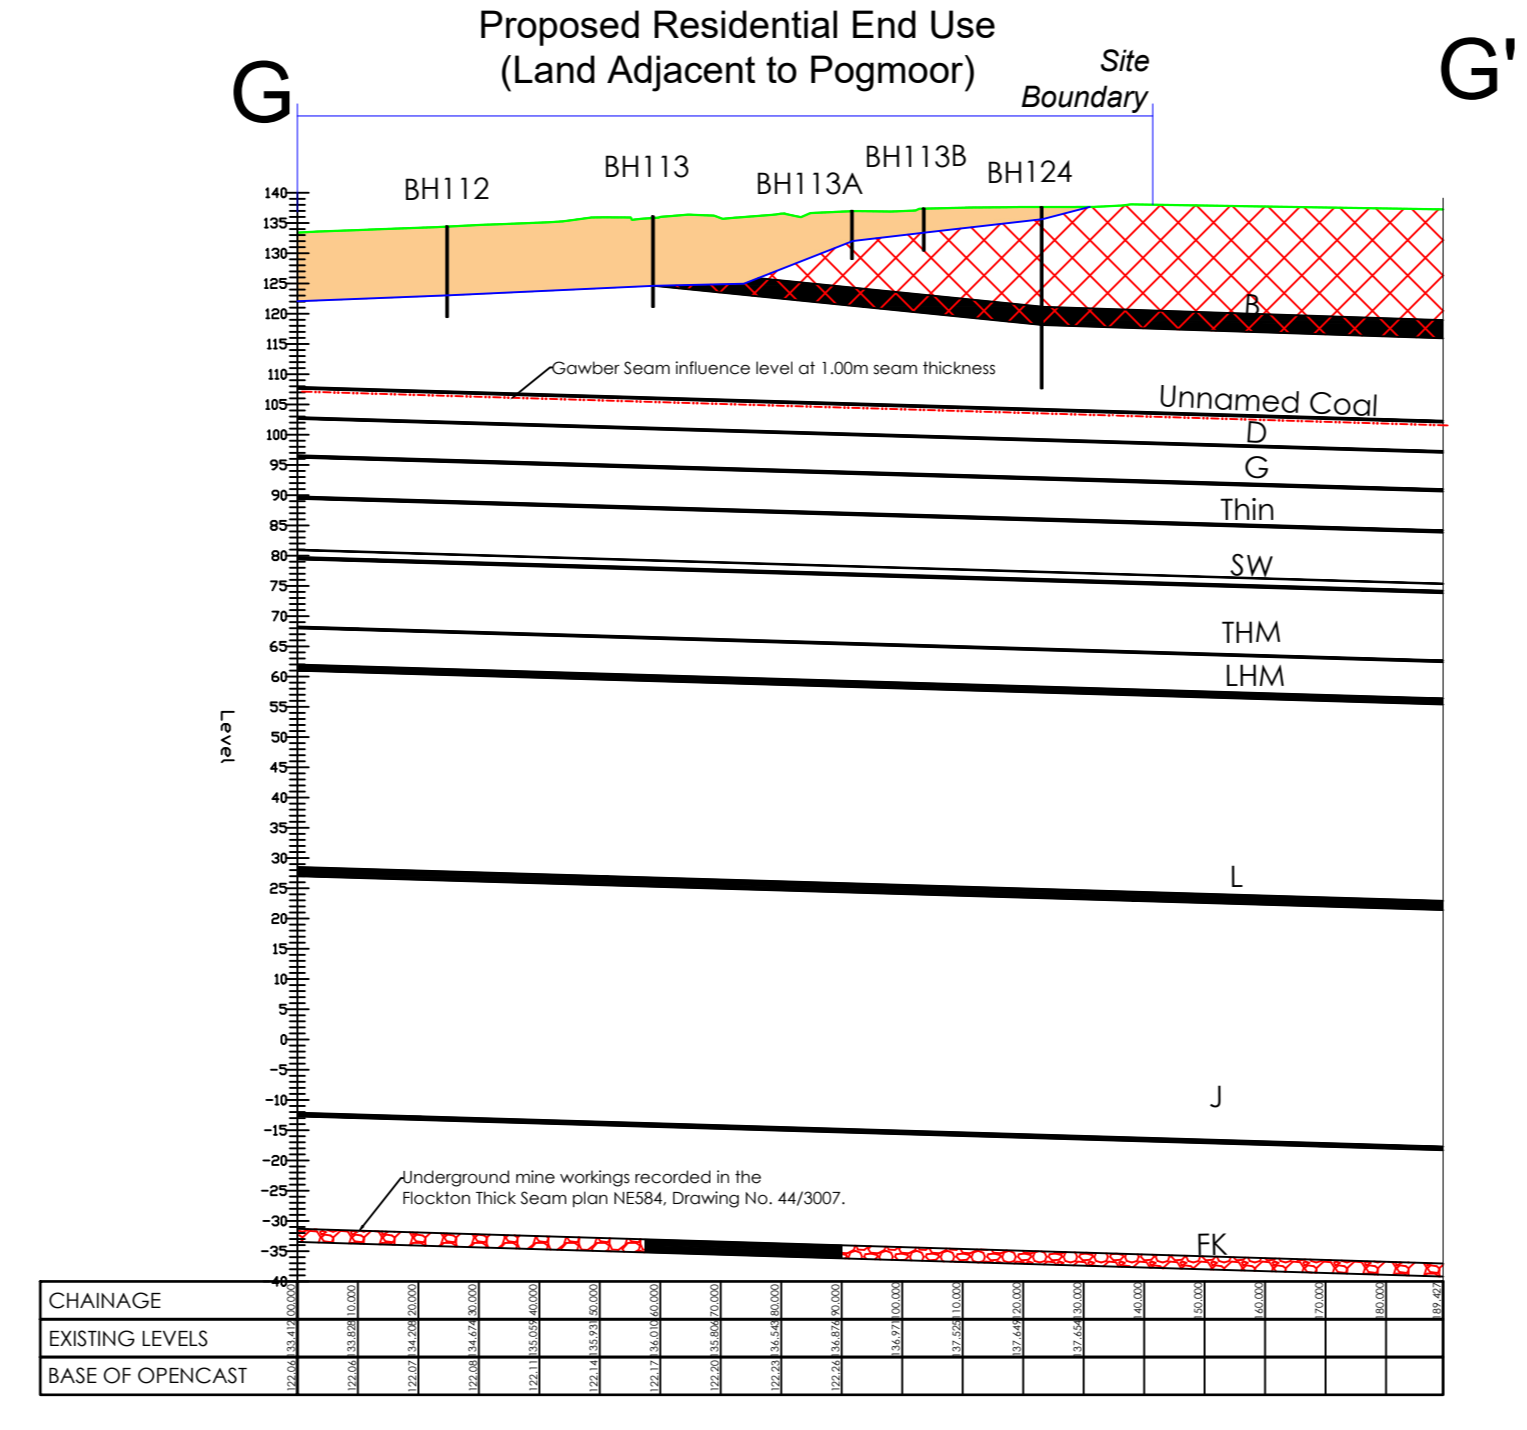
CROSS SECTION G-G'
FARMHOUSE LANE
SCALE: 1:1250

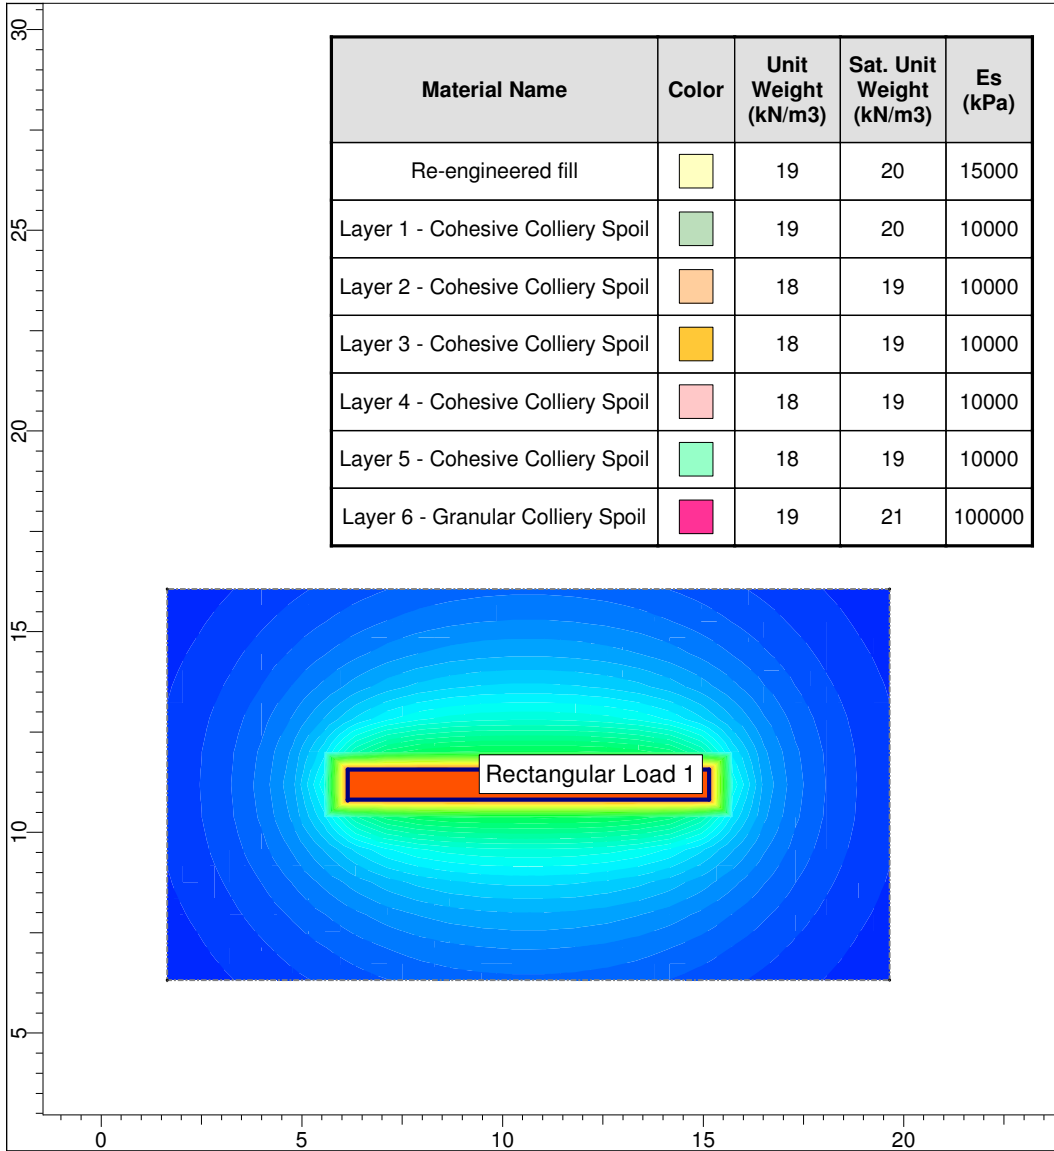
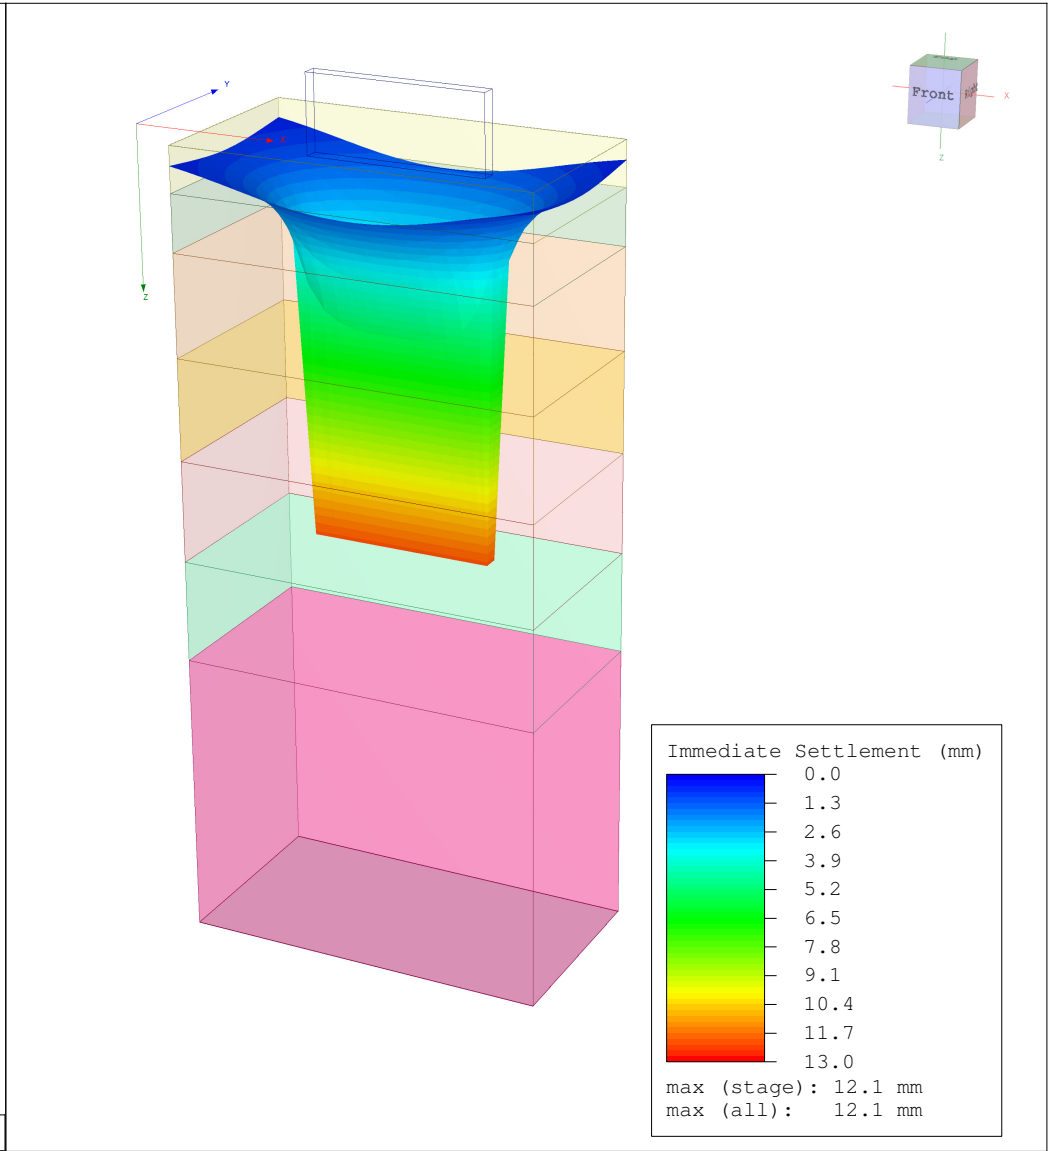
Project	4848 - Barnsley West	
	Analysis Description	Boussinesq - Immediate Settlement Only_Craven I & II	
	Drawn By	JAM	Company JPG (Leeds) Ltd
	Date	21/06/2019, 10:24:47	File Name 4848 - Craven I & II_Reinforced strips_60kPa_Empirical parameters.s3z

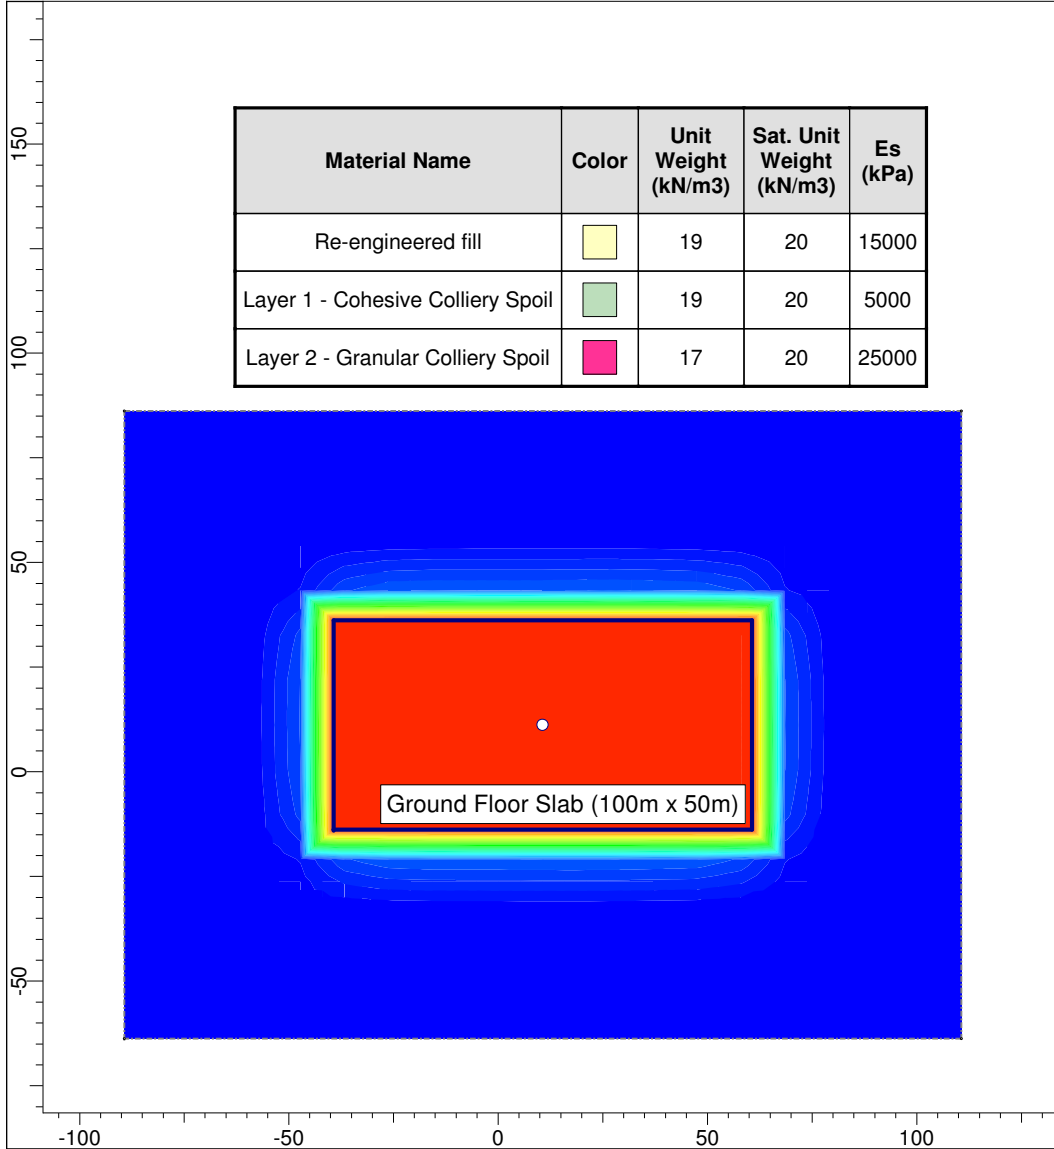
Project	4848 - Barnsley West	
	Analysis Description	Boussinesq - Immediate Settlement Only_Hunters Cottage	
	Drawn By	JAM	Company JPG (Leeds) Ltd
	Date	21/06/2019, 10:24:47	File Name 4848 - Hunters Cottage_GB Slab_25kPa_Empirical parameters.s3z

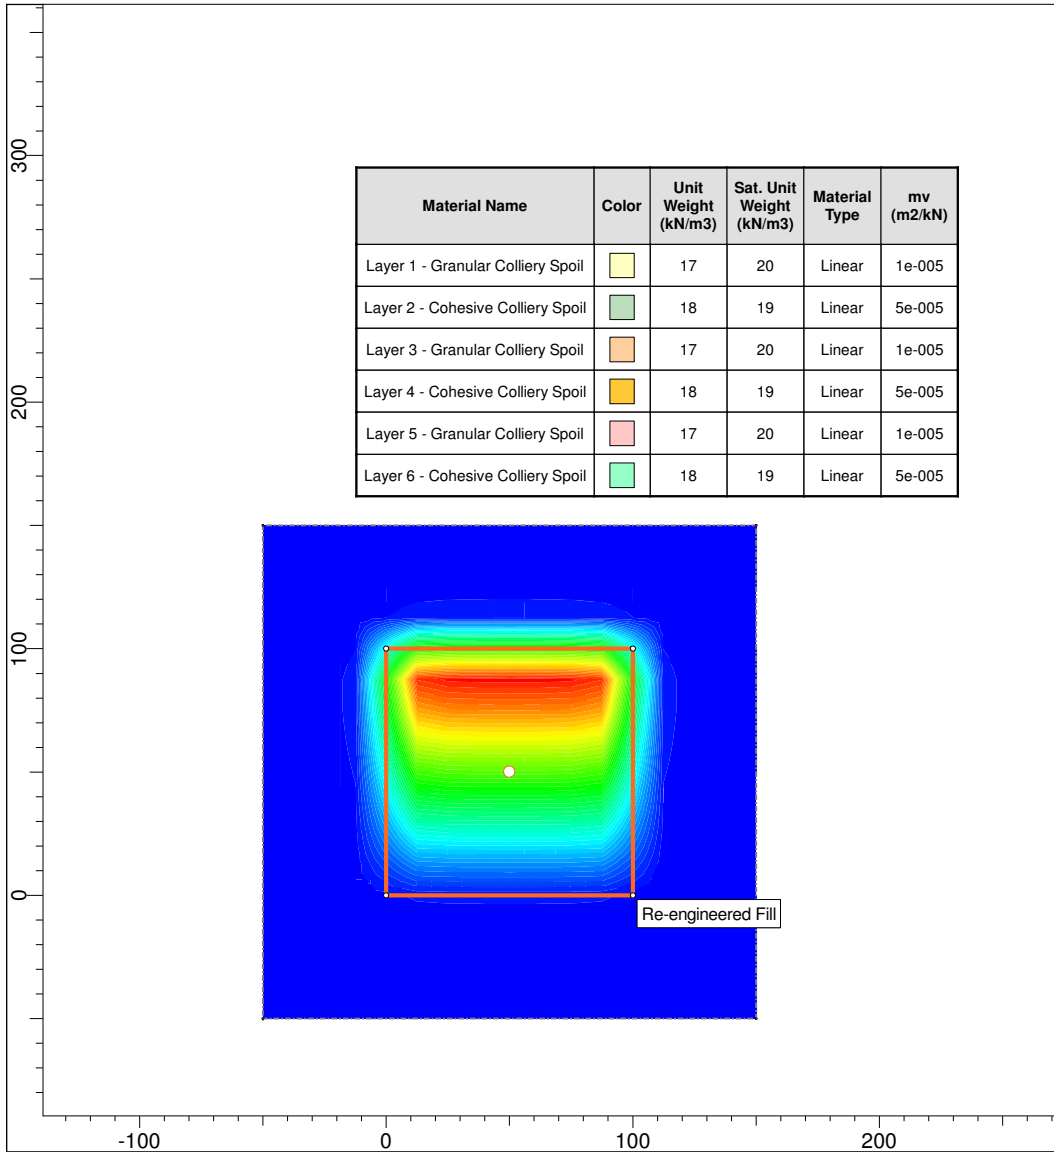
Project	4848 - Barnsley West	
	Analysis Description	Boussinesq - Consolidation Settlement Only_Craven I	
	Drawn By	JAM	Company JPG (Leeds) Ltd
	Date	21/06/2019, 09:20:59	File Name 4848 - CI_Consolidation_re-engineered fill_Empirical Parameters - Conv s3z

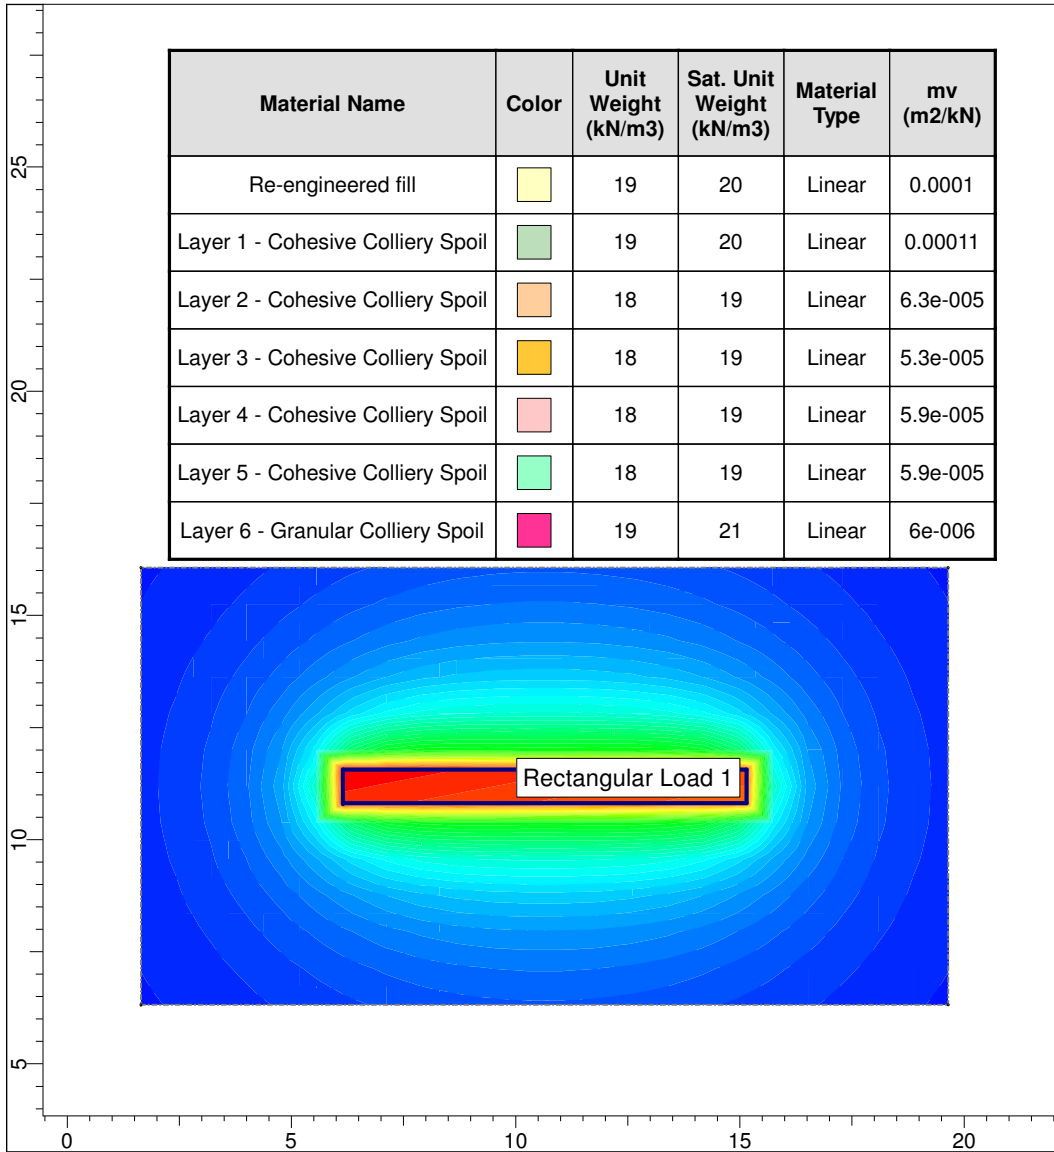
Project	4848 - Barnsley West	
	Analysis Description	Boussinesq - Consolidation Settlement Only_Craven I & II	
	Drawn By	JAM	Company JPG (Leeds) Ltd
	Date	21/06/2019, 10:24:47	File Name 4848 - Craven I & II_Reinforced strips_60kPa_Empirical parameters.s3z
