Harworth Group

Hay Green Lane, Birdwell

Phase 2 Geo-environmental Site Investigation

350283-R02 (00)

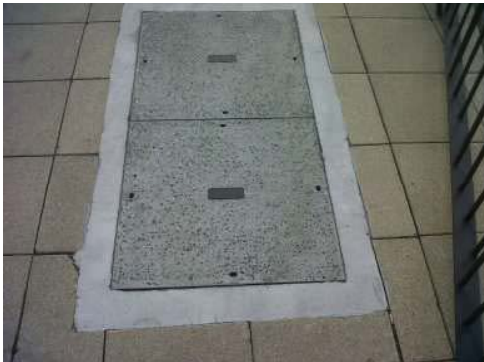
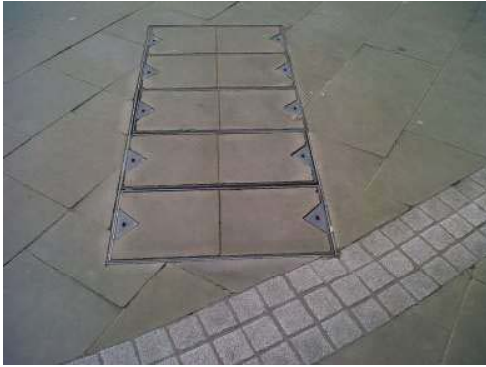
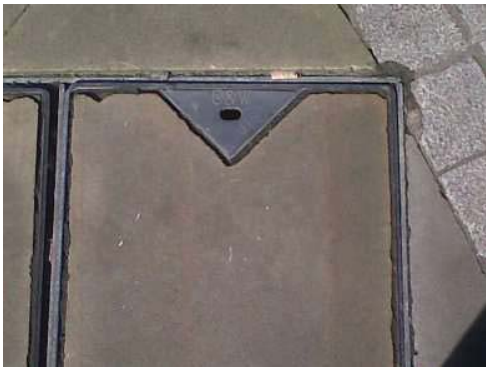
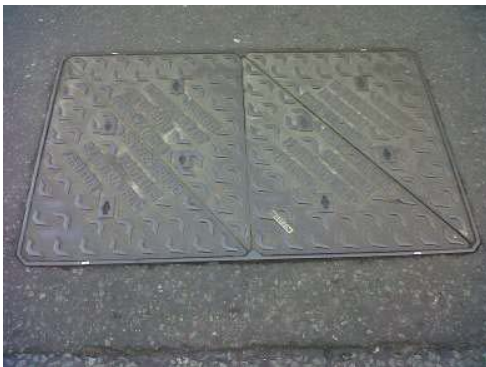
Our apparatus is installed in roads and streets of UK and Ireland, however in some places is undistinguishable from other operators' apparatus, for example in City Centres where high quality infill modular paving chamber covers are found; some with labels and some without.

See below as examples:

The apparatus shown here is now owned, maintained and still in operation by Vodafone and includes.

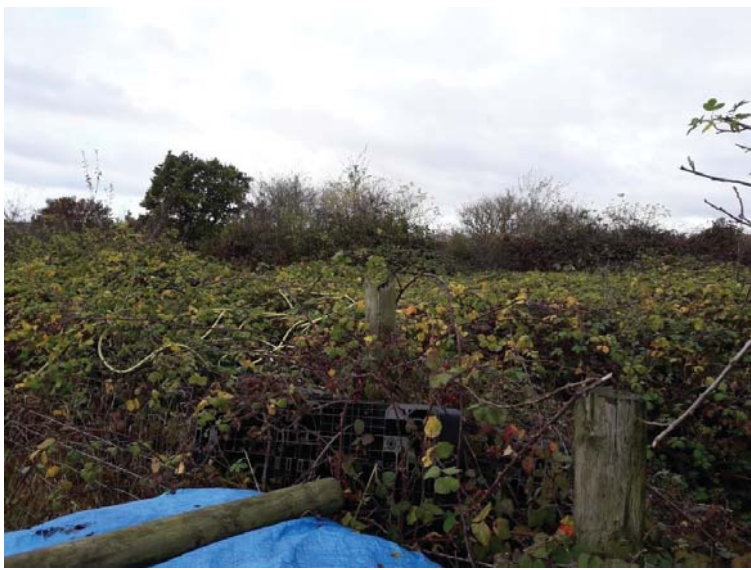
Photo No. 7	Date: 08.11.2019

Direction Photo Taken: North west		
Description: View of densely vegetated inaccessible land in the western part of site

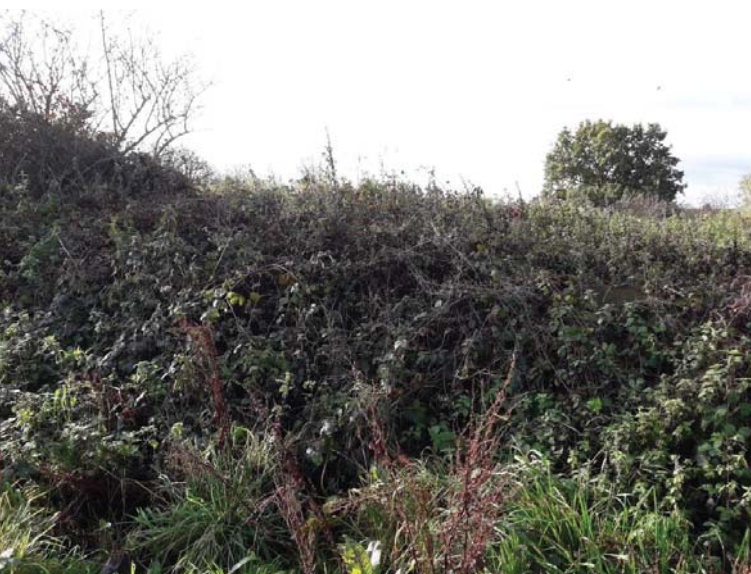
Photo No. 8	Date: 08.11.2019

Direction Photo Taken: South west		
Description: View of densely vegetated inaccessible land in the western part of site

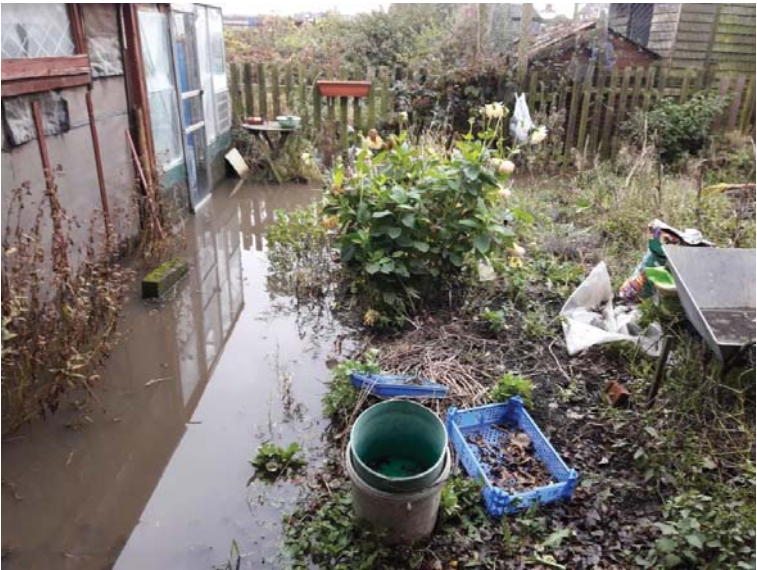
Photo No. 11	Date: 08.11.2019

Direction Photo Taken: South		
Description: Flooded allotment

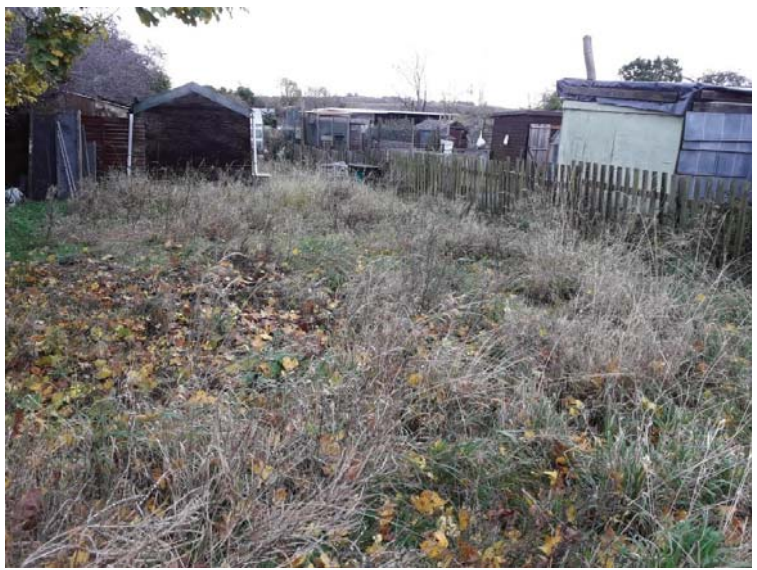
Photo No. 12	Date: 08.11.2019

Direction Photo Taken: South east		
Description: View across allotments

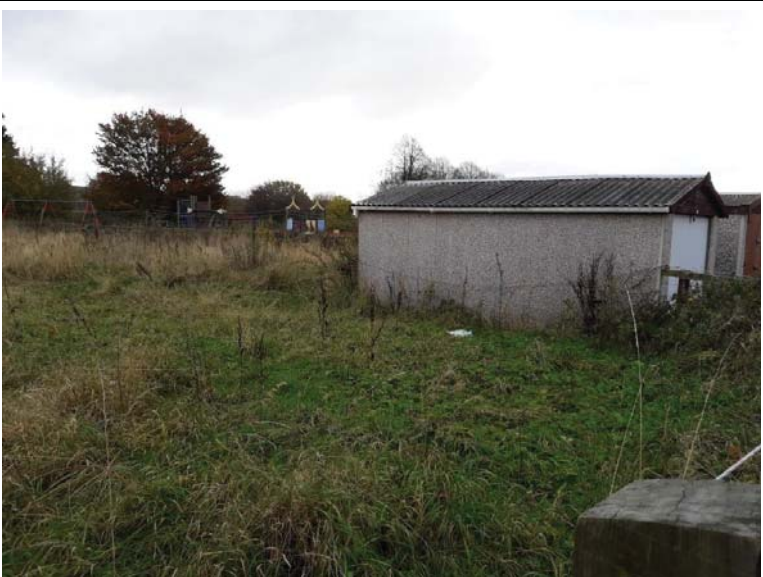
Photo No. 14	Date: 08.11.2019

Direction Photo Taken: South east		
Description: Garages with possible asbestos cement sheet roofing

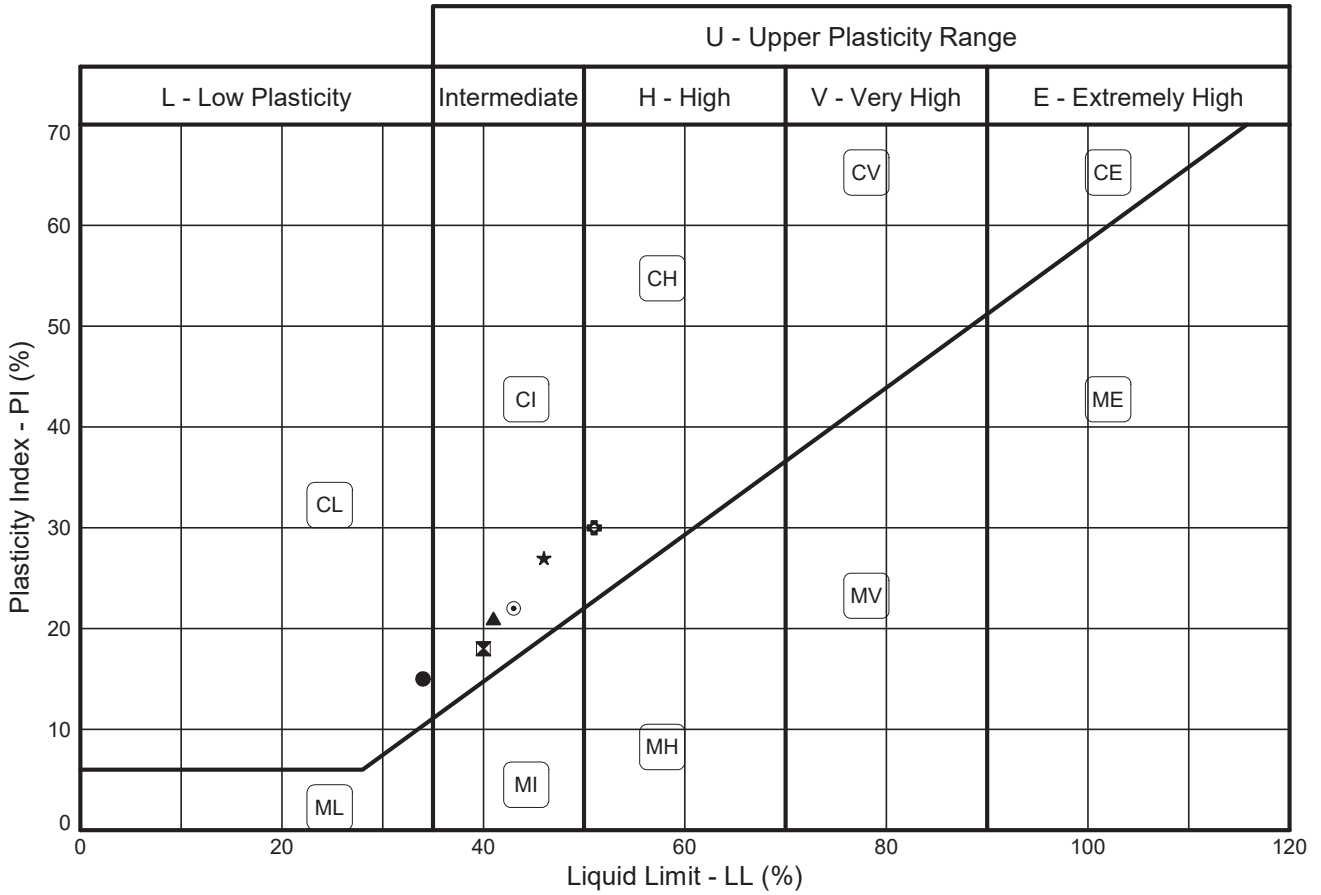
Sample Identification			BS Test Method #	Preparation Method +	MC %	LL %	PL %	PI %	<425um %	Lab location	
Exploratory Position ID	Sample	Depth (m)									
●	TP01	D	0.75	3.2/4.3/5.3/5.4	4.2.4	17	34	19	15	70	C
⊠	TP02	D	0.40	3.2/4.3/5.3/5.4	4.2.4	25	40	22	18	86	C
▲	TP02	D	0.80	3.2/4.3/5.3/5.4	4.2.4	23	41	20	21	97	C
★	TP04	D	2.50	3.2/4.3/5.3/5.4	4.2.4	15	46	19	27	86	C
⊙	TP06	D	1.20	3.2/4.3/5.3/5.4	4.2.4	20	43	21	22	94	C
⊕	TP07	D	1.50	3.2/4.3/5.3/5.4	4.2.4	20	51	21	30	99	C

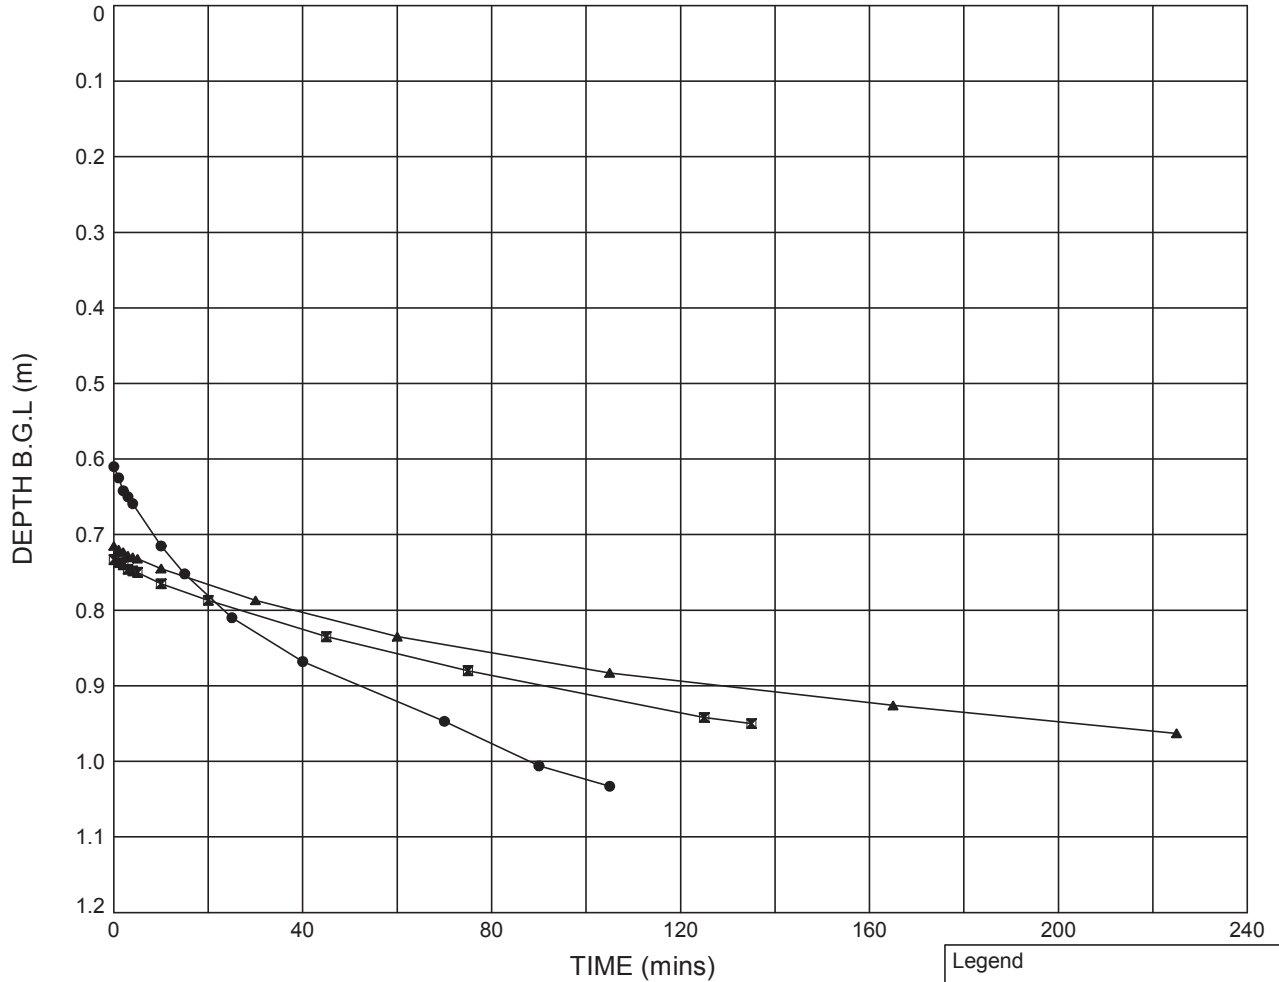
Plot of Depth of Water Below Ground Level Against Time

Test 1	Test 2	Test 3	
Pit start depth:	1.15	1.15	1.10	m
Pit final depth:	1.15	1.10	1.10	m
Effective depth, D_e	0.54	0.37	0.39	m
Effective storage volume, V_{p75-25}	0.3969	0.2697	0.2830	m^3
Surface area, a_{p50}	2.9820	2.4976	2.5480	m^2
Time, t_{p75-25}	4857	10089	14756	secs
Infiltration rate, f	2.74×10^{-5}	1.07×10^{-5}	7.53×10^{-6}	m/s

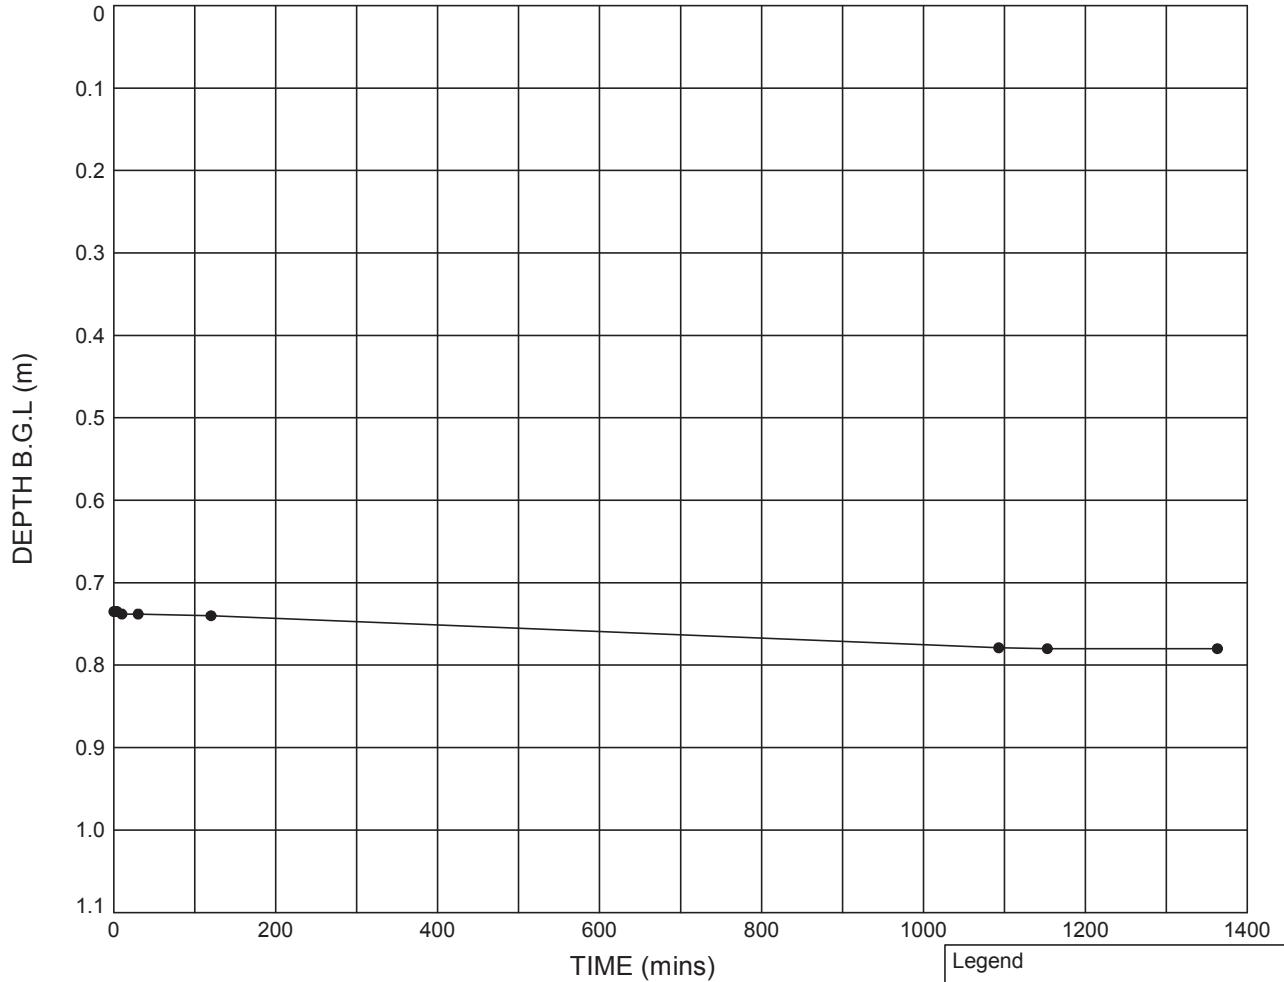
Plot of Depth of Water Below Ground Level Against Time

Pit start depth: = **1.10** m
 Pit final depth: = **1.10** m
 Effective depth, D_e = **0.37** m
 Effective storage volume, V_{p75-25} = **0.2172** m³
 Surface area, a_{p50} = **2.0660** m²
 Time, t_{p75-25} = **2956500** secs
 Infiltration rate, f = **3.56×10^{-8}** m/s

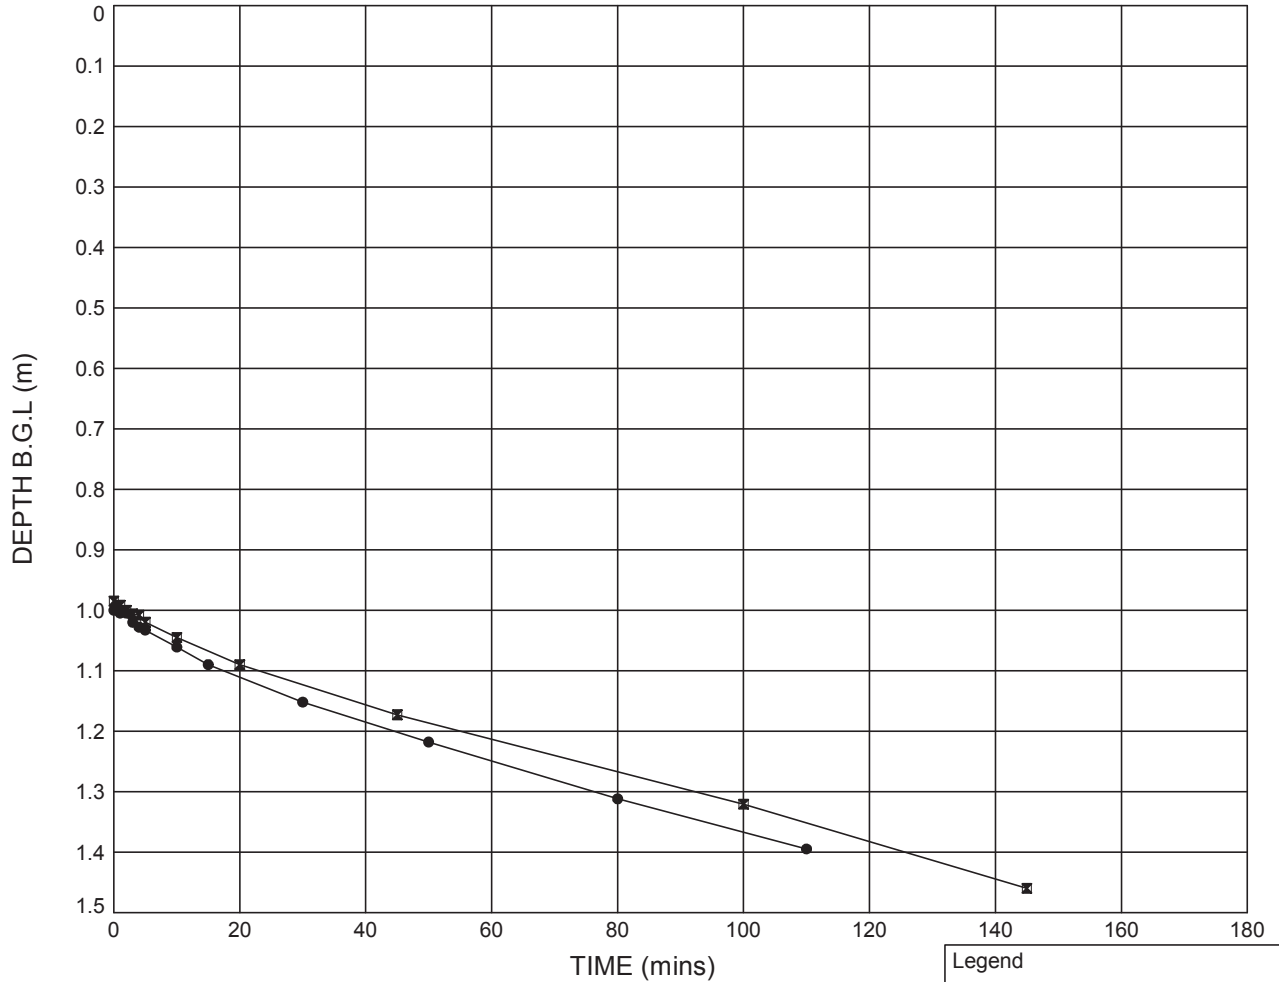
Plot of Depth of Water Below Ground Level Against Time

Test 1	Test 2	
Pit start depth:	= 1.50	1.50	m
Pit final depth:	= 1.50	1.50	m
Effective depth, D_e	= 0.50	0.52	m
Effective storage volume, V_{p75-25}	= 0.3150	0.3245	m^3
Surface area, a_{p50}	= 2.5100	2.5475	m^2
Time, t_{p75-25}	= 4758	5347	secs
Infiltration rate, f	= 2.64×10^{-5}	2.38×10^{-5}	m/s
