**GEOTECHNICAL AND GEO-ENVIRONMENTAL
SITE INVESTIGATION**

**FORMER MOORLAND PLASTICS SITE
BARNSELY**

GLEESON DEVELOPMENTS LTD

Job No. : 34235
Report Status : Final
Document Date : 11 January 2012

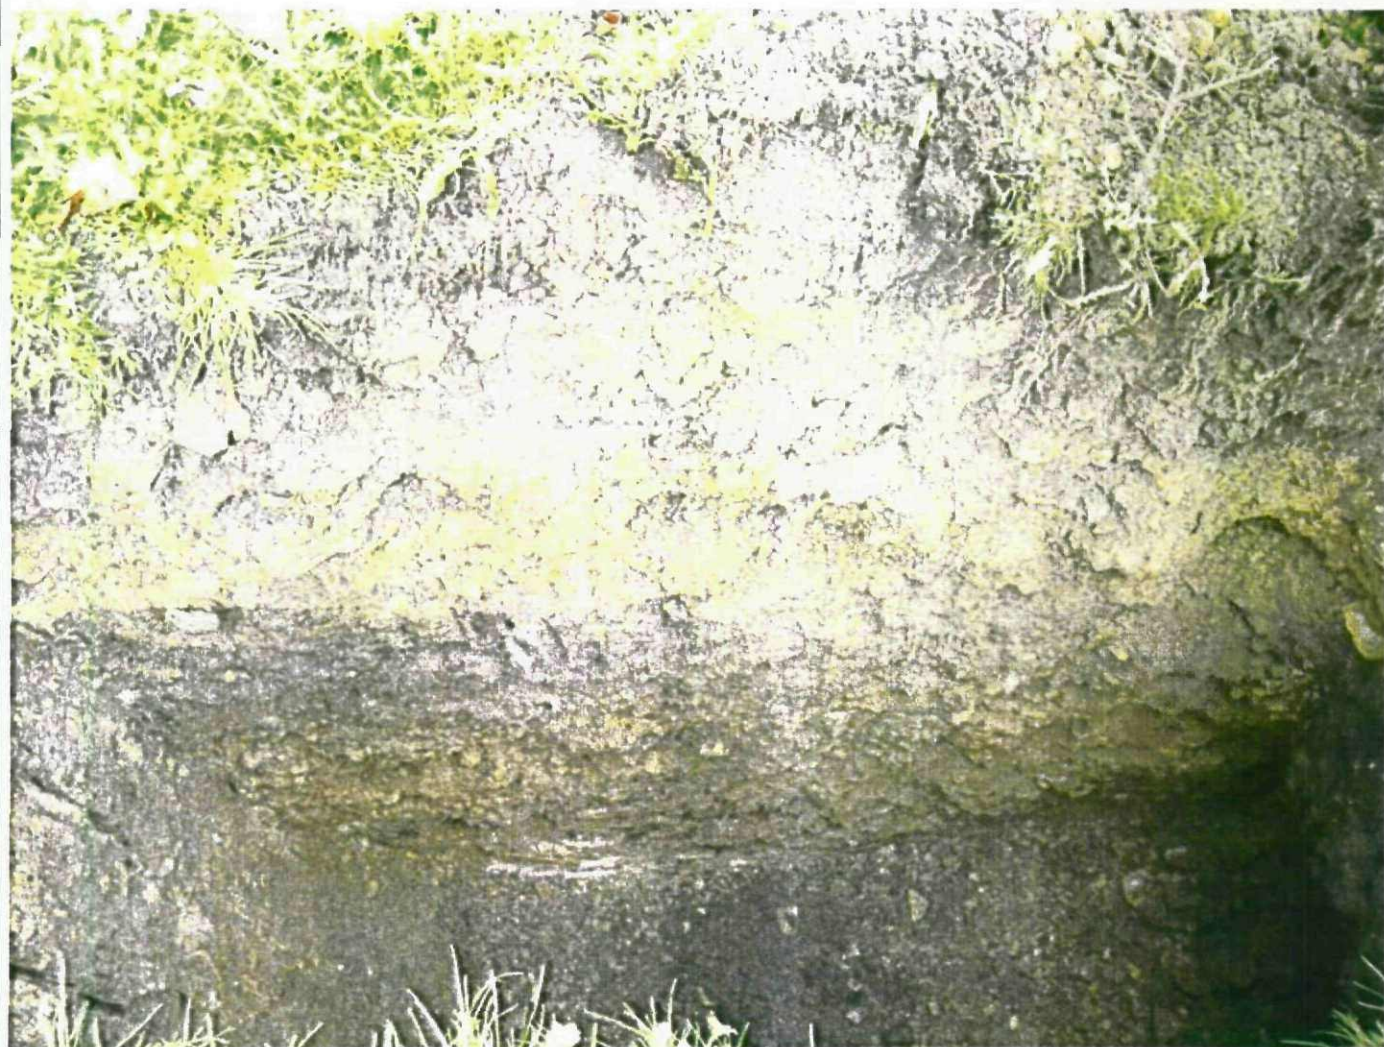
Prepared	DES	Checked	CAT	Date	24.10.2011	Photograph No	34235/P010
----------	-----	---------	-----	------	------------	---------------	------------

TRIAL PIT 2 SHOWING POSSIBLE OLD TOPSOIL LAYER

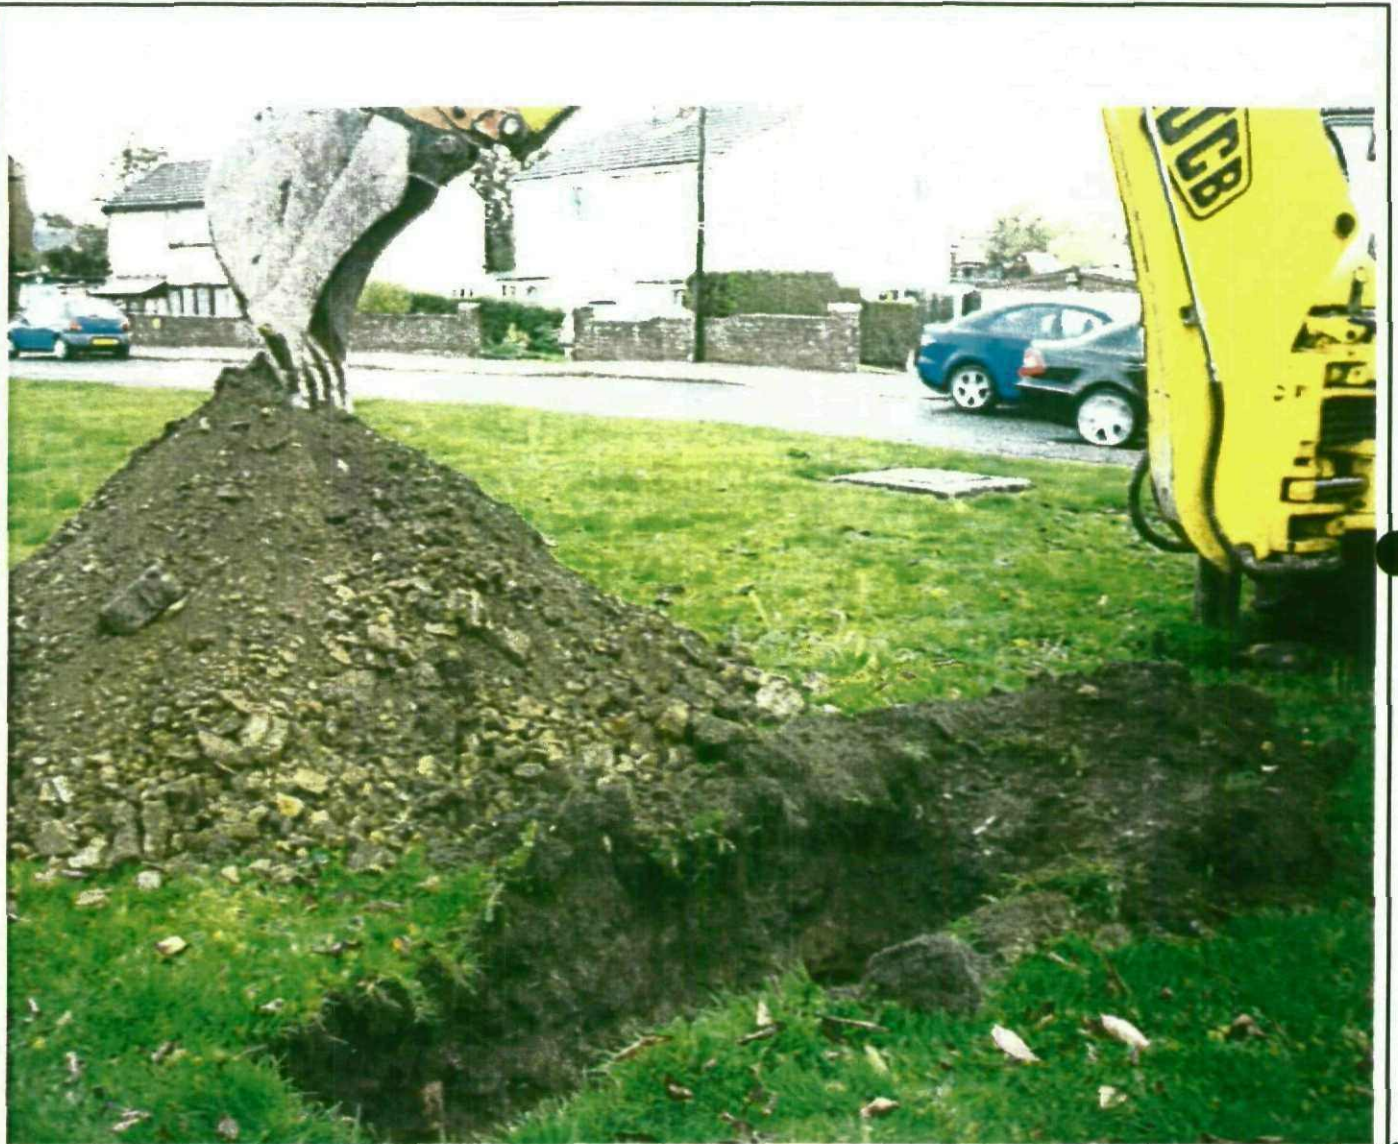
Prepared	DES	Checked	CAT	Date	24.10.2011	Photograph No	34235/P011
----------	-----	---------	-----	------	------------	---------------	------------

The areas in which potential contamination was expected were TP2 and TP3. Trial pit TP2 was situated close to the position of the historical tank, and could potentially be impacted with petroleum hydrocarbons. No olfactory or visual evidence of any contamination of this nature was found, but the sample was submitted for testing to confirm this.

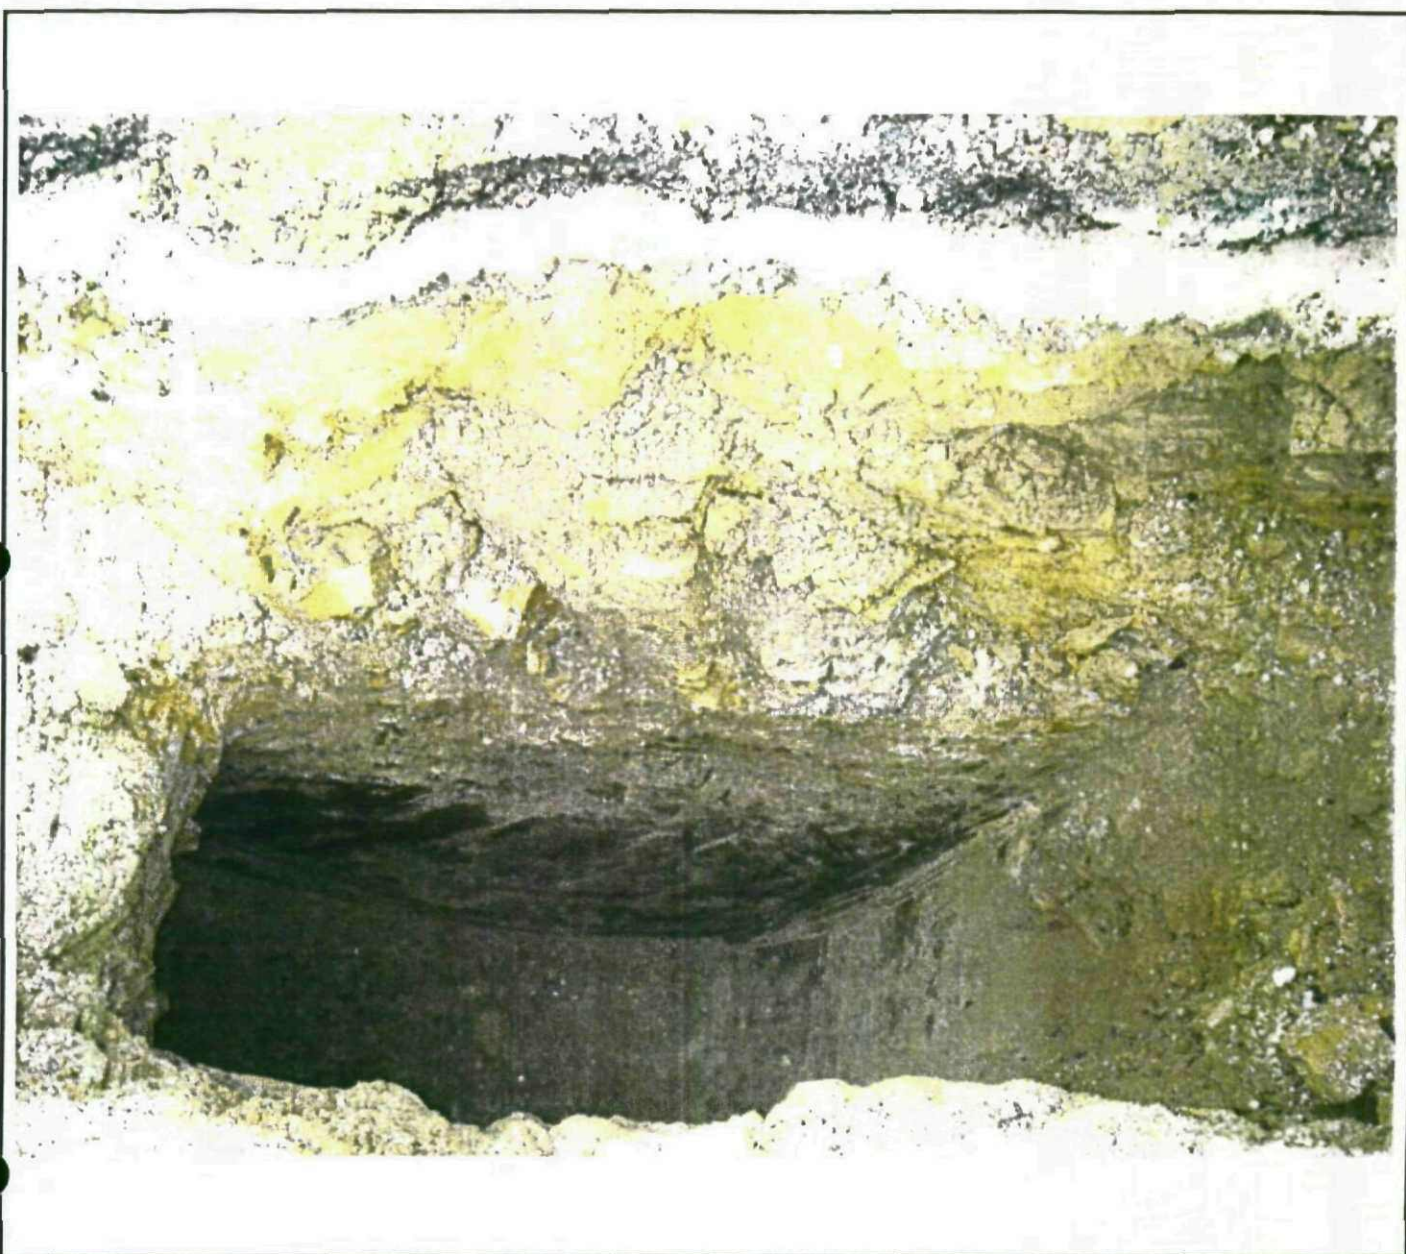
Prepared	DES	Checked	CAT	Date	24.10.2011	Photograph No	34235/P012
----------	-----	---------	-----	------	------------	---------------	------------

<p>E+P Eastwood&Partners <small>CONSULTING ENGINEERS</small></p> <p>St Andrew's House 23 Kingfield Road Sheffield S11 9AS</p> <p>Tel: (0114) 2554554 Fax: (0114) 2554330</p>	<p>GLEESON DEVELOPMENTS LTD</p> <p>FORMER MOORLAND PLASTICS SITE, BARNSELY</p> <p>TRIAL PIT 3 SHOWING MADE GROUND (SANDSTONE COBBLES) OVER CLAY</p>
--	--

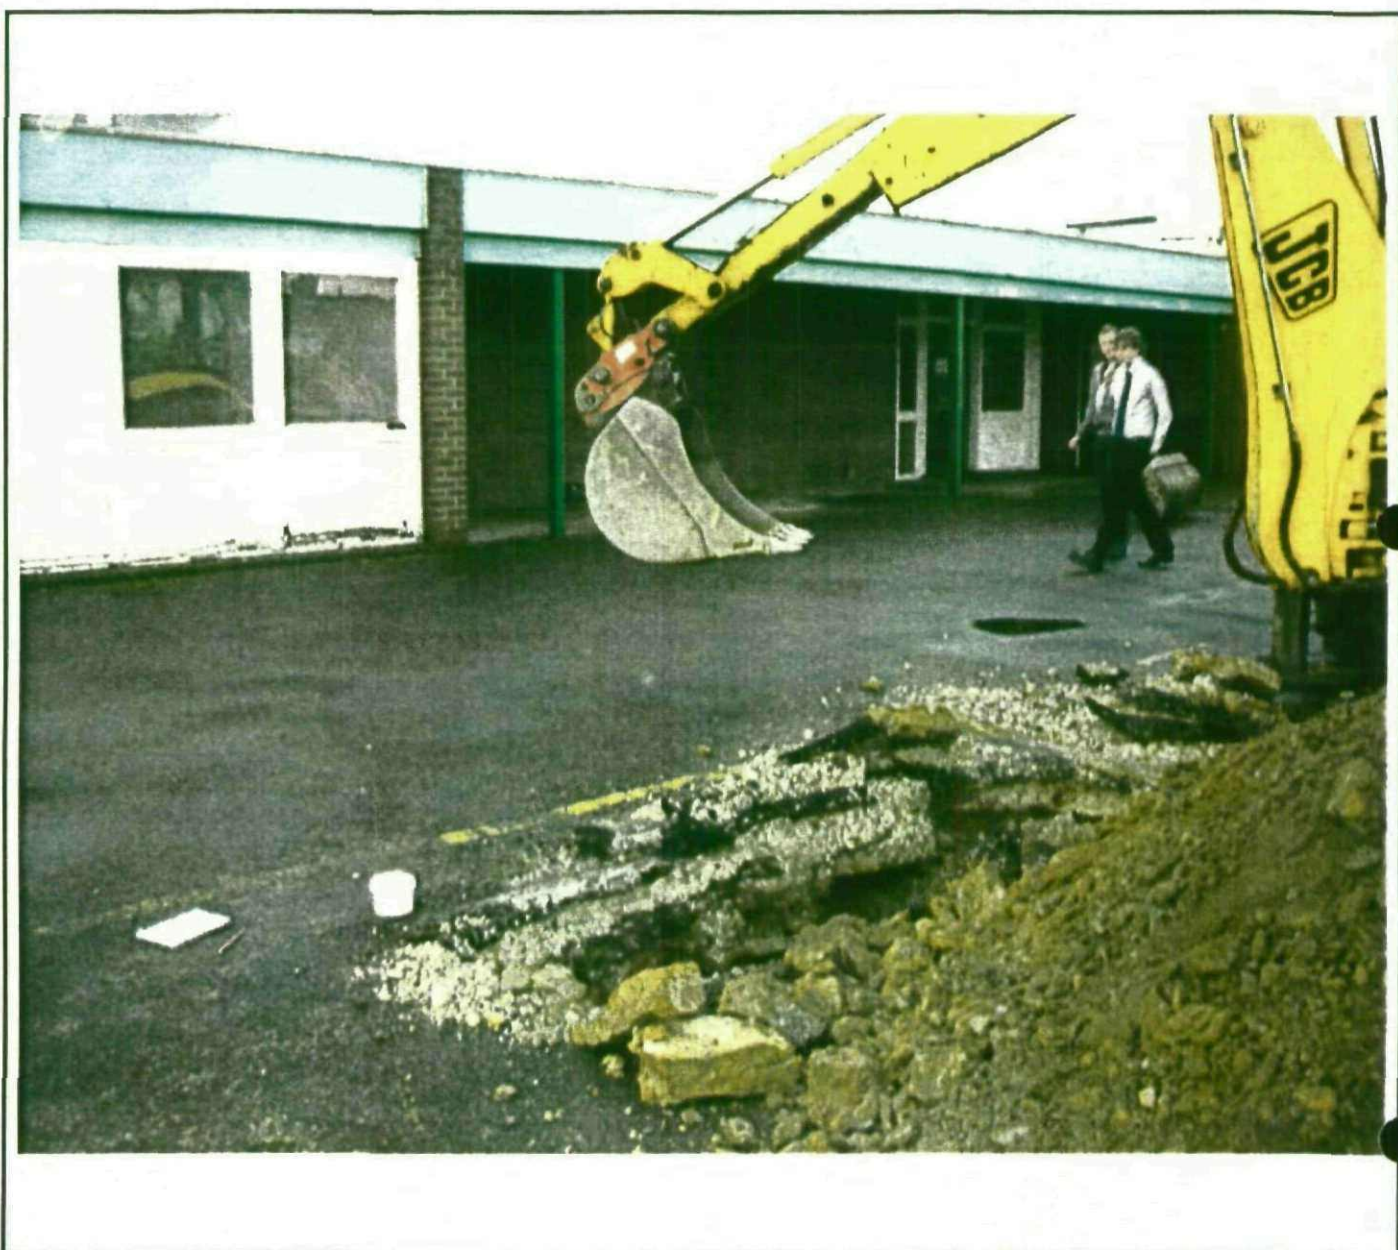
Prepared	DES	Checked	CAT	Date	24.10.2011	Photograph No	34235/P013
----------	-----	---------	-----	------	------------	---------------	------------

Trial pit TP3 was situated 10 m away from the substation, which is still live. The ground underneath and around the substation has the potential to be impacted with polychlorinated biphenyls (PCBs). No olfactory or visual evidence of any contamination of this nature was found, but the sample was submitted for testing to confirm this. However, further testing to test for the presence of PCBs will be required under the footprint of the substation when the substation is removed.

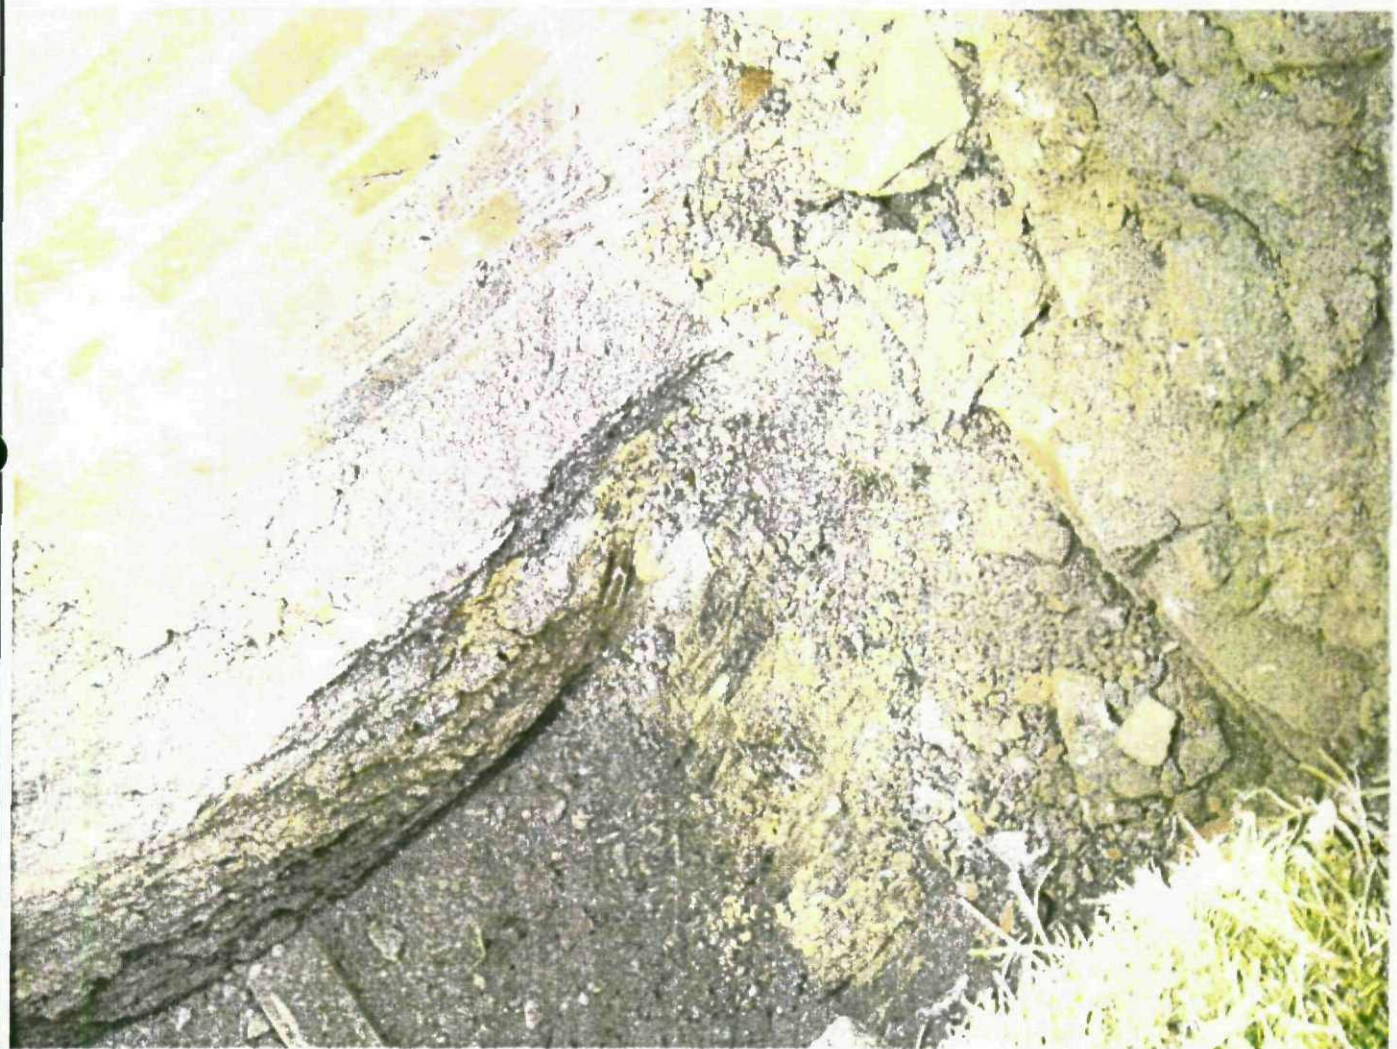
Prepared	DES	Checked	CAT	Date	24.10.2011	Photograph No	34235/P016
----------	-----	---------	-----	------	------------	---------------	------------

Intact brick walls and concrete footings were encountered between 0.3 and 1.3 m in TP5, and a concrete slab and large ceramic bowl or end of pipe was encountered in TP6 between 0.9 and 1.75 m bgl. Strong rock was found in TP2 at a relatively shallow depth of 1.85 m bgl. No other obstructions were encountered during the site investigation.

Relic foundations and infrastructure associated with the demolished and current buildings are likely to be present across the majority of the site, but especially in the west, such as the brick walls and footings encountered in trial pits TP5 and TP6.

TRIAL PIT 5 SHOWING BRICK WALL

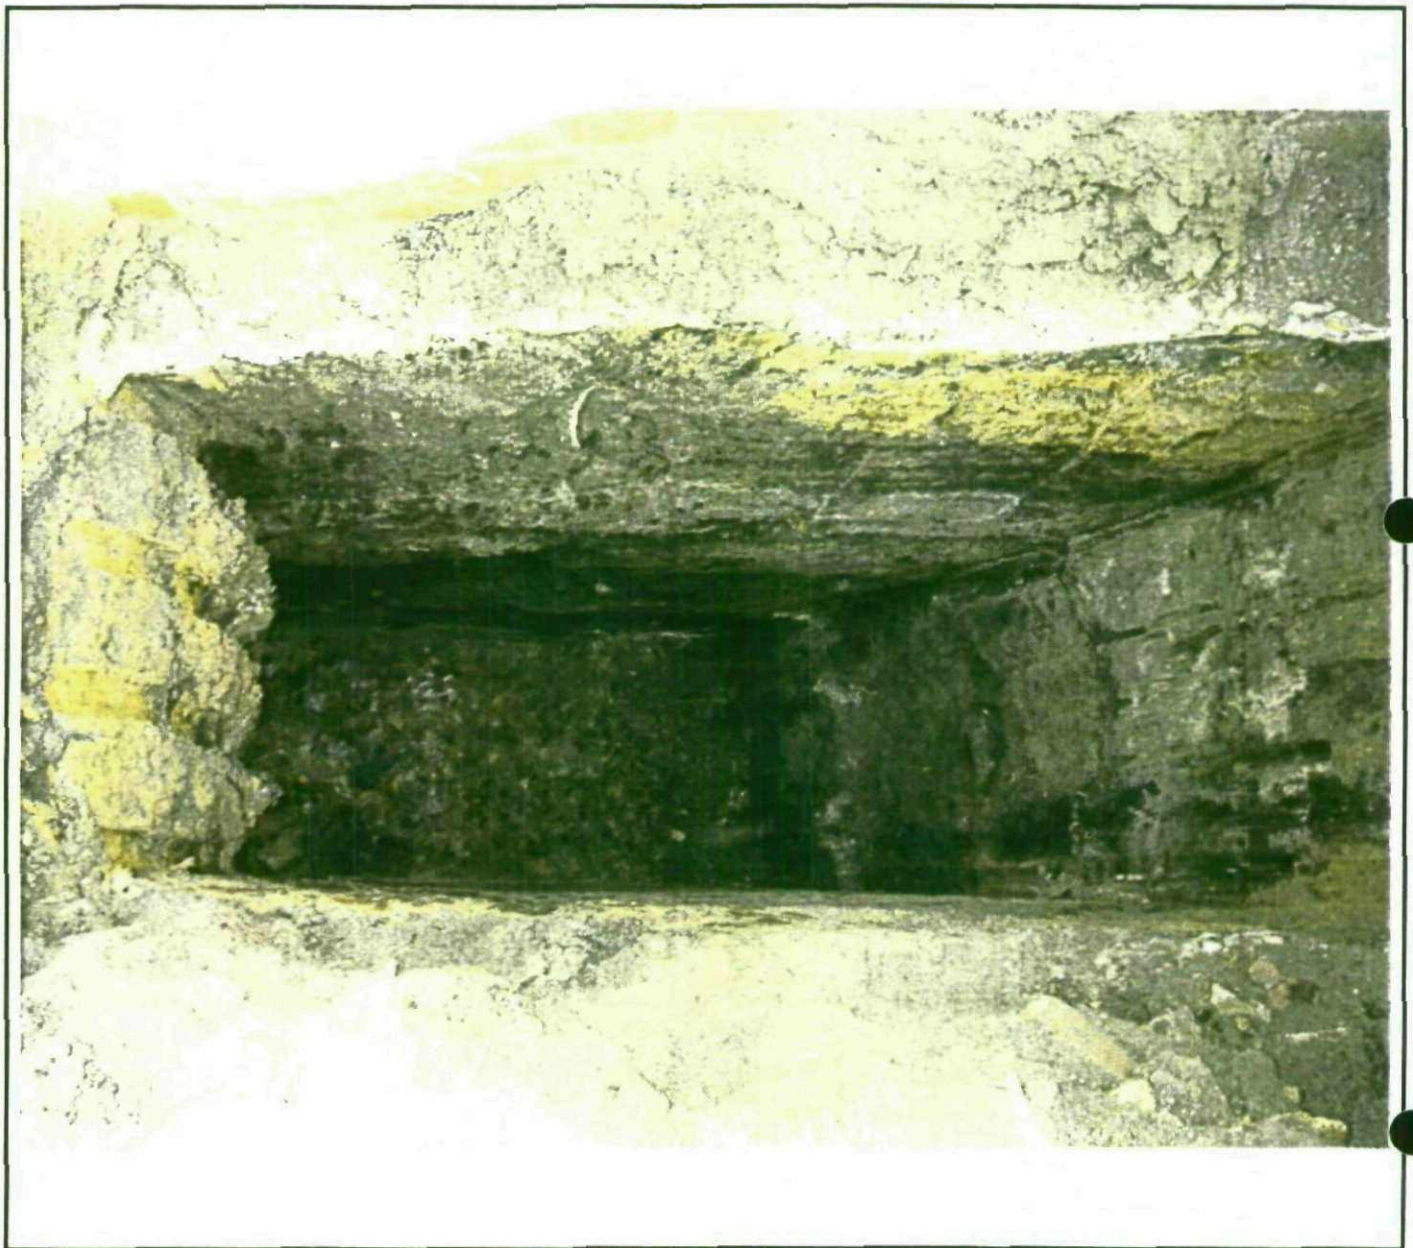
Prepared	DES	Checked	CAT	Date	24.10.2011	Photograph No	34235/P017
----------	-----	---------	-----	------	------------	---------------	------------

<p>E+P Eastwood&Partners CONSULTING ENGINEERS</p> <p>St Andrew's House 23 Kingfield Road Sheffield S11 9AS</p> <p>Tel: (0114) 2554554 Fax: (0114) 2554330</p>	<p>GLEESON DEVELOPMENTS LTD</p> <p>FORMER MOORLAND PLASTICS SITE, BARNLEY</p> <p>TRIAL PIT 5 SHOWING COAL AT BASE</p>
---	--

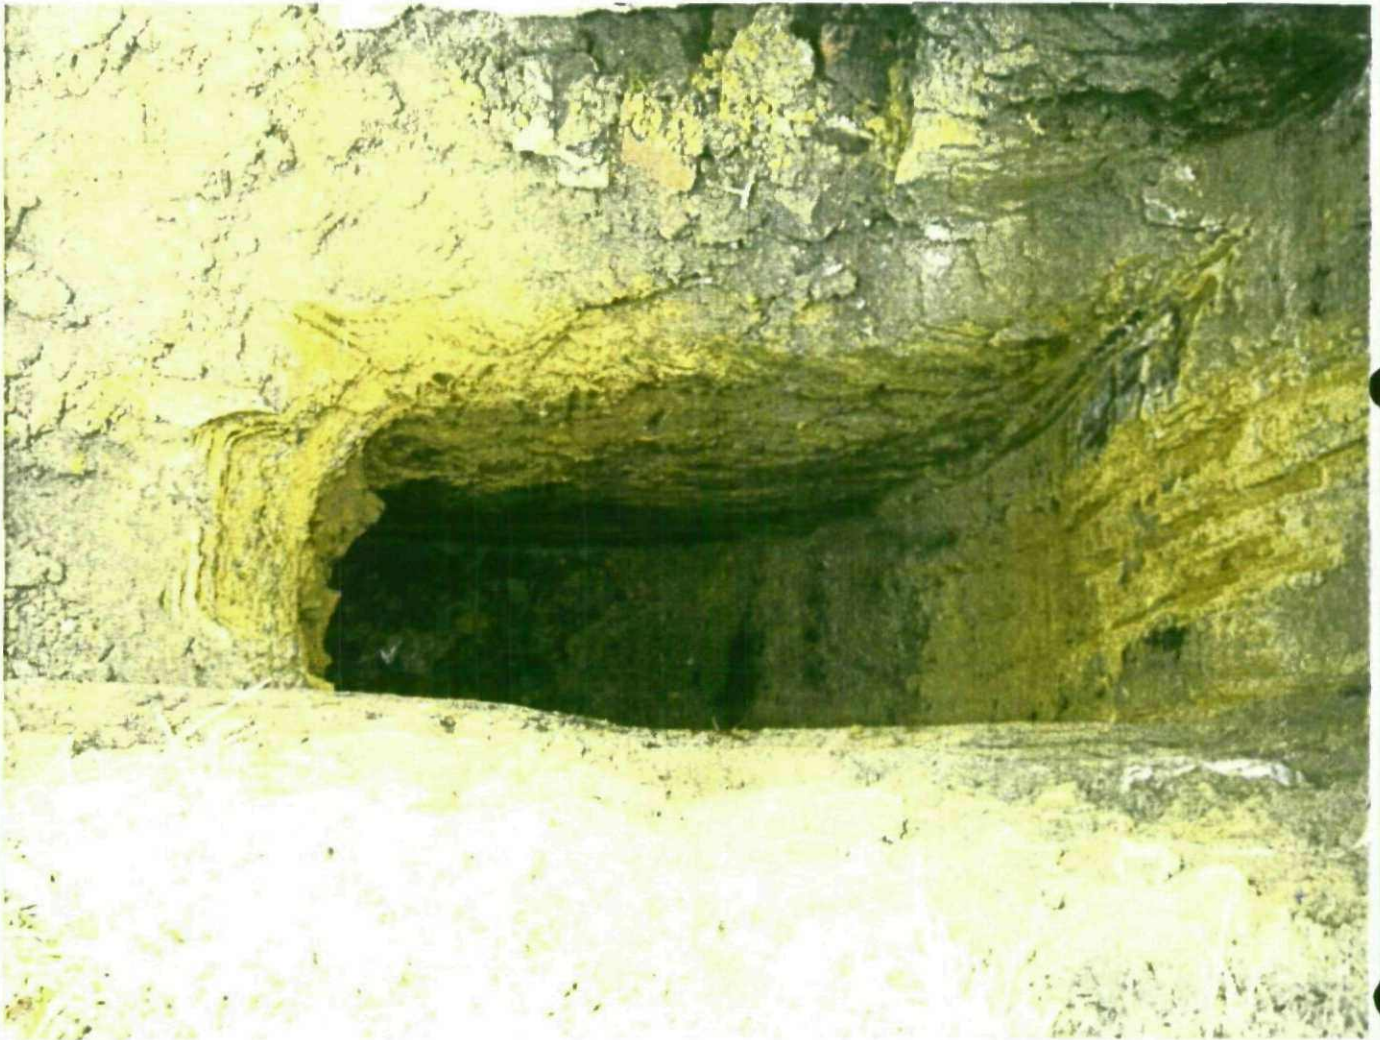
Prepared	DES	Checked	CAT	Date	24.10.2011	Photograph No	34235/P019
----------	-----	---------	-----	------	------------	---------------	------------

TRIAL PIT 6 SHOWING MADE GROUND OVER CLAY
