Wombwell Wetlands and Doveside Water Vole Surveys

Final Report

September 2017

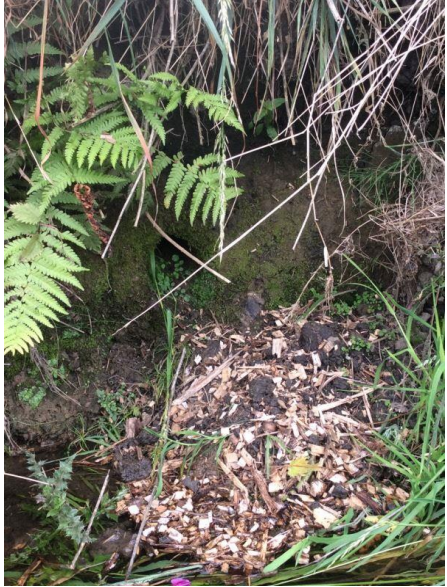
No Water Vole latrines were recorded during either survey. However, other potential signs of Water Vole were recorded in the optimal habitat areas (the River Dove). Several potential burrows were found towards the east of the surveyed reach (see Figure 2-1 and Figure 3-1), however, no definitive evidence of Water Vole presence was found (i.e. latrines). Furthermore, no other potential signs of Water Vole, such as footprints, feeding remains or runs through vegetation, were found.

<p>Figure 3-1: Potential Water Vole burrow along the River Dove.</p> <p>Photograph location: 53.529453, -1.374243</p>

- A toolbox talk on Water Vole should be given to all site staff prior to the commencement of works to make them aware of how to identify this species and the steps to take in the unlikely event that Water Vole are discovered on site during any works.

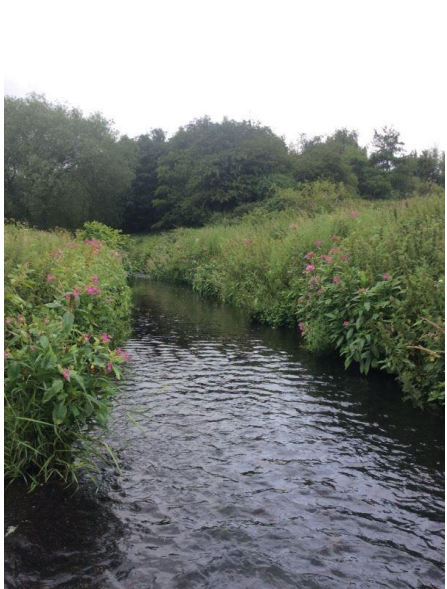
A number of invasive non-native species were recorded across the surveyed reach. Along the River Dove, both Himalayan Balsam *Impatiens glandulifera* and Japanese Knotweed *Fallopia japonica* were identified. Himalayan Balsam was relatively widespread on both banks of the River Dove (see Figure 3-2), but Japanese Knotweed was more localised in its distribution (see Figure 2-1 and Figure 3-3).

<p>Figure 3-2: River Dove corridor showing Himalayan Balsam on both banks.</p> <p>Photograph location: 53.529491, -1.374463</p>

As Himalayan Balsam is present on the site, works should be avoided in infested areas when it is in seed (i.e. June - October) to avoid causing its spread. Alternatively, an appropriate mitigation strategy should be implemented.

Biosecurity measures should be adhered to throughout the course of works to ensure this, and other invasive non-native species, are not spread. Biosecurity measures should include the 'Check, Clean, Dry method'. For more information about this method the GB non-native species secretariat website should be consulted: <http://www.nonnativespecies.org/factsheet/factsheet.cfm?speciesId=1810> [site accessed: 02/06/17].

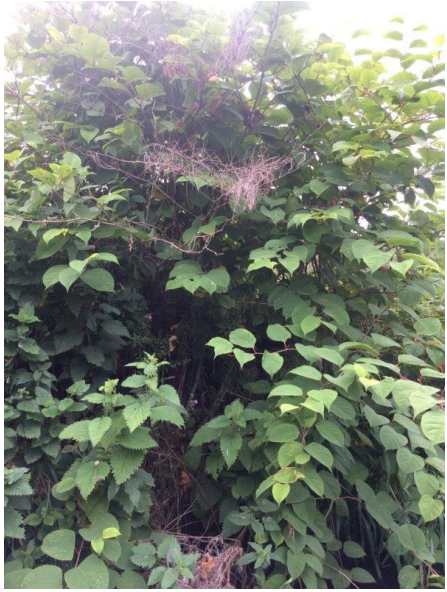
<p>Figure 3-3: Japanese Knotweed along the River Dove.</p> <p>Photograph location: 53.529415, - 1.379597.</p>

Japanese Knotweed and soil containing Japanese Knotweed material is classified as controlled waste and would need to be treated and/or disposed of in a lawful manner. If possible, all works should avoid the stand of Japanese Knotweed, and no excavation should be undertaken within 7m of above-ground growth, with a suitable exclusion zone fenced-off. However, given that the proposed works will likely incorporate an area of the site known to contain Japanese Knotweed infestations, options for the disposal and treatment of this species on site should be explored. It is recommended that advice contained within the Environment Agency's publication the Knotweed Code of Practice (3rd Revision) (Environment Agency, 2013) is followed and that a management plan is produced to address eradication and control, including a site hygiene protocol.

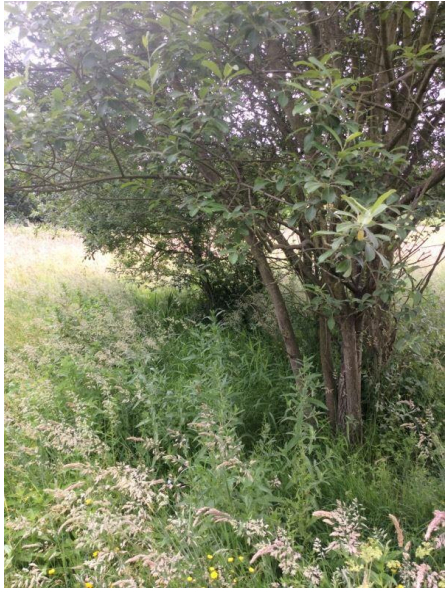
The River Dove contained habitat of optimal quality to support Water Vole on account of the suitable bank profile and good vegetation cover. The drains intersecting the wetland to the north were almost entirely unsuitable for Water Vole being largely dry with encroaching scrub and shallow banks (see Figure 3-4 and Figure 3-5).

<p>Figure 3-4: Drain running north of wetland area; dry with encroaching vegetation.</p> <p>Photograph location: 53.530491, - 1.379065</p>

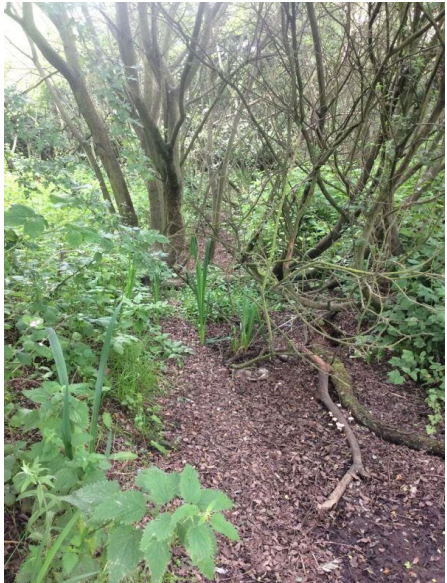
<p>Figure 3-5: Drain running between ponds in wetland area with dry, bare earth/leaf litter substrate.</p> <p>Photograph location: 53.530319, - 1.380193.</p>

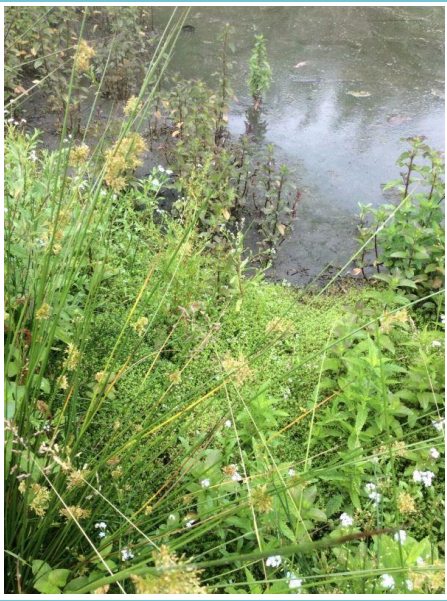
Within the wetland area, a dense blanket of New Zealand Pigmyweed *Crassula helmsii* surrounded the southernmost pond and the westernmost drain (see Figure 2-1, Figure 3-6 and Figure 3-7). Himalayan Balsam was also relatively widespread within the wetland area, particularly along the drains (see Figure 3-8).

<p>Figure 3-6: New Zealand Pigmyweed growing by edge of southernmost pond.</p> <p>Photograph location: 53.530025, - 1.37908.</p>

New Zealand Pigmyweed is especially difficult to control and hence to avoid the spread of this species it is recommended that works avoid the areas in which it is present and adhere to strict biosecurity methods elsewhere. An invasive non-native species management plan should be prepared to prevent its spread on site.

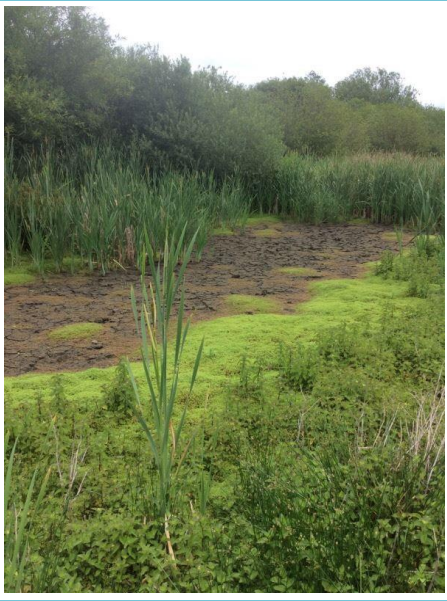
<p>Figure 3-7: New Zealand Pigmyweed growing by edge of southernmost pond.</p> <p>Photograph location: 53.529774, - 1.38043.</p>

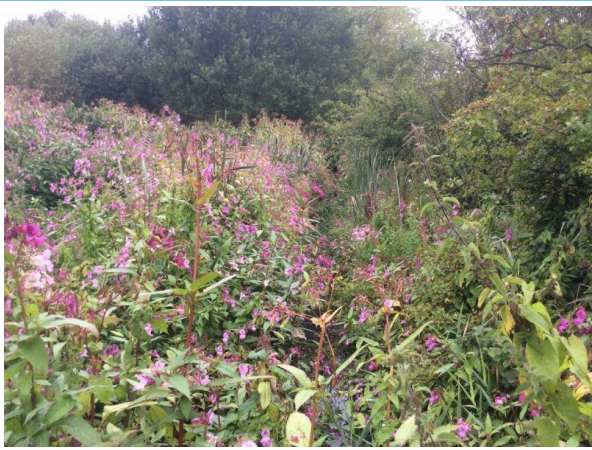
<p>Figure 3-8: Extensive Himalayan Balsam along drains.</p> <p>Photograph location: 53.529701, - 1.379333</p>

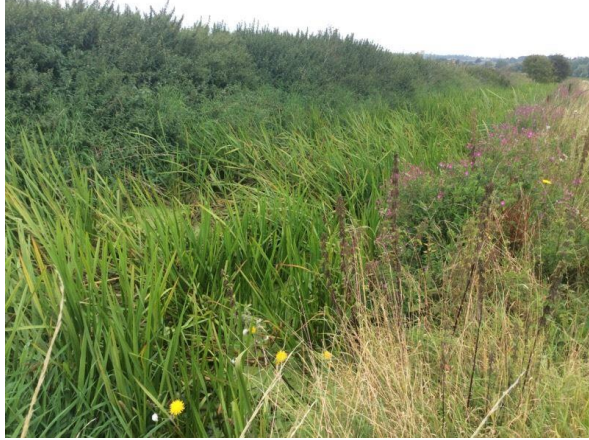
Bulling Dike offers suitable habitat for Water Vole, being sheltered, largely free from shade and with a vegetated margin. Encroaching vegetation may lessen the appeal to Water Vole and hence the southern extent was considered more suitable for this species.

<p>Figure 3-9: Encroaching channel vegetation.</p> <p>Photograph location: 53.524822, -1.372418</p>

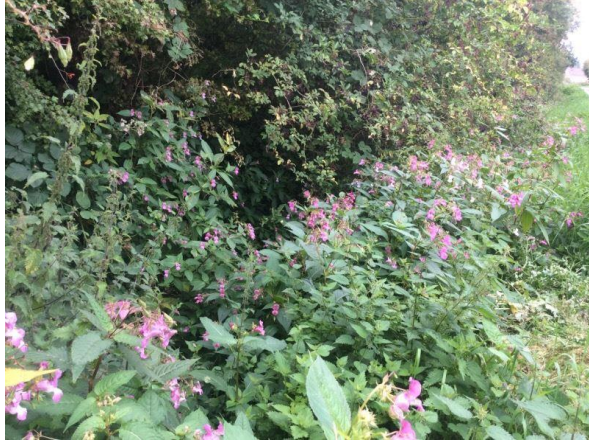
Himalayan Balsam was present along Bulling Dike, predominantly concentrated towards the north, particularly under the treeline adjacent to the caravan site where it encroached on the channel (see Figure 2-2 and Figure 3-10).

<p>Figure 3-10: Himalayan Balsam encroaching on channel to the north of Bulling Dike.</p> <p>Photograph location: 53.527351, -1.379795</p>
