Land off Shaw Lane, Carlton, Barnsley

Associated Highway Improvements –
Stage 1 Road Safety Audit

February 2023

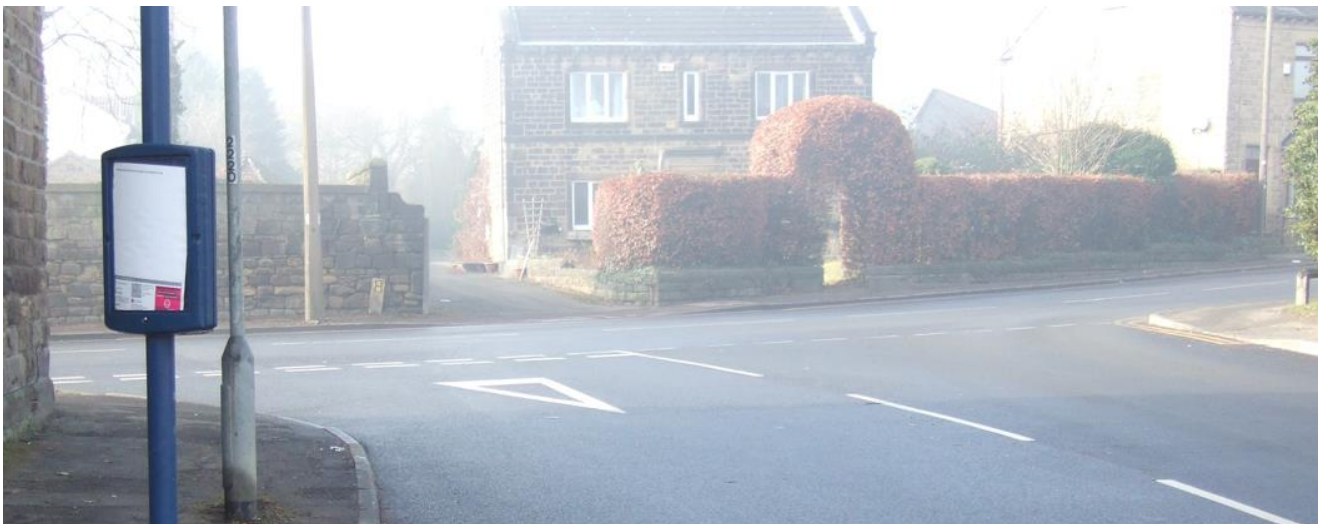
Figure 2 Driveway emerging into junction

Summary: The controlled crossing on the north side of the junction conflicts with a private driveway

It is proposed to signalise the existing priority junction where Shaw Lane meets Church Street and Fish Dam Lane. The proposal includes controlled pedestrian crossings on Shaw Lane and Church Street to the east and north side of the junction respectively. On the western side of the junction is a private driveway. The western end of the pedestrian crossing on Church Street will result in the red blister tactile paving being laid within the width of the vehicular crossing across the footway. This will result in a risk to waiting or crossing pedestrians being struck by a vehicle emerging from, or turning into, the driveway. The associated signal pole, supporting the push button and pedestrian indicator, will restrict vehicular access to the driveway making access more hazardous, resulting in the manoeuvre to and from the driveway taking longer and increasing the risk of a sideswipe collision with passing vehicles.

It is recommended that the location and orientation of the controlled crossing of Church Street is amended to avoid any conflict with the driveway.

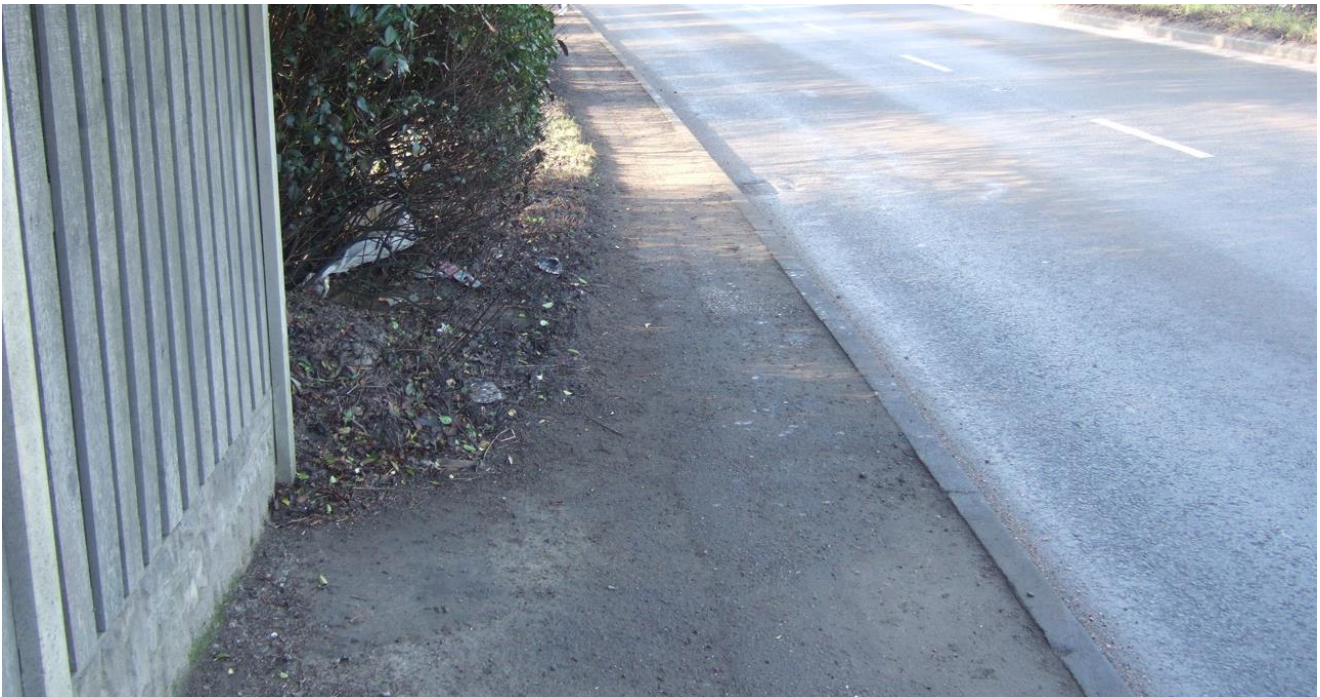
Figure 3 Shaw Lane footway narrowing to 700mm wide west of the proposed toucan crossing

Summary: The use of the southern footway by cyclists may lead to conflict with pedestrians

A Toucan crossing is being provided to the west of the proposed site access junction. This will provide a crossing for pedestrians and cyclists from the site to cross onto the southern footway along Shaw Lane. To the west of the toucan crossing the footway width reduces to as little as 700mm measured on site. This footway is insufficiently wide enough to accommodate both users without the potential for collisions between them.

It is recommended that the designer review the route for cyclists to and from the western side of the proposed development.

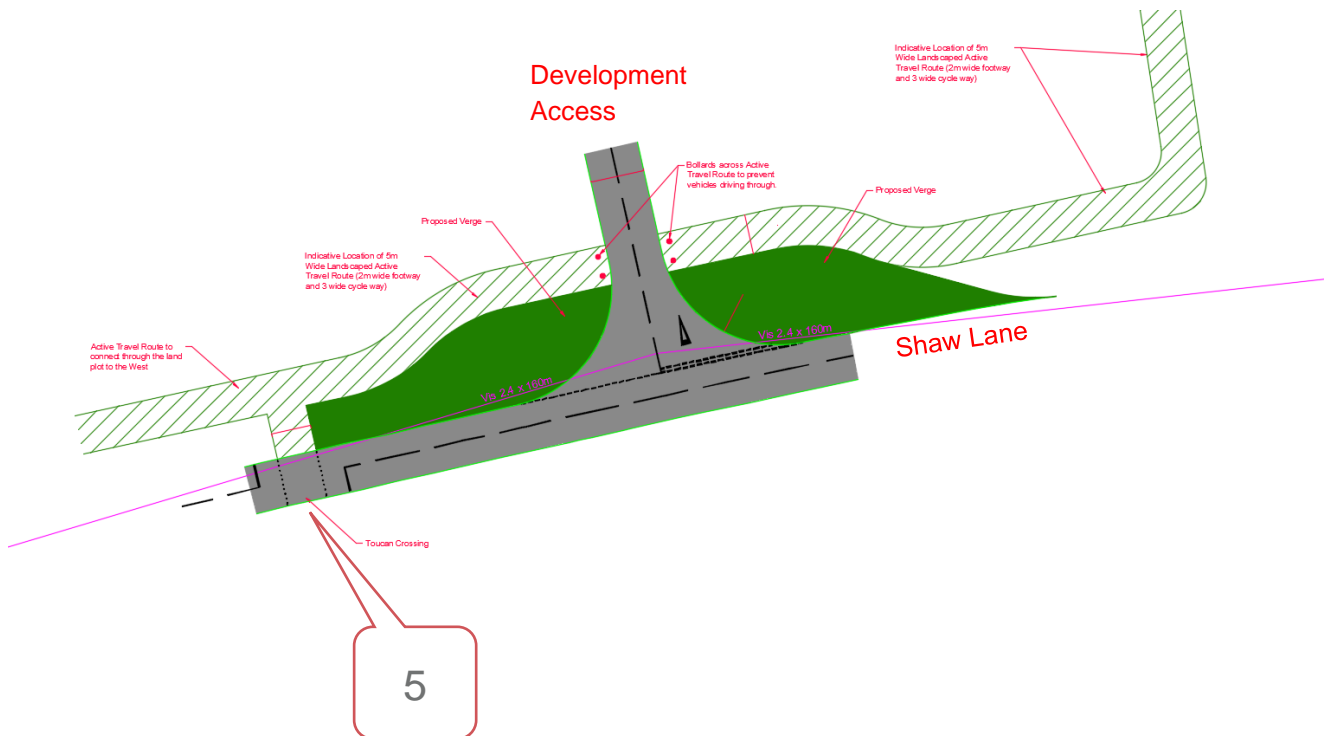
Proposed development access off Shaw Lane

Location: Shaw Lane west of development access – proposed toucan crossing
