**HARTCLIFFE ROAD, PENISTONE.**

**BAT SURVEY.**

**Ref No:- 130514.**

**Date: 23<sup>rd</sup> May 2013.**

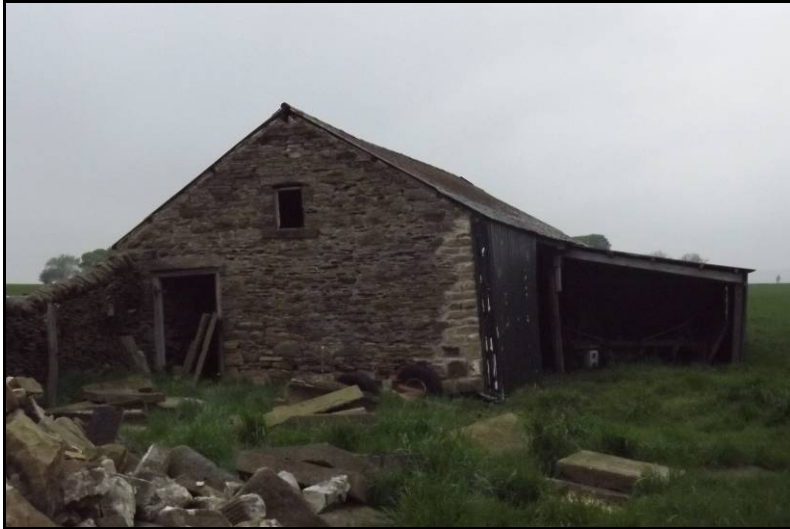
3.3.1. The building comprises a single storey farm store located towards the southern end of the surveyed area.

3.3.2. The walls of the building predominantly comprise rubble filled stone walls with occasional areas of recent pointing. The rear wall of the building has been partially repaired with concrete blocks. Abundant voids were identified within the walls although no bat field signs were identified around the voids during this survey.

3.3.3. The front wall of the building comprises single skin corrugated sheeting. This area provides no suitable bat roosting opportunities.

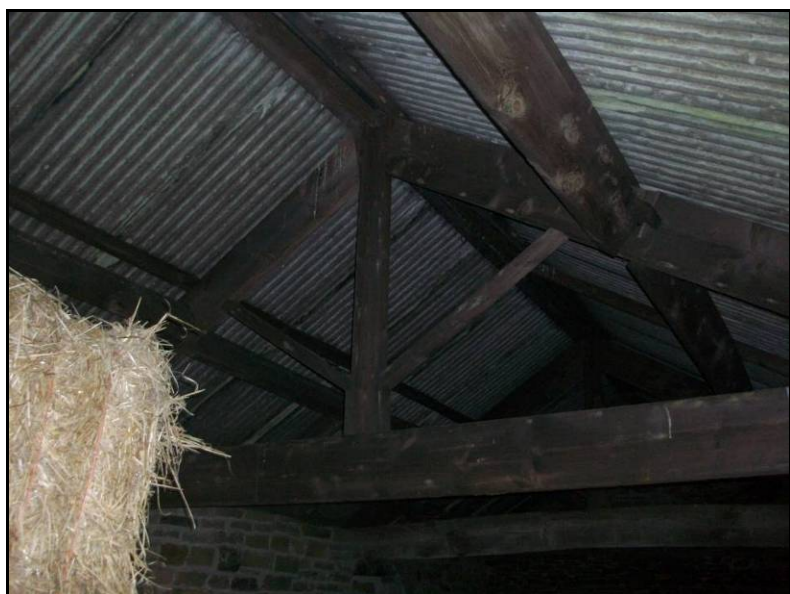
3.3.4. The roof of the building comprises a low pitched corrugated sheet roof with a small section of sloping roof to the front of the building. Internally the roof is open to the inside of the corrugated sheeting with exposed king post timbers.

3.3.5. The corrugated sheet roof does not provide suitable opportunities for roosting bats and no bat field signs were identified around the roof during this survey.

3.3.6. Internally the building displays abundant voids within the walls although no bat field signs were identified around the voids during this survey. The roof timbers were all found to be in a good condition with tight joints displaying no suitable bat roosting sites.

5.1. The building have a low potential for roosting bats with no bats or bat field signs found during the day time inspection and no bats emerging from the buildings during the dusk emergence survey. Therefore, no further surveys are recommended and there is no requirement for a Natural England EPS licence in connection with the proposed demolition of the existing buildings on the site.

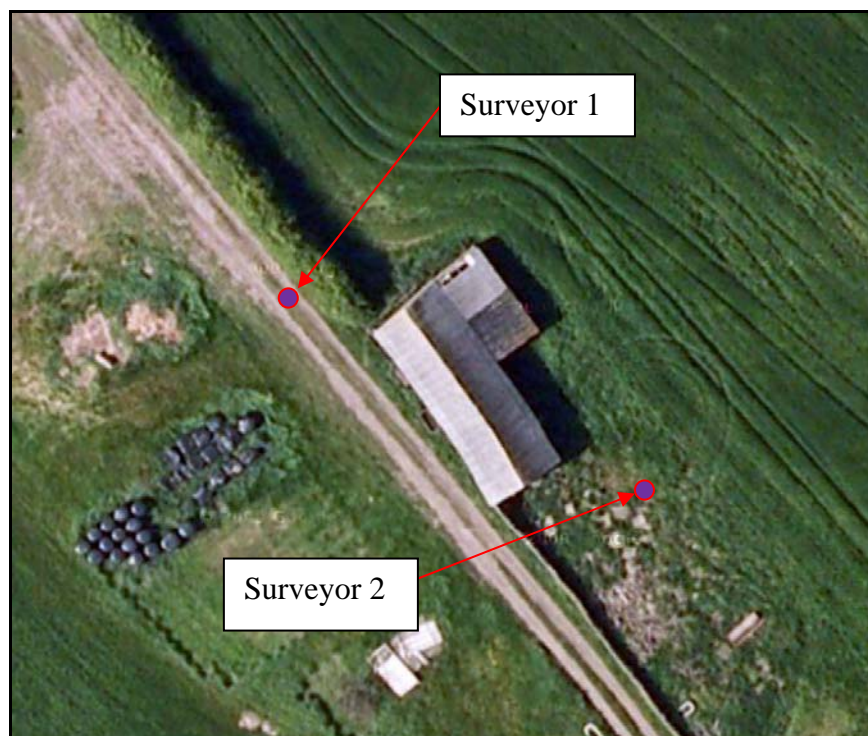
3.4.5. The position of each surveyor was as shown on the following aerial photograph.
