**Proposed Rockingham Development  
Birdwell**

**Phase II Geo-Environmental Assessment**

**Hartwood Estates Ltd.**

## Rockingham Development, Birdwell Phase II Geo-Environmental Assessment

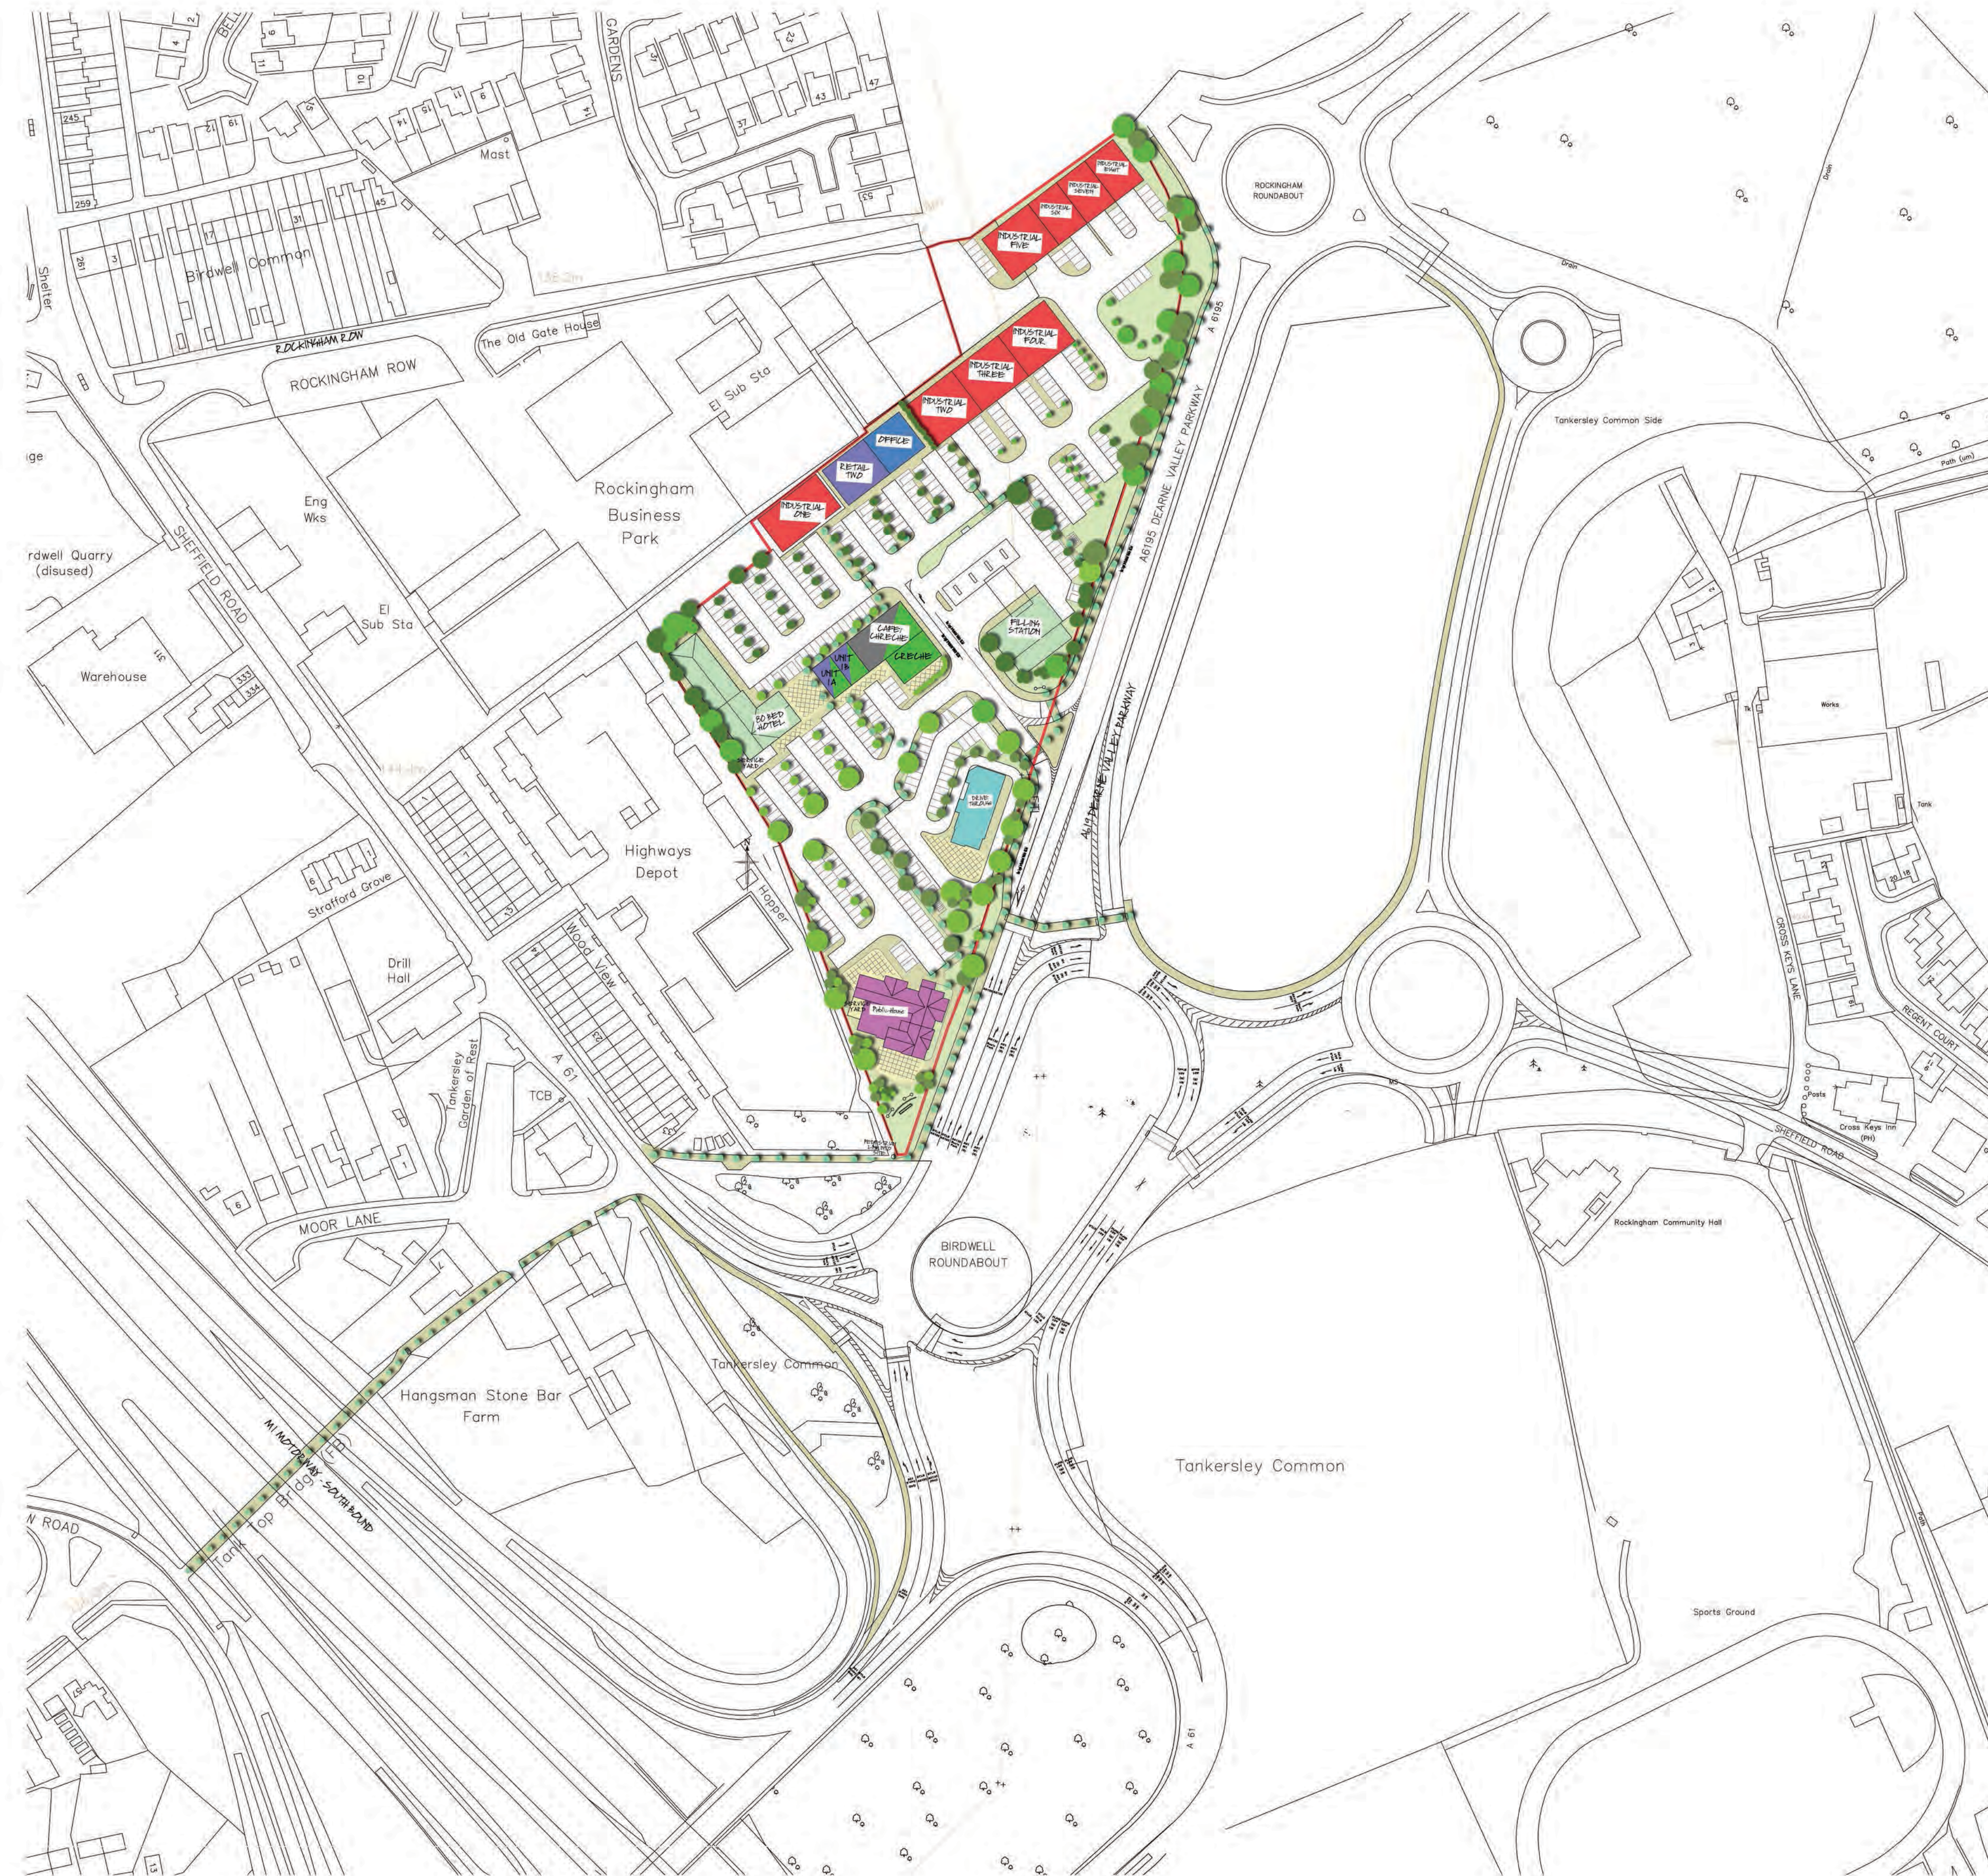
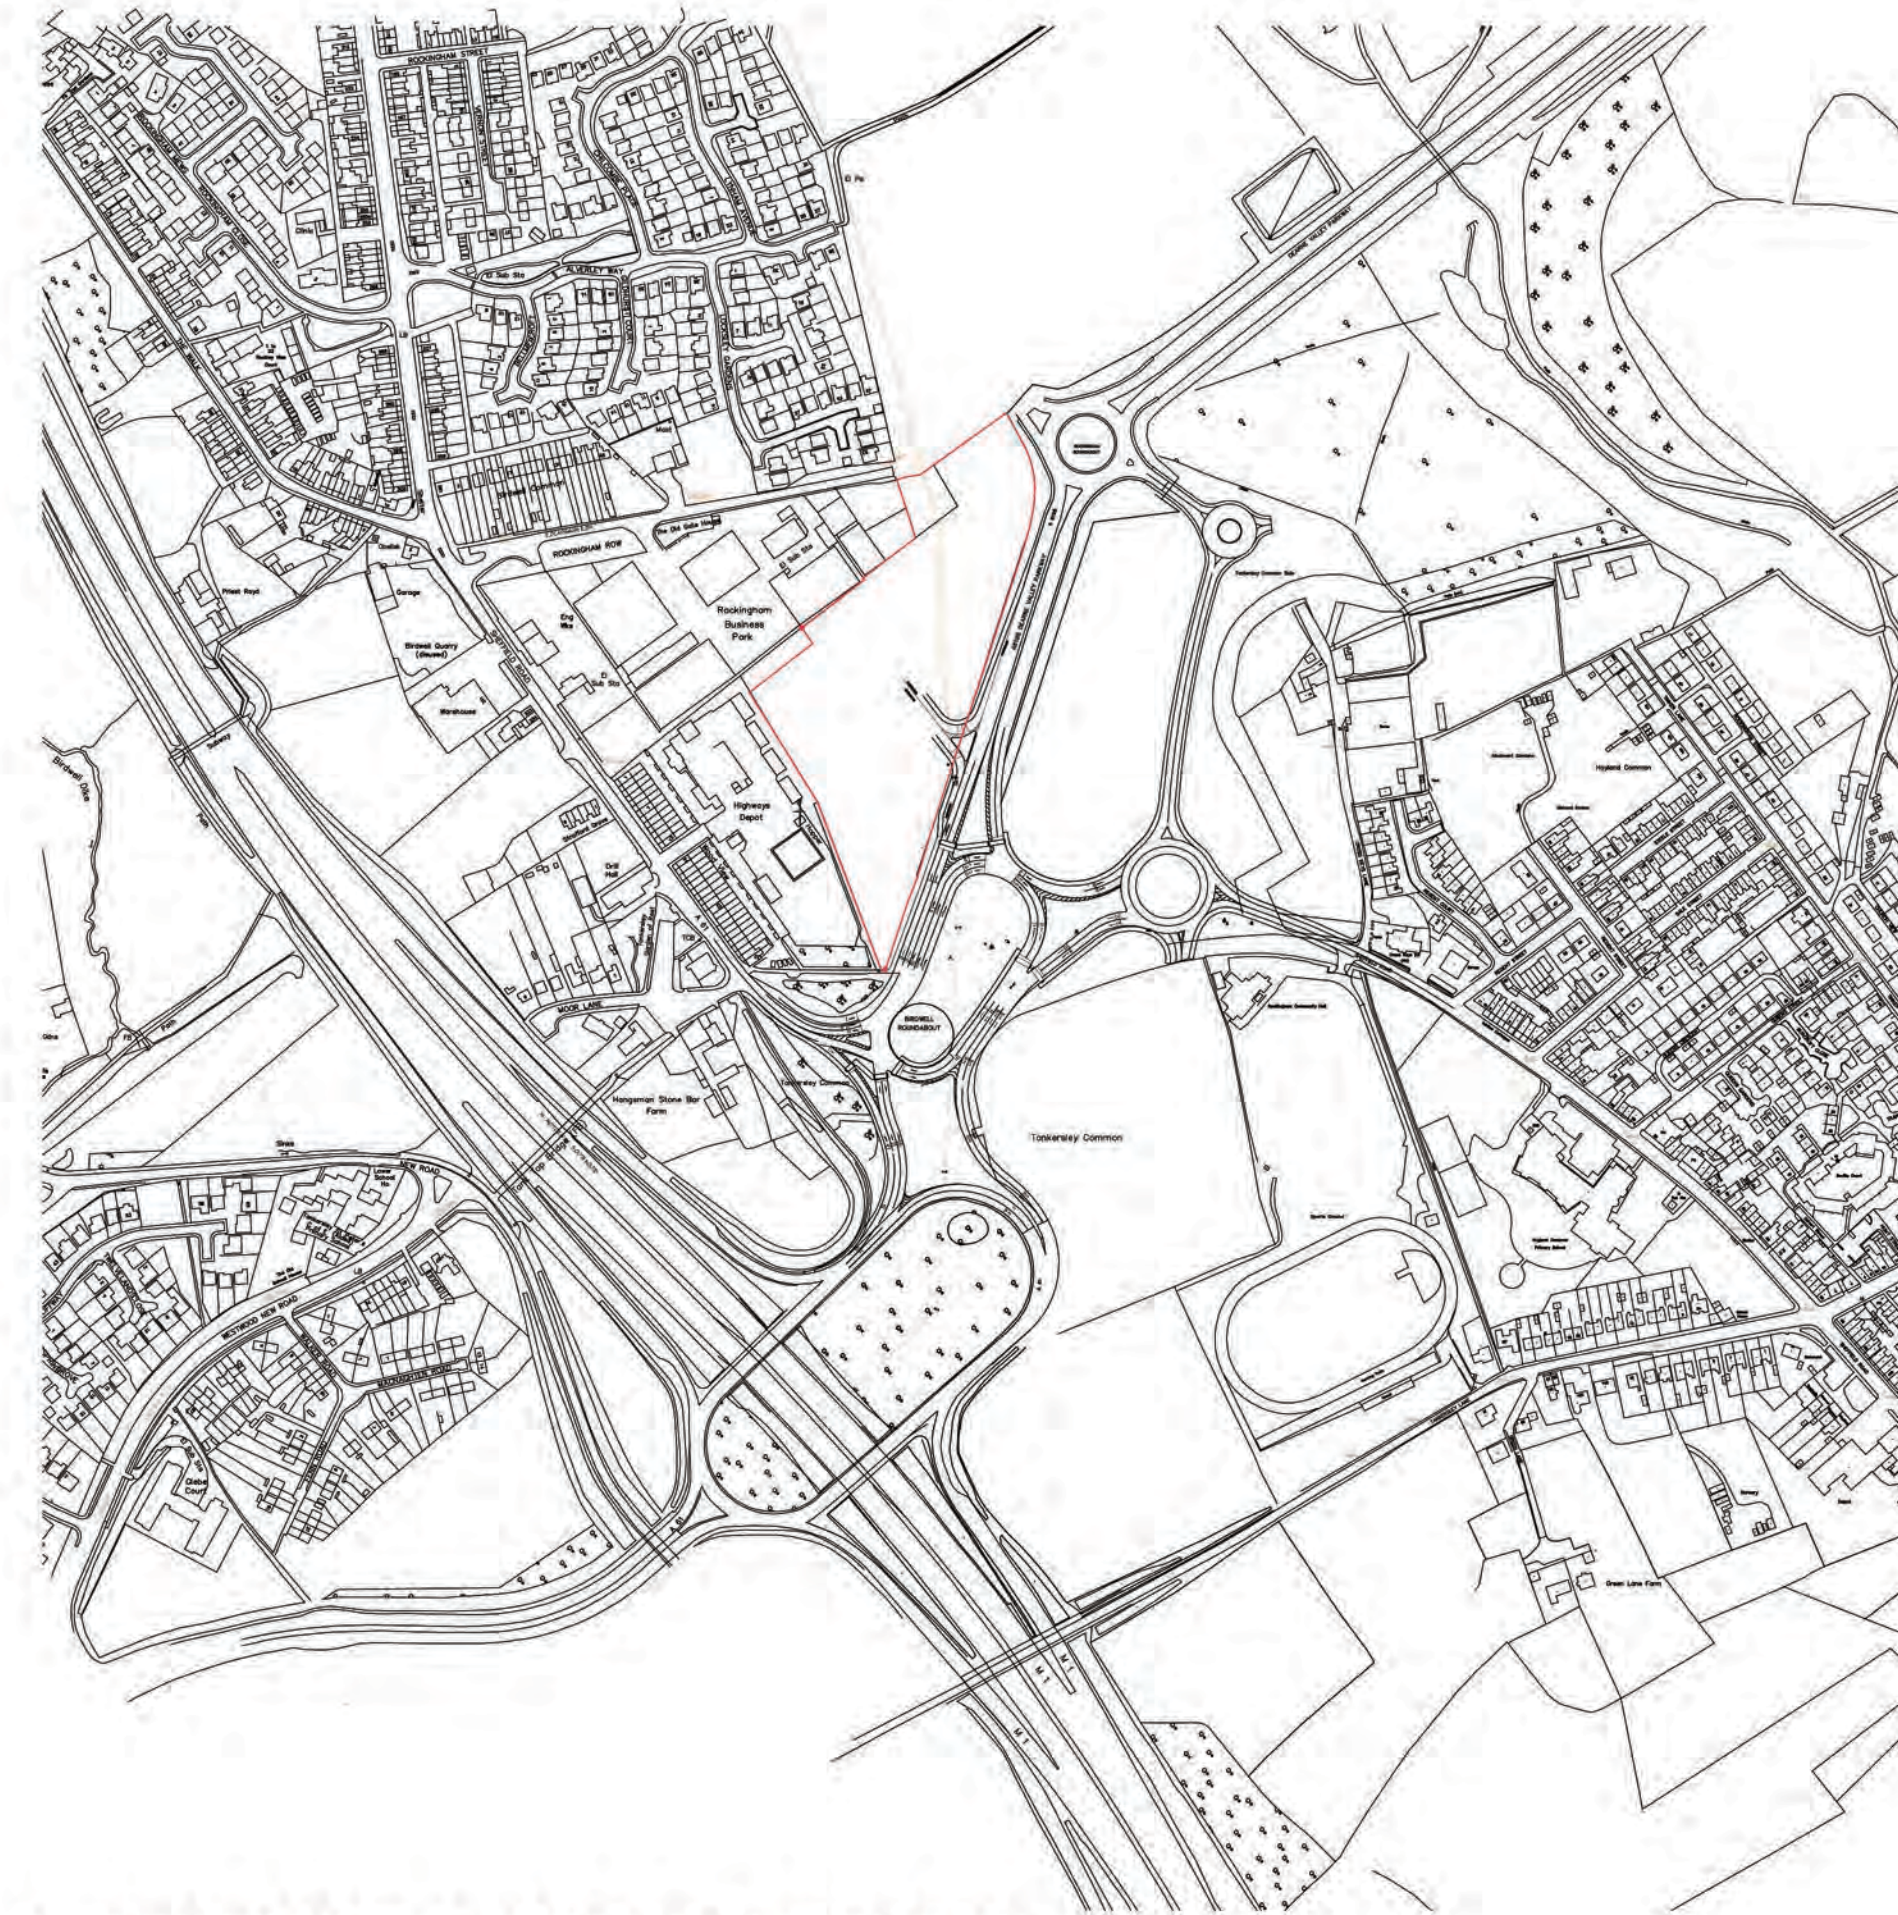
## Proposed Development Plan

1.1 3e Consulting Engineers Ltd (3e) were commissioned by Hartwood Estates Ltd. to carry out a Phase II geo-environmental assessment of land located off Dearne Valley Parkway, Birdwell, South Yorkshire. The proposed development for mixed use with associated car parking and landscaping, details of which are provided in **Appendix A**.
