ROYD FIELD FARM
ROYD FIELD LANE
CUBLEY
PENISTONE
SHEFFIELD S36 9AW
SURVEY

BARN

Dwg No. S02 Rev. A

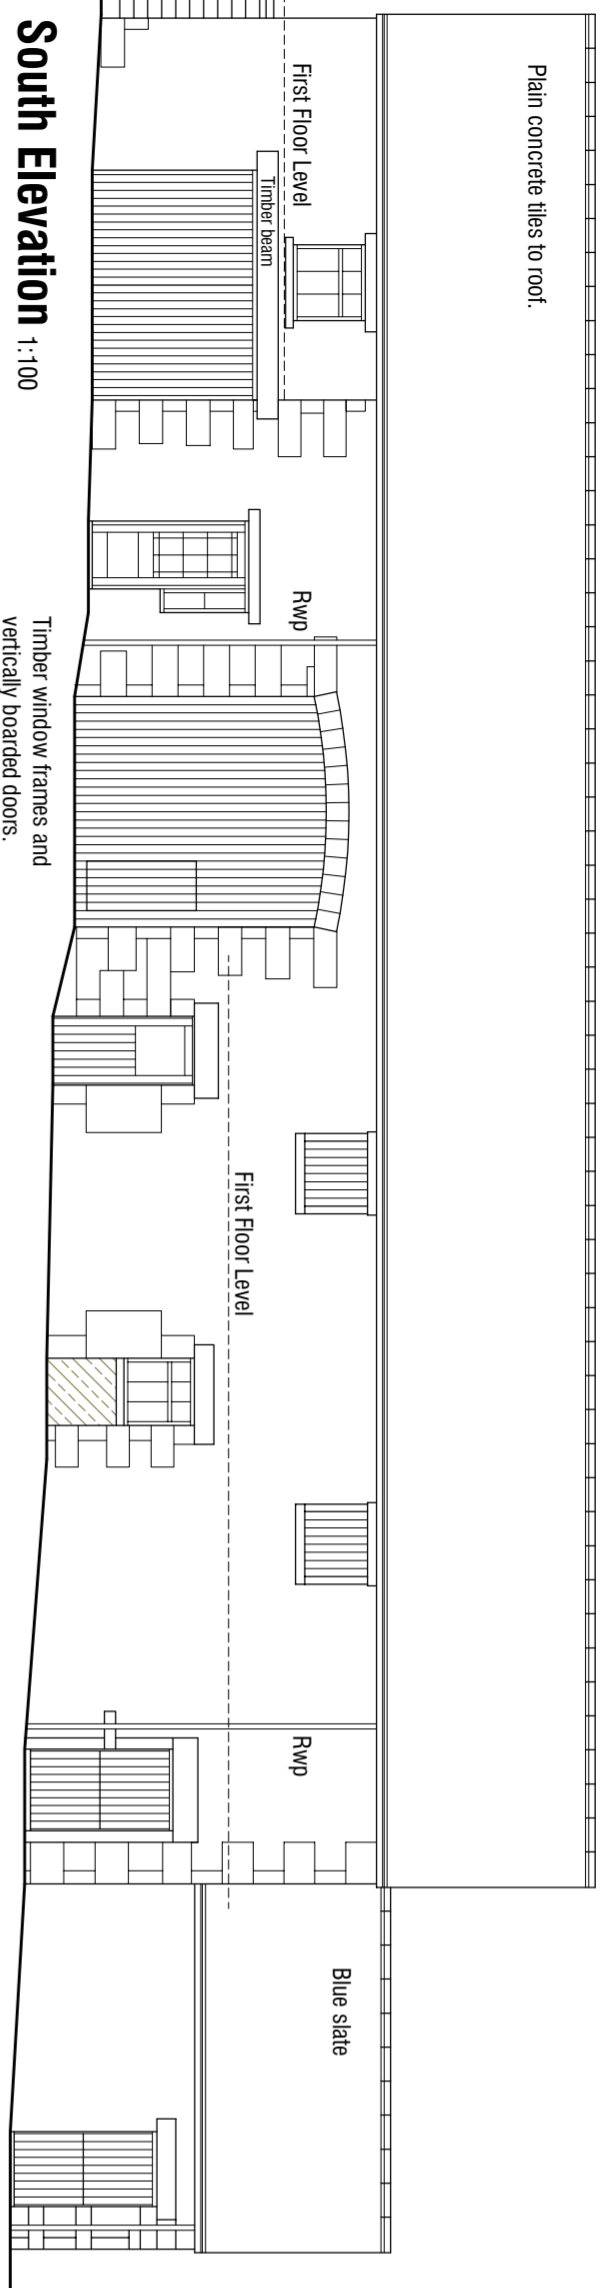
Plain concrete tiles to roof.

Timber window frames and vertically boarded doors.

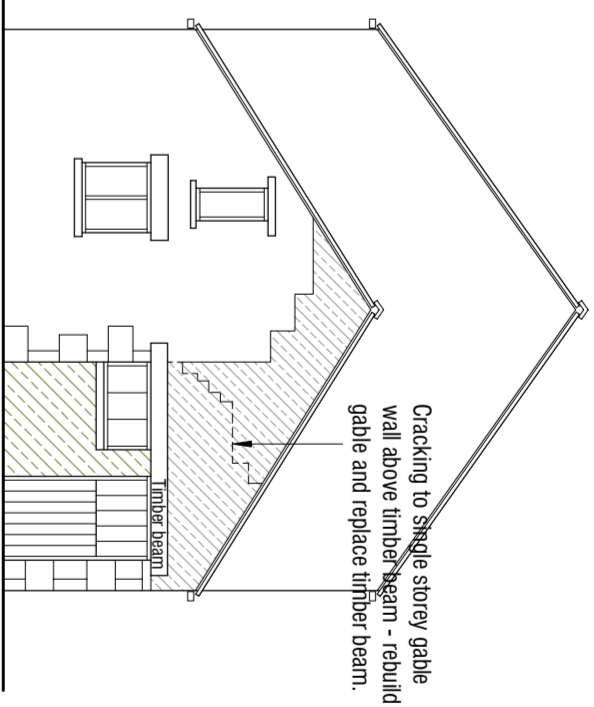
East Elevation 1:100

Cracking to single storey gable wall above timber beam - rebuild gable and replace timber beam.

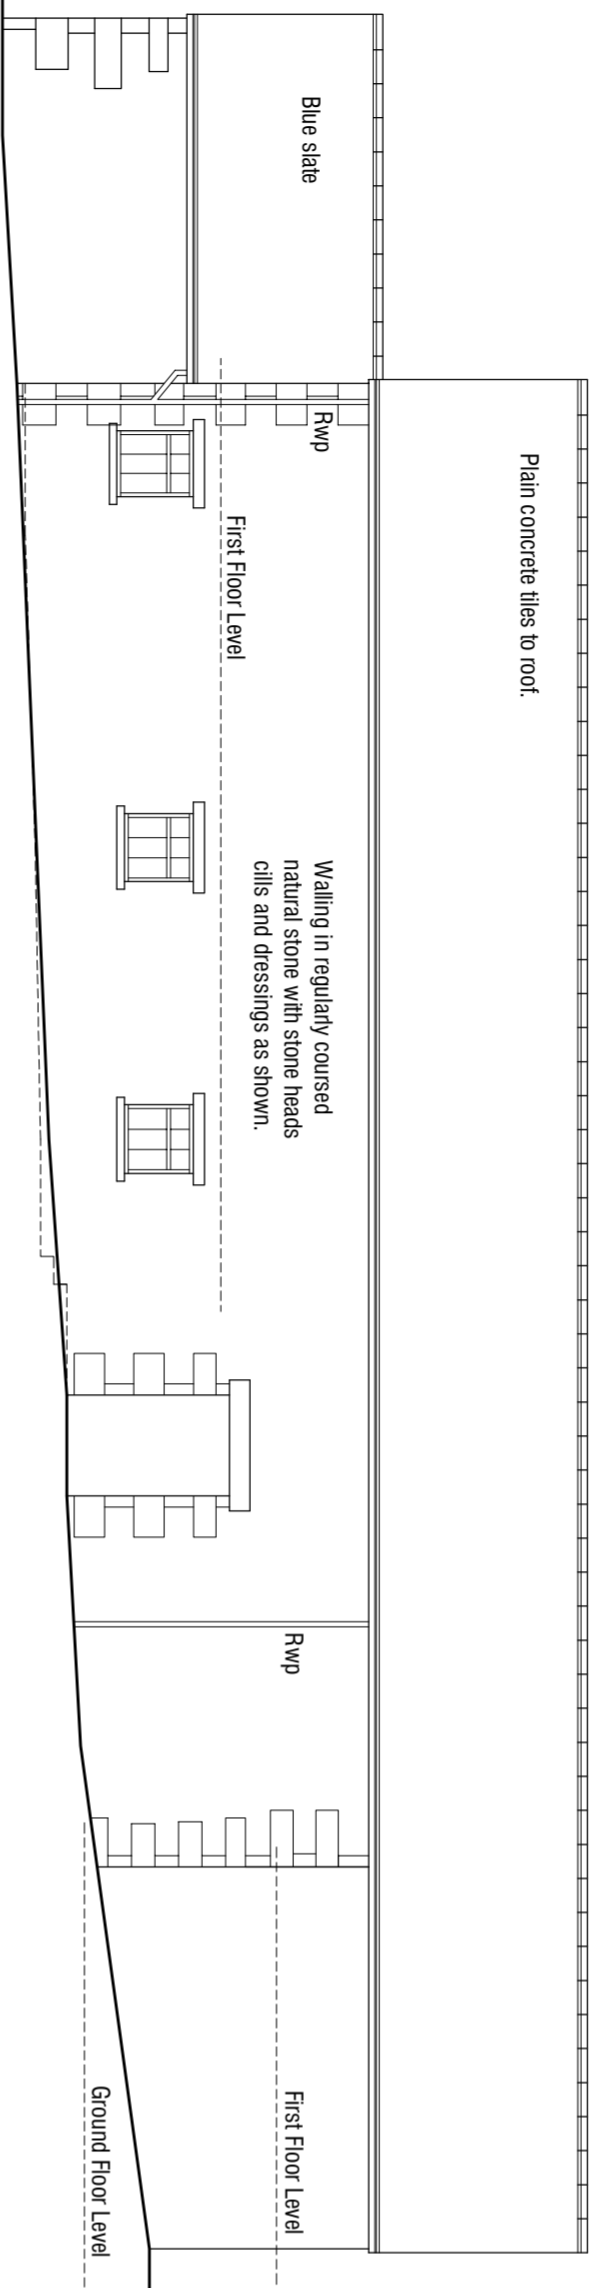
Plain concrete tiles to roof.

Walling in regularly coursed natural stone with stone heads cills and dressings as shown.

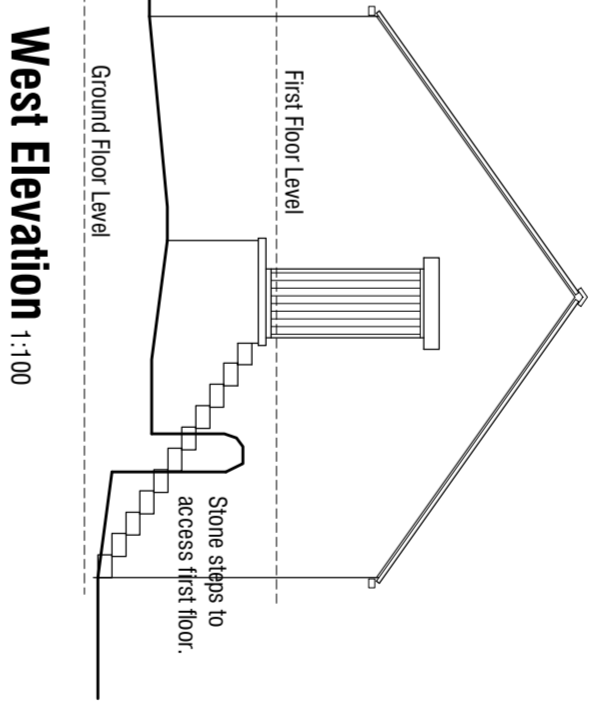
Stone steps to access first floor.

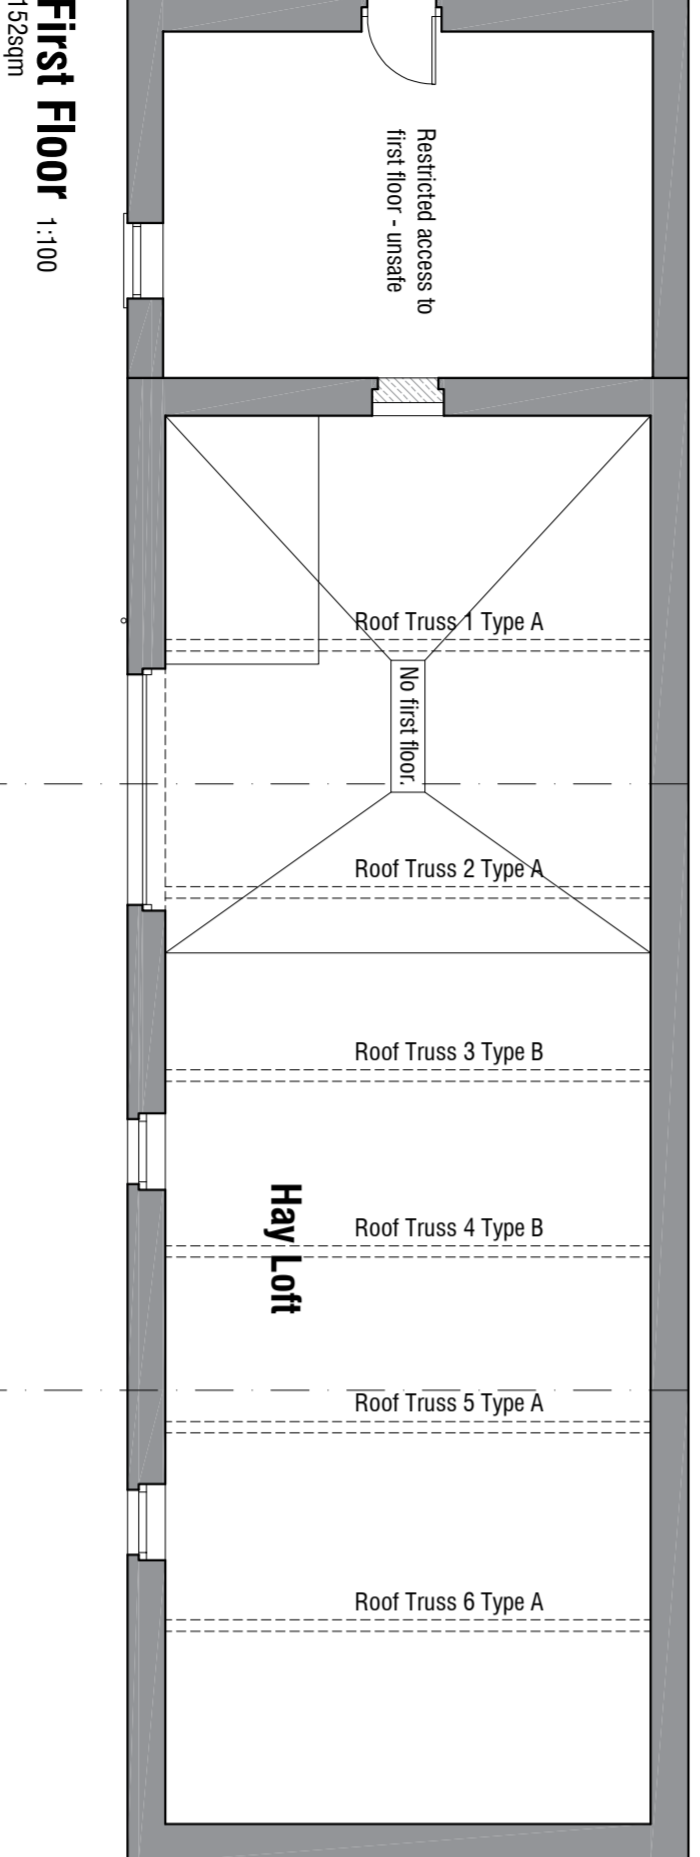
Section A 1:100

Roof Truss 1 Type A
Roof Truss 2 Type A
Roof Truss 3 Type B
Roof Truss 4 Type B
Roof Truss 5 Type A
Roof Truss 6 Type A

Hay Loft

Restricted access to first floor - unsuitable

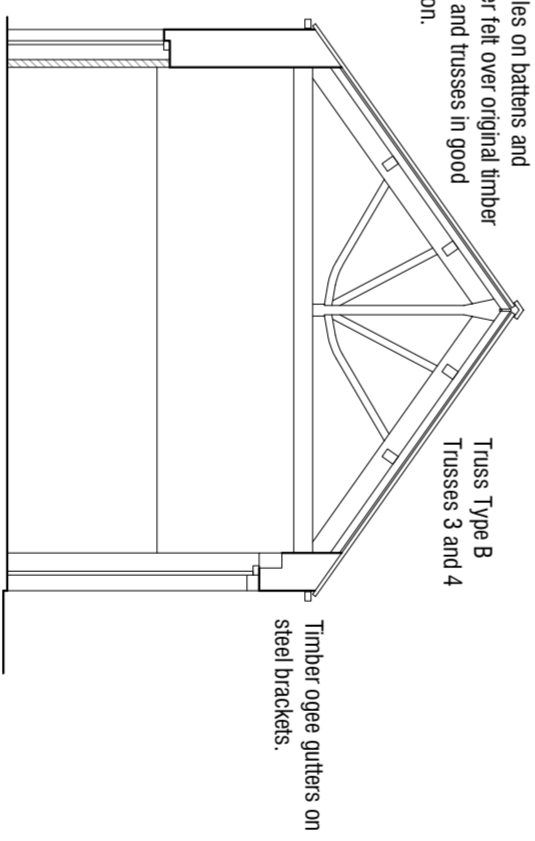
Conc. tiles on battens and breather felt over original timber purlins and trusses in good condition.

Truss Type B
Trusses 3 and 4

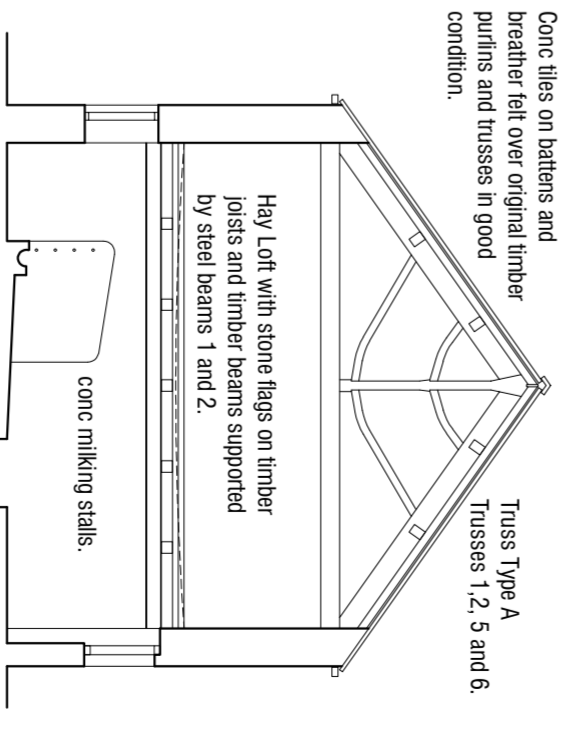
Section B 1:100

Timber ogee gutters on steel brackets.

Conc. tiles on battens and breather felt over original timber purlins and trusses in good condition.

Truss Type A
Trusses 1, 2, 5 and 6

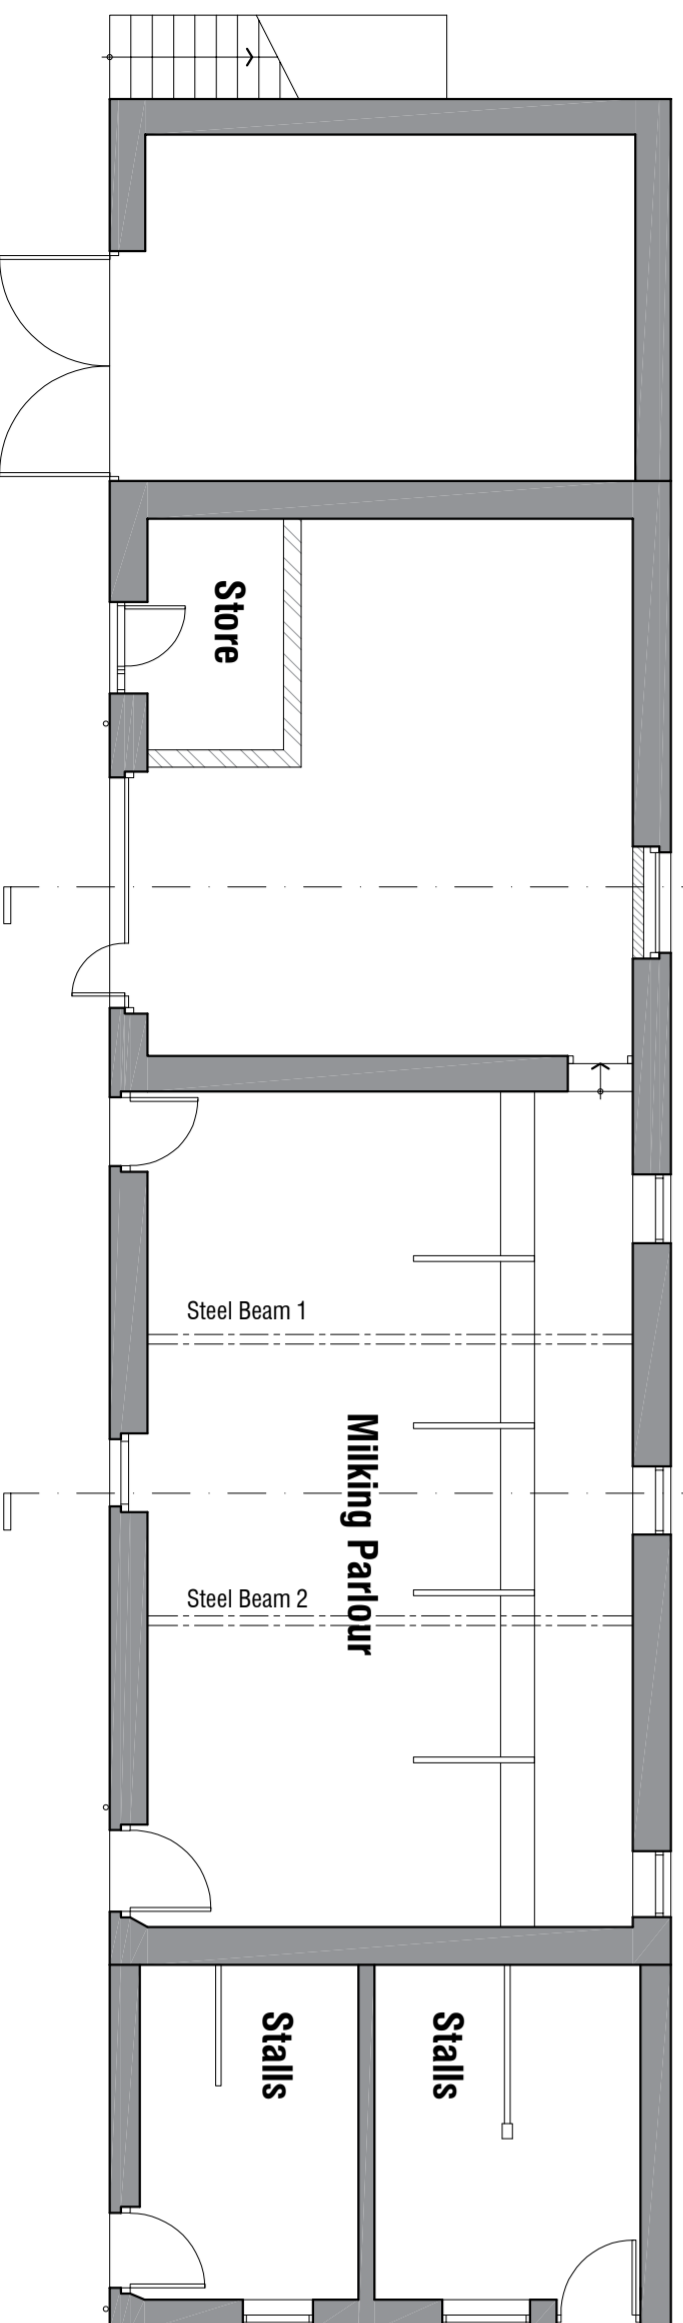
Ground Floor 1:100
185sqm

Hay Loft with stone flags on timber joists and timber beams supported by steel beams 1 and 2.

conc. milking stalls.
