Bat Scoping Survey to
Town Farm
Churchfield Lane
Kexborough
S75 5DU

1st October 2019

1. Summary

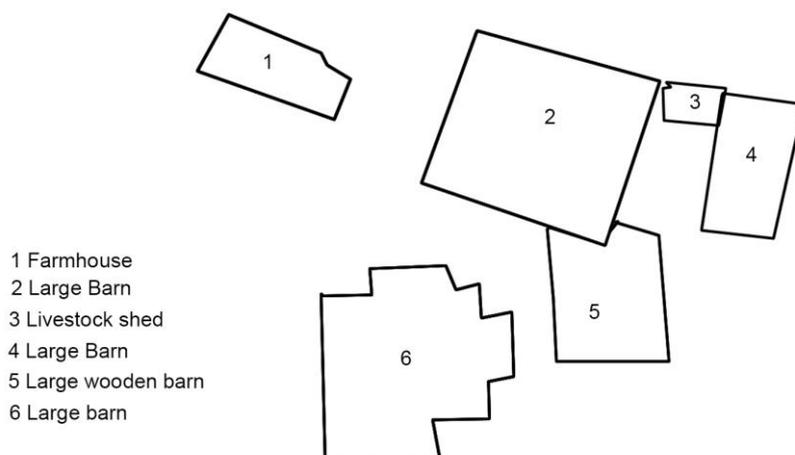
Figure 3. Layout of the buildings

The site consists of several large agricultural units, a livestock shed and a farmhouse. Figure 3 plots the location of each and identifies each of the buildings.

The large units (fig.3 buildings 2, 4 & 6) are all of the same style of construction with the lower section of walls made from breeze block in between a steel framework, while the upper walls and roofing is covered with corrugated sheeting, mostly cement fibre. The walls have no cavities that would allow bats to roost and the single thickness sheeting on the upper walls and roof are also of no potential interest to bats. The ridge sections tend to be wide, open and without a central ridge beam and are highly unlikely to be used by ridge dwelling species.

Building 3 is a small, open-fronted livestock shed that has been partially bricked up to the front. The original building has stone walls to rear and sides and a slate roof. The roof has been replaced in recent years and is in good condition with a full set of ridge tiles that are well bedded and in situ. The gable walls have heavy stone caps and are sound on the verges. There is no evidence to suggest use by bats and the building appears to have limited potential. It may be worth checking during the summer period when the farmhouse is being surveyed.

Building 5 is a large open-fronted wooden barn with a tin sheeting over the roof. The lower walls are single thickness blockwork while the upper walls are single thickness cedar planks on a

timber frame. The lack of wall cavity and open ridges make this an unlikely unit for bats to roost in.

The farmhouse is built from artificial stone and is sound and has no structural cracks. The walls have a traditional cavity that bats often use when they can gain access to them. The dry verges are very well sealed and the roof has a sound, slate covering which has no obvious entry points. The soffits along the north elevation are fairly well sealed to the walls and, where there are any minor gaps, they have a heavy build-up of dust and cobwebs. The soffits running along the south elevation do have some suitable gaps between the woodwork and the stone walls. In places these are large enough for birds to gain entry and may be less suited to bats. However, given the south facing aspect and the partial suitability of the gaps, it would be difficult to establish that bats are not present without at least one activity survey during the summer months.

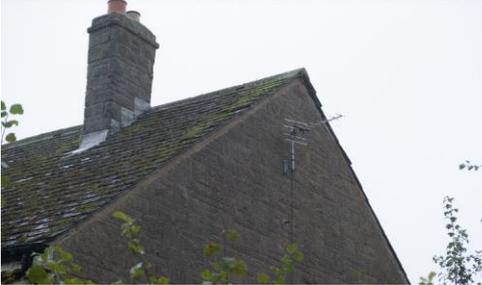
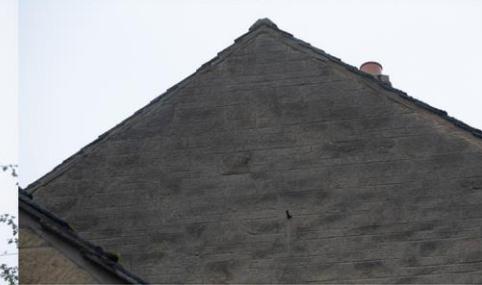
Farmhouse

10.2 The farmhouse has the most potential to provide bat roosting sites behind the soffits on the south elevation. Here, there are some potentially suitable gaps and they occur on the aspect that bats tend to favour most. There is no evidence of bats using this building but it would not be possible to discharge it without at least one activity survey being undertaken during the summer period (May to August inclusive). It is likely that starling is nesting in the SE corner of the building and consideration must be given to this species which will be noted in the LPA biodiversity action plan. Swallows do not appear to use these barns or the farmhouse and they are more likely to use the older stone barns at the adjacent Kexborough Farm which is also being surveyed for bats under a separate report.

- The buildings should not be demolished during the bird nesting season March to August unless a thorough check for nesting birds has been carried out. Demolition of the barns between November and the end of February is unlikely to impact bats or birds
- Work to demolish the farmhouse shall not commence until at least one summer activity survey has been carried out. Either a dawn return or evening emergence survey should be carried out by suitably qualified ecologists using enough staff to sufficiently cover the building.
- Any scheme put forward for the site must include compensation and mitigation for both bats and birds, including starling, house sparrow and swallow. A full mitigation plan will be determined by the ecologists carrying out the bat activity survey during the summer months.
