Plot of Land for 10 Dwellings - Grove Street Worsborough near Barnsley S70 4SN

Summary of Coal Mining Site Investigation November 26th to 3rd December 2018.

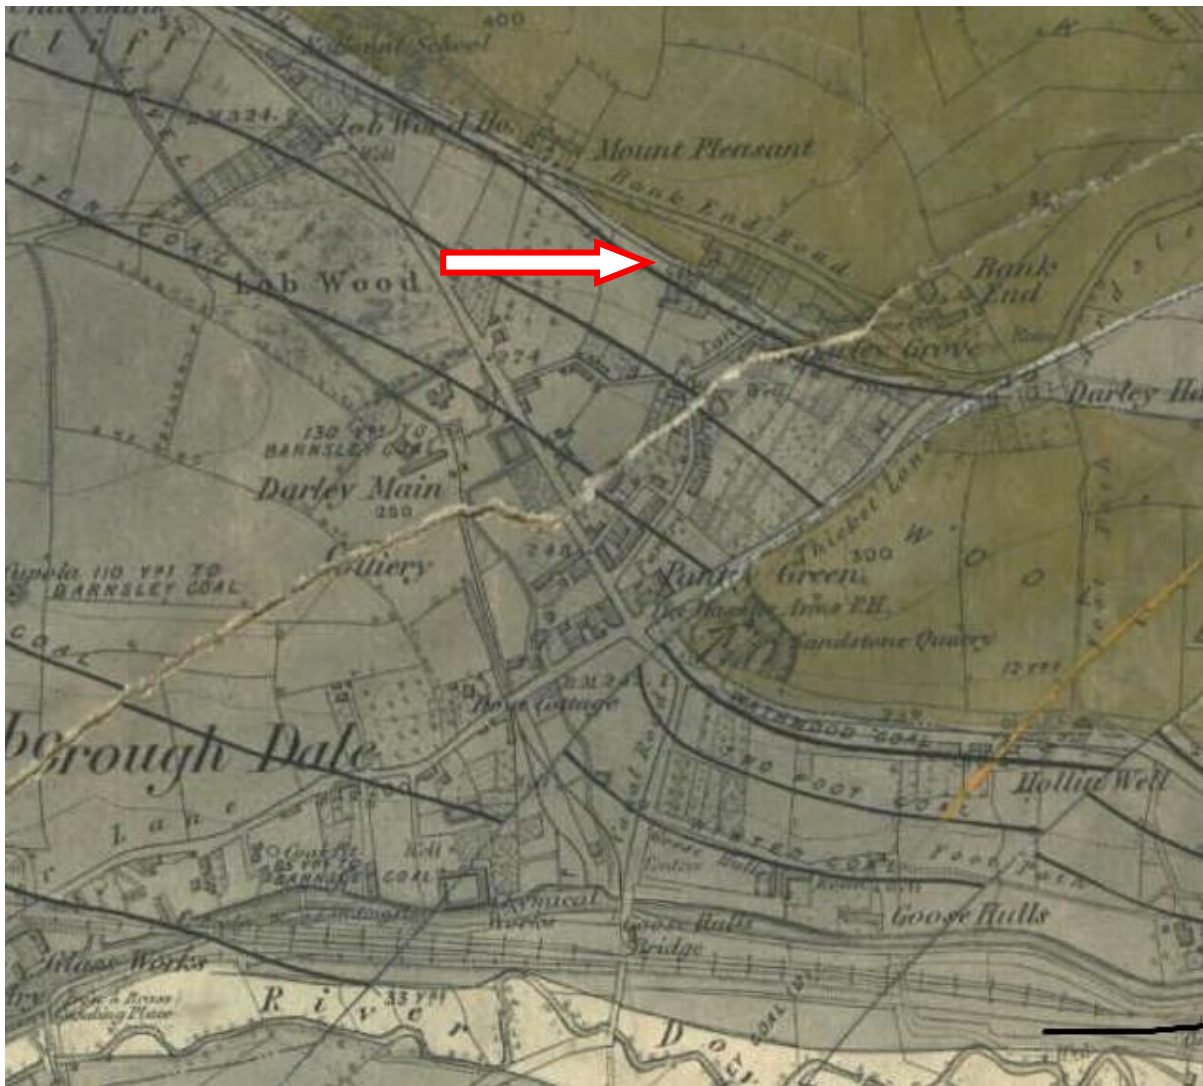
APPENDIX B – Geology Map 274

Figure 1 showing the 1st Edition Geology Sheet 274 with the site shown by the red arrow. Note the shaft to the south west of the site is possibly Darley Main Pit. Note it is 130 yards to the Barnsley Coal and the Winter Coal is further up the hill from the Colliery so cannot have been worked from this colliery. Note the fault to the east that throws the Rock down and displaces the 3 seams south.

- 1.3 There was no evidence of the seams being worked as they are on the valley side falling from Bank End Road to the river Dove and West Street and the mines were located in the valley bottom to sink shafts to the Barnsley Seam and are shown on the first edition geological sheet included with the method statement.
