## Heritage Impact Assessment

### Repair of unstable ceiling within Queen Anne Suite, Room 3 at The Northern College, Wentworth Castle, Barnsley

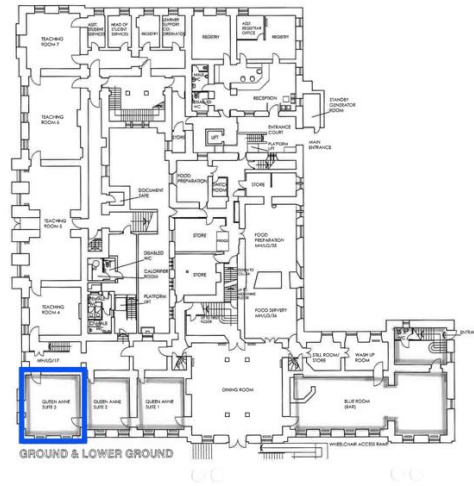
*Figure 37. Queen Anne Suite 3 Location.*

Methods Employed for Survey: visual inspection, tactile push test. 5.4 x 6.3 x 5.7 Height.

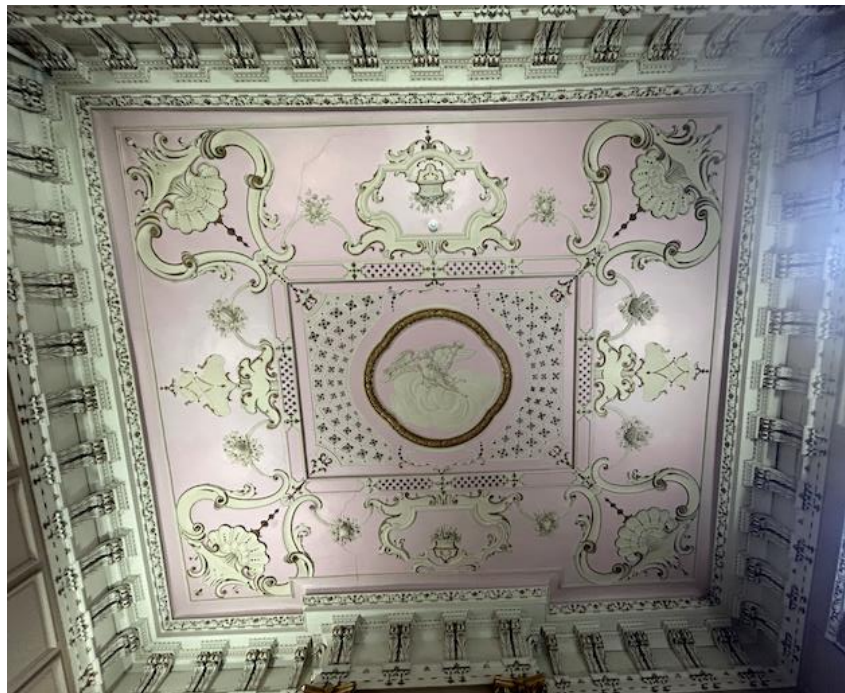
*Figure 38. Queen Anne Suite 3 Ceiling.*

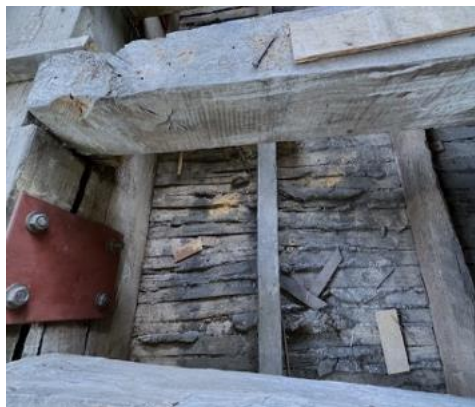
- The condition of the lath and plaster is considered to be very poor especially when compared to the other areas observed within the Long Gallery. Laths are fixed very closely to each other and there are minimal plaster nibs/keys evident. Where they are present many were found to be fractured when subjected to tactile examination. There is clear evidence of woodworm activity and decay of the laths which were reduced to dust when physically examined. In addition, a significant amount of springing laths were found.

- There are signs of previous interventive works such as metal joist hangers which are found to be too rigid. Additionally, multiple steel plates were found inserted in the oak beams where they have split over time. None of these methods have assisted in supporting the plasterwork.
- There are signs of wood worm, heavily decayed and loose/springing lath, and loose joists.
- Tight laths with no keys were found to be present.
- Where the reverse of the ceiling is exposed, the limited haired lime grinning through the lath, that have mostly been originally installed too close to each other, shows 'very little or no key/nibs' at all. It seems that when the void was potentially cleaned out some time back, all the key/nibs were scrapped-off and removed along with the pugging layer etc resulting in a ceiling which is unstable and requires stabilization.

*Tight lath and minimal key, previous interventions visible.*

- It is recommended that the reverse receives the Crystacal plaster pad system, inserted into the lath, on suspended on wires. Then, depending on the ceiling joist positions, SS screws and washers inserted into the lime face at approx. 350-400mm centres.

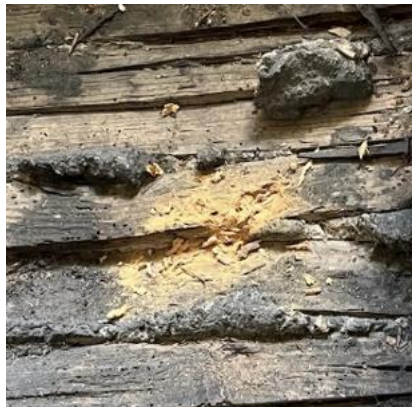
*Insect presence visible.*

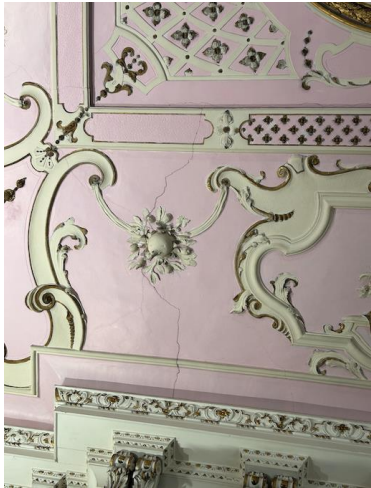
- The ceiling had multiple hairline fractures and cracks visible throughout the expanse of the ceiling, cornice, and decorative elements (Figure 39).
- An area of splitting was observed on the East wall cornice (Figure 40). Splitting was also found in multiple areas on the South wall cornice and between the ceiling and cornice at the corner of the South and East walls (Figure 41).

*Figure 39. Hairline cracks visible throughout the ceiling and cornice.*

Plaster repairs using lime /plaster of Paris or other approved to any cracks or defects.

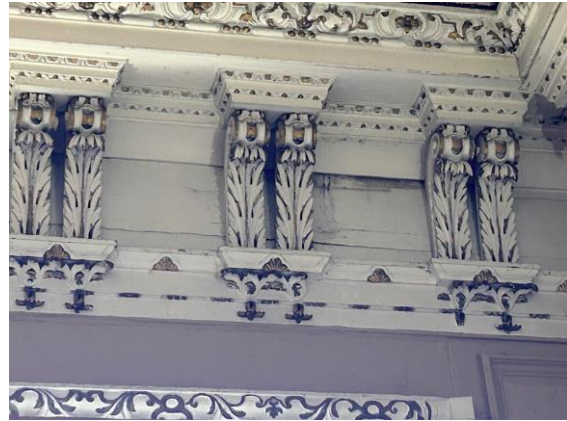
- What appears to be water ingress was visible on the East wall (Figure 41). Additionally, some paint loss was noted in the area of localized damage on the East wall. Possible water ingress was also visible on the South wall cornice (Figure 42).

*Figure 40. Splitting and ingress visible on the East wall cornice.*

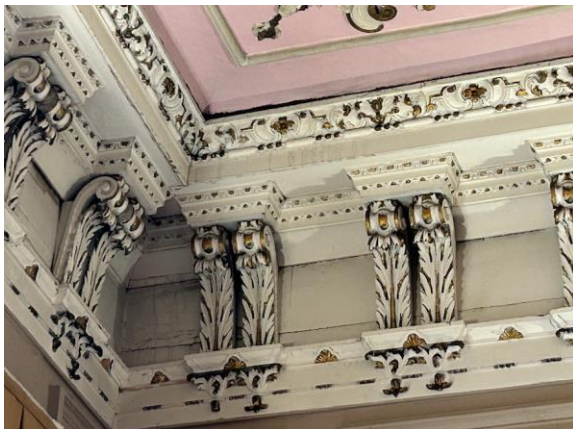
*Figure 41. Splitting and ingress observed on the South wall cornice and ceiling.*

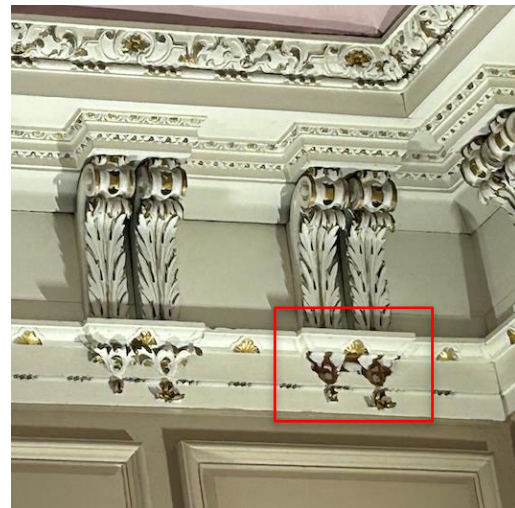
- There were multiple embellishments missing from the cornice (Figure 42).
- One loose embellishment was removed during the survey as it was found to be a hazard to visitors to the room (Figure 44 & 45). A second embellishment on the West wall was found to be loose but not deemed dangerous or urgent to remove.

*Figure 42. Multiple embellishments missing throughout the cornice.*

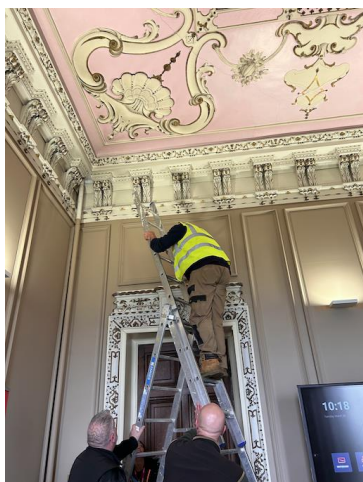
*Figure 43. A loose embellishment was removed above the West wall during the survey due to being a hazard to visitors to the room.*

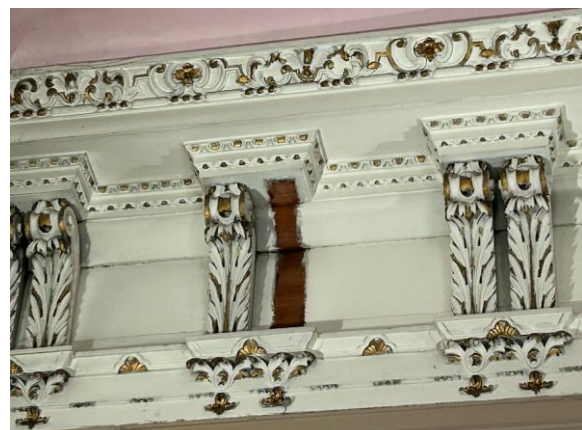
- The cornice and embellishments appear to be made from timber. Removal of the loose embellishment confirmed the materials was made of timber (Figure 45).

*Figure 44. Removed loose embellishment revealing the cornice to be made of timber.*
