Edwins Close, Barnsley
Desk Study Report
Yorkshire Housing

Solmek Report Number S90715

August 2009

Desk Study Report

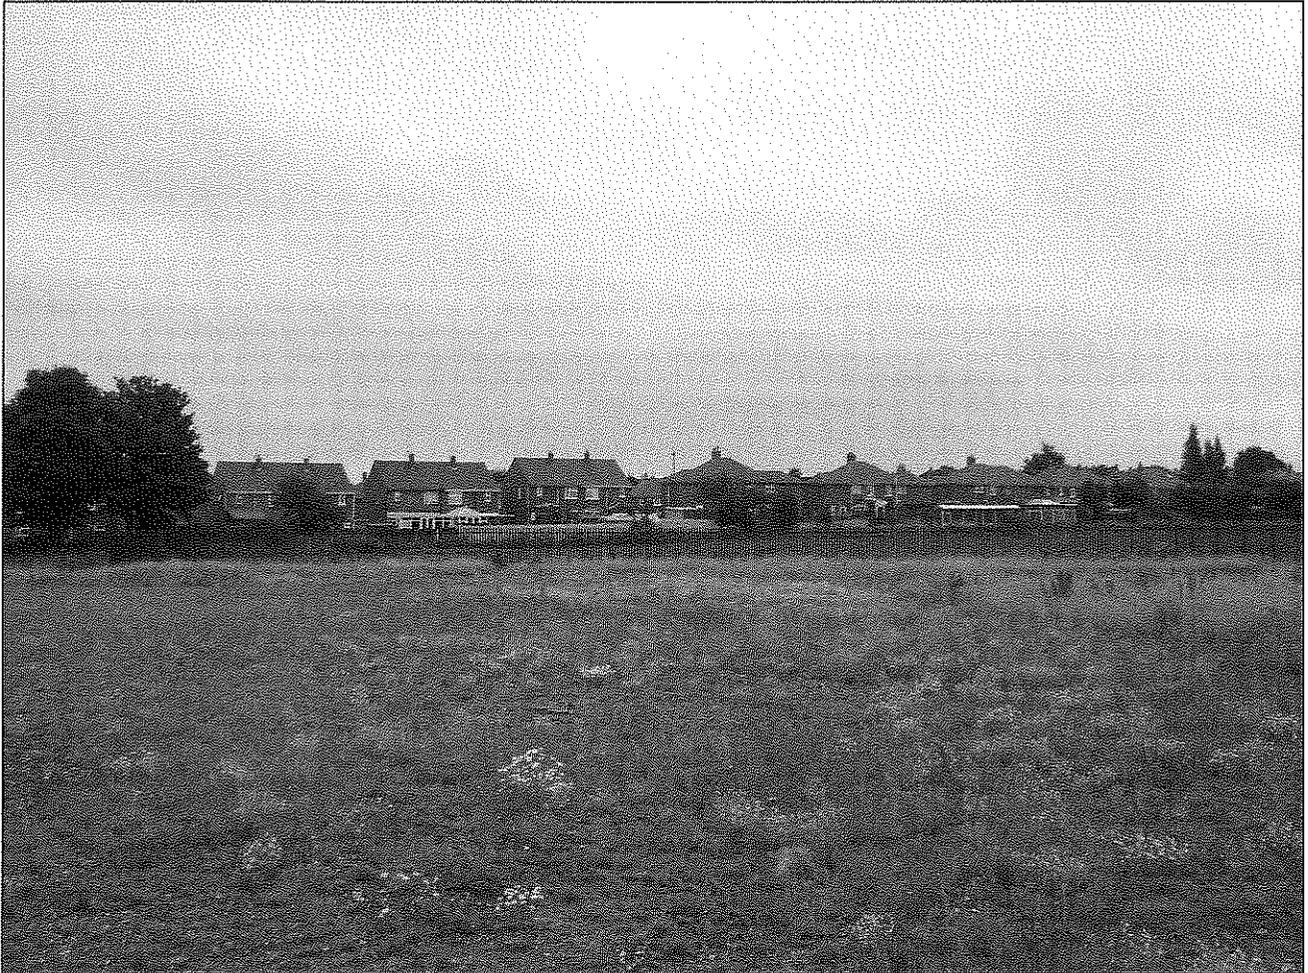
Client:	Yorkshire Housing	
Project:	Edwins Close, Barnsley	
Title:	Plates 1	
Drawing No:	Figure 3	Scale: NTS
Date	August 2009

Plate 1: An overview of site looking to the east showing the site surrounded by the railing fence and residential surroundings
