**Dorothy Hyman Sports Centre
New AGP**

Surface Water Strategy

R - 00191 – 001 – SDS – A
April 2024

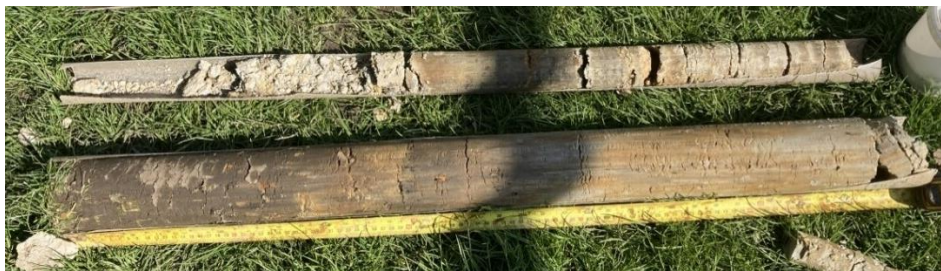
Figure 4-1: Photo of soil profile at WS01

- 4.1.5 Photographs representing the typical ground conditions are presented in Figures 4-1 and 4-2 below.

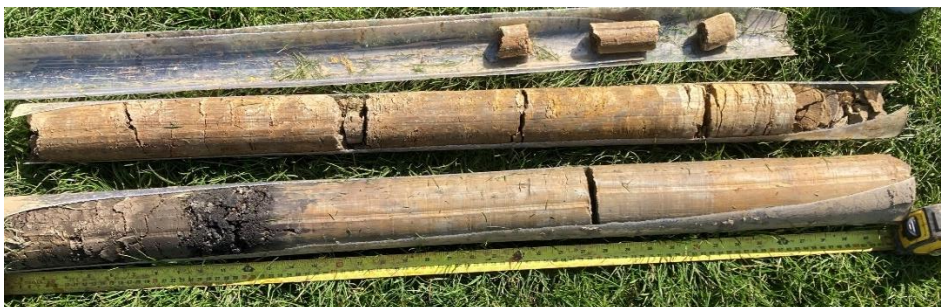
Figure 4-2: Photo of soil profile at WS07

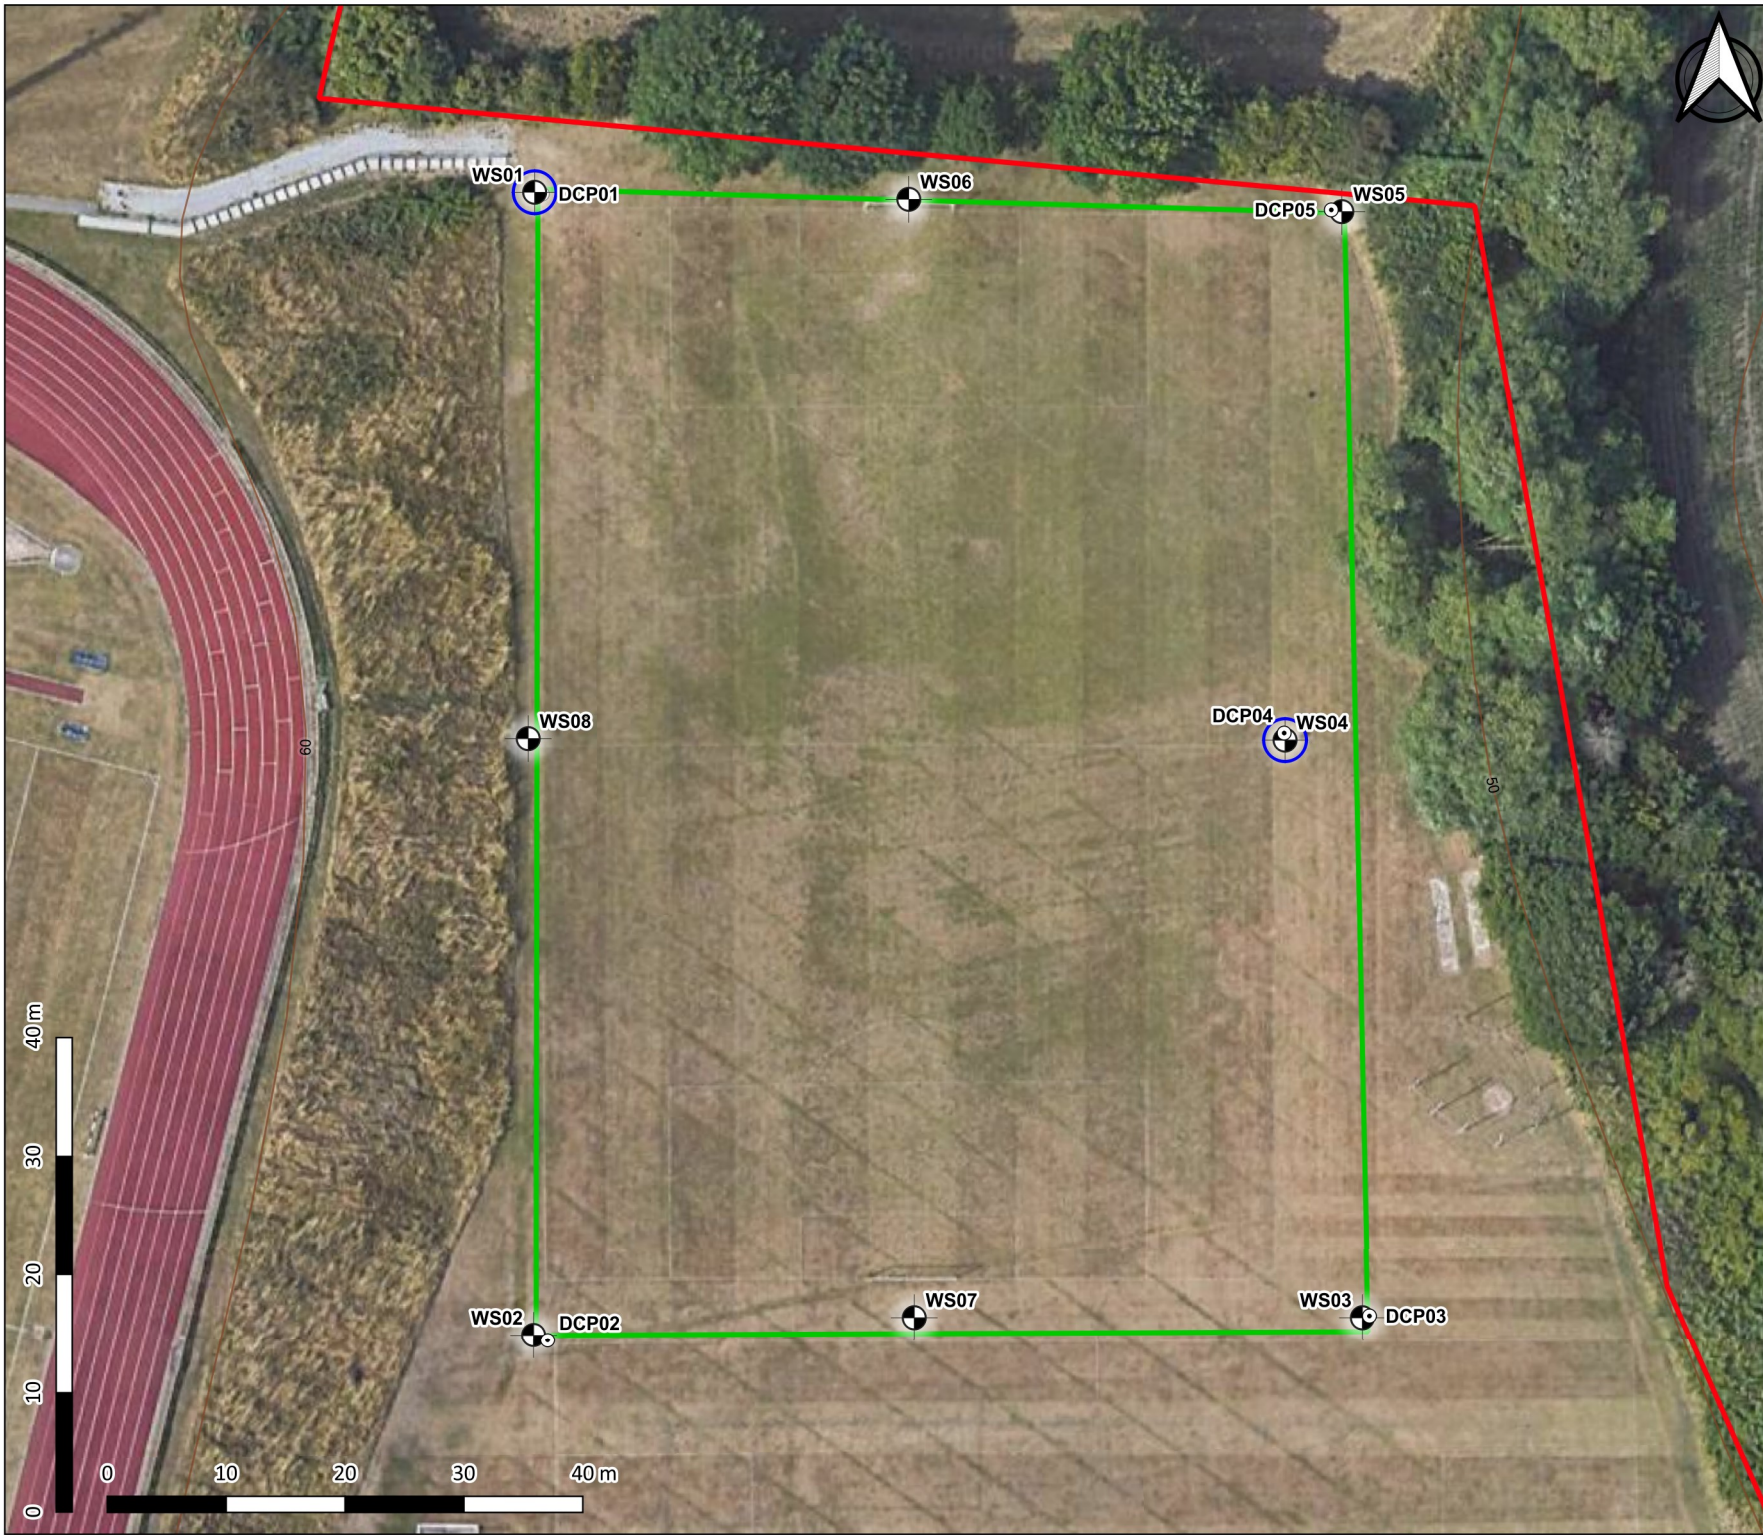
TITLE
Exploratory Hole Location Plan

Soakaway / Permeability Testing
-

DCP (CBR)
-

Proposed FTP Area

7.4.1 We have determined CBR value for the proposed artificial pitch using in-situ Dynamic Cone Penetrometer testing following the methodology defined by the Highways England Document CS229 Data for Pavement Assessment. The results are presented in Appendix D and the location of test positions are shown on Drawing 01.
