## **Penistone Footbridge & Car Park**

Arboricultural Survey Report

For **Barnsley Metropolitan Borough Council**

Project No.: **BAR010-003**

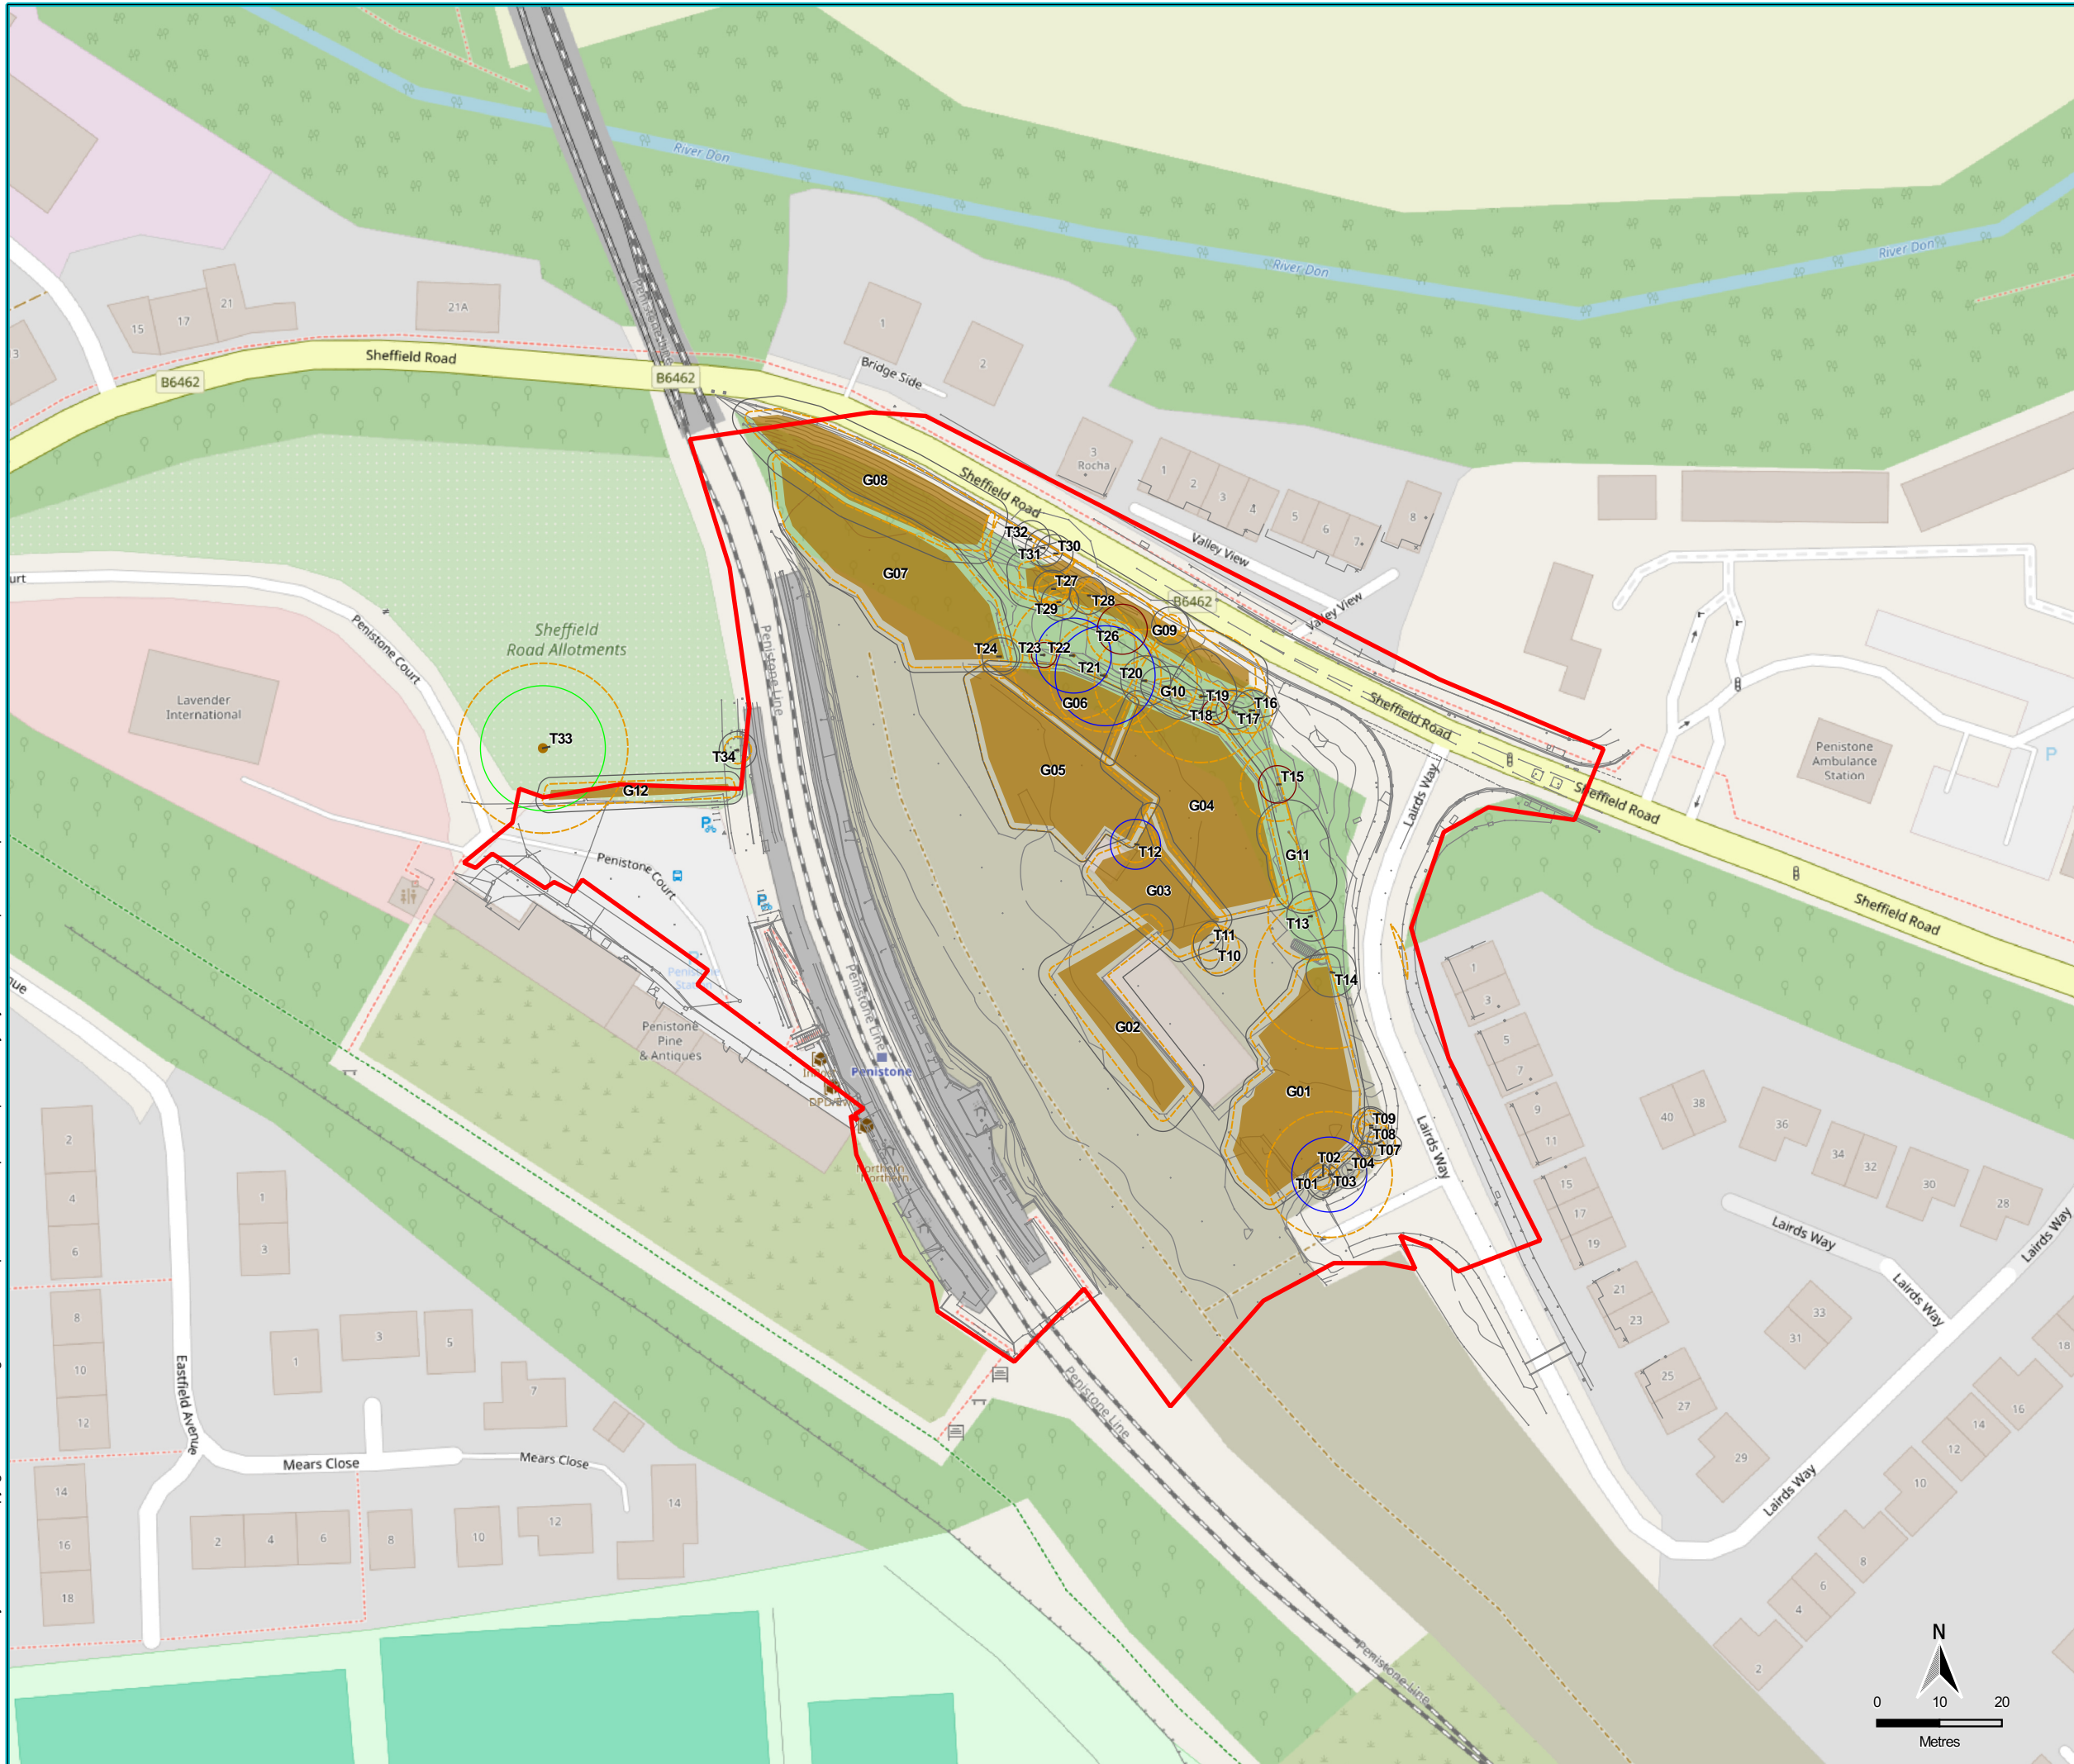
| 2a | |

Tree Constraints Plan  
(TCP01)

- 5.1.3** Category B trees are good condition trees and are important features within the locality. Loss of these trees would adversely affect the landscape and reduce the canopy cover in the area. Category 'B' trees/ groups are shown with a blue canopy on the attached Tree Constraints Plan at Figure 2.

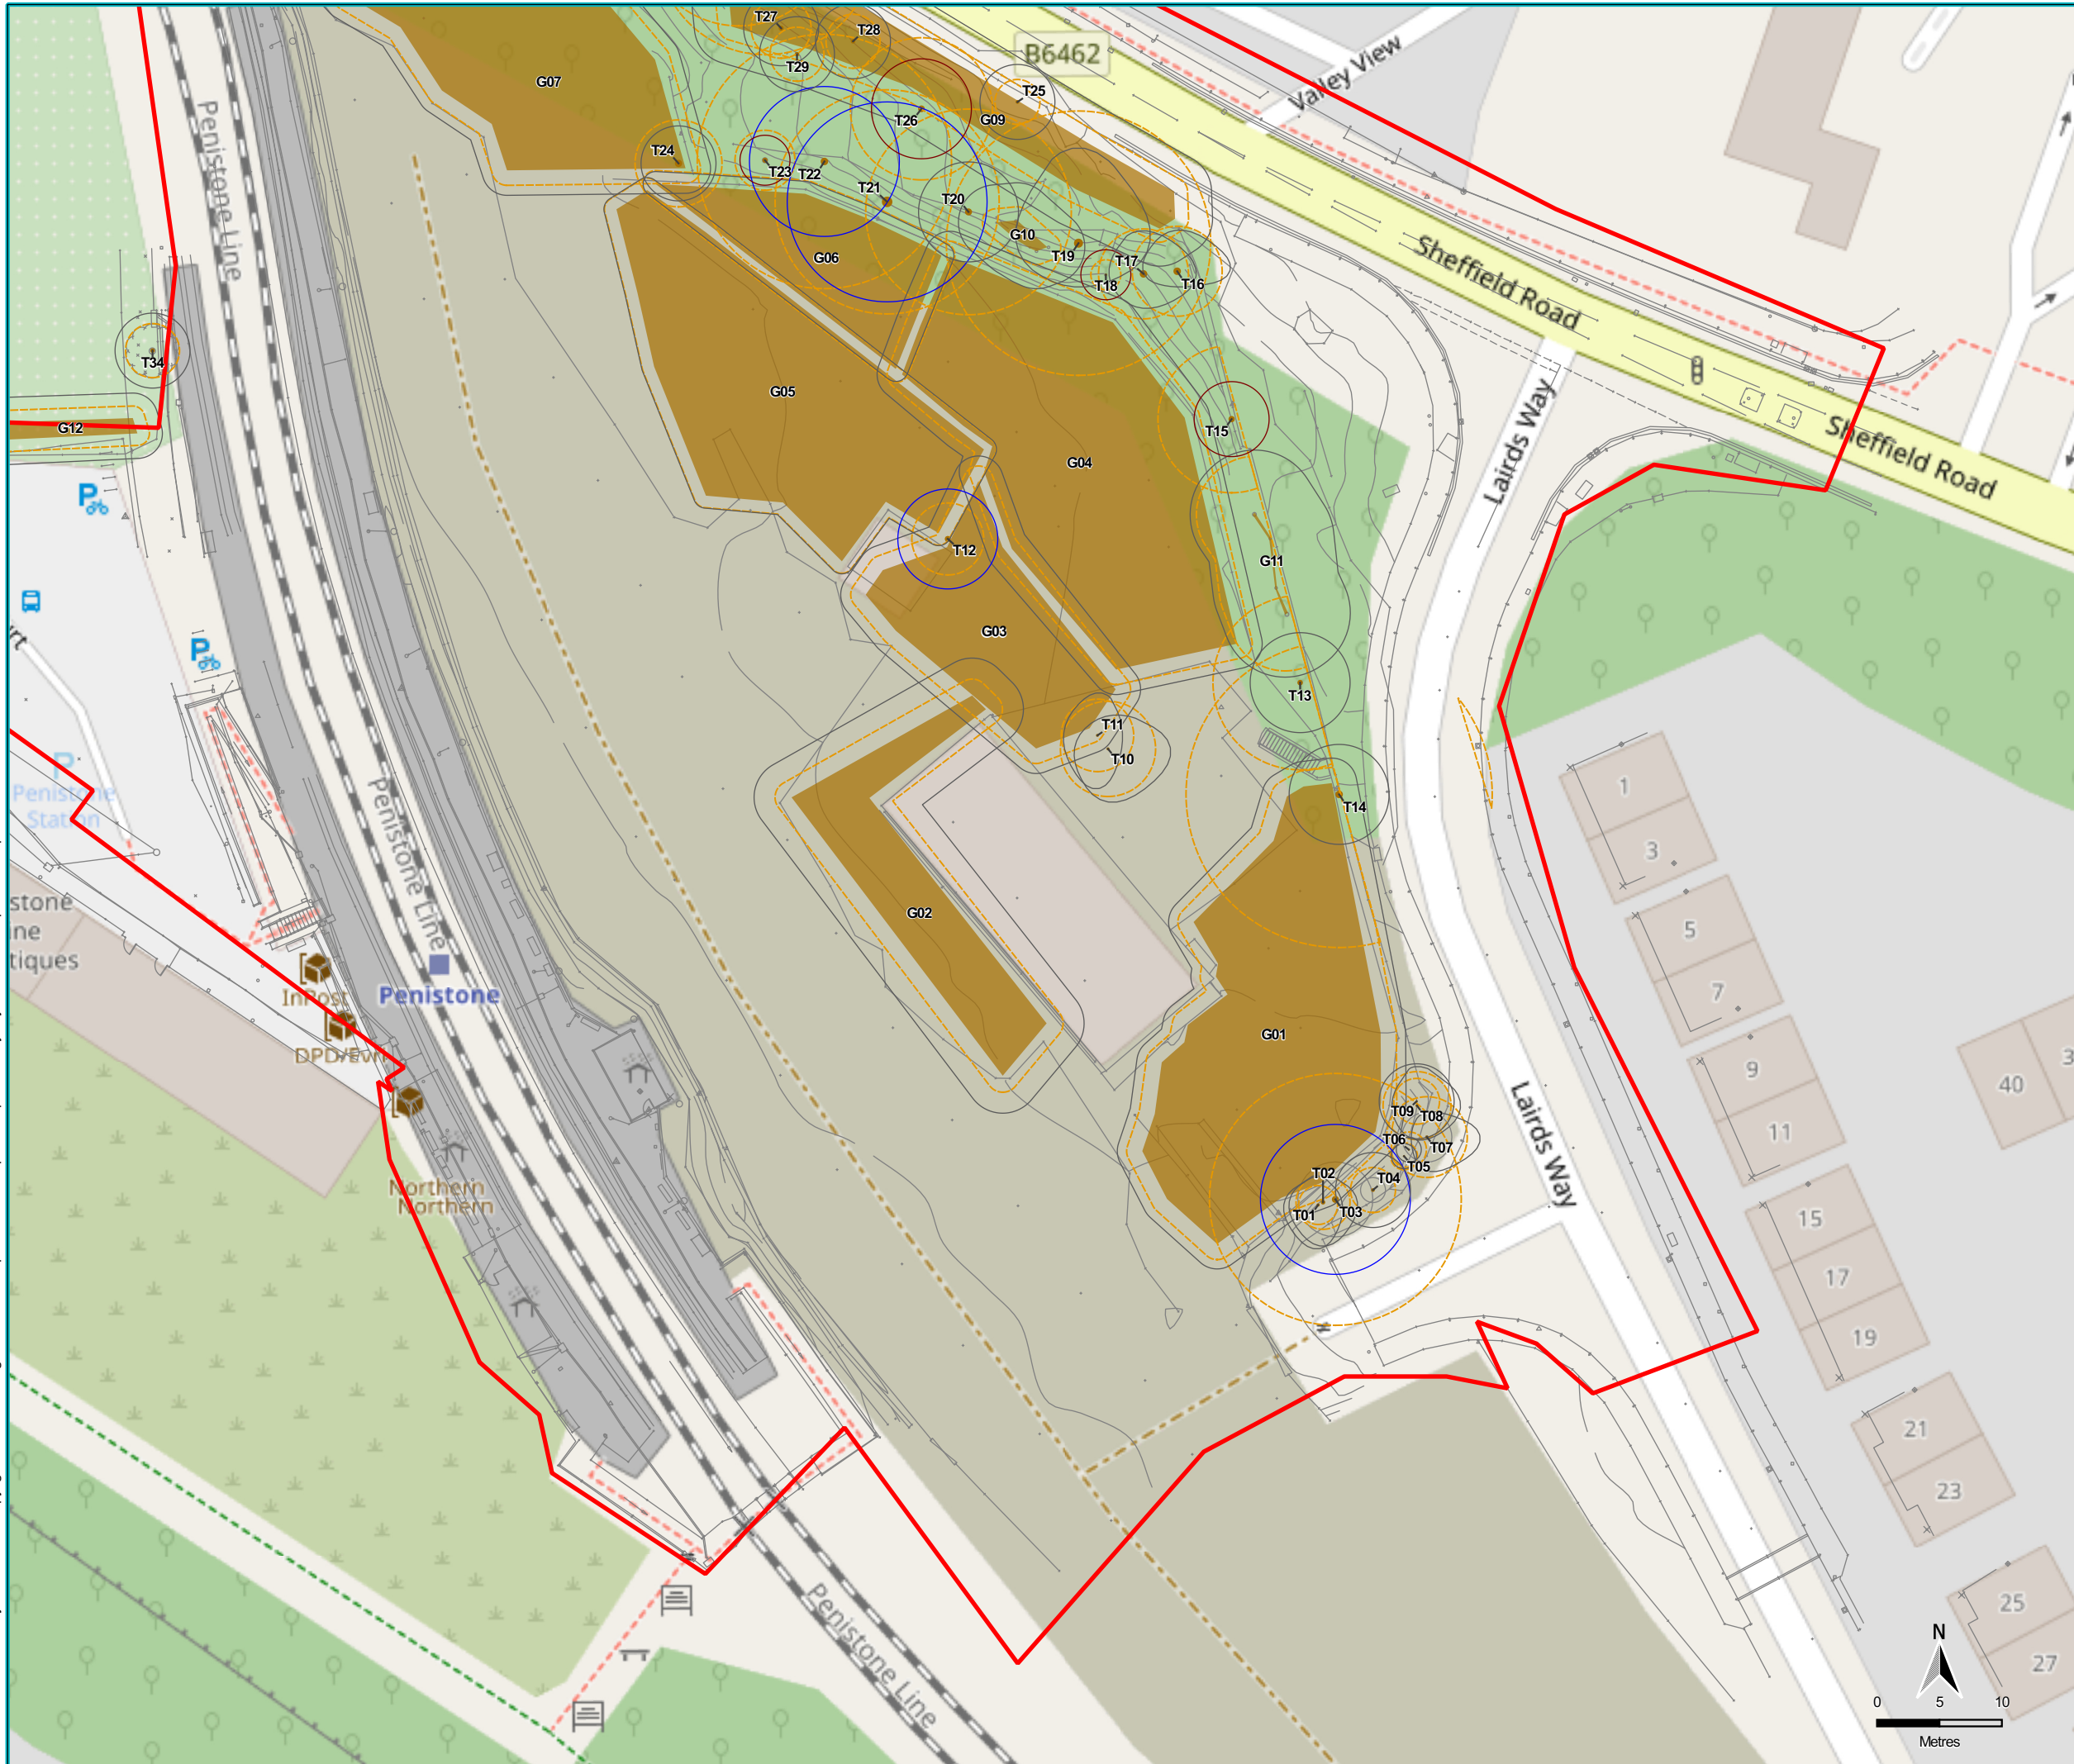
| Figure Number<br><b>2b</b> | |

| Figure Title<br><b>Tree Constraints Plan (TCP01)</b> | |
