**Bat Roost Potential Survey  
Barnsley Road Cottage, Penistone**

Report reference: R-2371-03  
October 2015

The building has been found to have *Moderate* bat roost potential in the areas to be affected.

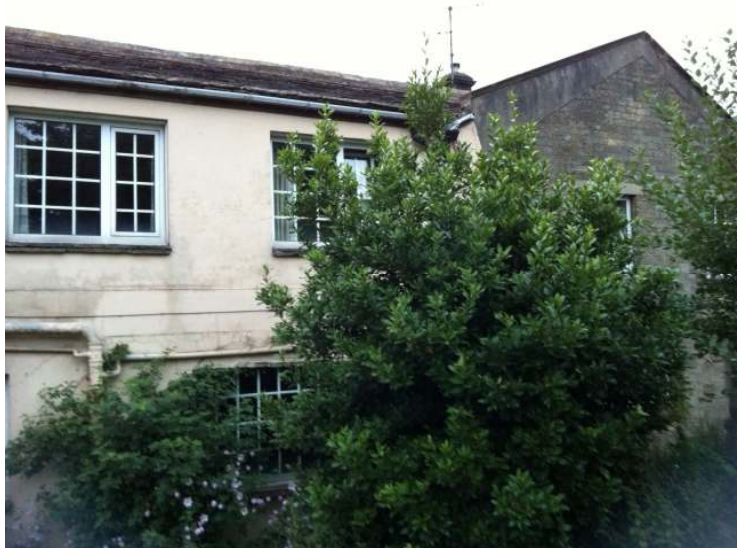
**Figure 2**

14. The older adjoined section of cottage is of a similar construction but with a variety of rendered and stone walls. Immediately adjacent to the surveyed area a small section of the original roof is tied into, and likely connected to, the interior loft space of the survey area. The stone of walls of this original section appear in good condition, and the large stone copings on the gables

appear well sealed. The roof pitches of this section have been raised to a shallow pitch and adjoin other roof sections at each side – it presents very little opportunity for roosting.

Stone gable of adjacent building seen on the right of this picture.

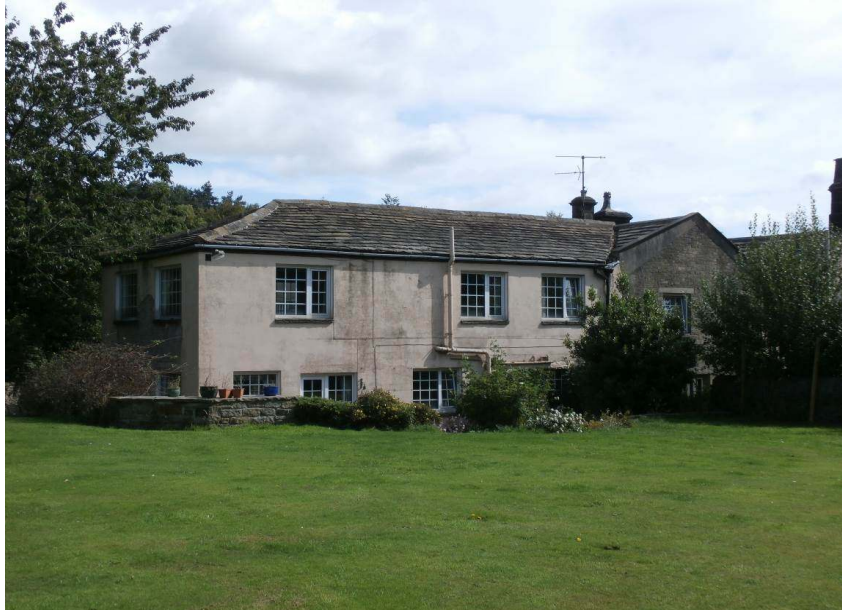
15. The walls of the surveyed building have been rendered up to a well fitted wooden fascia / gutter board allowing little opportunity for roosting along this feature. The rendered walls are well sealed, with no apparent large cracked or flaking areas which may be used for roosting.
16. The shallow pitch of the surveyed roof and adjacent areas reduces the value of the interior space for roosting of species which prefer to fly internally before emergence.

**Figure 3** General view of the extension from the North West.

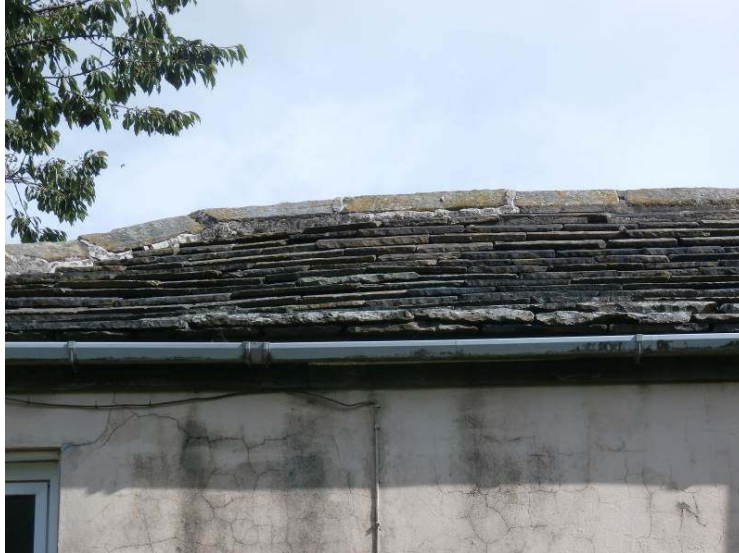
**Figure 4**

17. The stone tile roof of the building is slightly uneven creating multiple narrow gaps between the tiles throughout, providing multiple small crevices for roosting between tiles, furthermore any larger gaps may provide access to the loft space. However, access to the interior was not possible during the time of survey to confirm this. The stone tiles of the adjacent roof section are of a similar condition.

Showing uneven roof with gaps between tiles and gap below ridge.

18. Though generally well-sealed, some gaps within the roof can be found along the ridge and hip ridges where small pieces of mortar have fallen away, allowing access to these areas.
19. The flashing between roof sections appears generally well sealed, with only one small slightly lifted area, lower down the roof this may offer some limited roost potential.

20. The buildings location near several features of good foraging and commuting value to bats, alongside a large number of general sightings and roost records for the area, is suggestive of healthy bat populations. As there are multiple gaps between roof tiles suitable for roosting the building is evaluated as having *moderate* roost potential.
21. As such a further two emergence surveys are recommended, with at least one taking place in the optimal survey period May – August, in order to establish the status of roosting bats.
