# Bat Building Assessment & Bat Activity Surveys

Barn at  
Water Slack Farm  
Cawthorne, Barnsley

Report Reference: BG133

May 2013

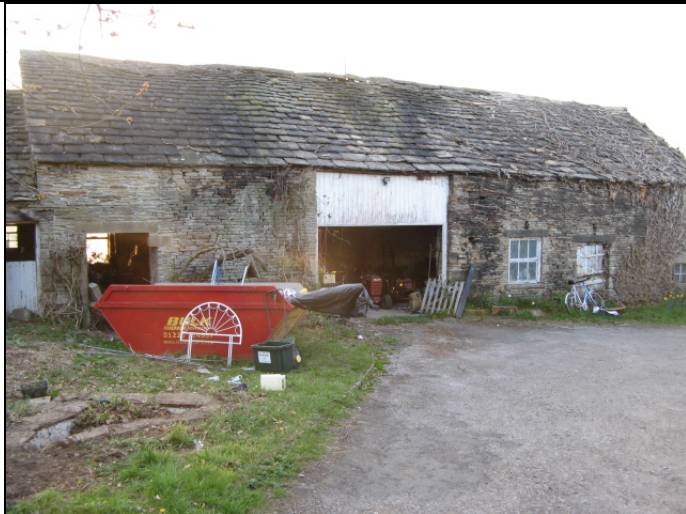
Large stone roof tiles with  
numerous gaps.

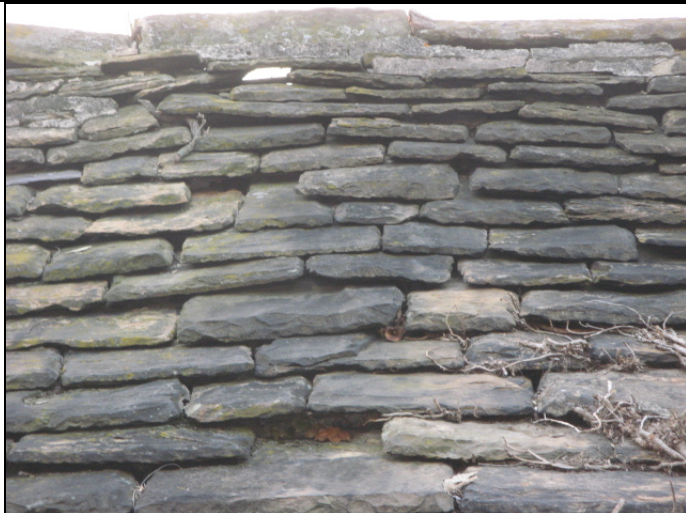
Substantial thickness of walls  
c45cm wide.

The results of the survey shows no evidence that bats were using the barn and only a few foraging bats were recorded in the surrounding area during the surveys. This is surprising because the barn is covered in holes and crevices that on first impression look suitable for bats. Walls as wide as this usually allow bats to get within the wall in crevices that are free from the influences of the weather.

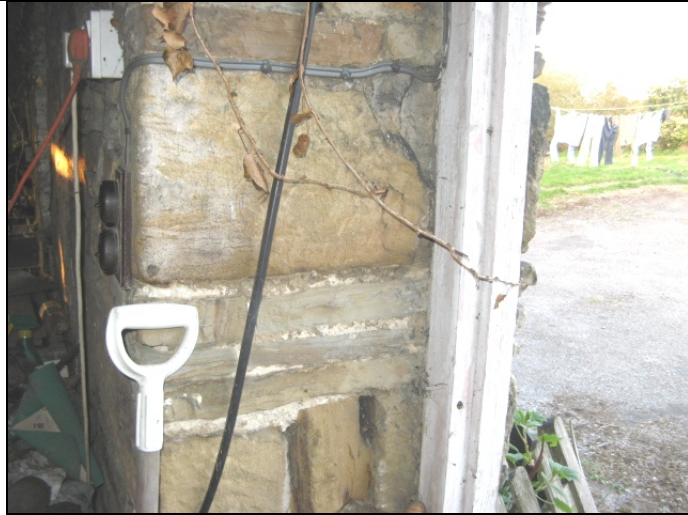
Rear of the barn showing that  
large portion of the building  
have been constructed by dry  
stone walling methods.

It can only be assumed that the dry stone wall construction is allowing wind to move through the walls and thus deterring bats from using the barn.

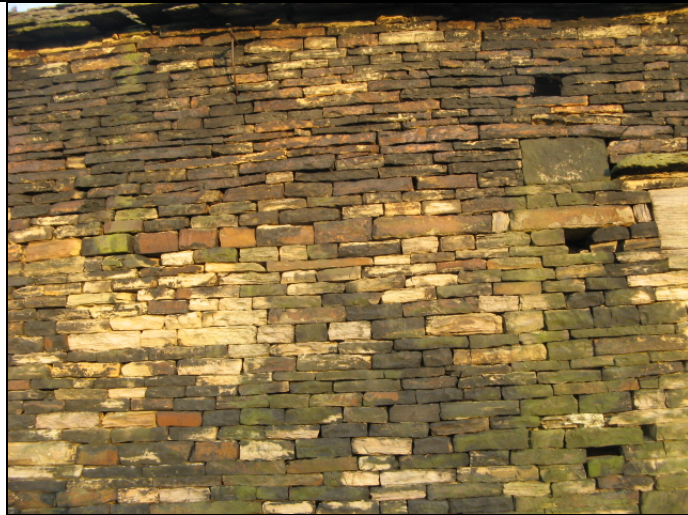
Small stones have been used  
in the construction of the  
building. This allows holes  
and crevices to exist around  
most of the individual stones  
within the walls.

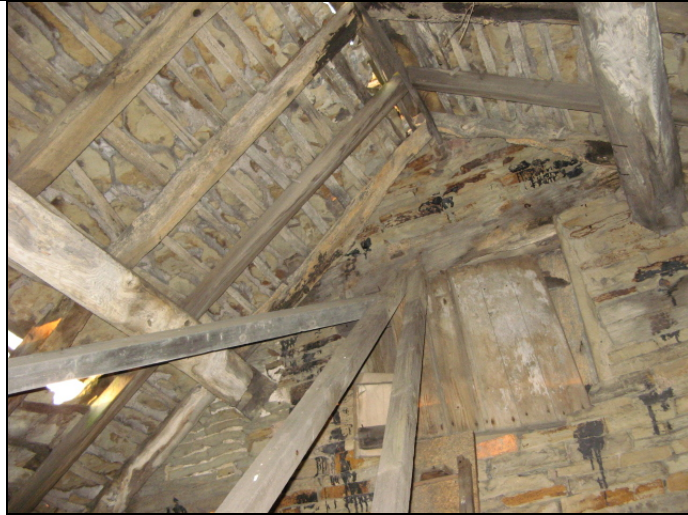
Interior of the barn.  
Mortise and tenon joints used  
in the construction of the roof  
rafters. Gaps between these  
types of joints are sometimes  
used by roosting bats.

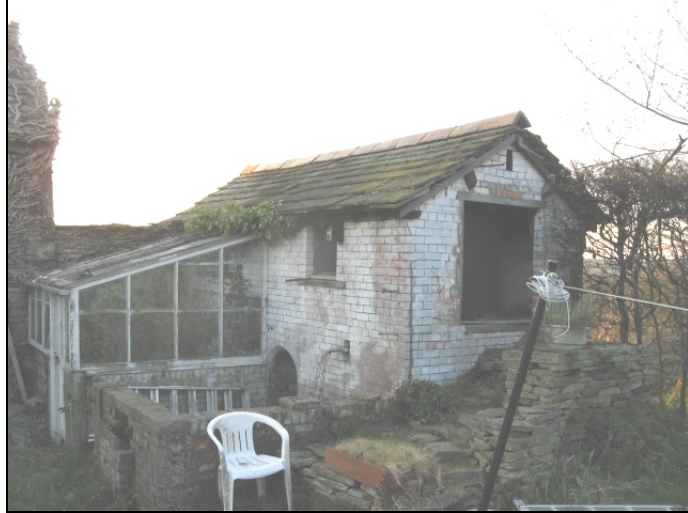
A roof space exists within this smaller barn.
