**STABLE AT COOPER LANE,  
HOYLANDSWAINE**

**BAT SURVEY REPORT**

**Ref No:- 131021**

**Date: 24<sup>th</sup> October 2013**

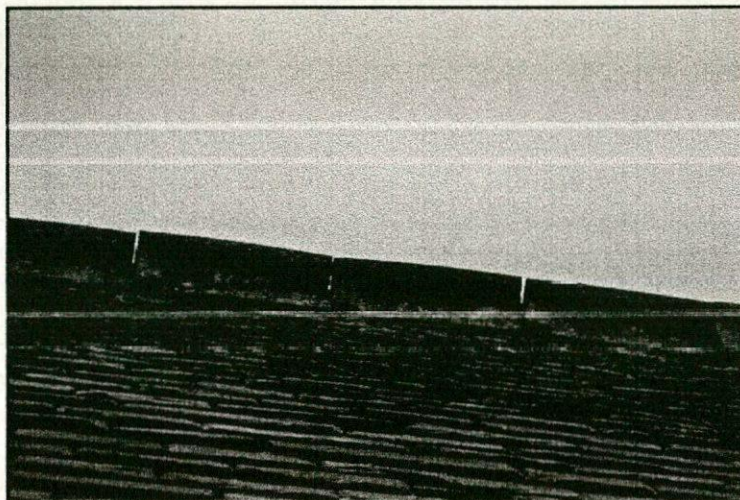
3.3.4. The building has a pitched slate roof with terracotta ridge tiles and parapets with stone coping stones at the top of each gable end. The roof is generally in good condition although there are a small number of slipped tiles and gaps under the ridge tiles which may allow access to bats between the slates and roof lining. Flashing is also present along each parapet wall at the gable ends. This is in good condition providing no suitable roosting locations for bats.

- A small number of missing tiles and/or gaps under the ridge tiles may allow access to potential roost locations between the roof tiles and roof lining.
- The timber boxed soffits are damaged in one location on the building's southern elevation, allowing access to bats into the soffit to a potential roost location.
- A small area of missing pointing in the stonework on the southern elevation may provide access to bats to gaps between the stone facing and breezeblock walls. The gap is approximately 1.5m off the ground and therefore is not ideal as a roost access point for bats as it leaves bats open to predation on entering and exiting any roost.
- Missing stonework underneath a window on the northern elevation may allow access to bats to the interior of the building to be used as a foul weather foraging area, feeding perch or 'night roost'.
