**BANK VIEW, WELL HILL, GREEN MOOR.**

**BAT SURVEY.**

**Ref No: 210944/2.**

**Date: 9<sup>th</sup> December 2022.**

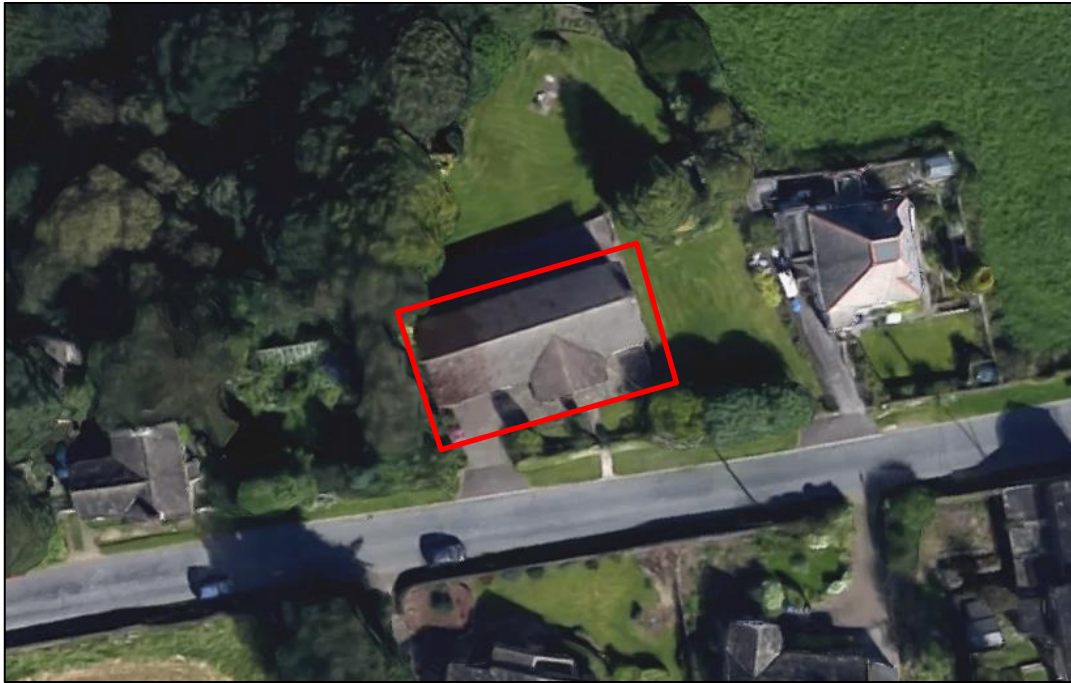
3.2.1. The survey area is the bungalow, Bank View off Well Hill in Green Moor. The aerial photograph below shows the bungalow.

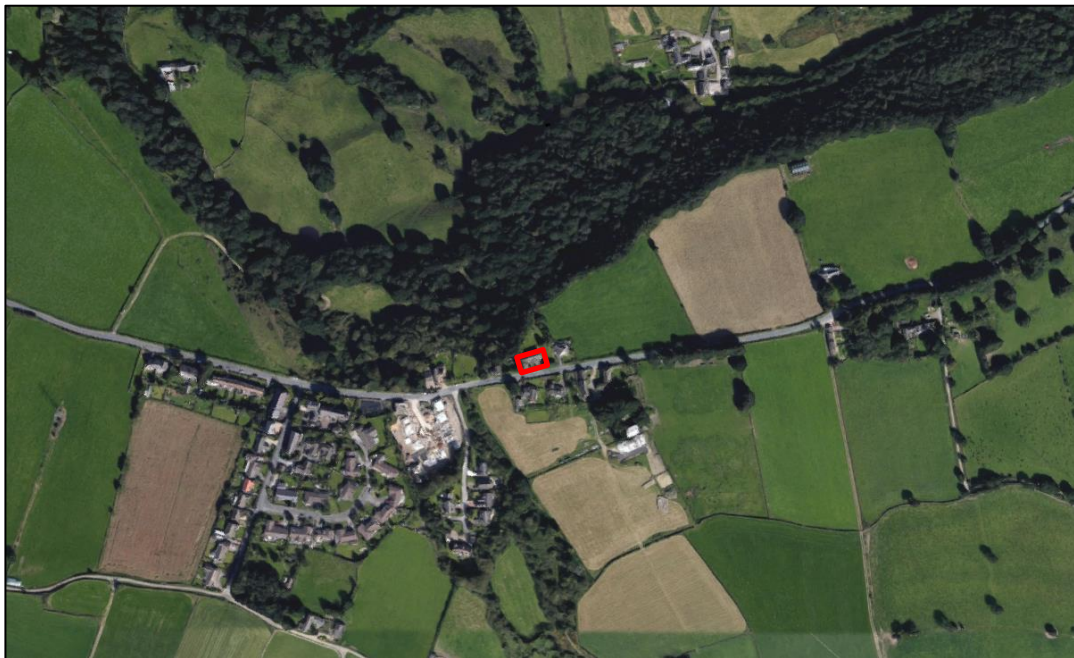
3.2.2. The site is on the eastern edge of the village with a few residential properties surrounding it and the wooded River Don valley to the north. The aerial photograph below shows the survey area and the wider surrounding area.

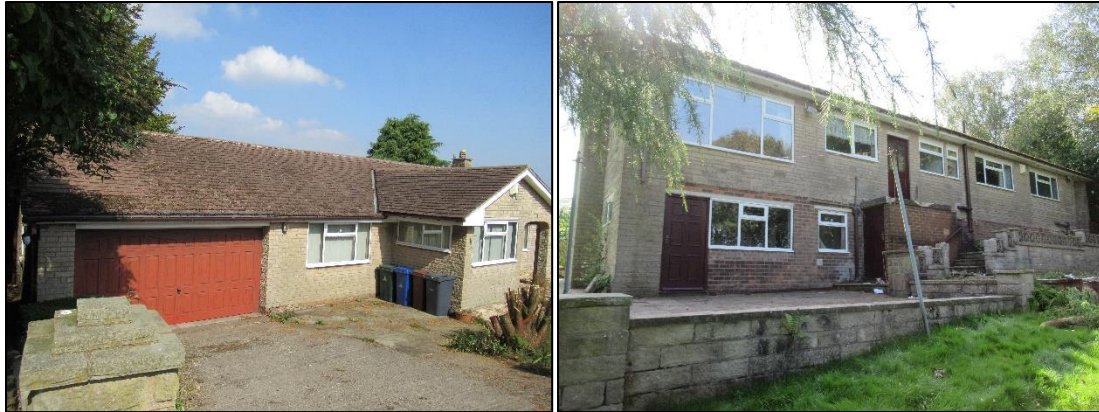
3.3.1. The bungalow is built on a hill and is single storey at the south and west sides and two storey on the east and north. There is an integrated garage on the western end of the building.

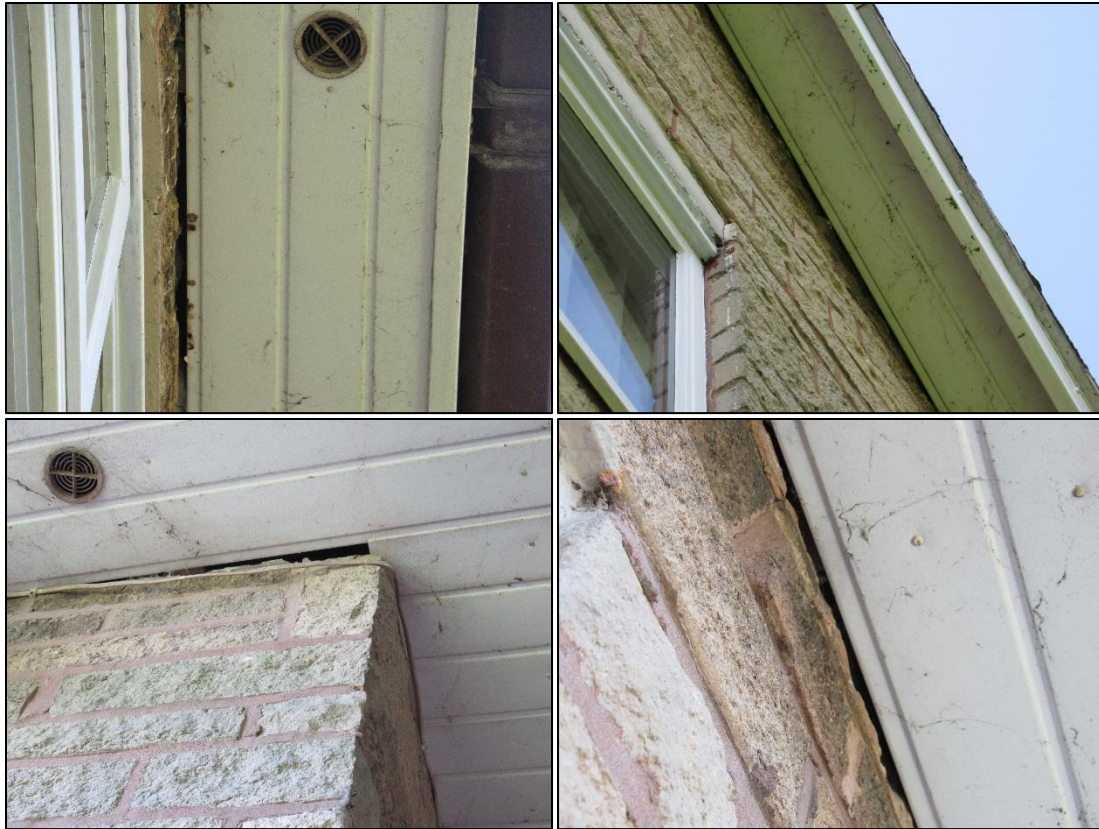
3.3.5. There are narrow gaps where the soffits meet the stone walls on all sides of the building. This provides potential for roosting bats. The photographs below show some of these gaps around the building.

4.1. The building is generally in good condition, however, there are gaps where the soffits meet the stone walls on all sides of the building, which could provide potential for roosting bats.

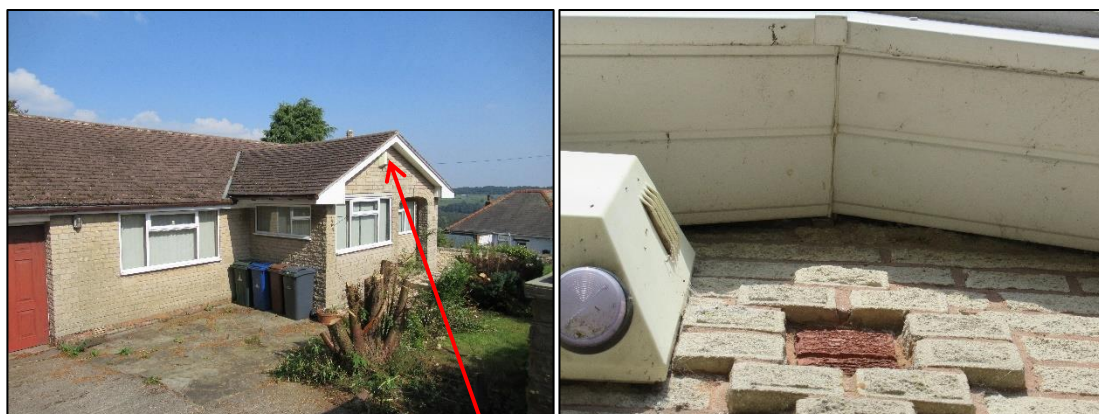
3.3.6. During the survey approximately 25 fresh bat droppings were found on the window cill of the southern porch gable end, on the wall, window, window frame and alarm box. Above these droppings there is a gap between the soffit and the wall at the ridge of the gable end. No droppings were found on the floor below as the slabs here have recently been removed.

3.3.7. The photographs below show the location of the bat roost.

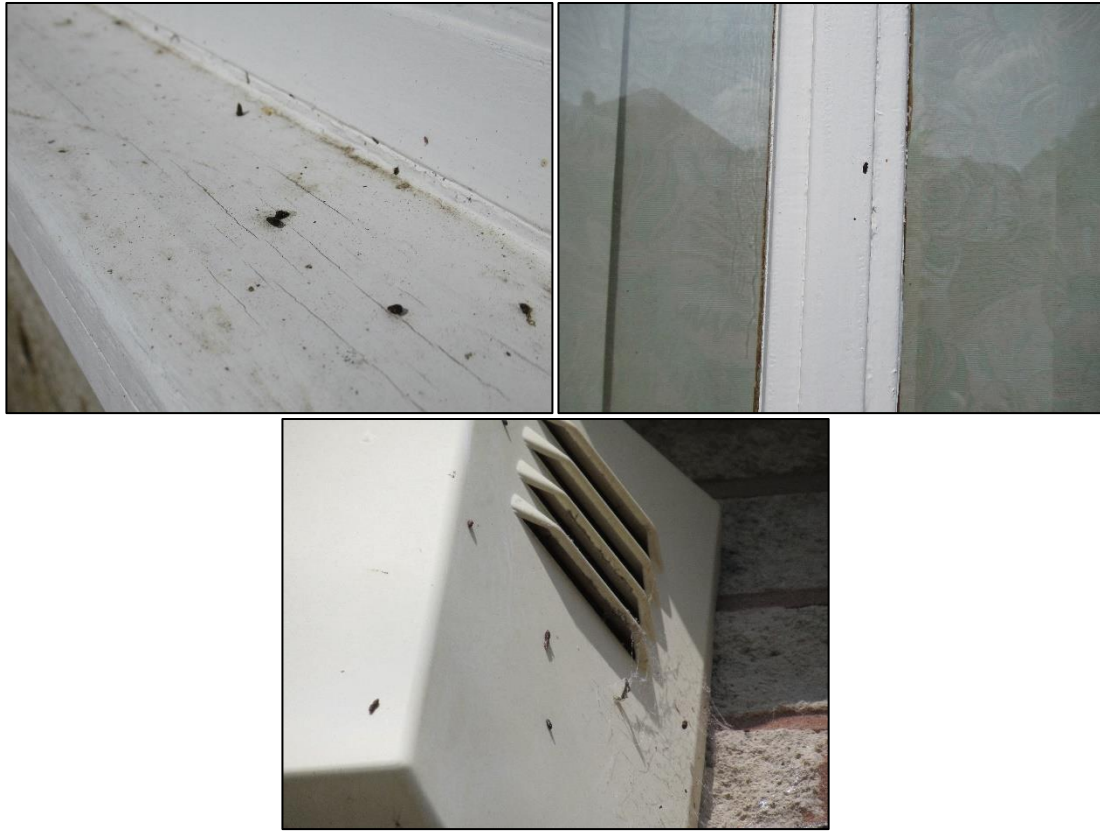
3.3.8. The photographs below show the droppings found below the roost.

3.3.9. Comparison with library samples show these to be Pipistrelle droppings.

3.3.10. As there are bat droppings present on the southern side of the building and potential on all sides for further roosts behind the soffits the building is assessed as providing **high** potential for roosting bats.

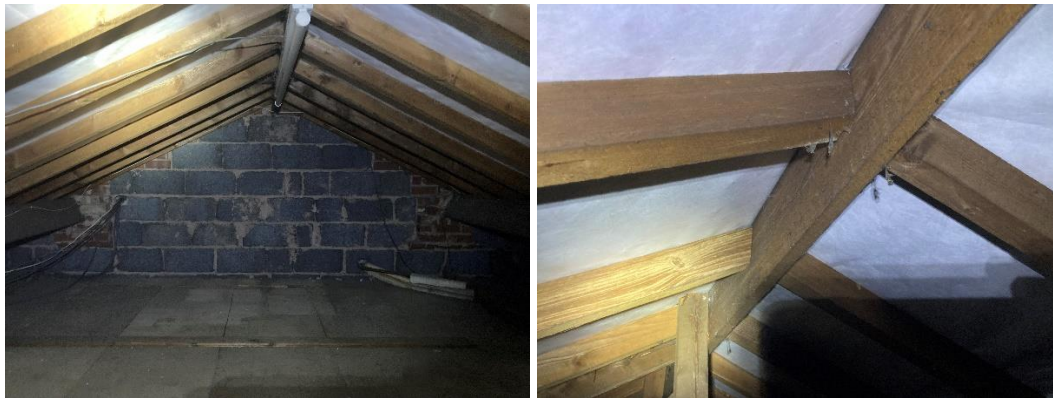
3.4.3. A full inspection of the loft space identified the roof to be effectively lined with tightly stretched breathable membrane. No tears or gaps were found anywhere in the loft space.

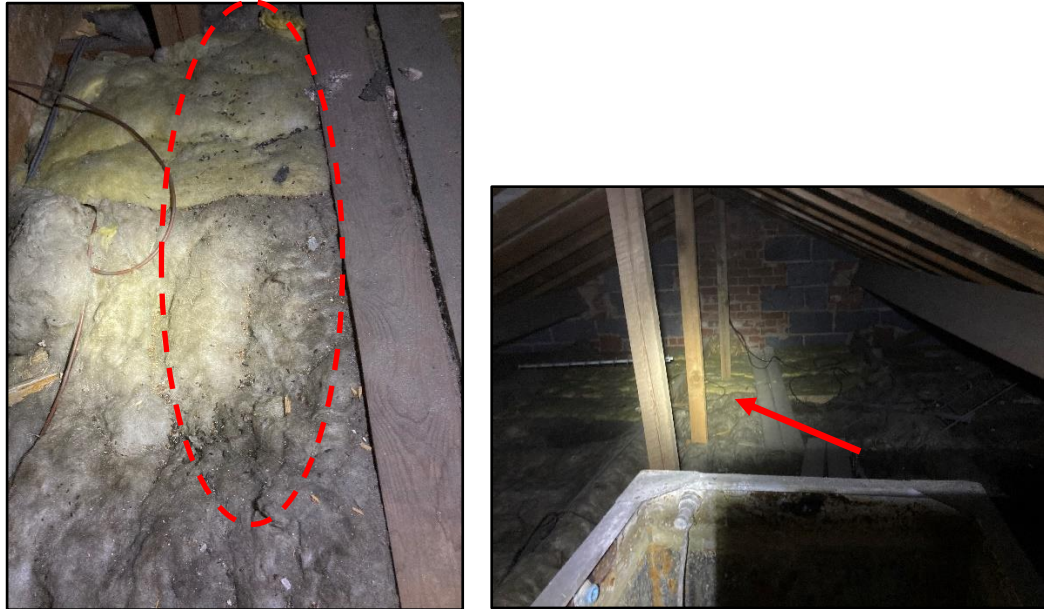
3.4.7. The second was a group of approximately sixty droppings underneath the ridge towards the eastern end of the building. These were small droppings and when compared to library samples were assessed to be Pipistrelle droppings. These are shown in the photograph below.

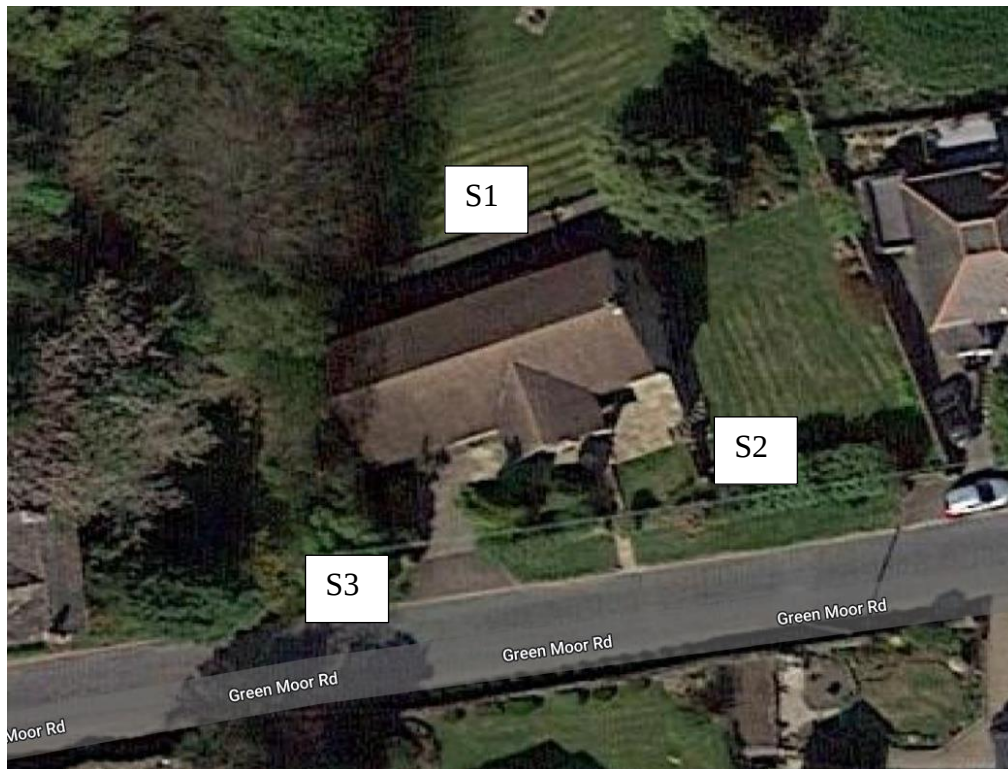
3.5.4. The three surveyors were positioned in order to view all sides of the property simultaneously.

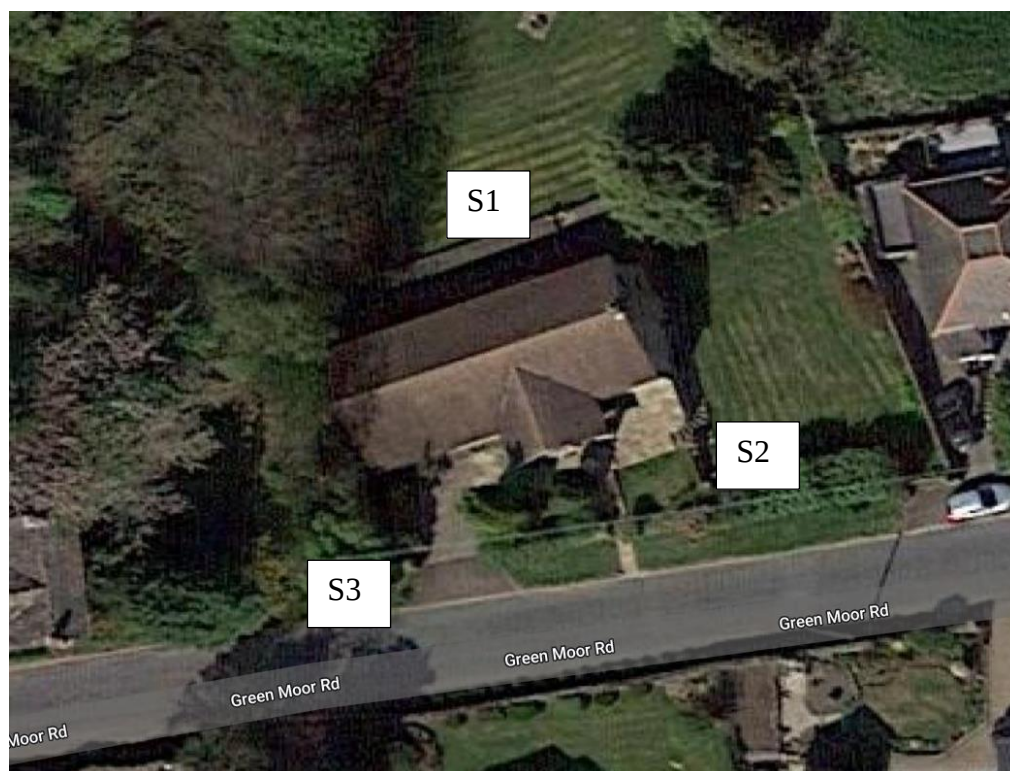
3.6.4. The three surveyors were positioned in order to view all sides of the property simultaneously.

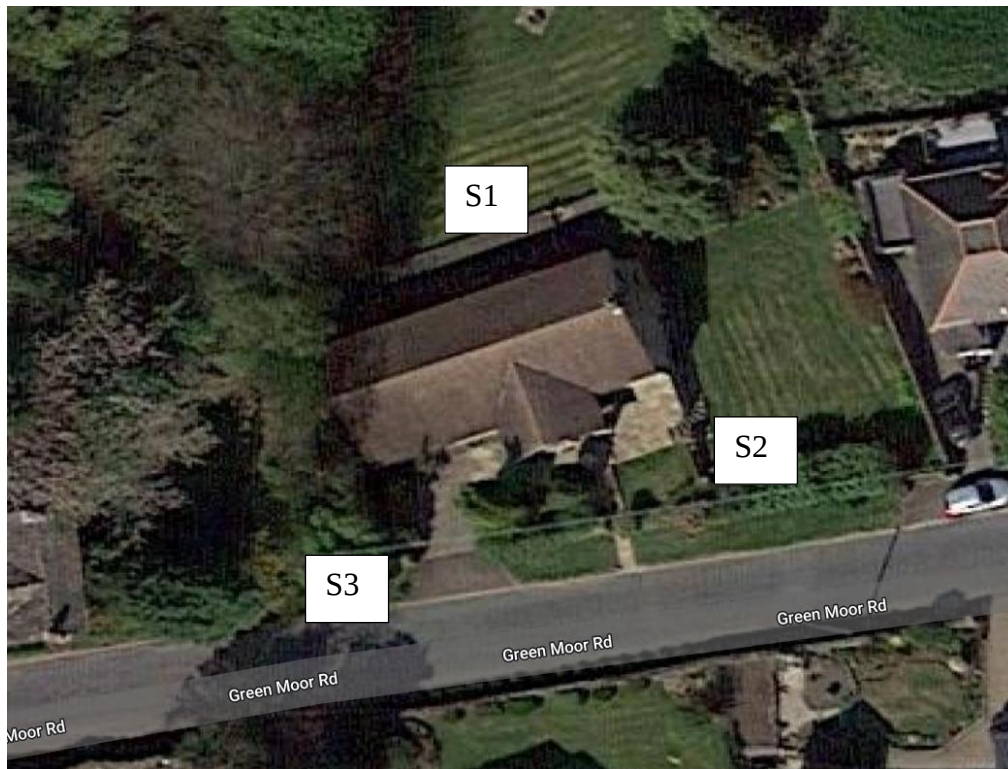
3.7.4. The three surveyors were positioned in order to view all sides of the property simultaneously.

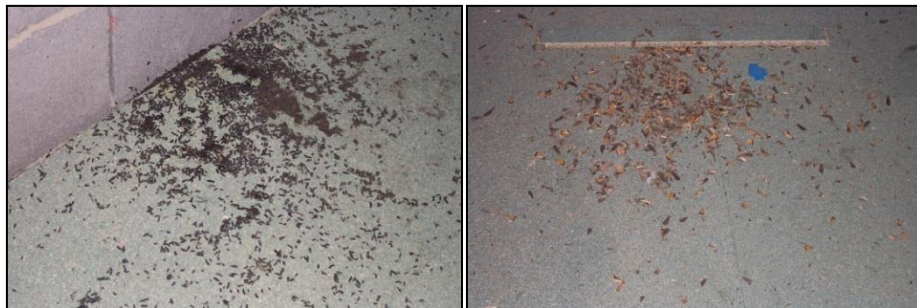
Bats are more easily identified by field signs such as droppings or feeding remains.
