**Land at Cliff Road, Darfield  
Barnsley**

**Phase 2**

**Pre-development Arboricultural Report**

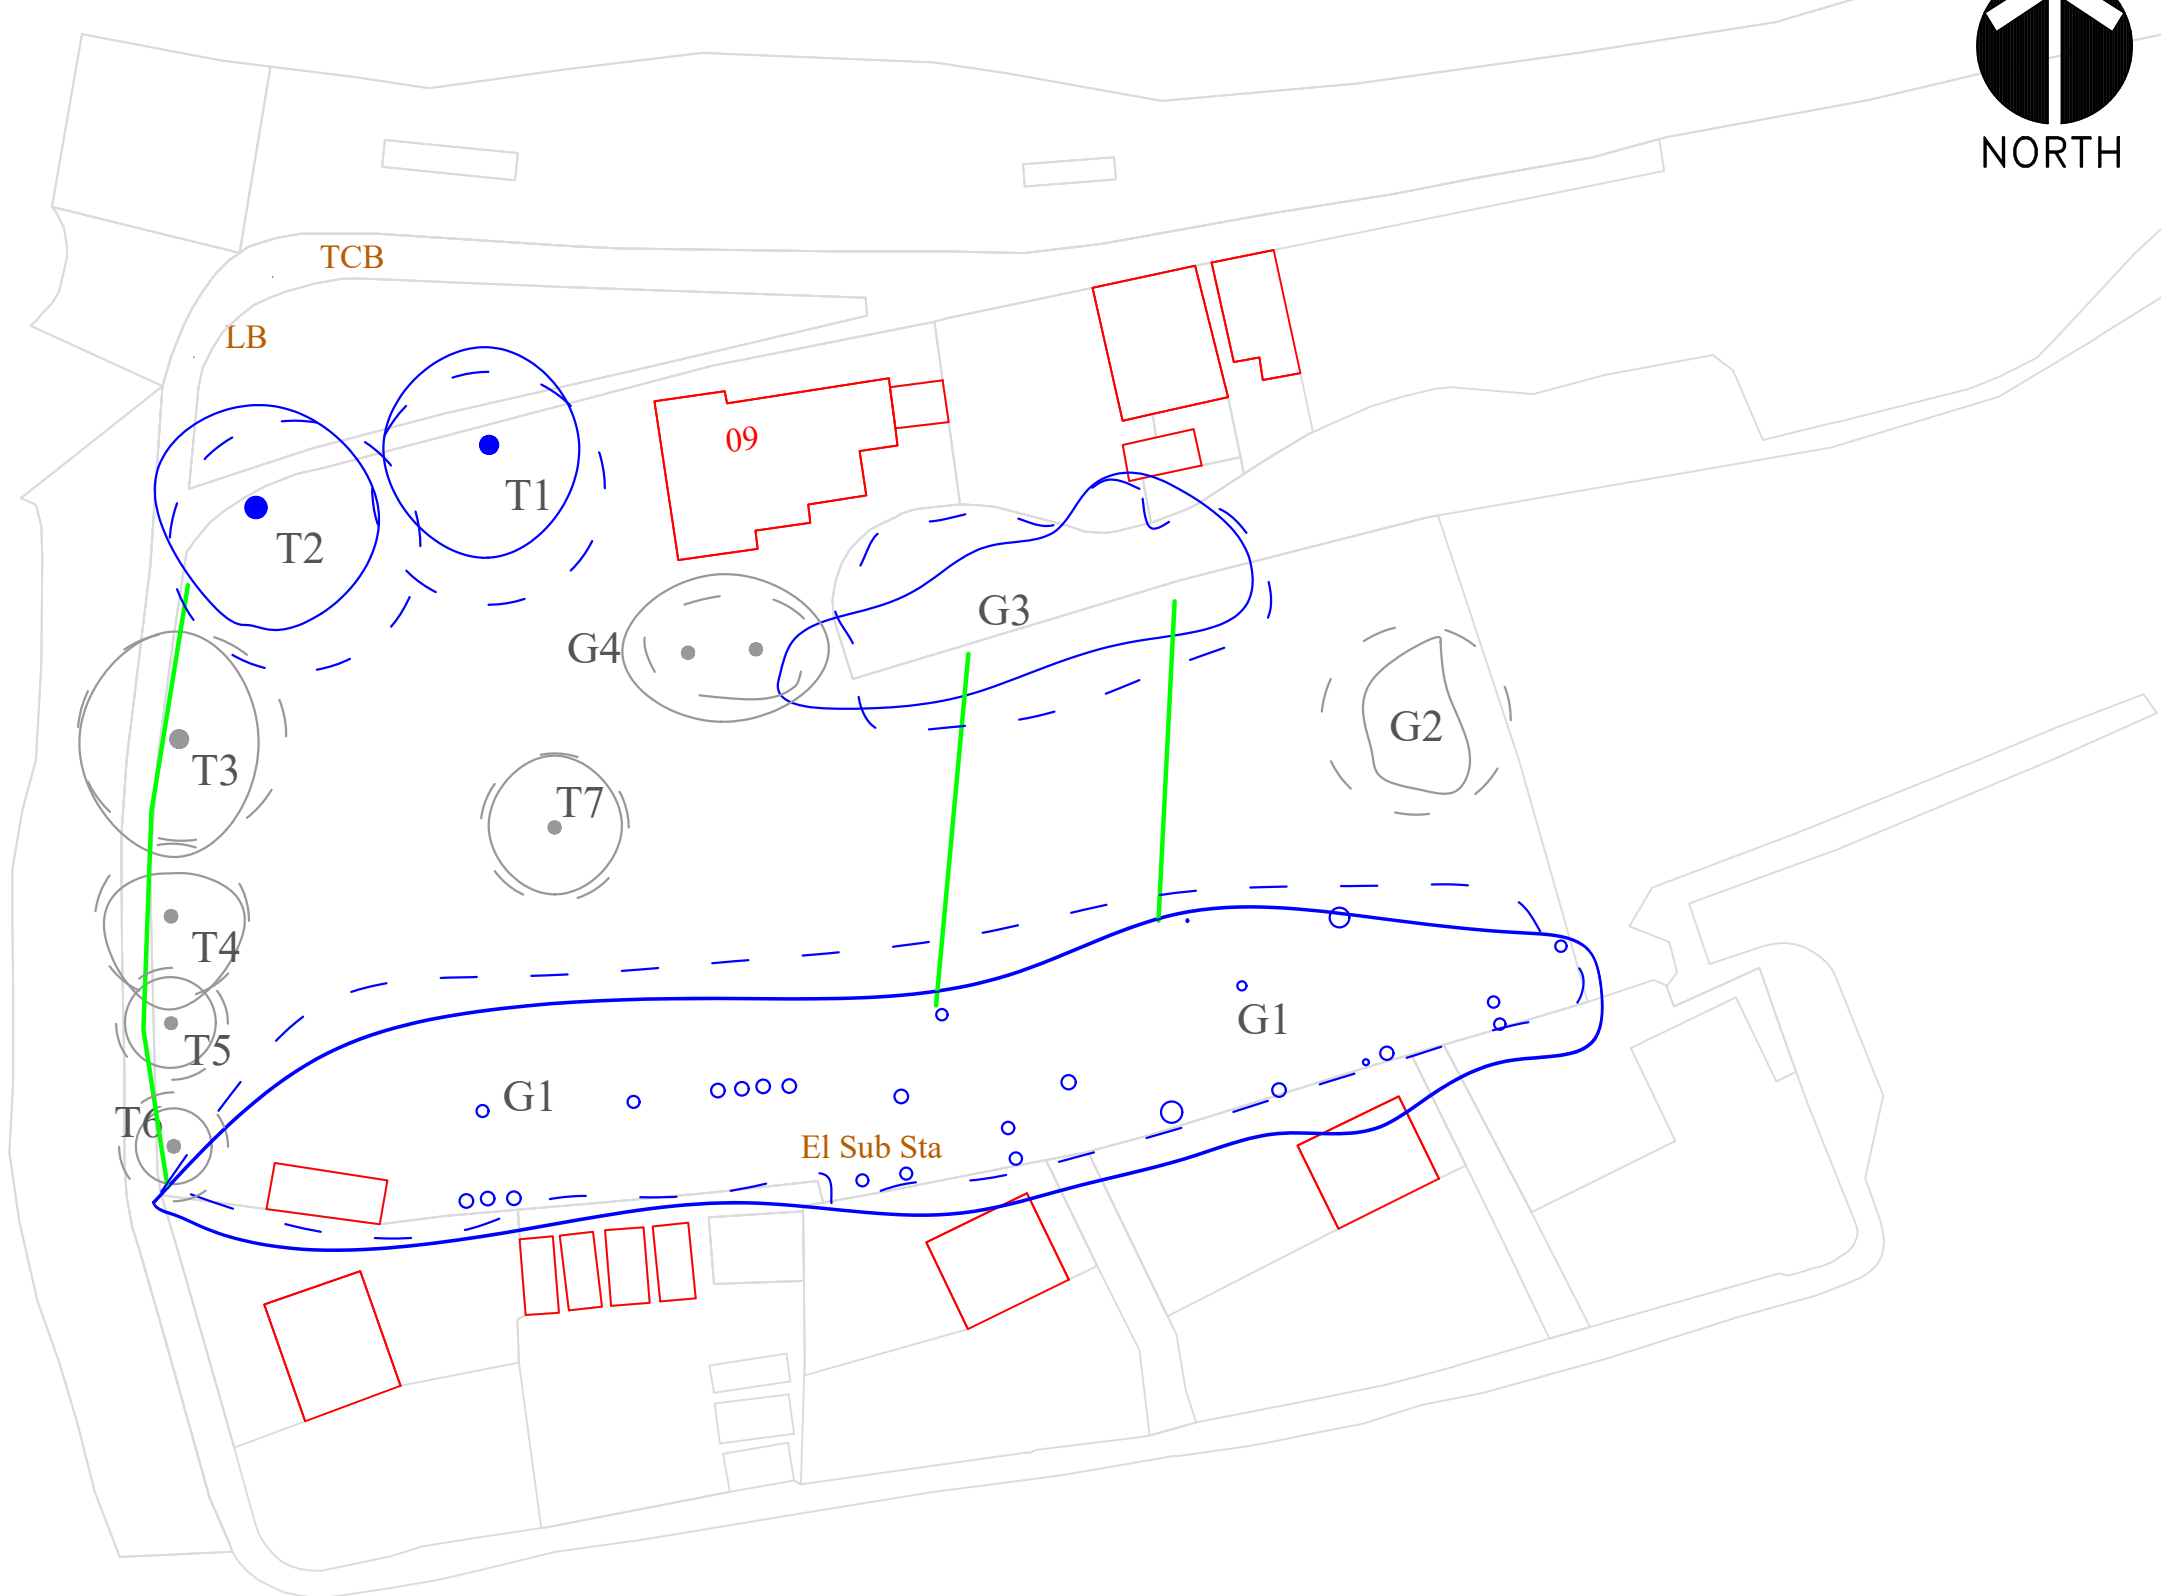
Plan 1 Tree constraints plan showing the existing layout

The trees are growing in the garden of a large property on Doncaster Road. The approximate location of seven individual trees and three groups are recorded on Plan 1 that shows the existing site layout.

Two of the individual trees have been included in retention category 'B' (shown blue on plan 1) because of their favourable condition and high landscape value to the front of the site with Doncaster Road. Two of the groups have also been included in retention category 'B' because of the significance they have in the landscape as cohesive groups.

The remaining five individual trees and two groups have been included in retention category 'C' (shown grey on plan 1) because they are either relatively small, have limited landscape value to the wider area, or have declining health, preventing them being included in a higher category.

This section of the report considers the impact that the proposed layout could have on the trees that are included in Table 1 and shown on Plan 1; *Tree Constraints Plan showing the existing layout*.

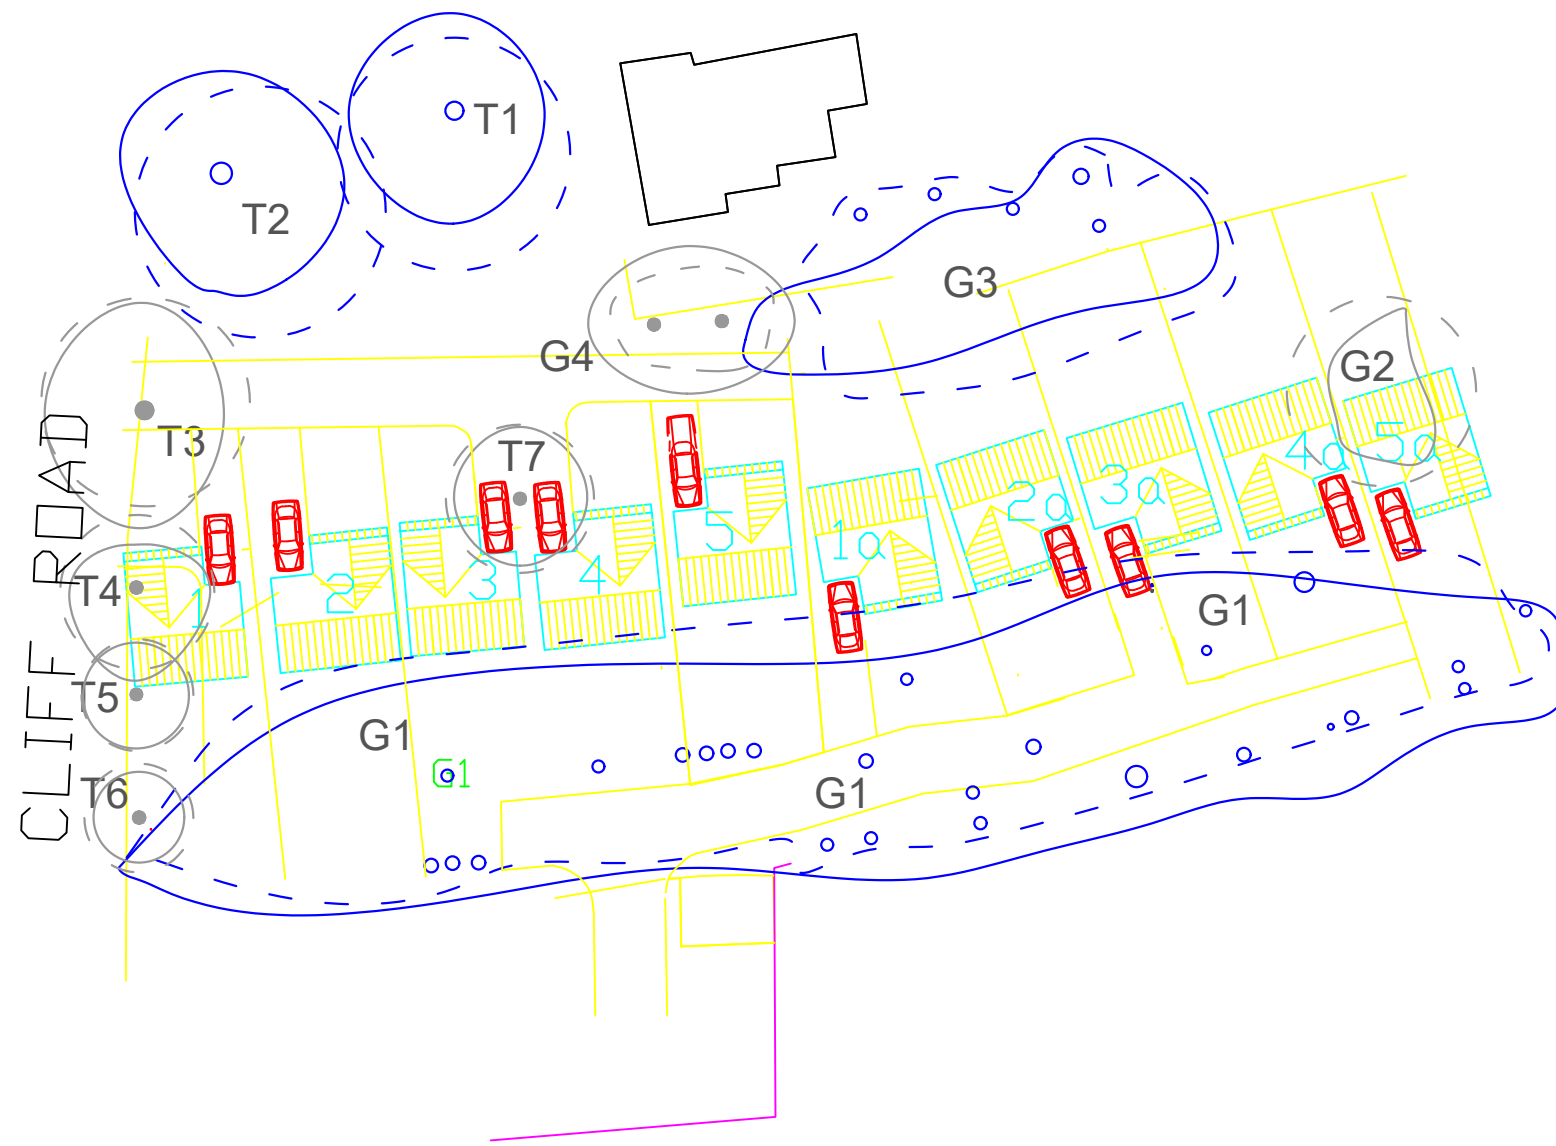
Plan 2 Tree constraints plan showing the proposed layout

The development proposes 10 dwellings across the middle and southern parts of the site.

This would require removal of all but two of the trees. The two trees that would be retained are the large sycamores on the northern boundary that are included in retention category B.

These trees would be unaffected by the proposed layout and could be retained without detriment. There would be no significant shading of the dwellings or gardens because they are growing to the north of the proposed houses.

These trees would need to be removed to accommodate the proposed layout.

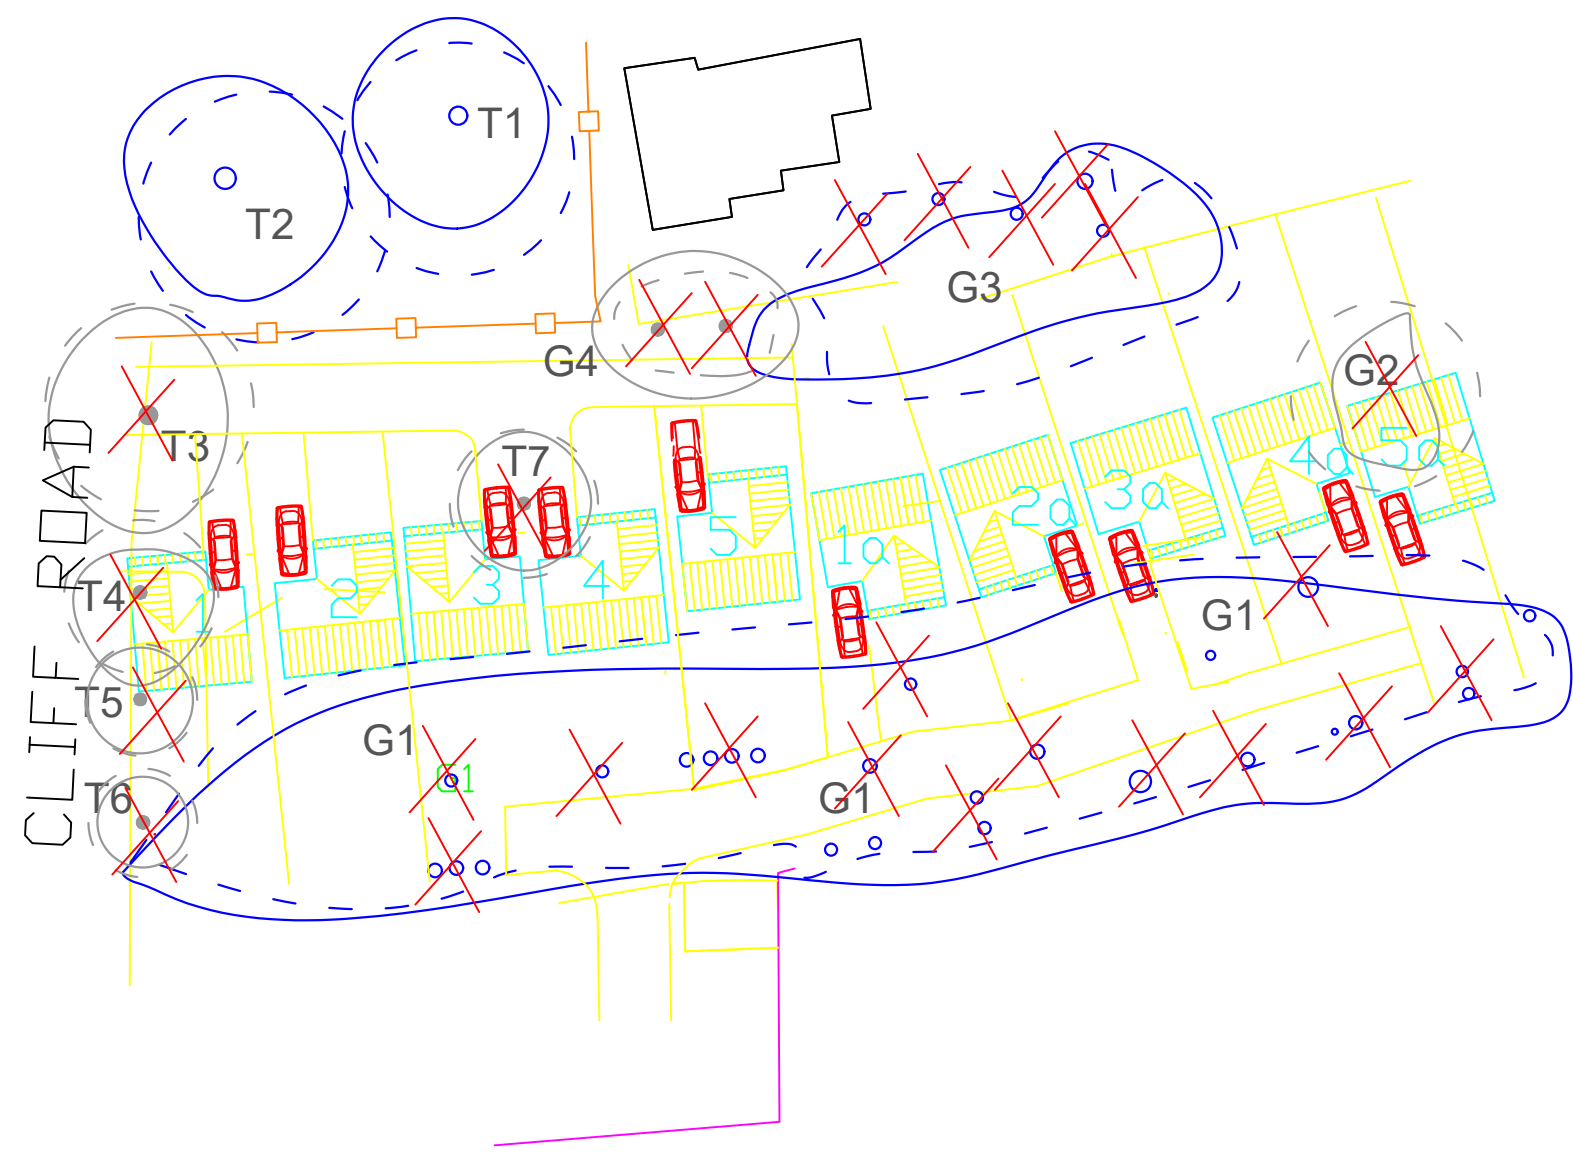
Plan 3 Tree protection plan showing the proposed layout

Tree protective fencing will be required to protect the trees being retained. These are Trees 1 and 2 in this report. This fencing should be erected outside of the RPAs and crown spreads of each tree.

Plan 3 is the suggested Tree Protection Plan showing the position of the fencing should the layout be implemented, and the trees retained as discussed in Section 4.1 above.

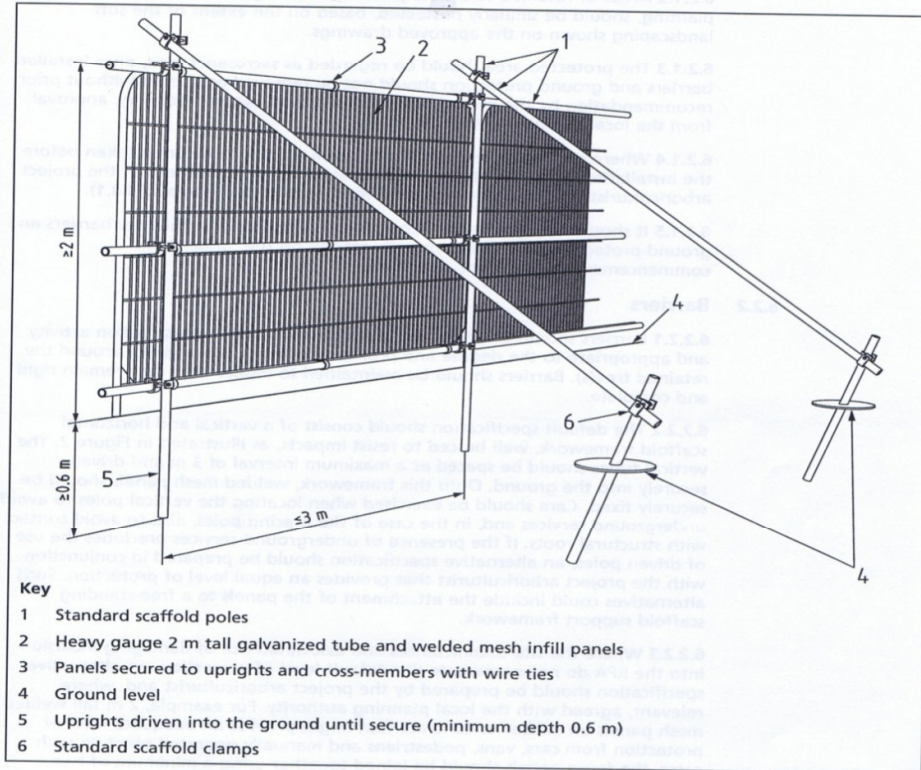
Figure 2 Default specification for protective barrier

6.2.2.4 All-weather notices should be attached to the barrier with words such as: "CONSTRUCTION EXCLUSION ZONE – NO ACCESS".

The fencing specification in Appendix 4 is the suggested level of protection in British Standard 5837: 2012. An alternative may be agreed with the local planning authority.
