## Existing Material Features

The Fitzwilliam Arms No42

Hill Street

Elsecar

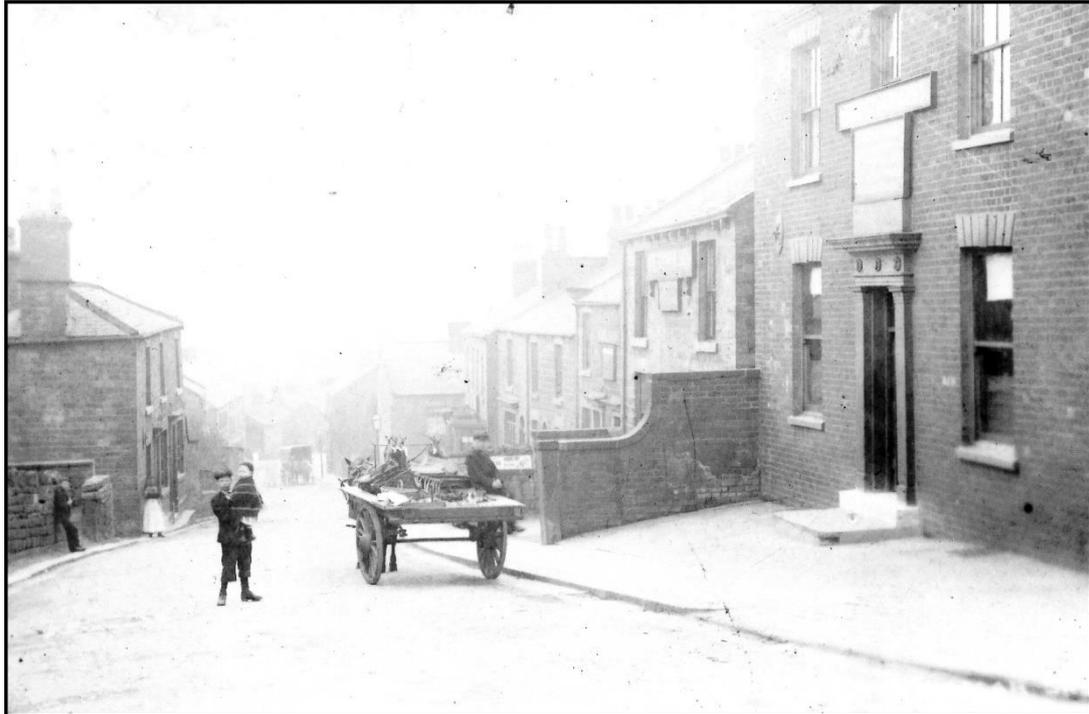
## Brickwork and Features

- Facade brickwork showing Flemish bond pattern.
- Tie bar ends to be reinstated in the same locations.
- Window heads and cills to be restored.

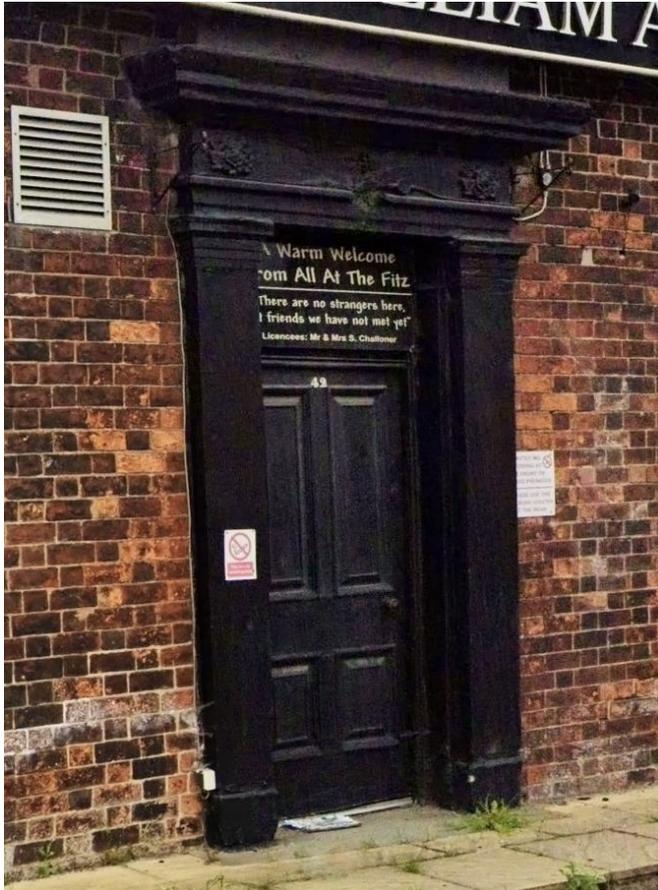
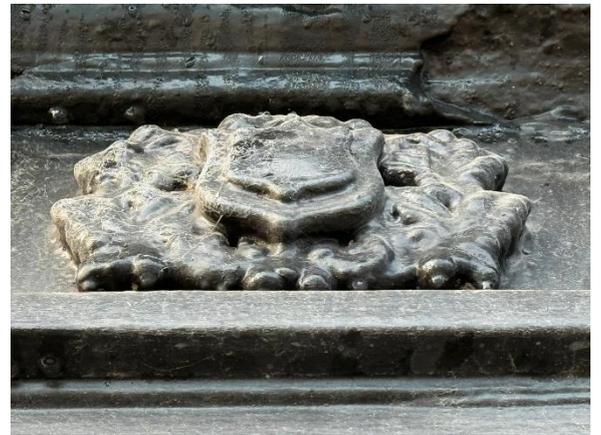
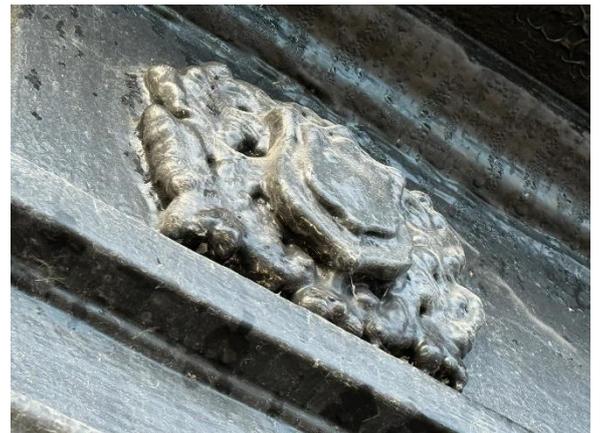
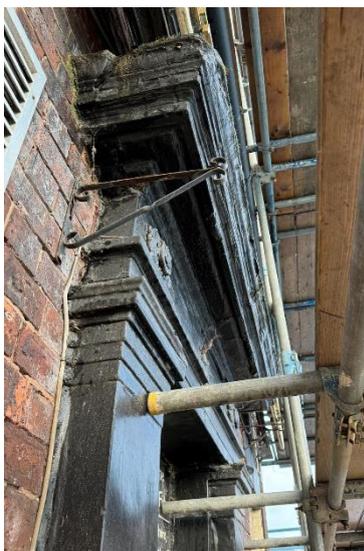
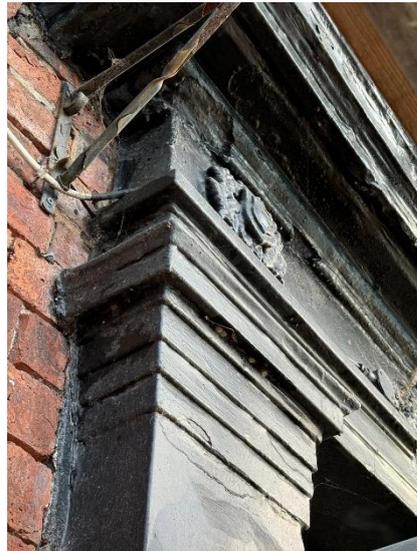
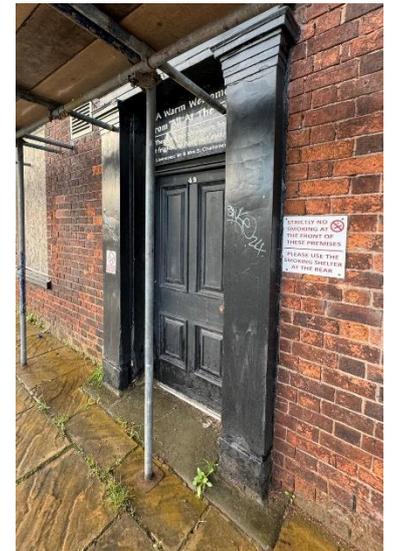
## Stone Door Surround

- Images showing crests and profiles.
- Surround to be sent off for specialist restoration.
- To be painted black as existing.

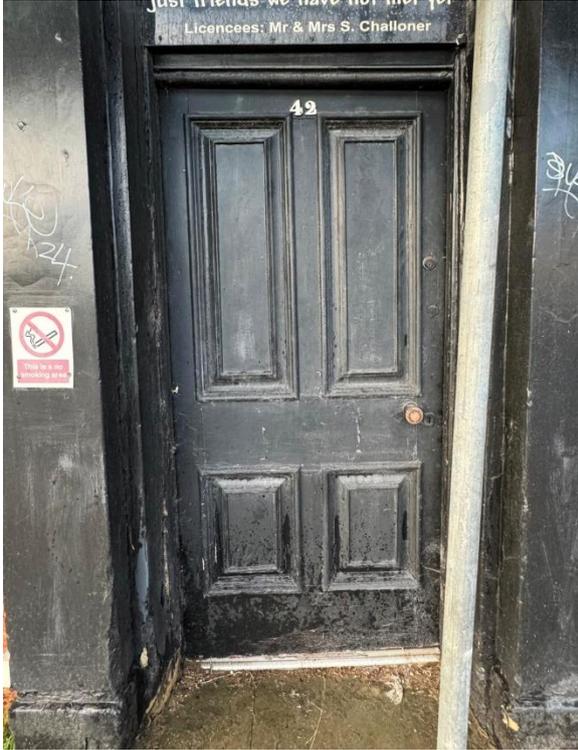
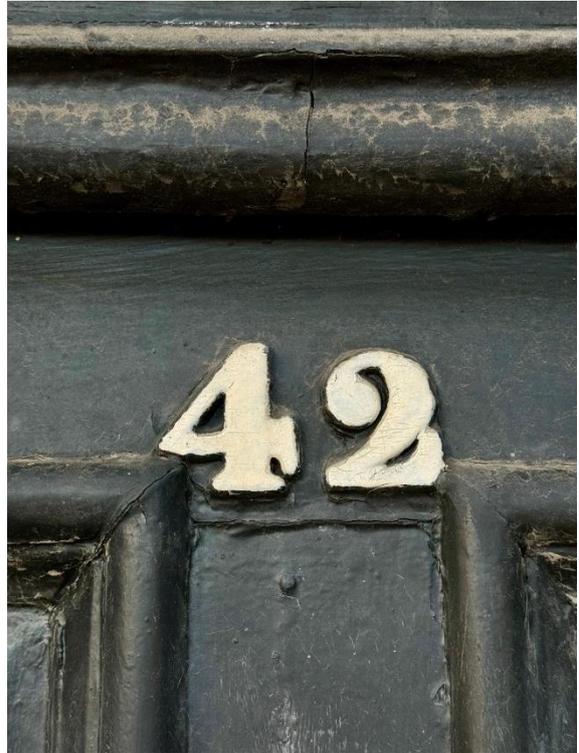
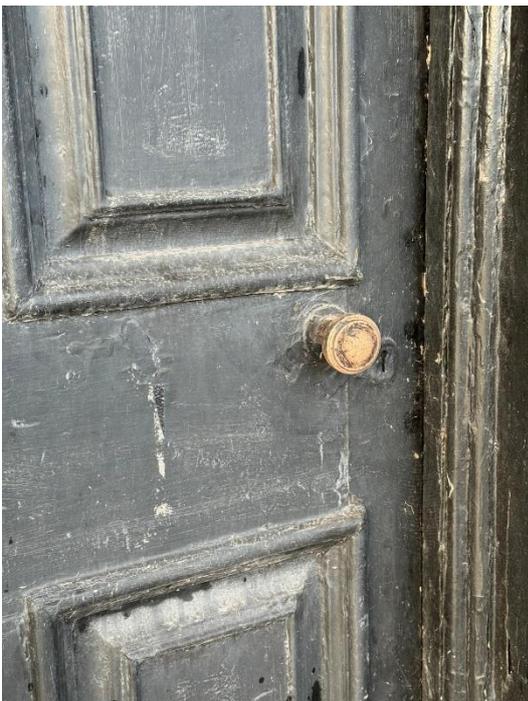
## Front Door

- Front door to be restored, painted black and reinstated on rebuilt elevation.
- No42 restored and reinstated.
- Door knob to be restored and instated
